**DECLARATION OF SUMEET SINGH  
SUPPLEMENTING THE VERIFIED STATEMENT OF  
PACIFIC GAS AND ELECTRIC COMPANY'S VICE  
PRESIDENT OF GAS TRANSMISSION MAINTENANCE  
AND CONSTRUCTION IN RESPONSE TO RULING OF  
ASSIGNED COMMISSIONER AND ASSIGNED  
ADMINISTRATIVE LAW JUDGE.**

5. Attached as Exhibit 1 is a copy of Anamet's September 6, 2013 Report No. 5005.9268, Metallurgical Evaluation of a Section From L-147 MP 2.2 Brittan Ave. and Rogers Ave., San Carlos.

Report No. 5004.9268

**METALLURGICAL EVALUATION OF A SECTION FROM  
L-147 MP 2.2 BRITTAN AVE. AND ROGERS AVE., SAN CARLOS**

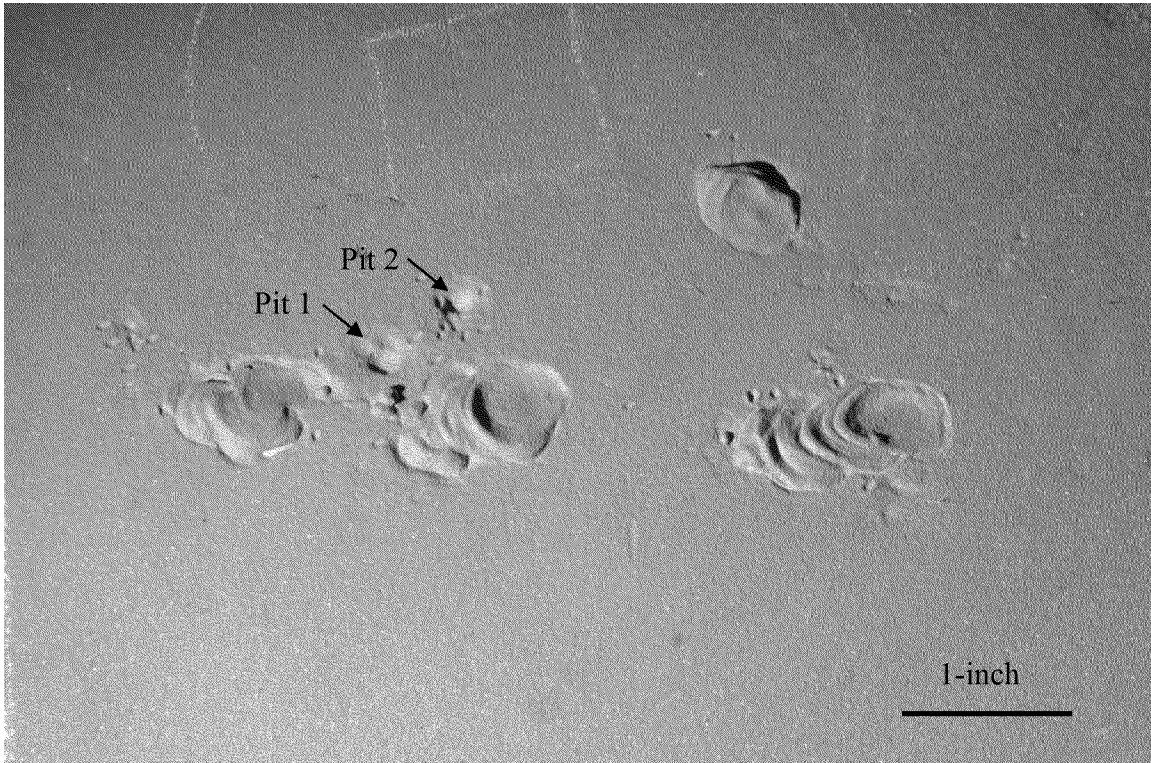
(a) Boxed area  $\beta$  in Figure 1a

Figure 2 Photographs of the outside surface of sample half A as-received.

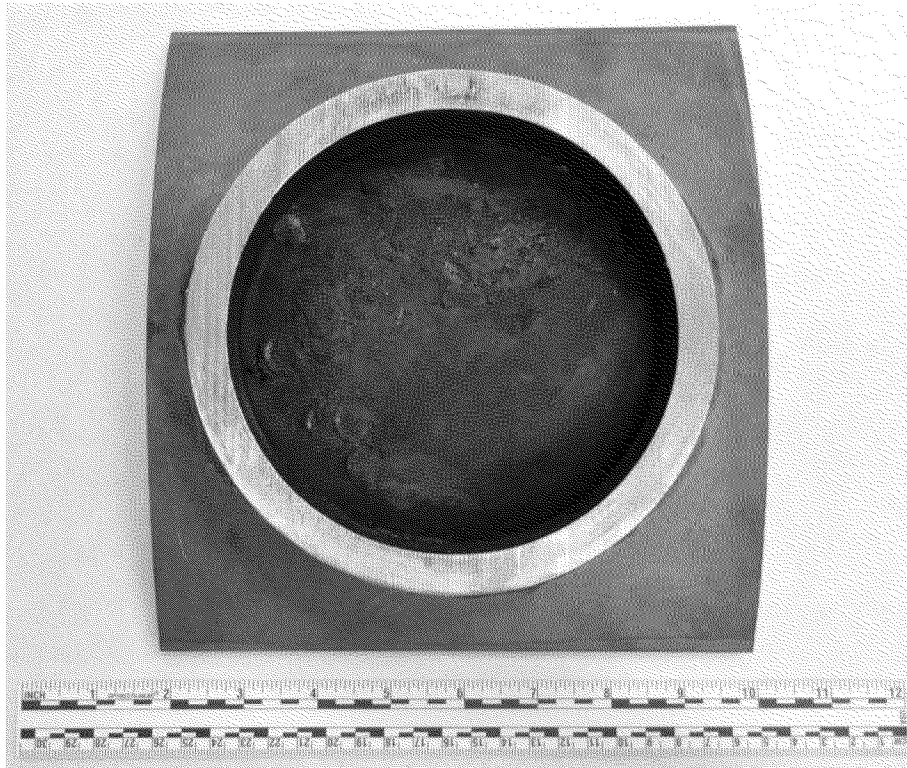
(a) Before cleaning

Figure 6 Photographs of the PLIDCO cap area after sectioning.

The region containing the PLIDCO cap was sectioned from sample A and the cap was cut off to expose the outside surface of the pipe wall. The outside surface was covered with rust and had a slightly oily feel. Both surfaces were cleaned with dilute Oakite® 33 and a wire brush. The outside surface is shown before and after cleaning in Figure 6. Several regions of weld metal were visible on the outside surface. Examination using low-power optical microscopy revealed a pit consistent with corrosion on the outside surface, indicated in Figure 7. The inside surface is shown after cleaning in Figure 8. Indications of heat exposure were visible on the inside surface, corresponding to the weld metal on the outside surface. No evidence of weld burn through was detected, and fine grooves typical of wrought steel surfaces were continuous across the region, which indicated that repairs did not extend to the inside surface. Examination using low-power optical microscopy revealed a crack-like feature on the inside surface within the heat affected zone of a weld deposit, as shown in Figure 8b.

Both sides of the cap sample shown in Figure 6 were thoroughly cleaned with acetone and dried with compressed air. A liquid penetrant test was performed by applying developer to the inside surface, and penetrant was liberally applied to the outside surface in the area covered by the cap. After 1.5-hours, no indication of penetrant was visible on the inside surface.

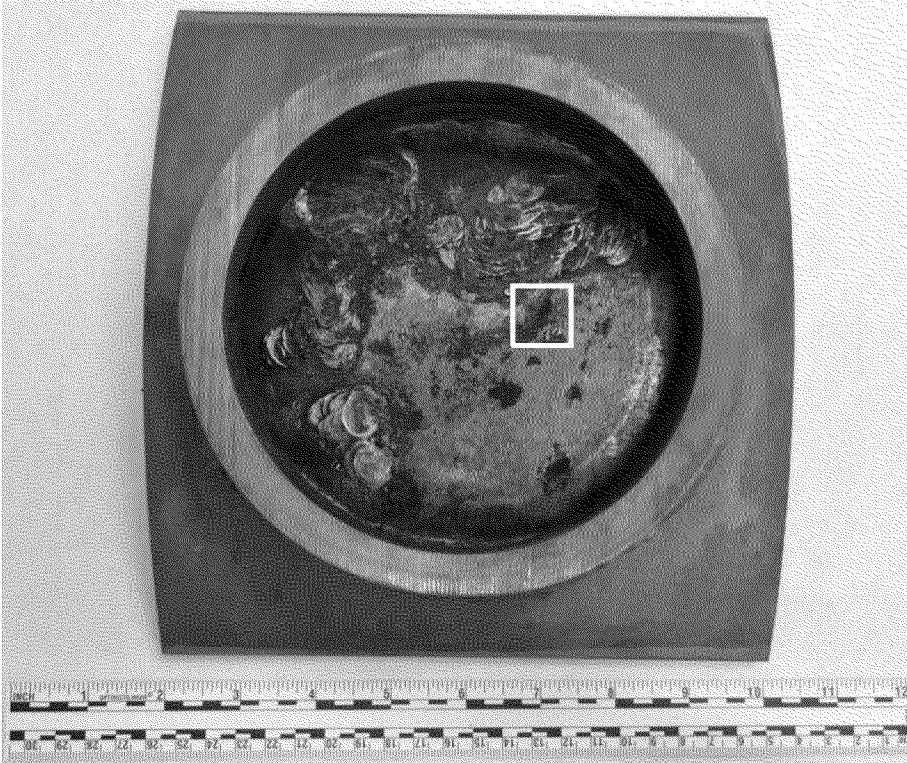
(b) After cleaning

The sample shown in Figure 6 was returned to PG&E for radiography. A digital radiograph of the sample is shown in Appendix A along with a photograph of the sample. A crack indication was found that corresponded to the crack-like feature detected visually on the inside surface, shown in Figure 8b.

A pressure test was performed by clamping a plate over the sectioned cap, sealed with a silicone gasket, and introducing 40-psig of compressed air. Snoop® liquid leak detector was applied to the inside surface. No leaks were detected. The compressed air was valved-off, and no pressure drop from 40-psig was detected after 45-minutes.

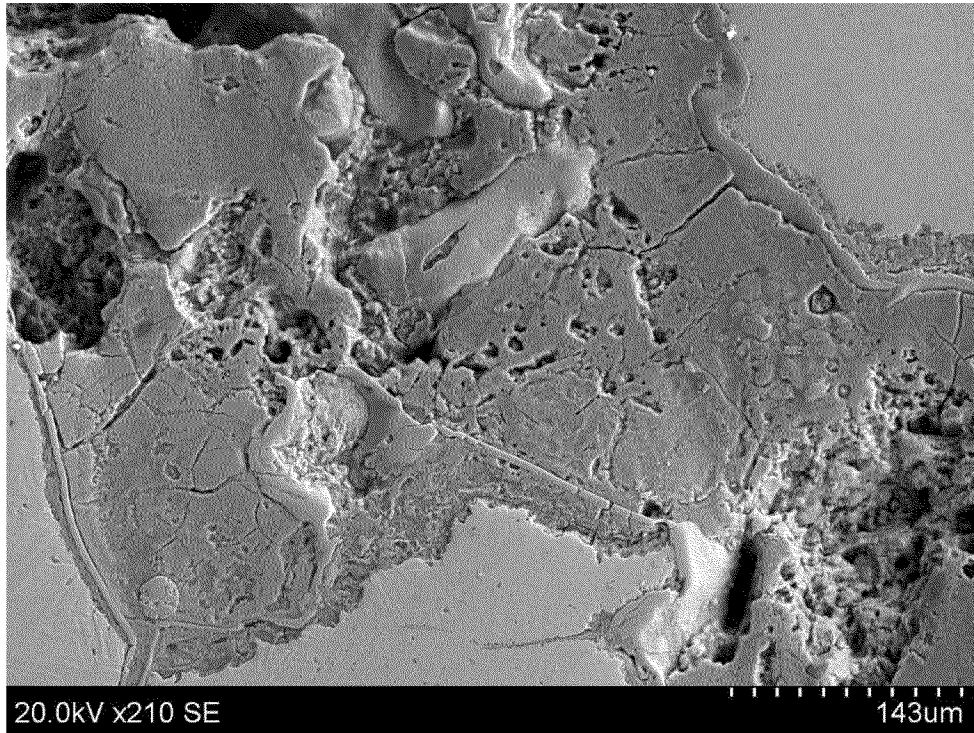
(a) SEM micrograph

Figure 22 SEM image and EDS dot map for iron from the specimen prepared for metallography, section 1c.

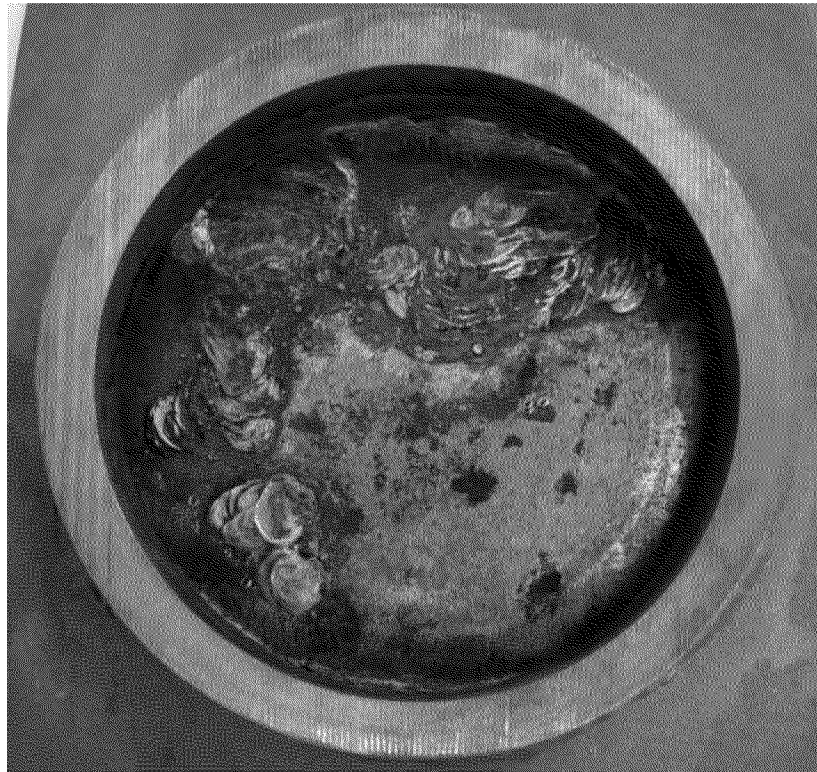
(a) Photograph of area under PLIDCO cap after cleaning

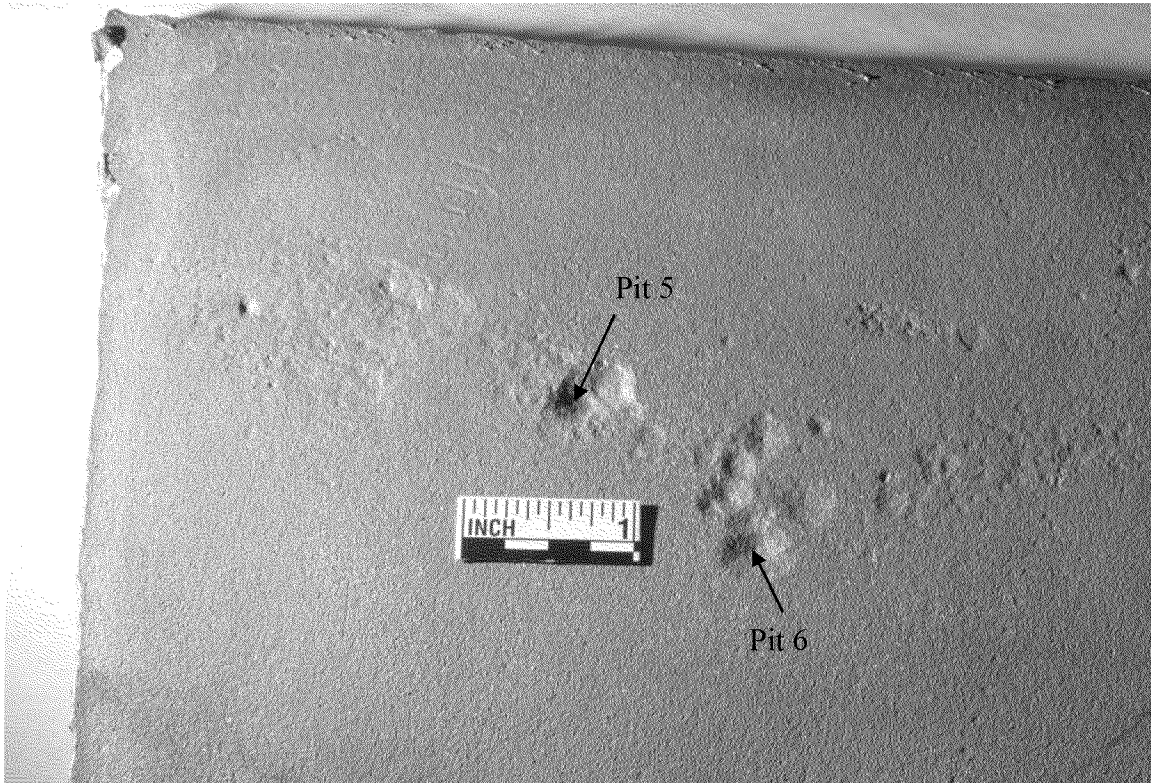
(a) Location  $\delta$ , just past three o'clock, indicated in Figure 1a

Figure 3 Photographs of pits on the outside surface and the inside surface of sample A.

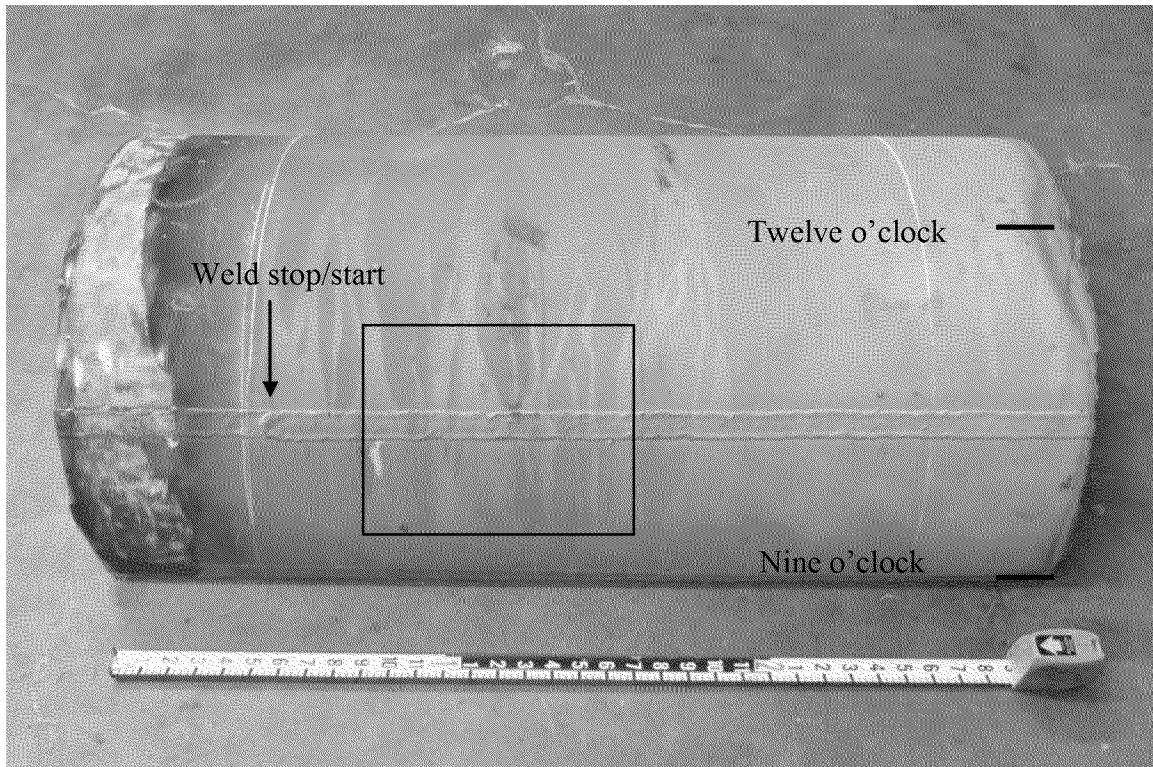
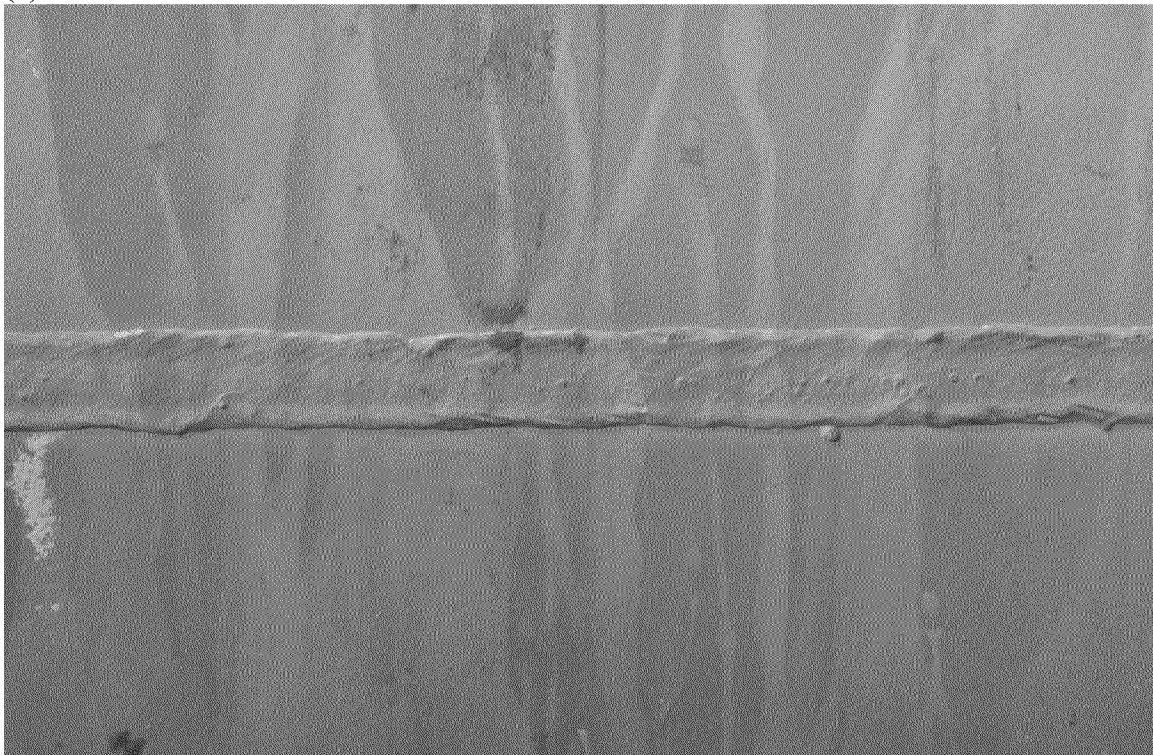
Figure 4 Photographs of the outside surface of sample half B.

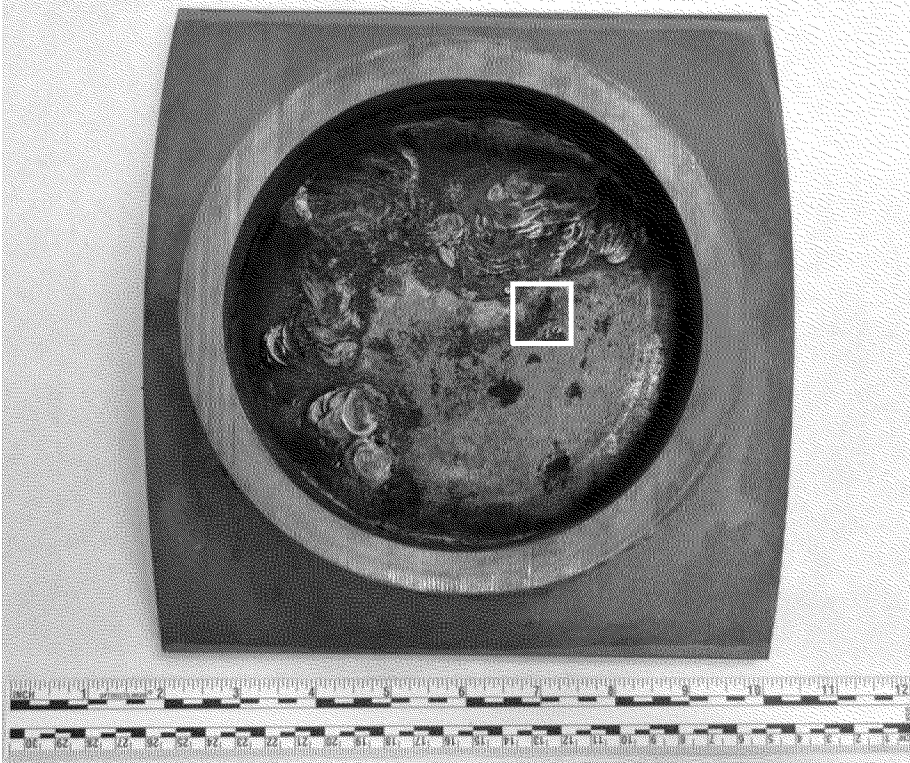
(b) After cleaning

Figure 6 Photographs of the PLIDCO cap area after sectioning.

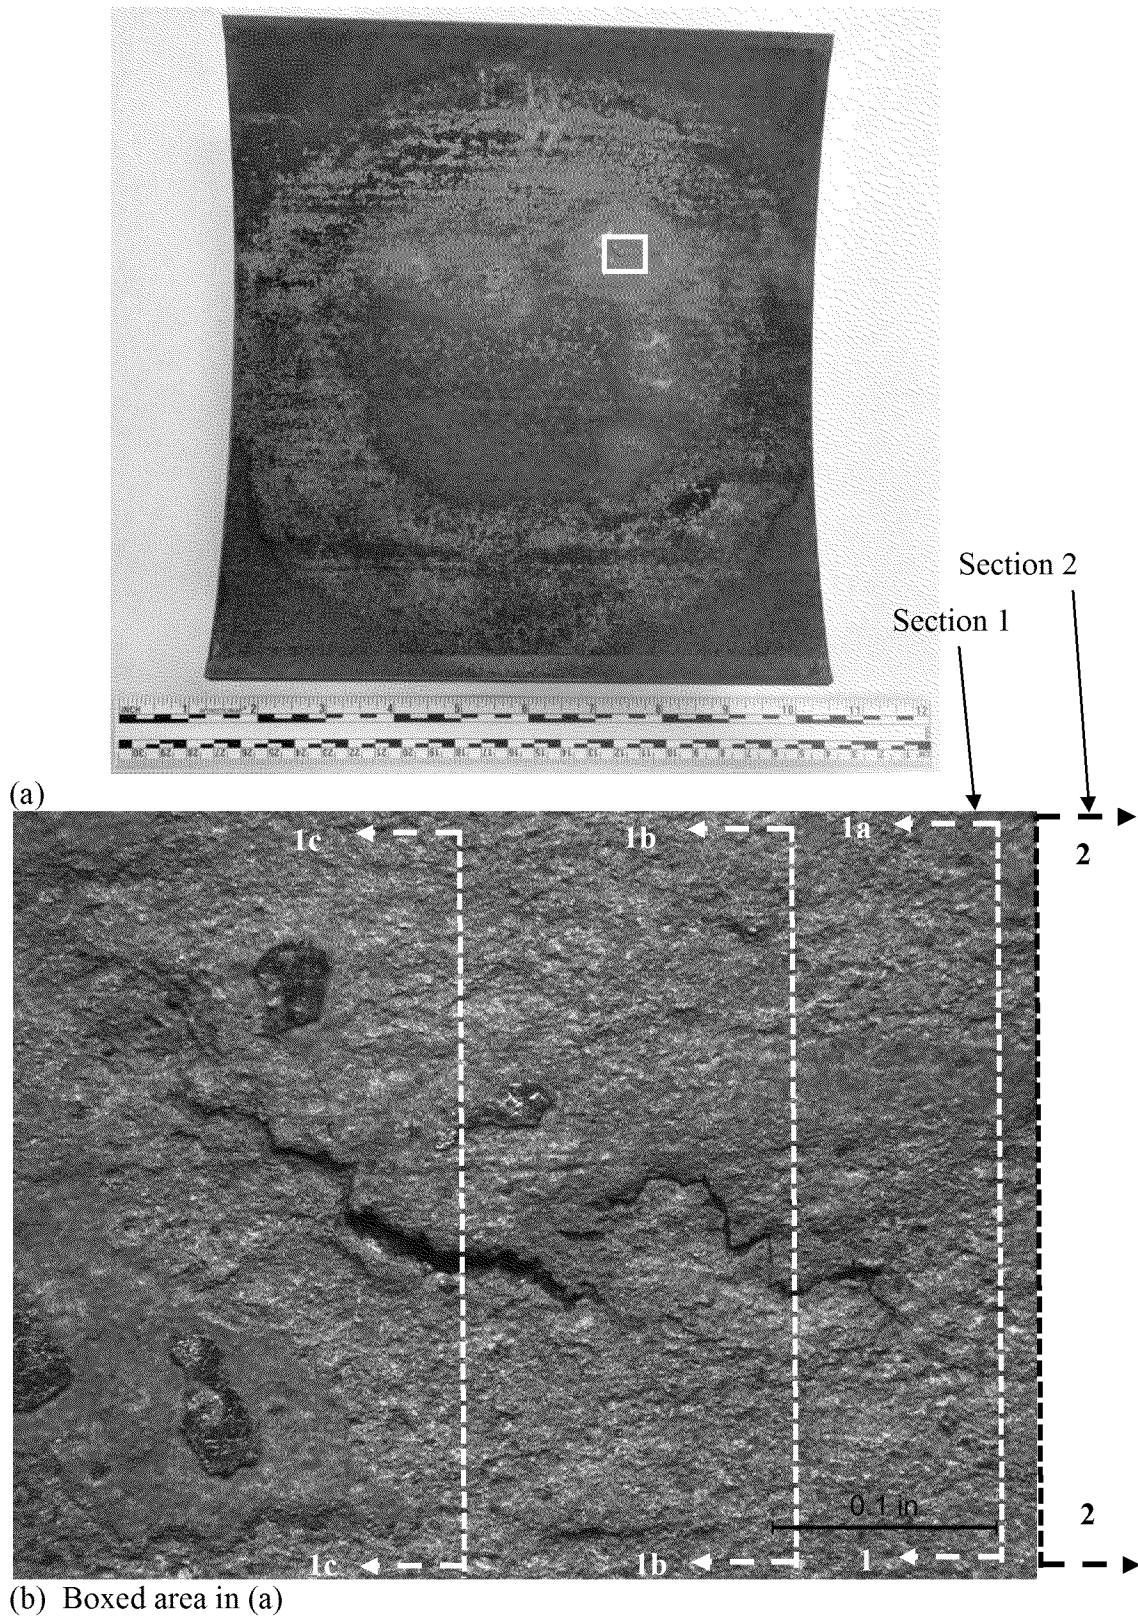
Specimens were prepared for metallography from section 1 and 2 indicated in Figure 8b. Weld crater cracks and heat affected zone liquation cracks were present in the sections. Serial grinding and polishing was performed on section 1, referred to as sections 1a, 1b, and 1c. As shown in Figure 10 through Figure 20, a weld crater crack extended from the outside surface into the weld heat affected zone in section 1a, but did not penetrate through the wall at this location. Shrinkage porosity was present near the outside surface, and intergranular cracks consistent with grain boundary liquation were present in the heat affected zone.

Figure 8 Photograph (a) and macrograph (b) of the inside surface of sample half A under the PLIDCO cap, after cleaning.

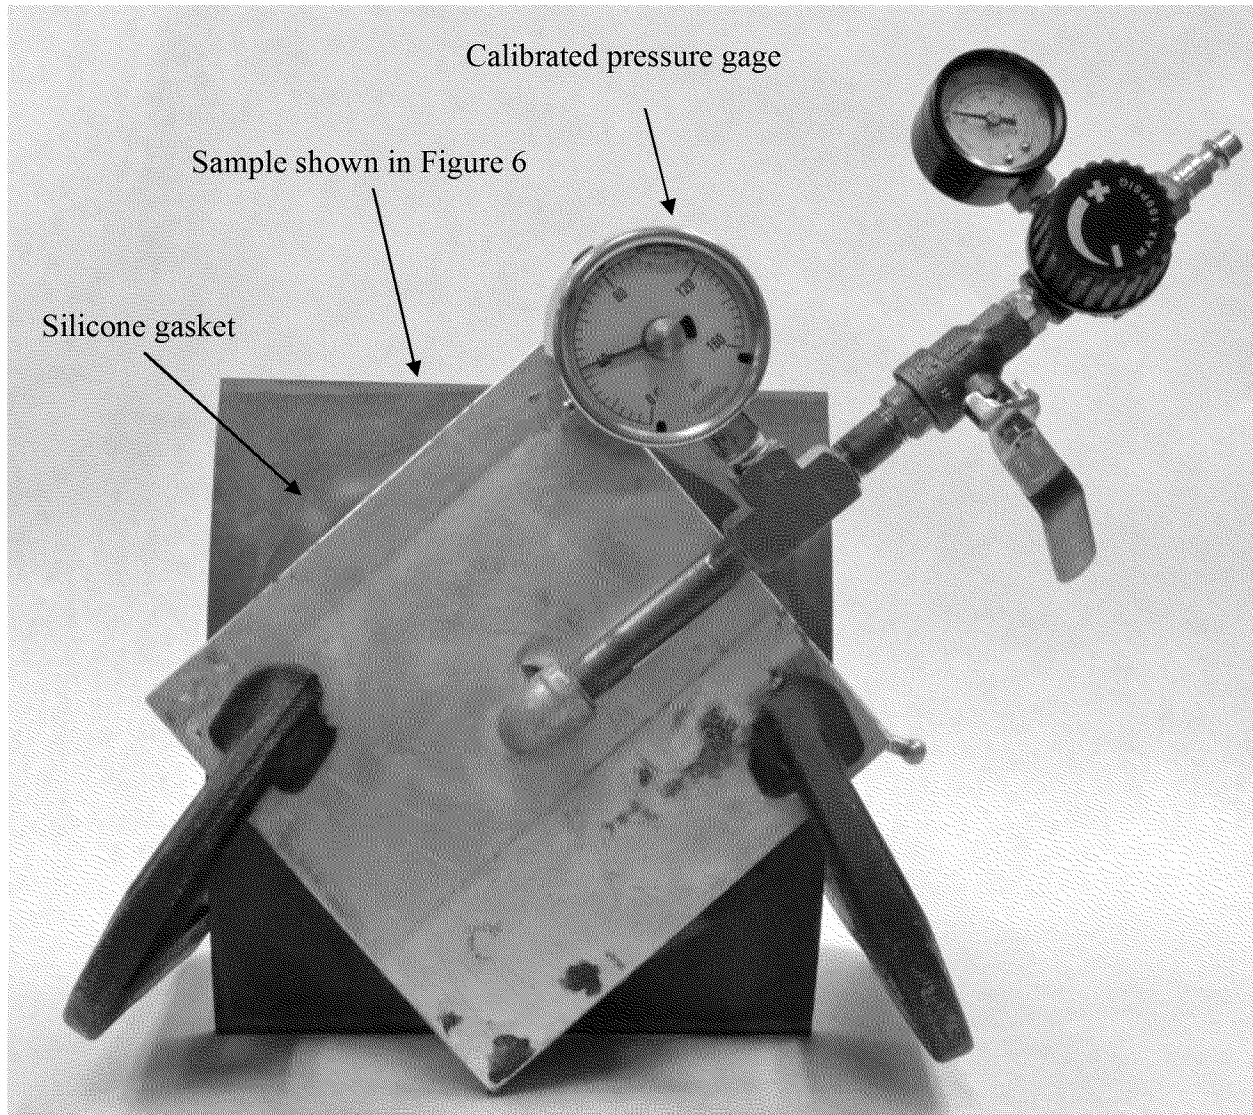
Figure 9 Pressure test setup.

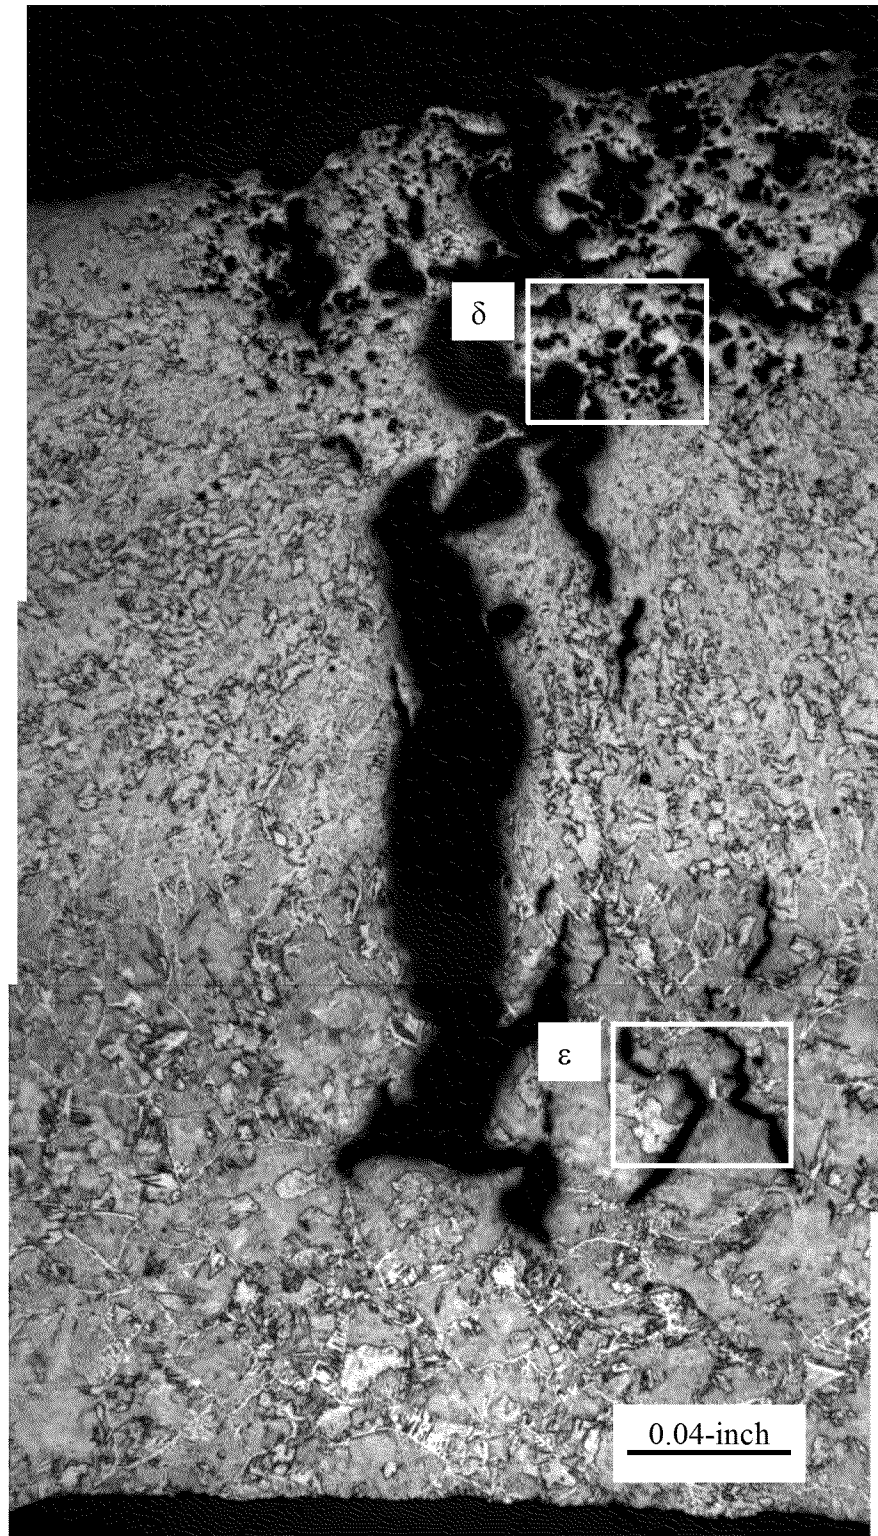
Figure 11 Composite optical micrograph of the specimen prepared for metallography, section 1a. Etched with 2% nital.

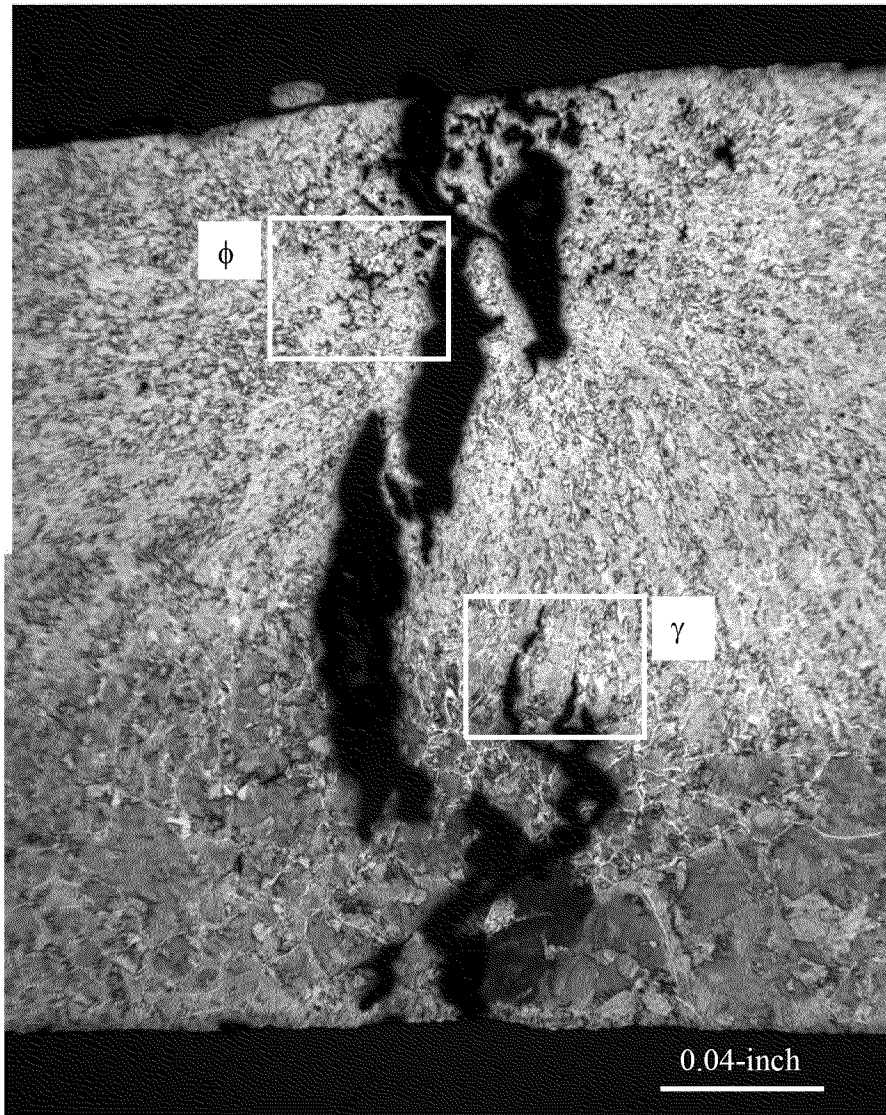
In section 1b, shown in Figure 13 through Figure 15, cracks were present from the outside surface to the inside surface. Only a few small ligaments prevented the demonstration of a through-wall leak path. However, it is likely that a leak path existed between section 1a and 1b. The weld metal crack morphology was consistent with shrinkage, and the heat affected zone crack morphology was indicative of grain boundary liquation.

Figure 14 Composite optical micrograph of the specimen prepared for metallography, section 1b. Etched with 2% nital.

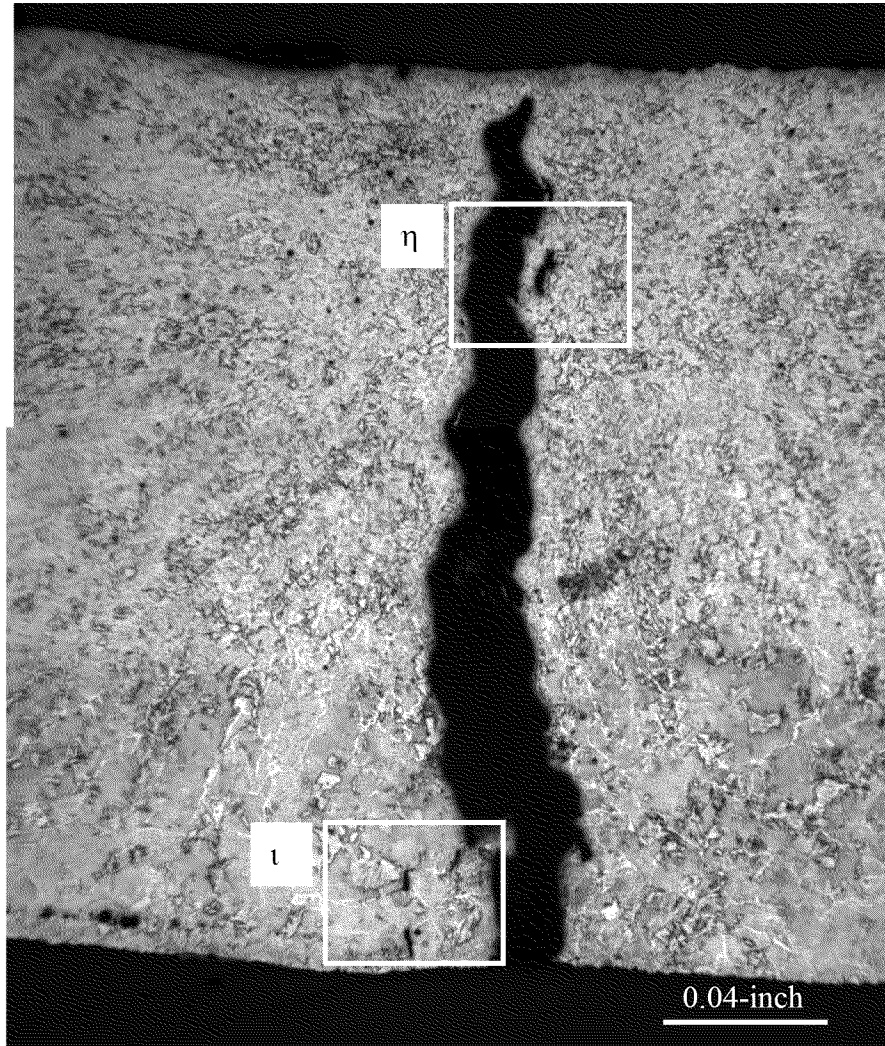
In section 1c, shown in Figure 16 through Figure 18, one small ligament at the outside surface prevented demonstration of a through-wall leak path. Once again, the weld crack morphology was consistent with shrinkage and the heat affected zone crack morphology was consistent with grain boundary liquation. In all three sections of specimen 1, the weld fusion zone followed a smooth broad contour with no indications of external corrosion prior to welding.

Figure 17 Composite optical micrograph of the specimen prepared for metallography, section 1c. Etched with 2% nital.

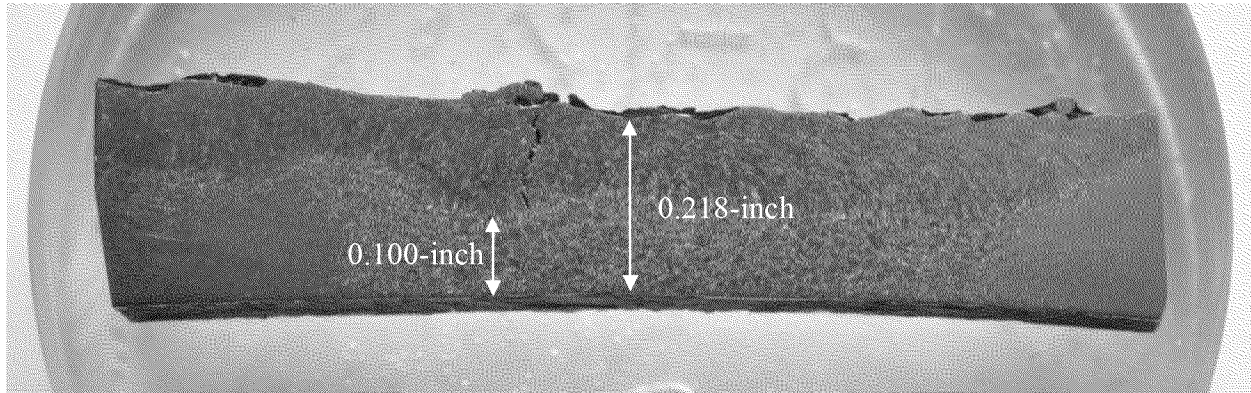
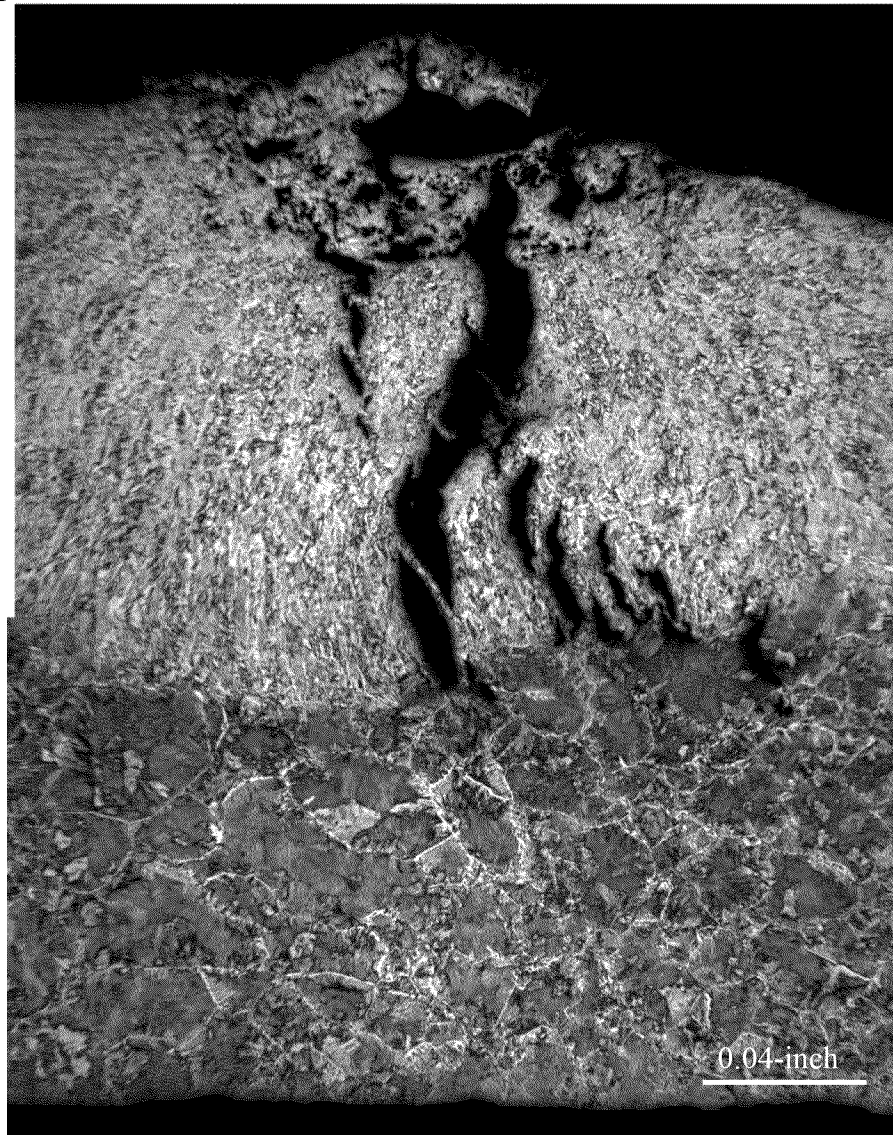
Figure 19 Photograph and composite micrograph of section 2. Etched with 2% nital.

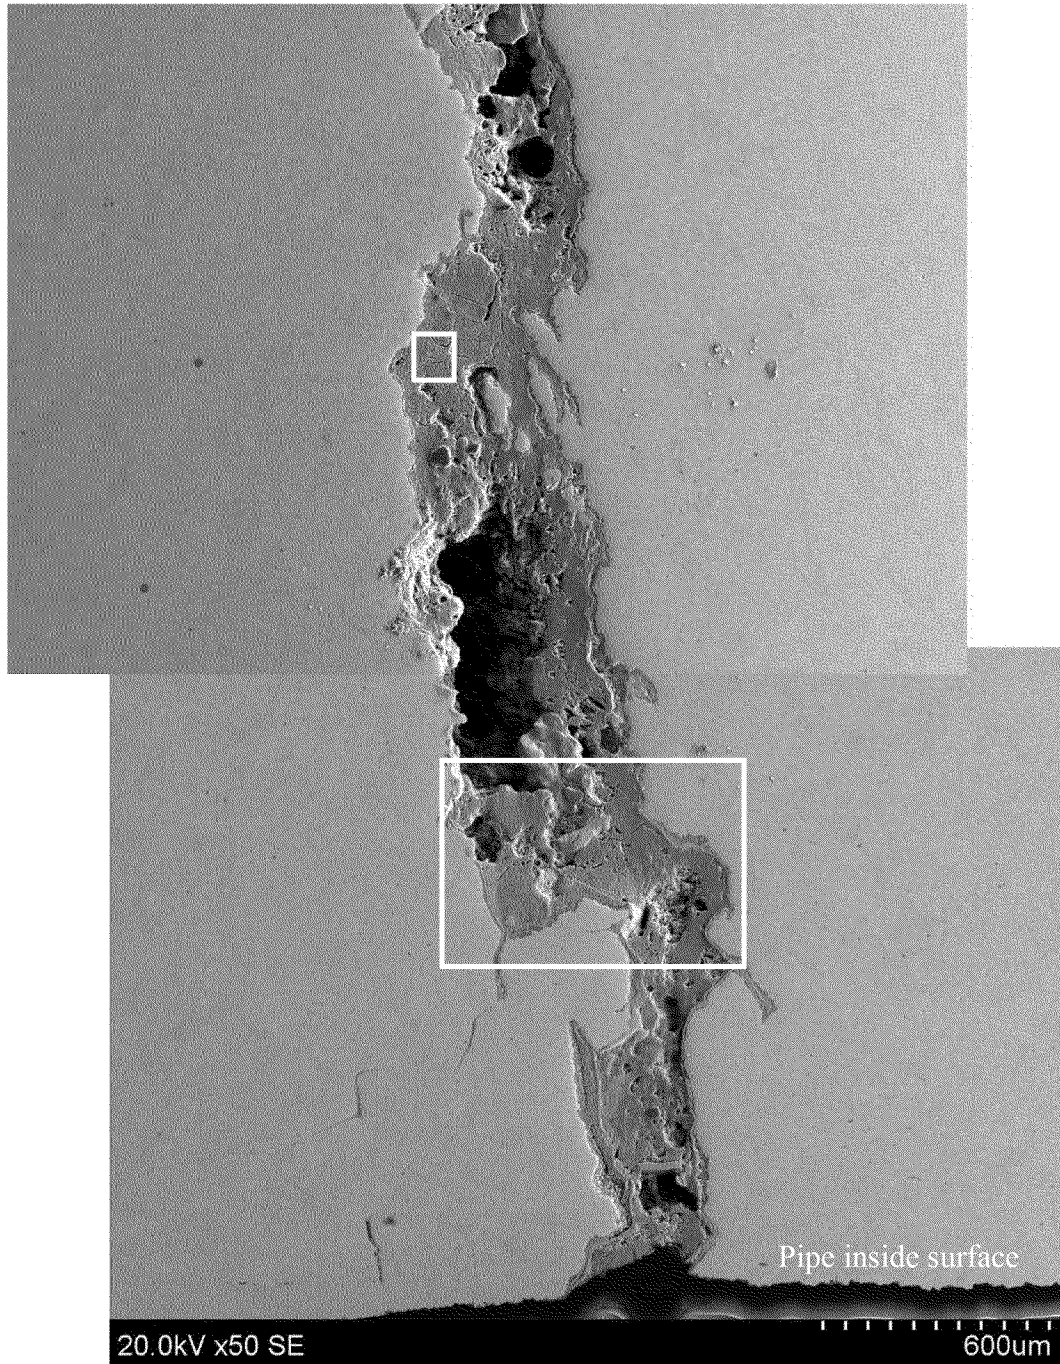
Based on the results of this evaluation, weld crater cracks and underlying weld heat affected zone liquation cracks likely formed a leak path under the PLIDCO cap. However, penetrant testing and 40-psig compressed air testing failed to detect a leak under the cap. Metallography revealed that the liquation cracks were filled with oxide. No evidence of crack growth during service or hydrotesting was detected.

Figure 20 Composite SEM micrograph of the specimen prepared for metallography, section 1c.

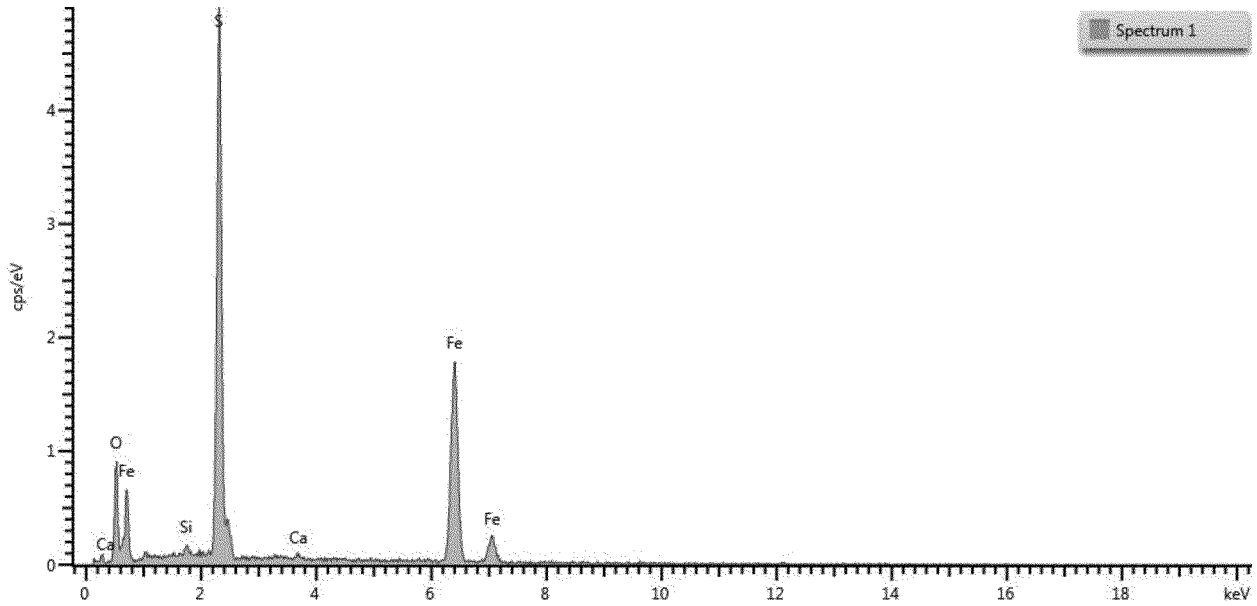
(a) EDS spectrum from the small boxed area in Figure 20

Figure 21 EDS spectra from the specimen prepared for metallography, section 1c.
