**BEFORE THE PUBLIC UTILITIES COMMISSION
OF THE STATE OF CALIFORNIA**

Order Instituting Rulemaking on the
Commission's Own Motion to Adopt New
Safety and Reliability Regulations for Natural
Gas Transmission and Distribution Pipelines
and Related Ratemaking Mechanisms

**DECLARATION OF SUMEET SINGH SUPPLEMENTING THE VERIFIED
STATEMENT OF PACIFIC GAS AND ELECTRIC COMPANY'S VICE
PRESIDENT OF GAS TRANSMISSION MAINTENANCE AND CONSTRUCTION
IN RESPONSE TO RULING OF ASSIGNED COMMISSIONER AND ASSIGNED
ADMINISTRATIVE LAW JUDGE**

**PG&E Line 147 Britton
and Rogers Avenue Leak:
Metallurgical Analysis**

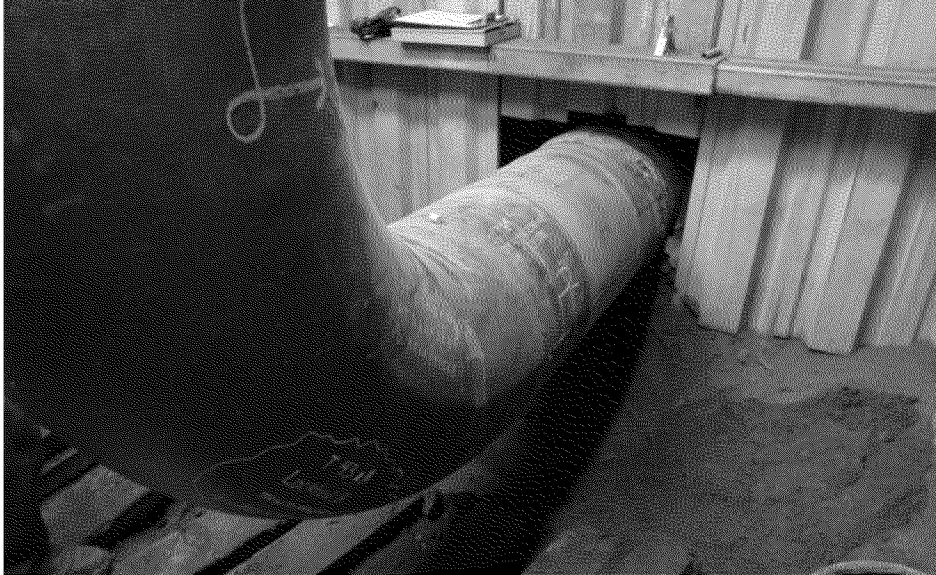
Overview of coating condition -1ft to 2ft, 9:00 position

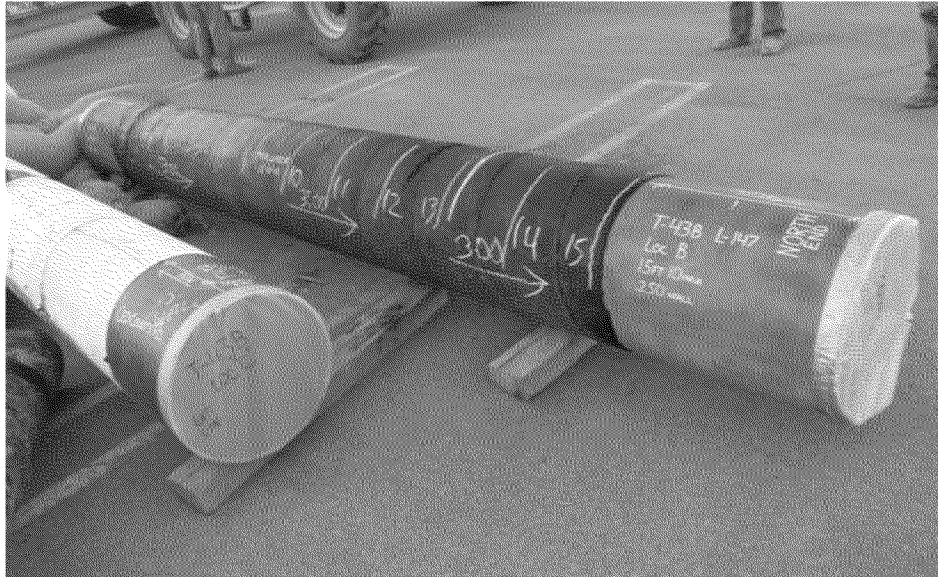
Removed pipe section coating assesment 3:00

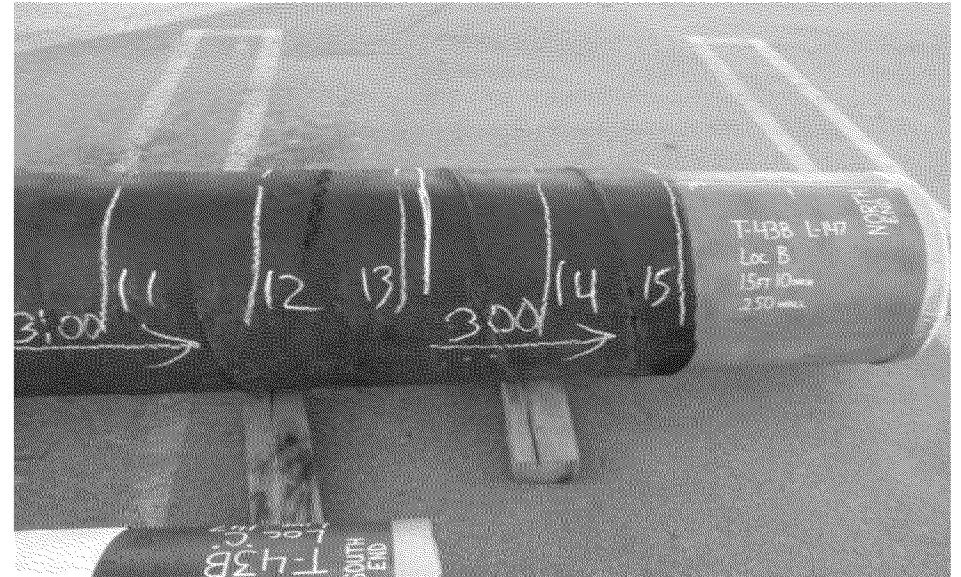
Overview of coating condition 3:00 position

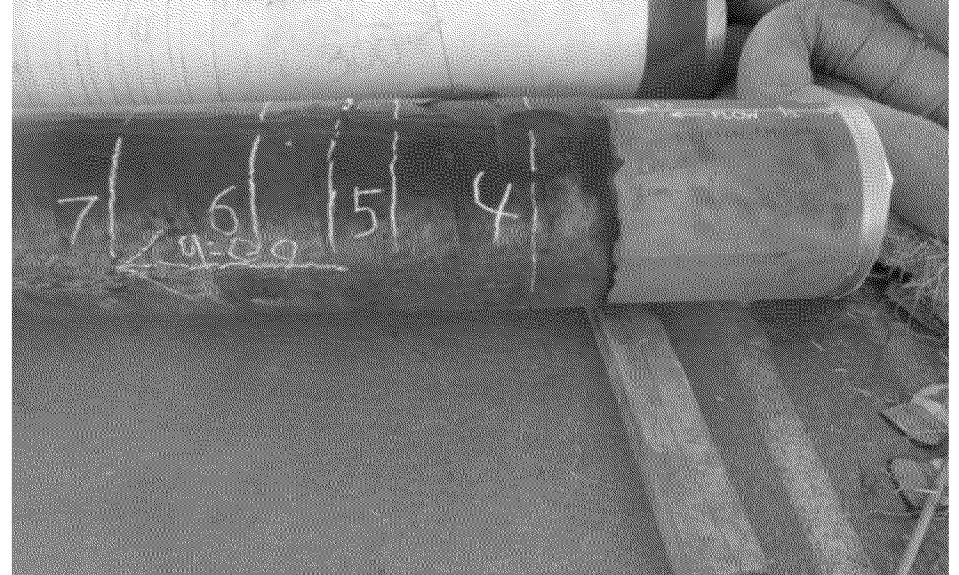
Overview of coating condition 9:00 position

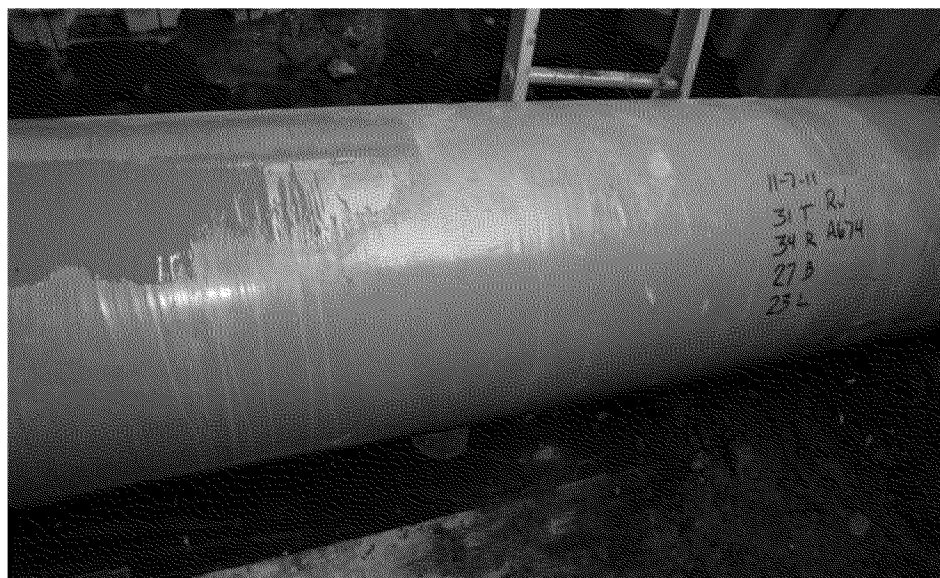
Overview of final coating condition 3:00

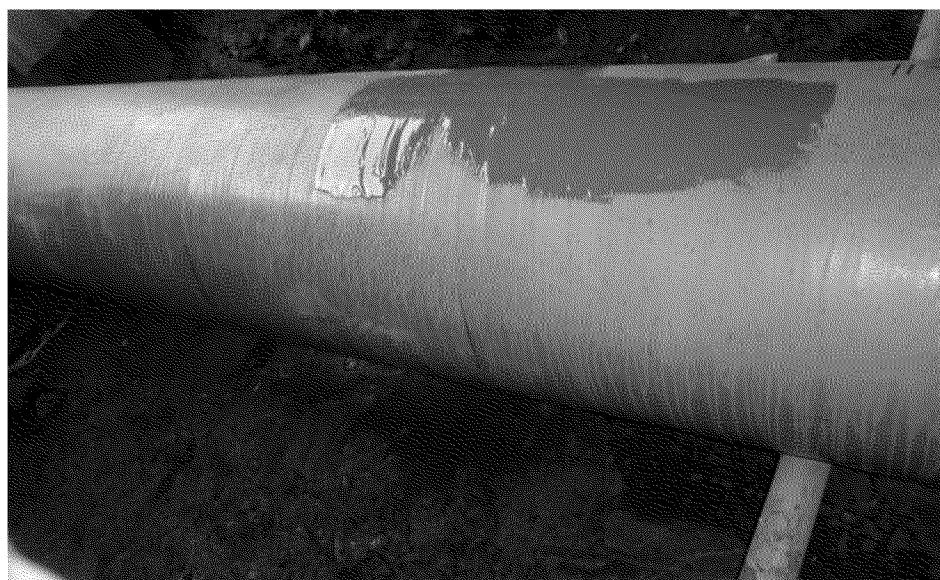
Overview of final coating condition 3:00

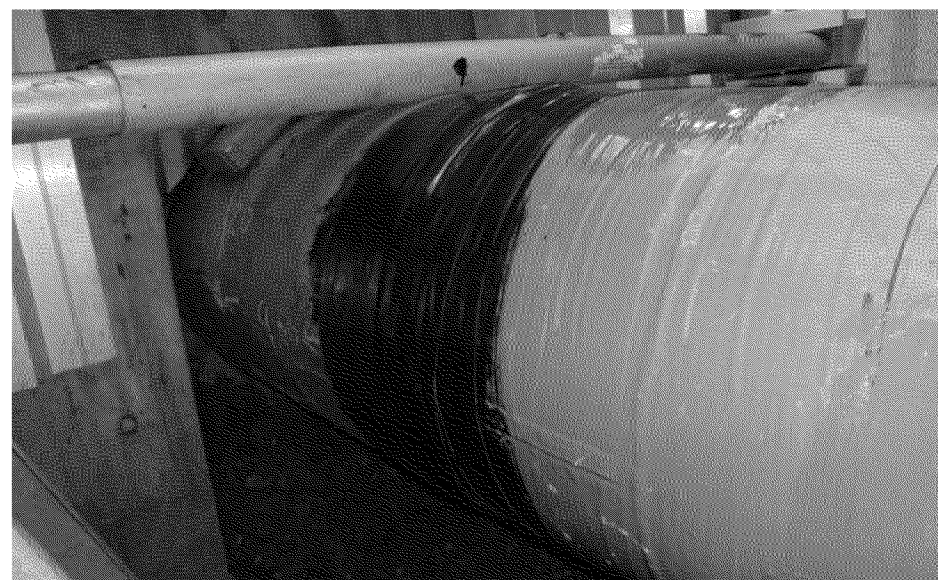
Overview of final coating condition US 3:00

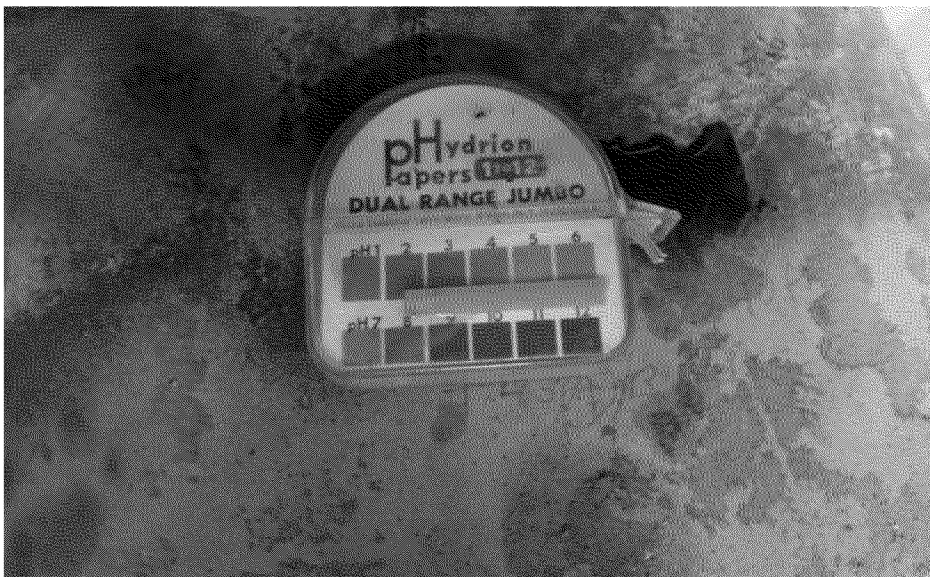
Closeup of pipe Ph.
