R.11-02-019
(Filed February 24, 2011)

**DECLARATION OF SUMEET SINGH SUPPLEMENTING THE VERIFIED
STATEMENT OF PACIFIC GAS AND ELECTRIC COMPANY'S VICE
PRESIDENT OF GAS TRANSMISSION MAINTENANCE AND CONSTRUCTION
IN RESPONSE TO RULING OF ASSIGNED COMMISSIONER AND ASSIGNED
ADMINISTRATIVE LAW JUDGE**

**PG&E Line 147 Britton
and Rogers Avenue Leak:
Metallurgical Analysis**

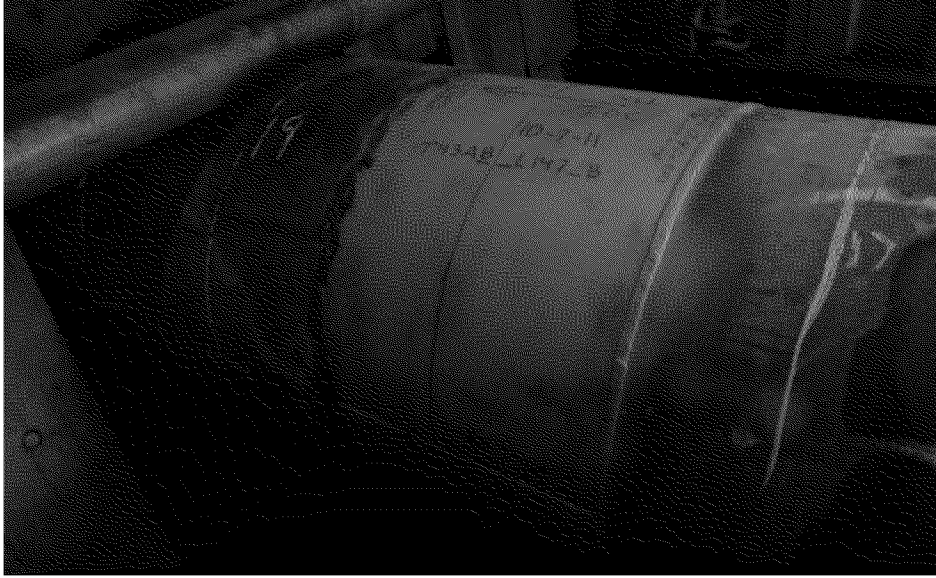
Overview of coating condition 17ft to 20ft, 9:00 position

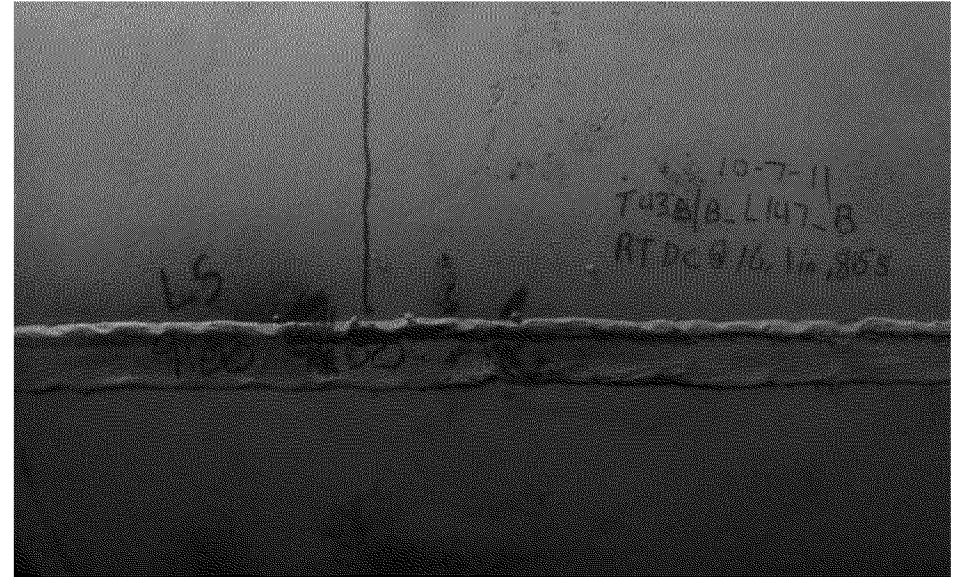
Overview of feature joint long seam @ 8:55

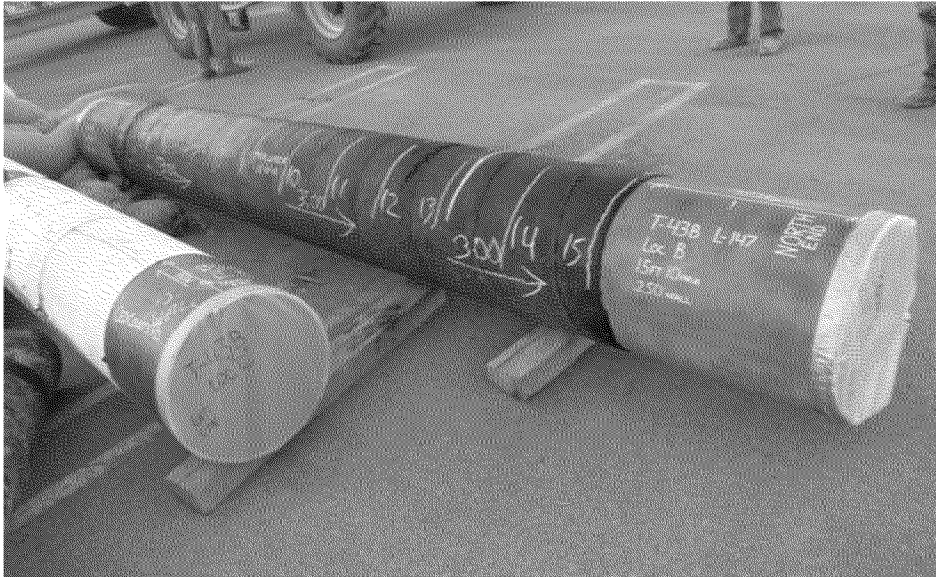
Removed pipe section coating assesment 3:00

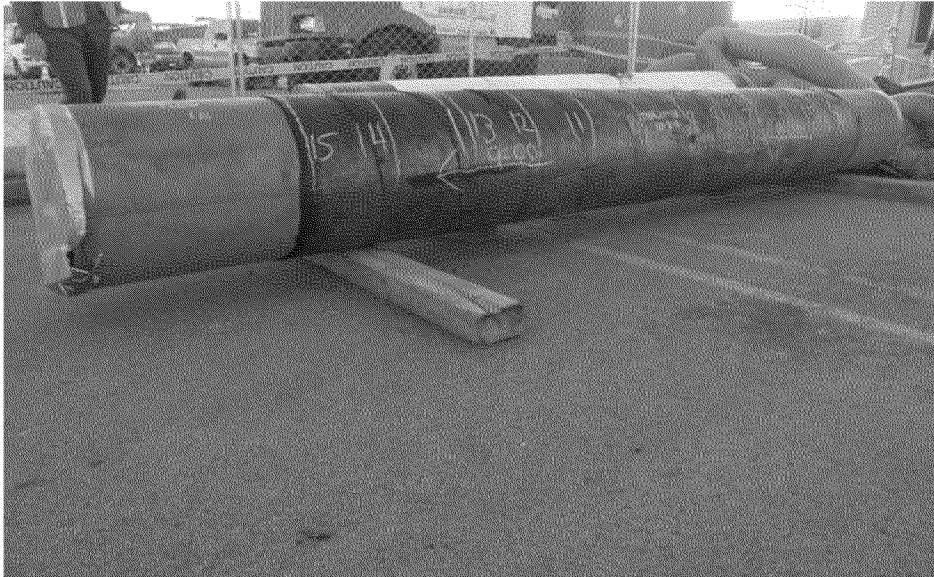
Removed pipe section coating assesment 9:00

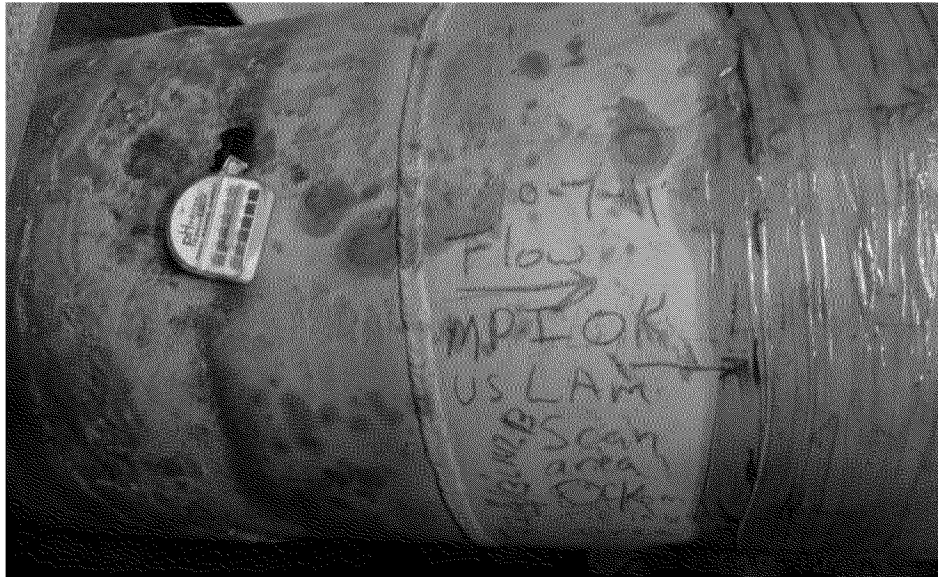
Overview of pipe Ph.

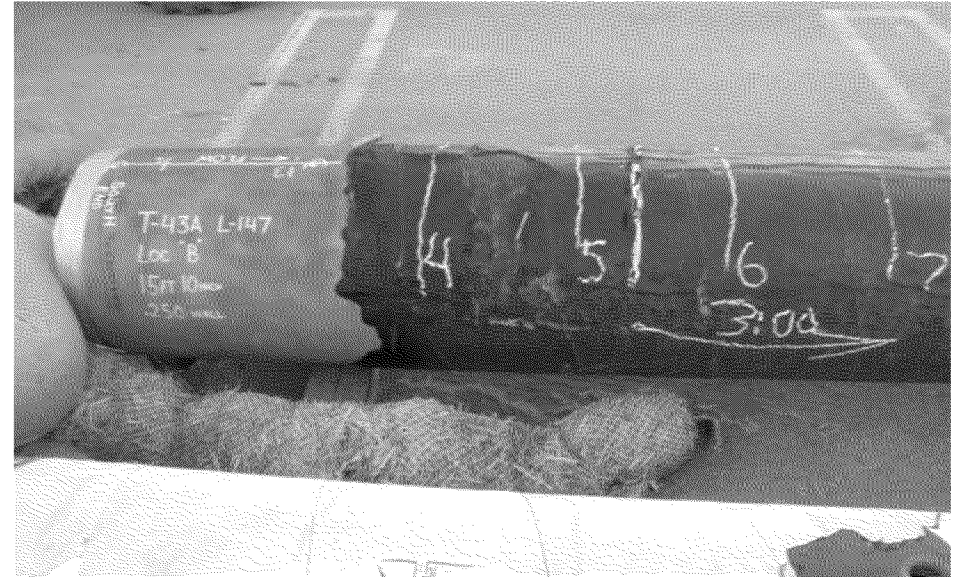
Overview of coating condition 3:00 position

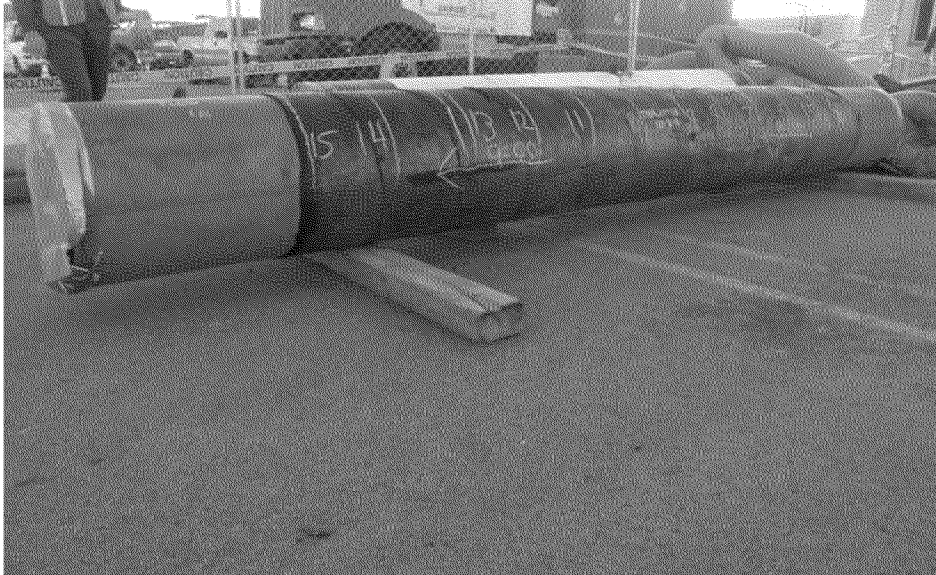
Removed pipe section coating assesment 9:00

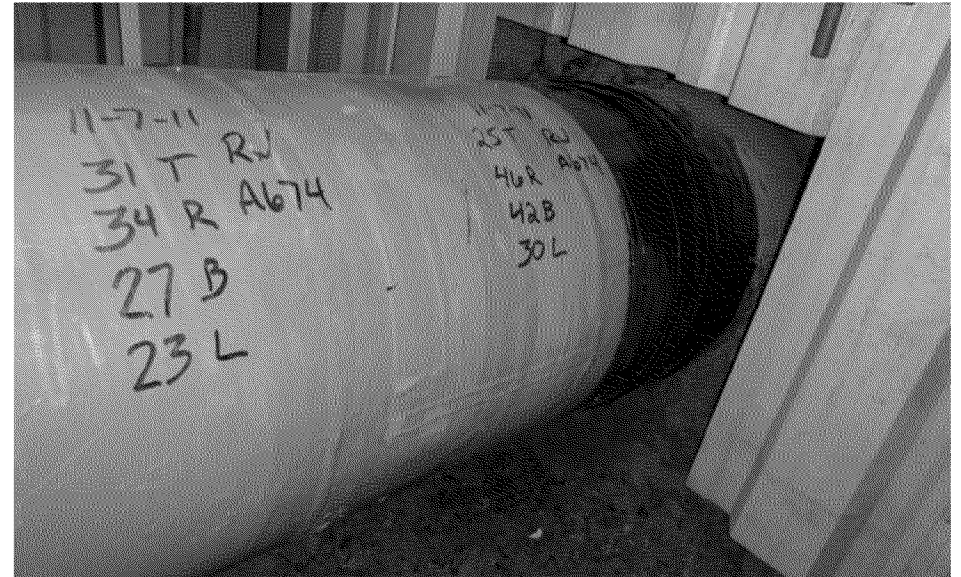
Overview of final coating condition US 3:00

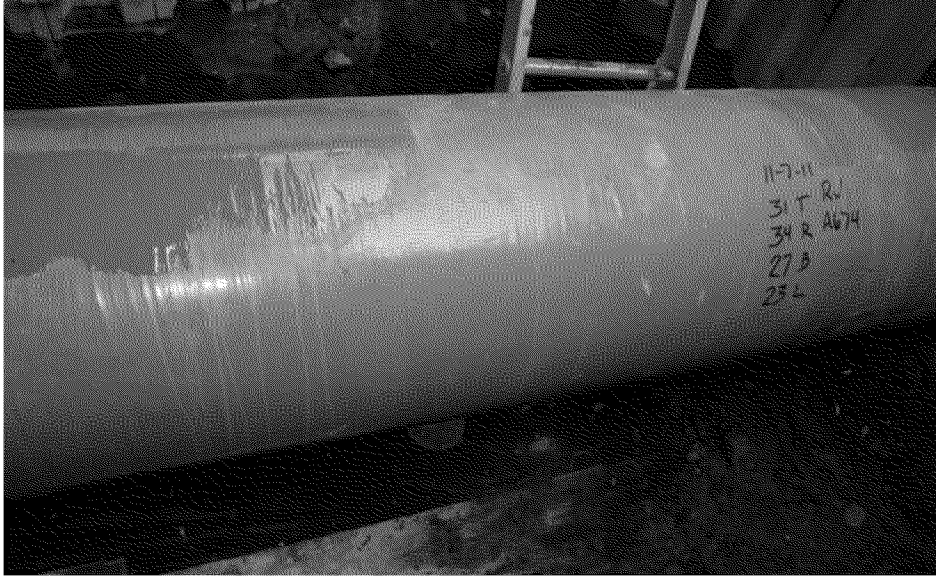
Overview of final coating condition 3:00
