**BEFORE THE PUBLIC UTILITIES COMMISSION
OF THE STATE OF CALIFORNIA**

R.11-02-019
(Filed February 24, 2011)

**DECLARATION OF SUMEET SINGH SUPPLEMENTING THE VERIFIED
STATEMENT OF PACIFIC GAS AND ELECTRIC COMPANY'S VICE
PRESIDENT OF GAS TRANSMISSION MAINTENANCE AND CONSTRUCTION
IN RESPONSE TO RULING OF ASSIGNED COMMISSIONER AND ASSIGNED
ADMINISTRATIVE LAW JUDGE**

**PG&E Line 147 Britton
and Rogers Avenue Leak:
Metallurgical Analysis**

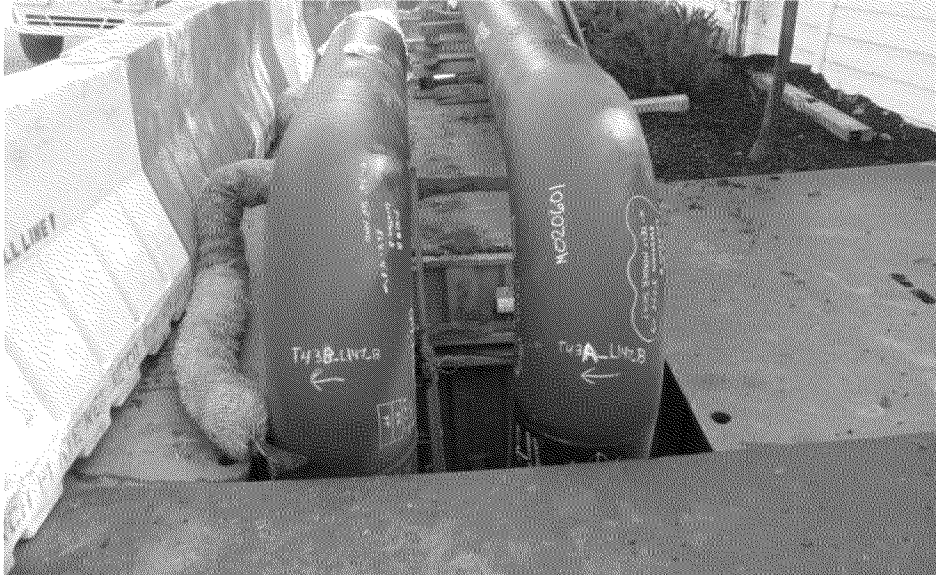
Overview of T43A(US) & T43B(DS) in same excavation.

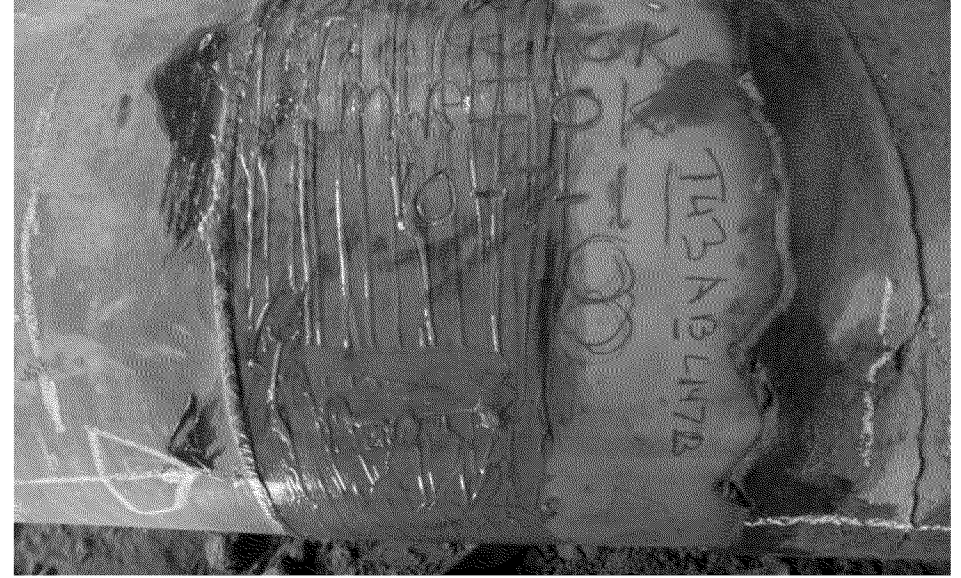
Overview DS of MPIOK and Lamination scan OK.

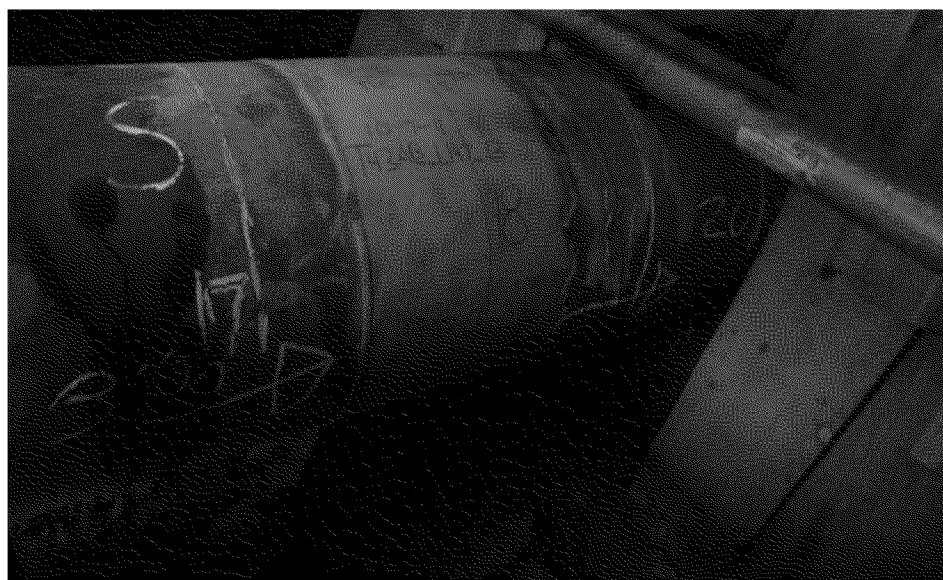
Overview of coating condition 17ft to 20ft, 3:00 position

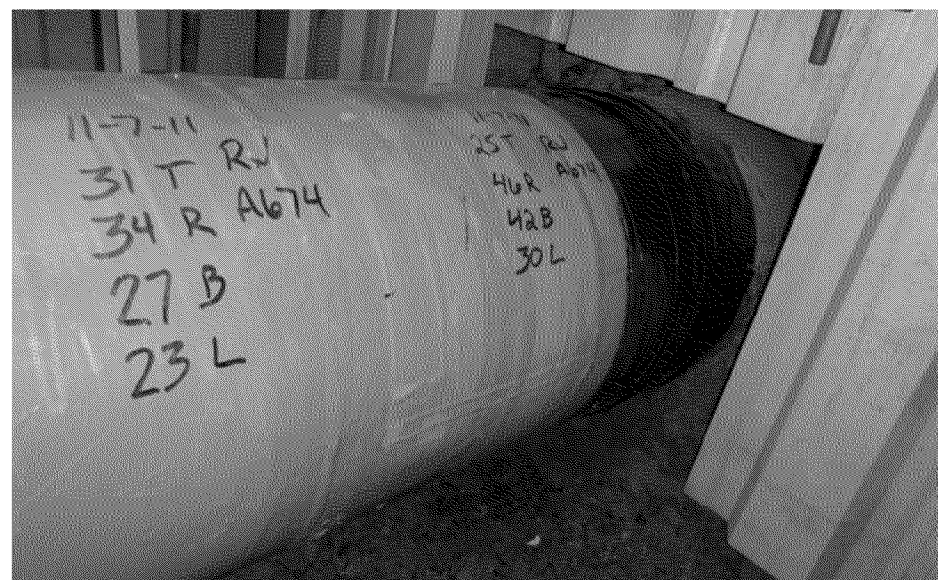
Overview of final coating condition US 3:00

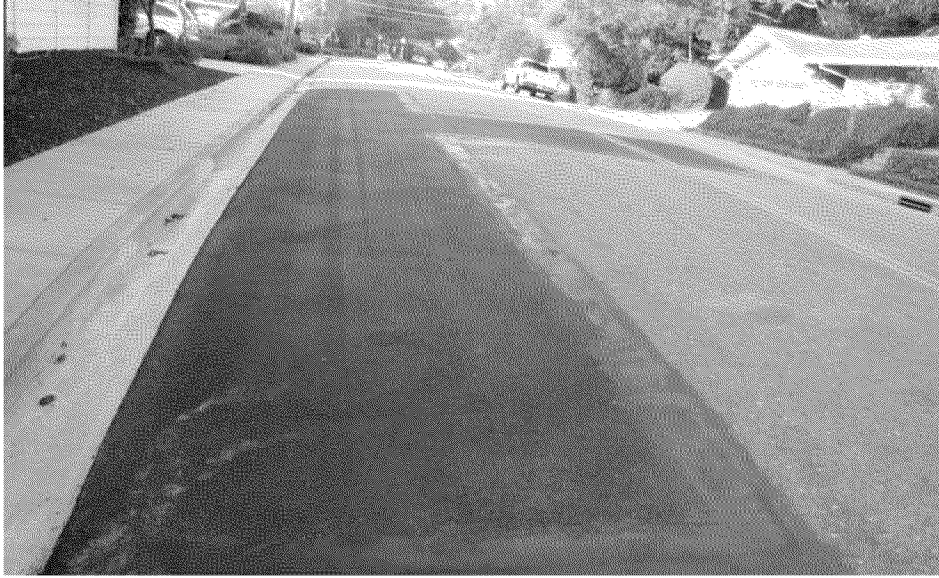
Overview of completed Cover, 3:00 view

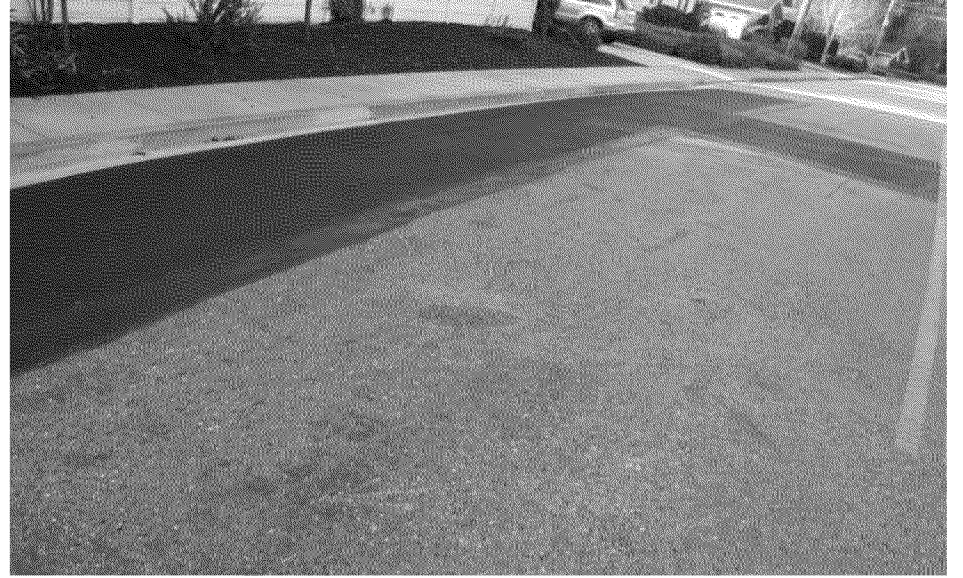
Overview of completed Cover, 9:00 view
