**Pipe Characterization and Weld Assessment  
San Carlos  
Line 147  
Mile Post 0.52**

**ATS Report #: 413.61-13.390**

**Gas Project: ICDA**

**Line 147 Mile Point 0.52 San Carlos**

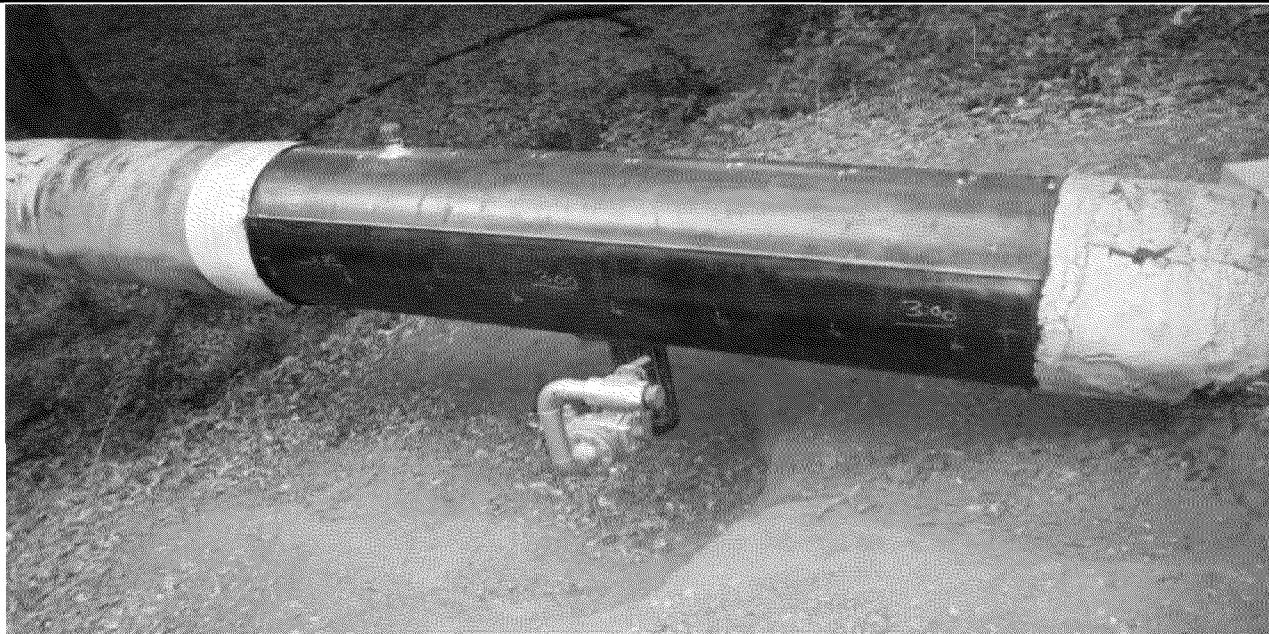
**24" Header: Exposed 4' either side of drip, 360-degrees, 8' total.**

**Performed 12 point UT thickness readings every foot.**

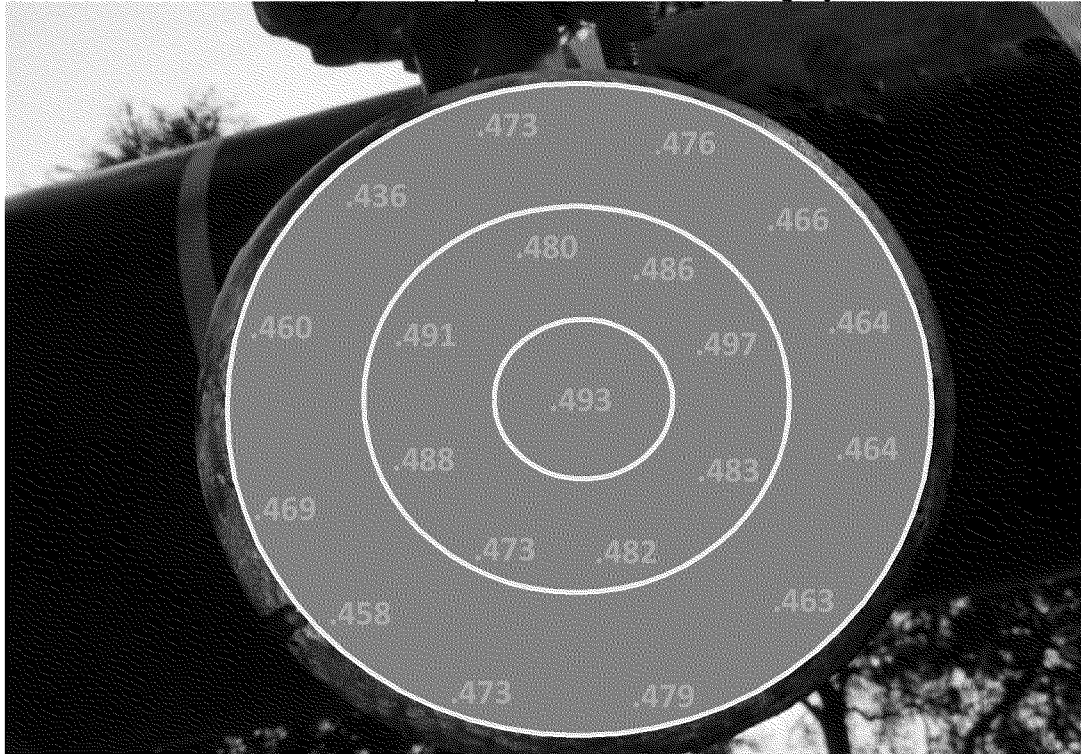
Bottom of the 6" Drip Pot UT thickness reading layout.

Outer Ring Clockwise	0.473
	0.476
	0.466
	0.464
	0.464
	0.463
	0.479
	0.473
	0.458
	0.469
	0.460
	0.436
Inner ring going clockwise	0.480
	0.486
	0.497
	0.483
	0.482
	0.473
Center	0.488
	0.491
	0.493

Maximum Found:	0.497
Minimum Found:	0.436
Average thickness:	0.474

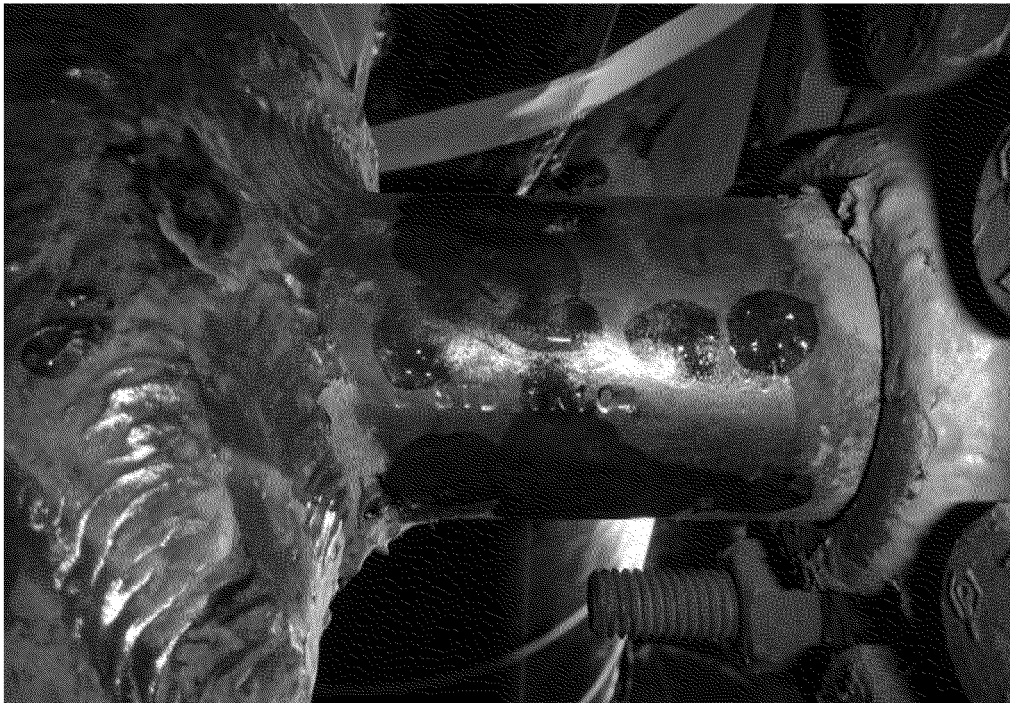
2" pipe between drip pot and valve.

12 top	1:30	3:00 North	4:30	6:00 Bottom	7:30	9:00 South	10:30
Loc 1	0.158	0.165	0.156	0.166	0.146	0.160	0.158	0.160
Loc 2	0.162	0.162	0.158	0.169	0.163	0.153	0.160	0.159
Loc 3	0.157	0.158	0.162	0.153	0.148	0.150	0.166	0.149
Loc 4	0.156	0.157	0.158	0.161	0.155	0.160	0.168	0.152
Maximum Found:	0.162	0.165	0.162	0.169	0.163	0.160	0.168	0.160
Minimum Found:	0.156	0.157	0.156	0.153	0.146	0.150	0.158	0.149
Average thickness:	0.158	0.161	0.159	0.162	0.153	0.156	0.163	0.155

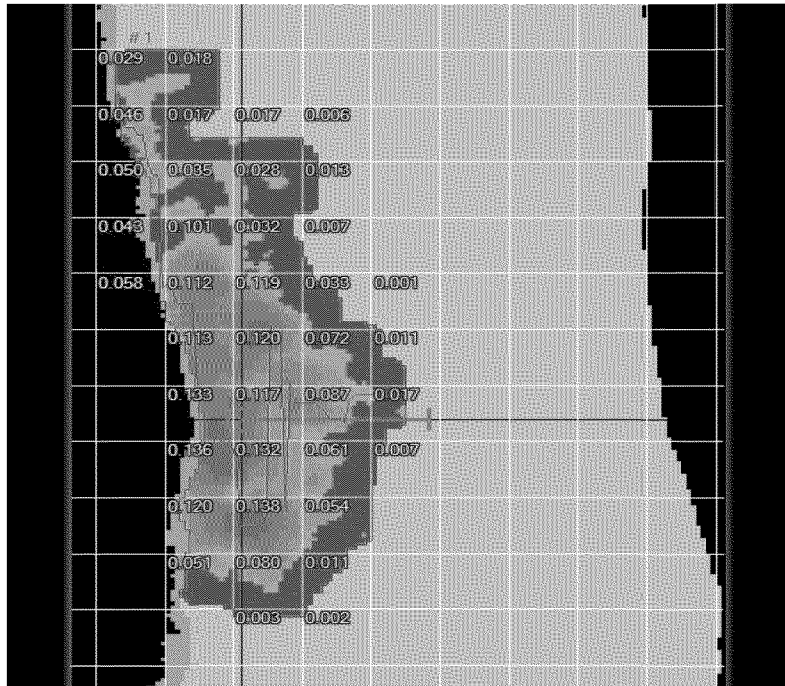
# Creaform Laser Scanner Data for Drip Pot EC-3

**EC-3:** Average Wall Thickness: 0.280", Min. 0.138" for 50.69% Wall Loss, (Per Laser Scanner see attached Report). an Impression Casting of the corroded weld, drip pot to saddle weld was difficult to obtain using multiple methods. This was: 4.00" width X 0.800" Long and approximately 0.150"-0.200" metal loss.

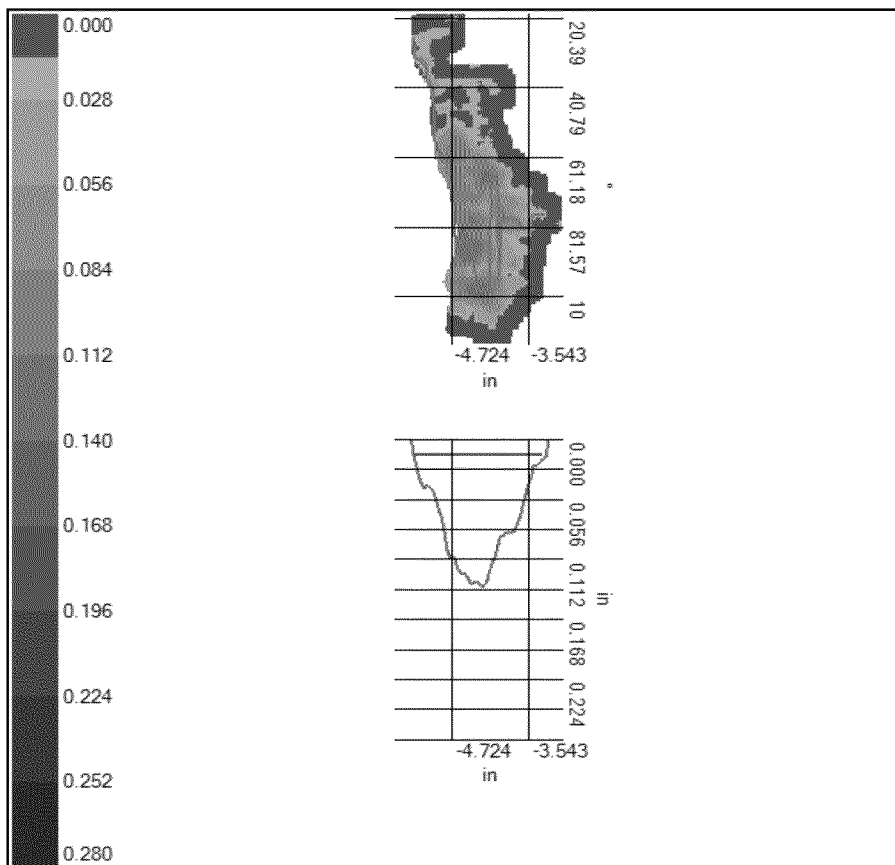
Axial Start	-5.354 in
Axial End	-3.268 in
Axial Length	2.087 in
Circ. Start	23.090 °
Circ. End	111.400 °
Circ. Length	88.300 °
Max. Depth	0.138 in
Axial Pos.	-4.272 in
Circ. Pos.	100.190 °

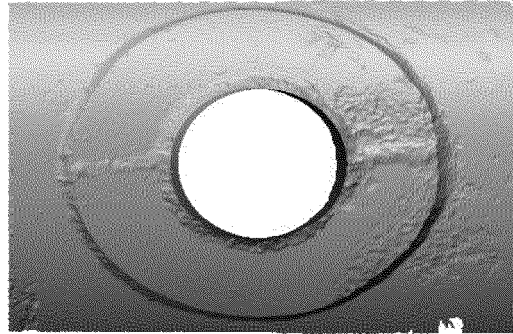
# Creaform Laser Scanner Data for Drip Pot to saddle weld

**Over View of L-147 MP 0.52 drip pot and weld pad**
