**BEFORE THE PUBLIC UTILITIES COMMISSION
OF THE STATE OF CALIFORNIA**

**DECLARATION OF SUMEET SINGH SUPPLEMENTING THE VERIFIED
STATEMENT OF PACIFIC GAS AND ELECTRIC COMPANY'S VICE
PRESIDENT OF GAS TRANSMISSION MAINTENANCE AND CONSTRUCTION
IN RESPONSE TO RULING OF ASSIGNED COMMISSIONER AND ASSIGNED
ADMINISTRATIVE LAW JUDGE**

**PG&E Line 147 Britton
and Rogers Avenue Leak:
Metallurgical Analysis**

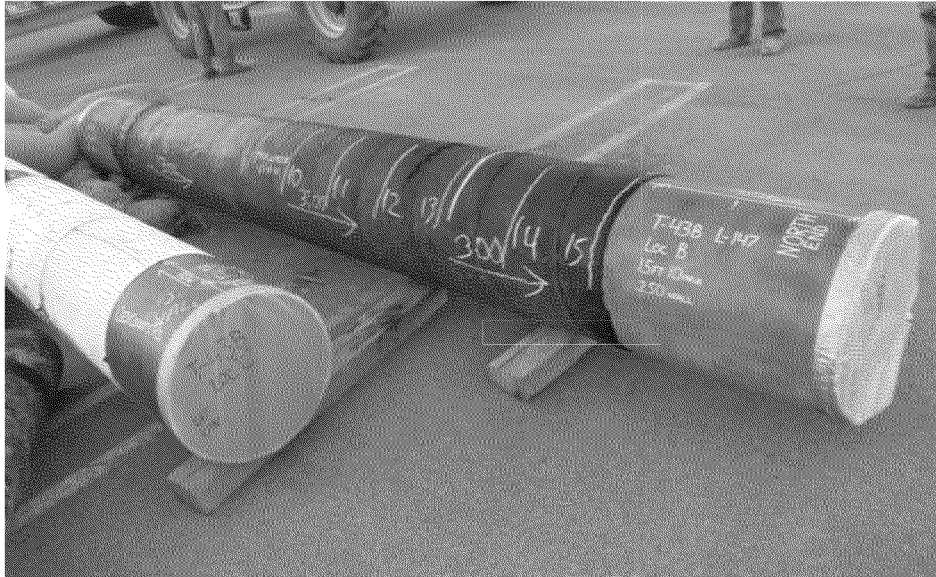
Removed pipe section coating assesment 3:00

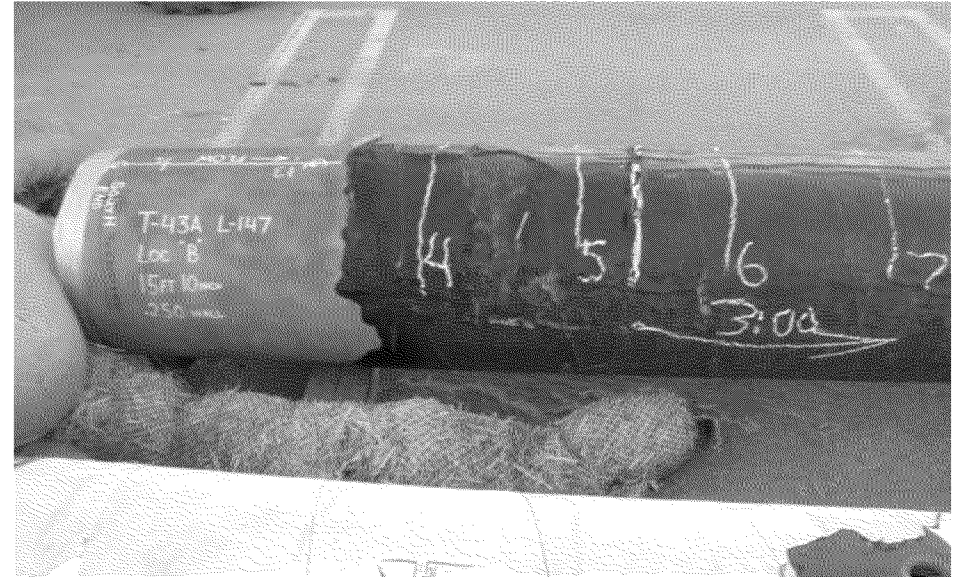
Overview of coating condition 3:00 position

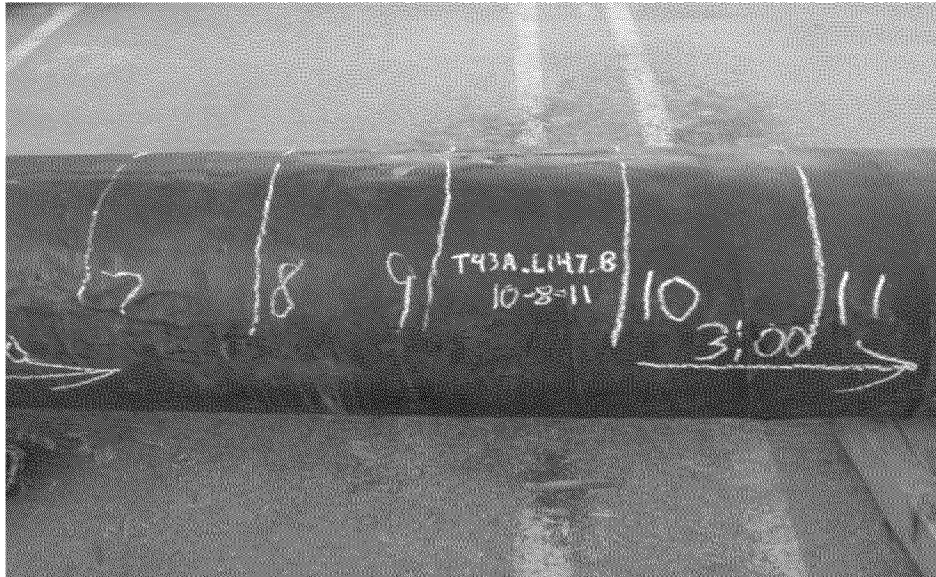
Overview of coating condition 3:00 position

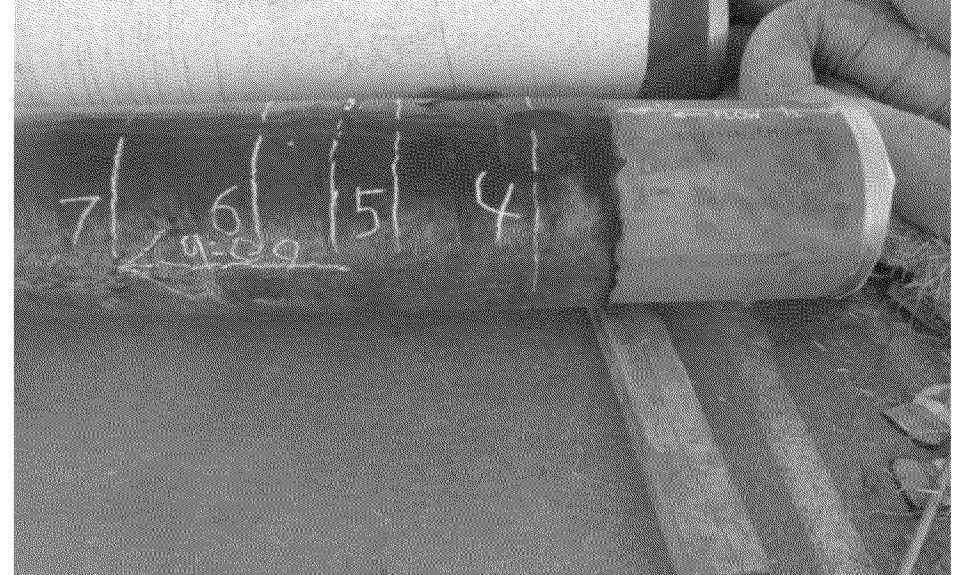
Overview of coating condition 9:00 position

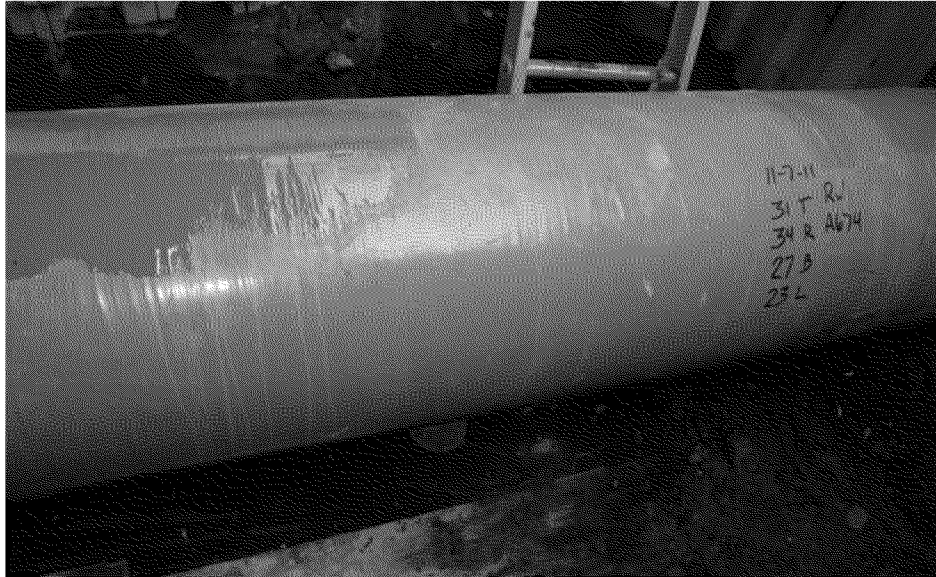
Overview of final coating condition 3:00

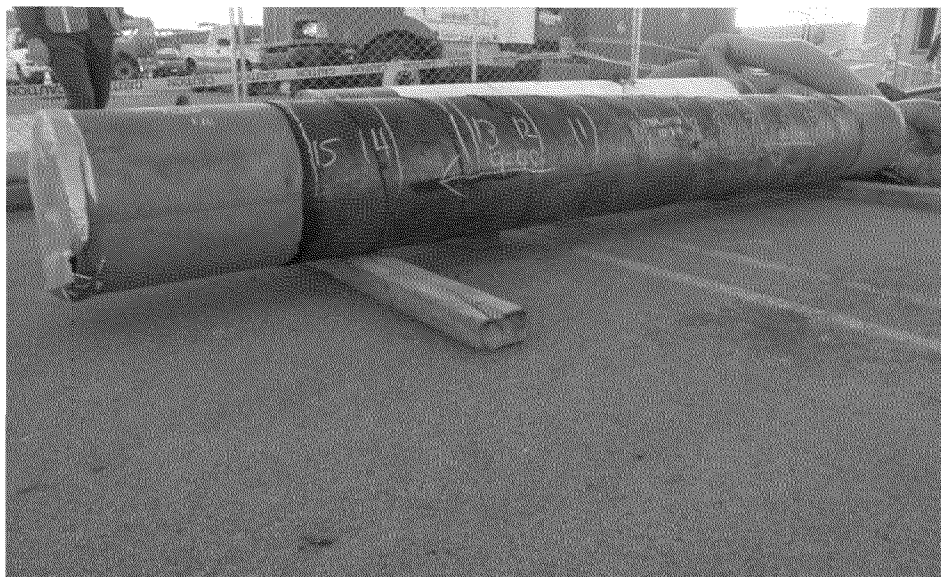
Removed pipe section coating assesment 9:00

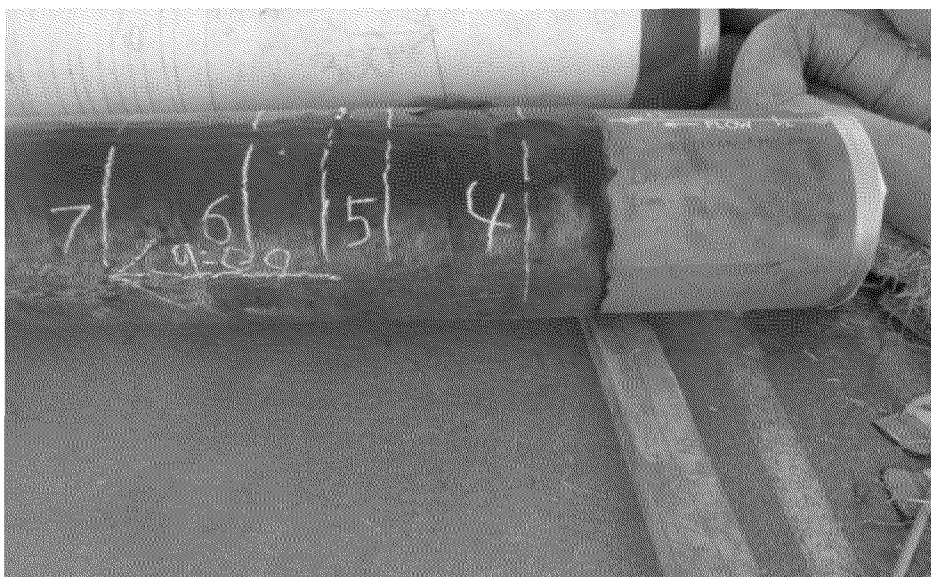
Overview of coating condition 9:00 position

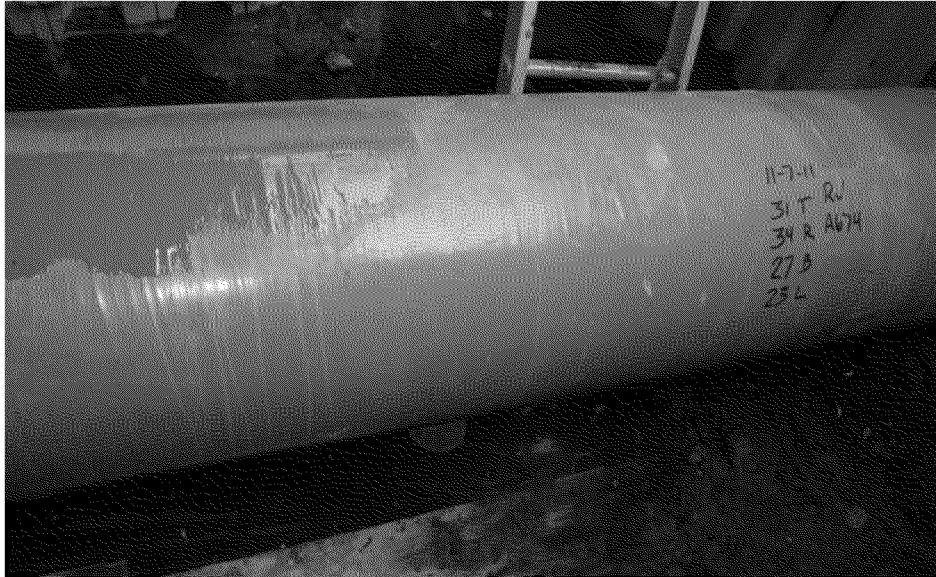
Overview of final coating condition 3:00

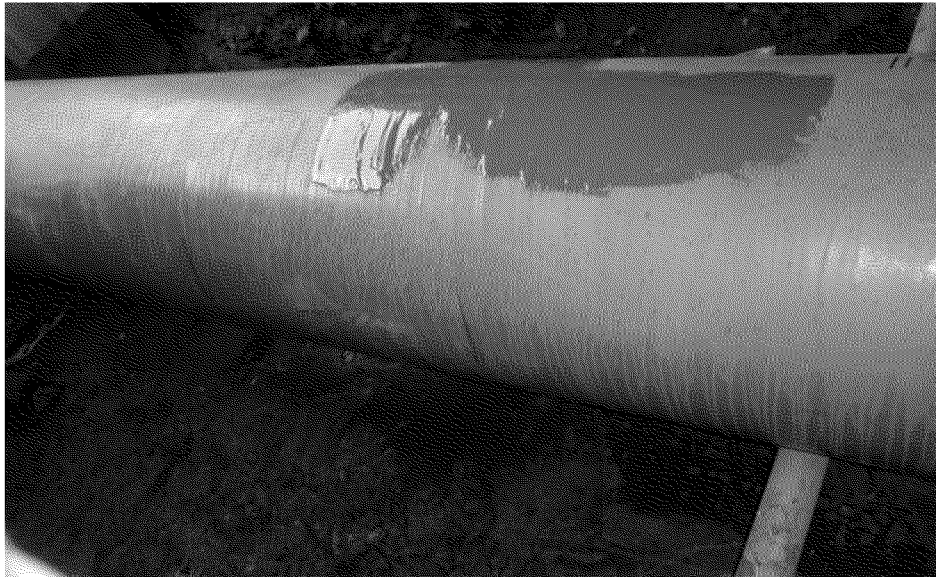
Overview of final coating condition 3:00

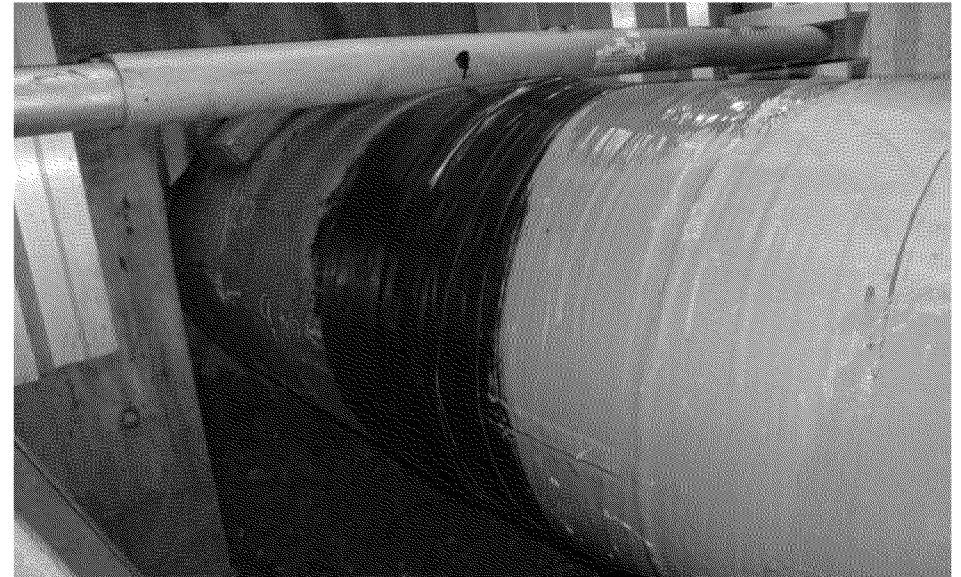
Overview of final coating condition US 3:00

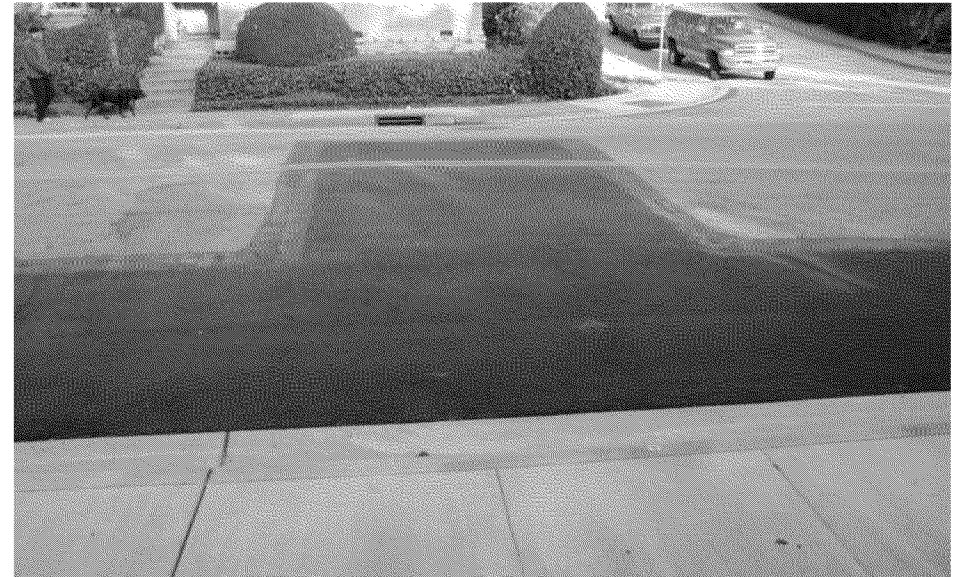
Overview of completed Cover looking upstream

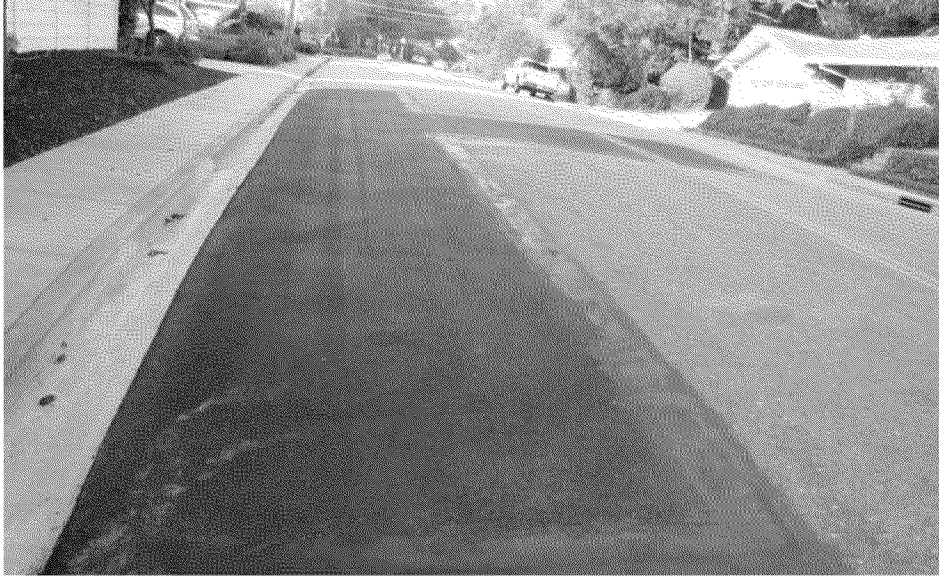
Overview of completed Cover looking downstream

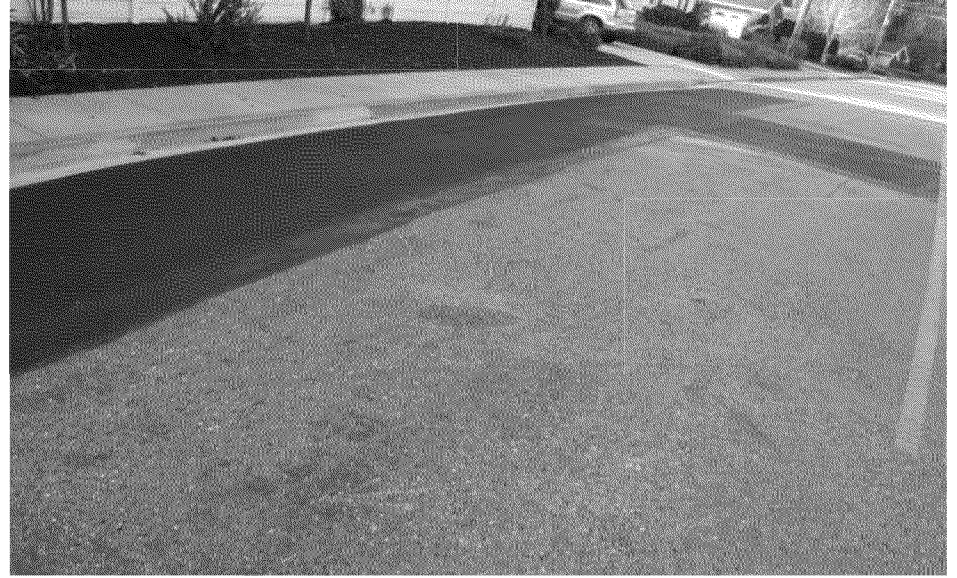
Overview of completed Cover, 3:00 view
