**Pipe Characterization and Weld Assessment
San Carlos
Line 147
Mile Post 0.52**

ATS Report #: 413.61-13.390

Gas Project: ICDA

Line 147 Mile Point 0.52 San Carlos

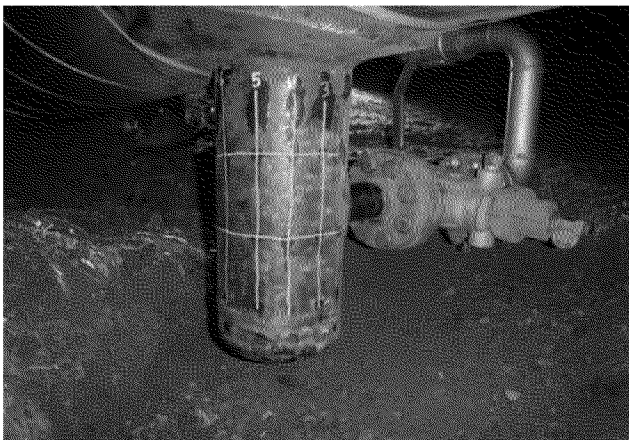
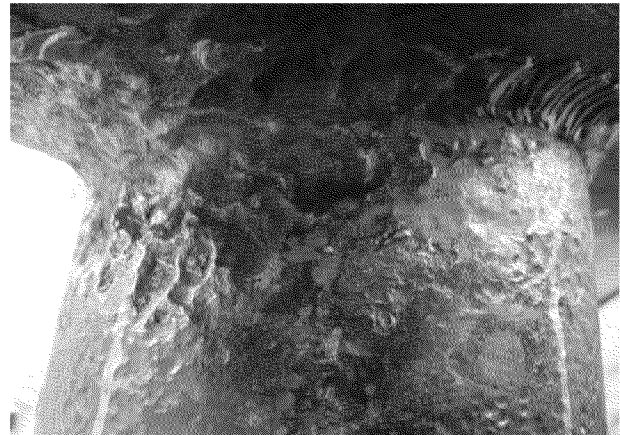
EC 3-1 UT thickness survey of corrosion cell between the reinforcement pad and the drip pot using a pencil probe.

Position	UT reading	Remaining wall
7:00	0.162	42.14%
plus 1"	0.179	36.07%
8:00	0.216	22.85%
plus 1"	0.185	33.92%
9:00	0.160	42.85%
Average wall thickness for the drip pot:		0.280

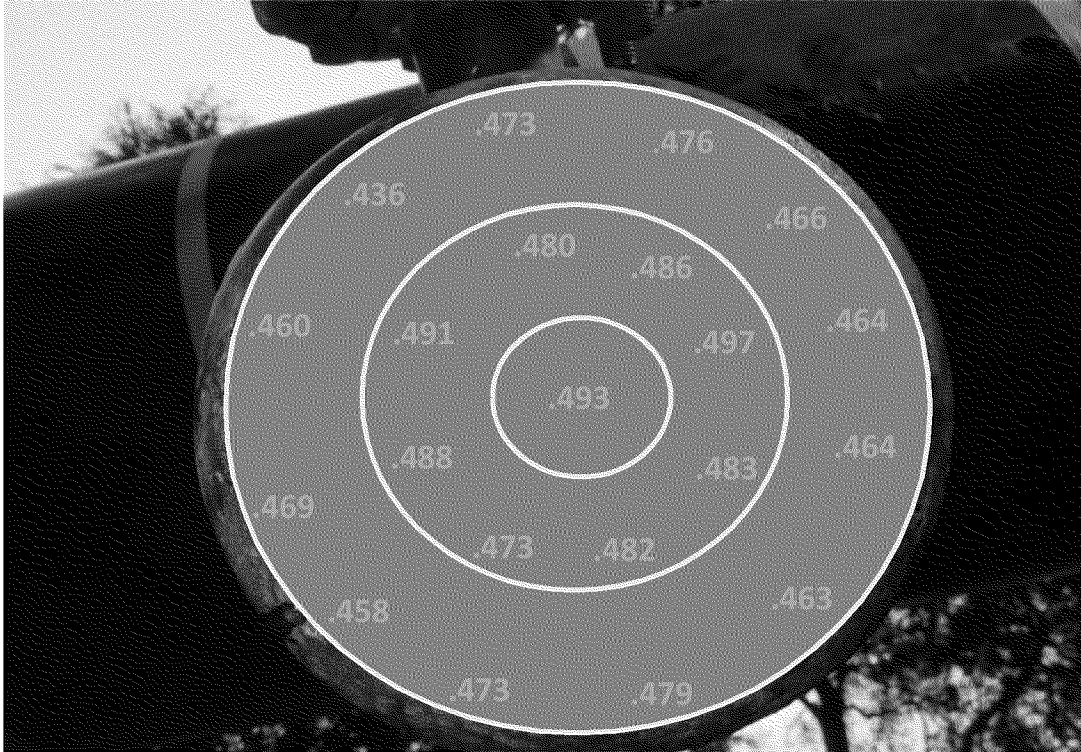
Bottom of the 6" Drip Pot UT thickness reading layout.

Outer Ring Clockwise	0.473	
	0.476	
	0.466	
	0.464	
	0.464	
	0.463	
	0.479	
	0.473	
	0.458	
	0.469	
	0.460	
	0.436	
	0.480	
	Inner ring going clockwise	0.486
		0.497
		0.483
0.482		
0.473		
0.488		
Center	0.491	
	0.493

Maximum Found:	0.497
Minimum Found:	0.436
Average thickness:	0.474

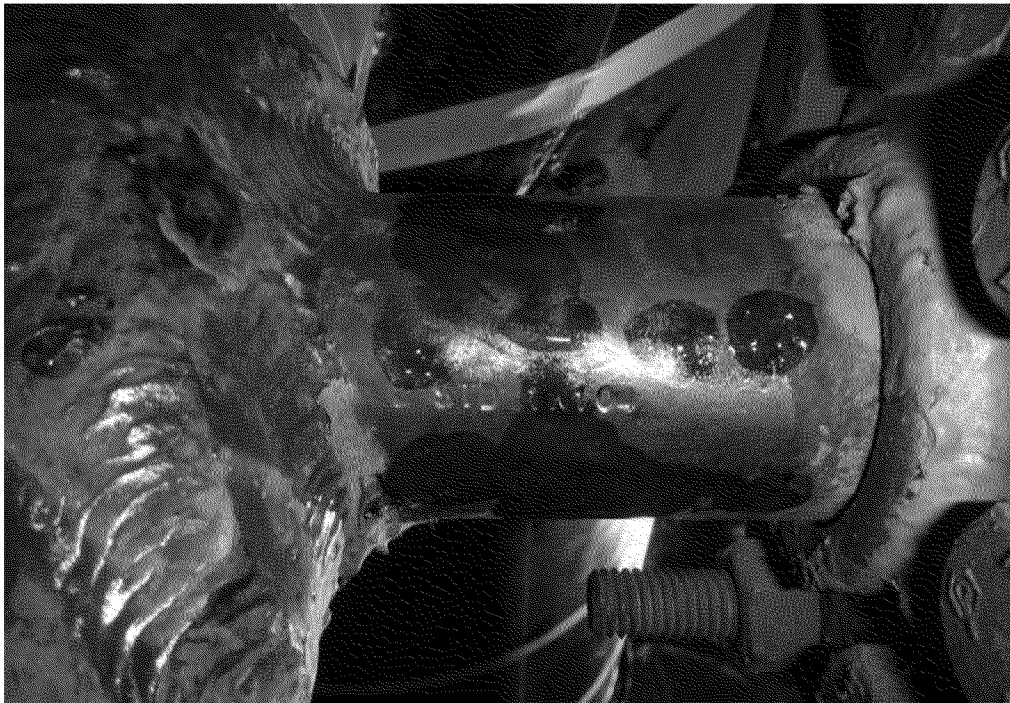
2" pipe between drip pot and valve.

12 top	1:30	3:00 North	4:30	6:00 Bottom	7:30	9:00 South	10:30
Loc 1	0.158	0.165	0.156	0.166	0.146	0.160	0.158	0.160
Loc 2	0.162	0.162	0.158	0.169	0.163	0.153	0.160	0.159
Loc 3	0.157	0.158	0.162	0.153	0.148	0.150	0.166	0.149
Loc 4	0.156	0.157	0.158	0.161	0.155	0.160	0.168	0.152
Maximum Found:	0.162	0.165	0.162	0.169	0.163	0.160	0.168	0.160
Minimum Found:	0.156	0.157	0.156	0.153	0.146	0.150	0.158	0.149
Average thickness:	0.158	0.161	0.159	0.162	0.153	0.156	0.163	0.155

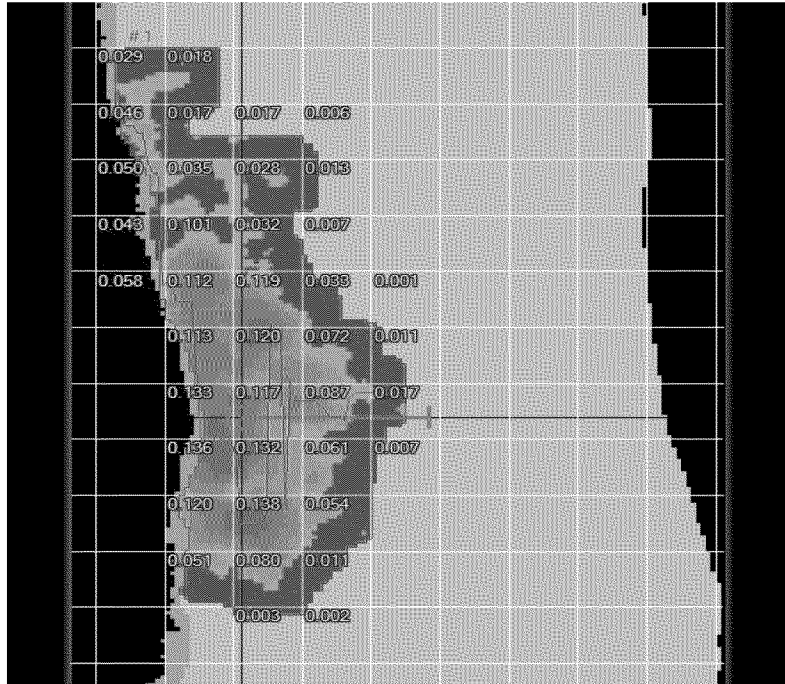
Creaform Laser Scanner Data for Drip Pot EC-3

EC-3: Average Wall Thickness: 0.280", Min. 0.138" for 50.69% Wall Loss, (Per Laser Scanner see attached Report). an Impression Casting of the corroded weld, drip pot to saddle weld was difficult to obtain using multiple methods. This was: 4.00" width X 0.800" Long and approximately 0.150"-0.200" metal loss.
