Pipe Characterization and Weld Assessment
San Carlos
Line 147
Mile Post 0.52

ATS Report #: 413.61-13.390

Gas Project: ICDA

Line 147 Mile Point 0.52 San Carlos

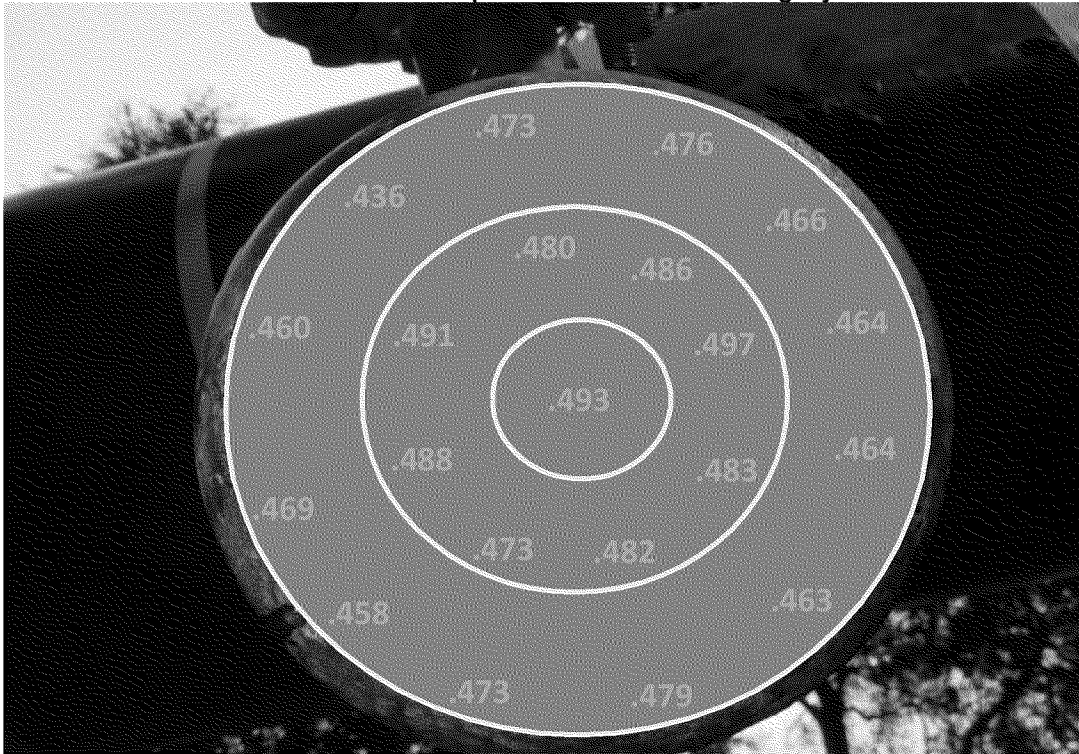
Bottom of the 6" Drip Pot UT thickness reading layout.

Maximum Found:	0.497
Minimum Found:	0.436
Average thickness:	0.474
