Pipe Characterization and Weld Assessment
San Carlos
Line 147
Mile Post 0.52

ATS Report #: 413.61-13.390

Gas Project: Internal Corrosion Verification

Line 147 Mile Point 0.52 San Carlos

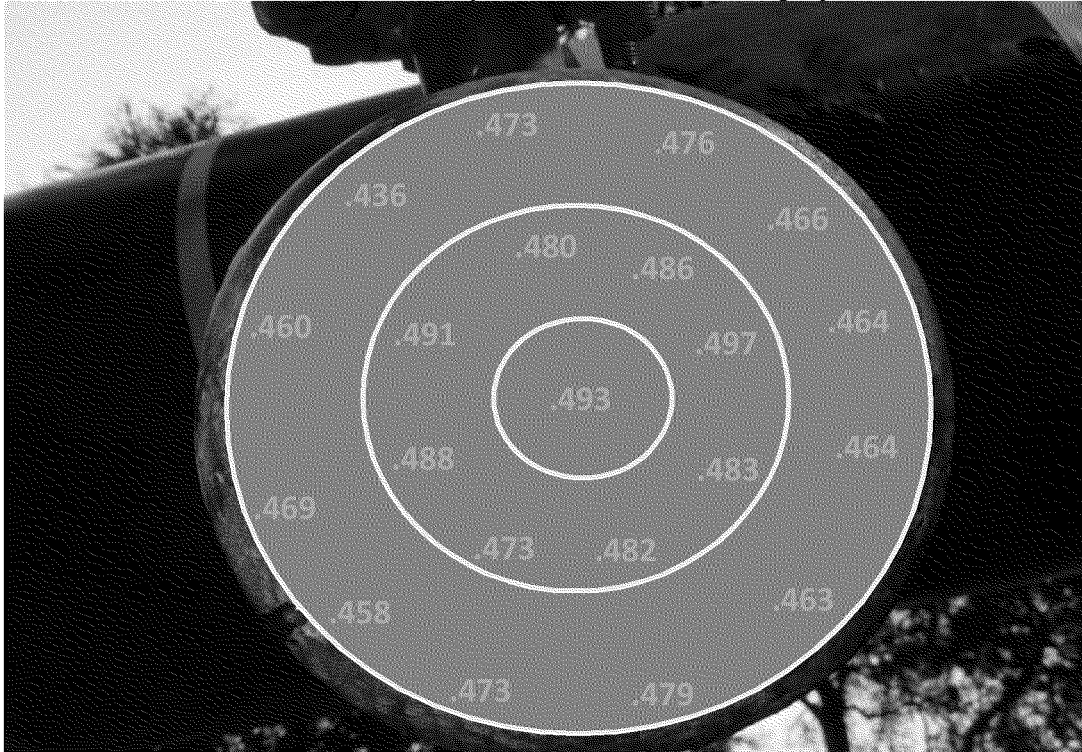
Bottom of the 6" Drip Pot UT thickness reading layout.

Outer Ring Clockwise	0.473
	0.476
	0.466
	0.464
	0.464
	0.463
	0.479
	0.473
	0.458
	0.469
	0.460
	0.436
Inner ring going clockwise	0.480
	0.486
	0.497
	0.483
	0.482
	0.473
Center	0.488
	0.491
	0.493

Maximum Found:	0.497
Minimum Found:	0.436
Average thickness:	0.474

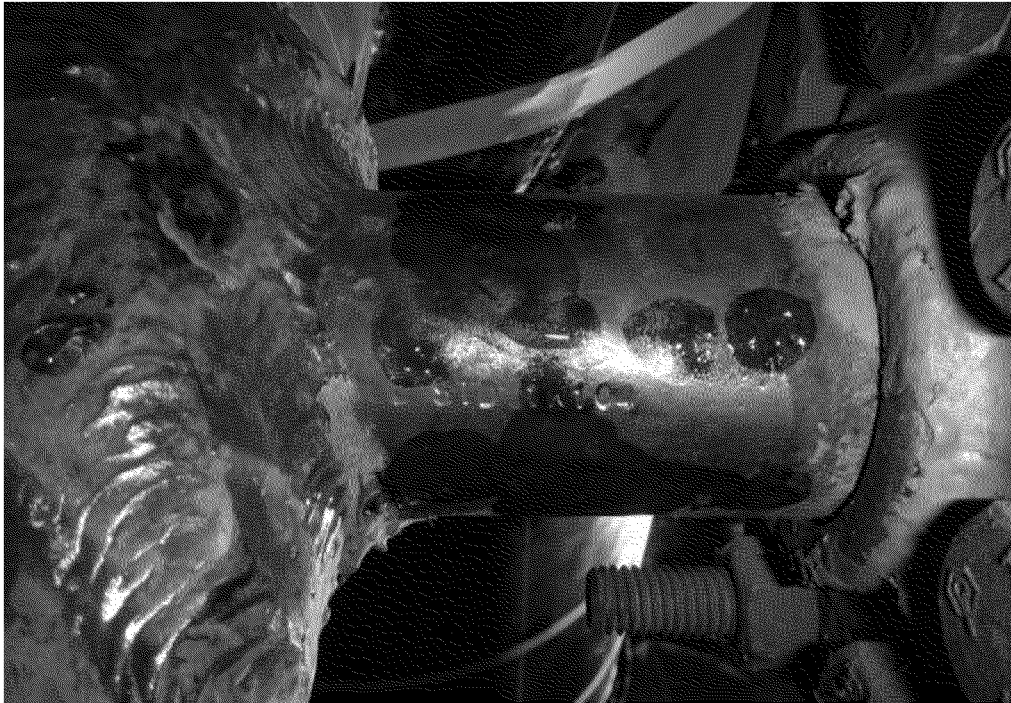
2" pipe between drip pot and valve.

12 top	1:30	3:00 North	4:30	6:00 Bottom	7:30	9:00 South	10:30
Loc 1	0.158	0.165	0.156	0.166	0.146	0.160	0.158	0.160
Loc 2	0.162	0.162	0.158	0.169	0.163	0.153	0.160	0.159
Loc 3	0.157	0.158	0.162	0.153	0.148	0.150	0.166	0.149
Loc 4	0.156	0.157	0.158	0.161	0.155	0.160	0.168	0.152

Maximum Found:	0.162	0.165	0.162	0.169	0.163	0.160	0.168	0.160
Minimum Found:	0.156	0.157	0.156	0.153	0.146	0.150	0.158	0.149
Average thickness:	0.158	0.161	0.159	0.162	0.153	0.156	0.163	0.155
