Form H: Direct Examination Data Sheet
Event 72298 on L-147 @97+70 M-147

PG&E

Route Number/MP	L-147 @97+70 M-147	N-Segment	147	ILI Log Distance (ft.)	0.000 Feet
Examination Date	11/4/2013	IMA Number	N/A	RMP-11 Ref. Section	N/A
Exam Performed By	Redacted	Region Number	1	Reference Girth Weld	N
Project Manager		Sub # (ICDA)	N/A	Dist. From Girth Weld (ft.)	0.000 Feet
Order Number	41976828	Stationing	97+70

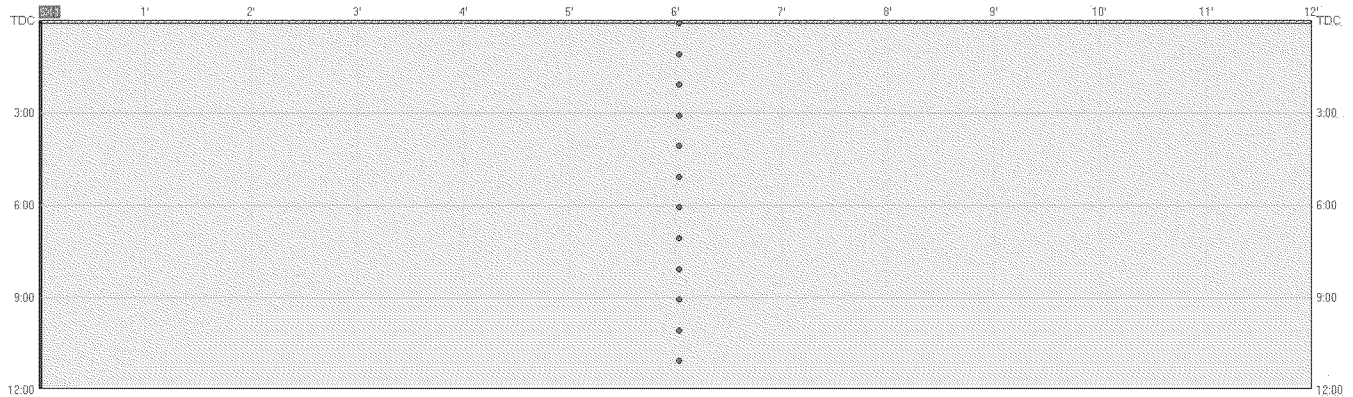
72298
 05:34 AM
 11/9/2013
 Flow →

ID	Axial Location (Inches from Ref.)	Circ. Location (Inches from TDC)	Type	Length (Inches)	Width (Inches)	Max Depth (Inches)	Description/Notes	Image Link
EC-001	34.00	35.78 6:45	Localized	1.75	1.00	0.062	Maximum wall loss is 24.71%	
EC-002	143.00	37.04 7:00	Localized	0.50	0.50	0.036	Maximum wall loss is 13.432%
