Pipe Characterization and Weld Assessment
San Carlos
Line 147
Mile Post 0.52

ATS Report #: 413.61-13.390

Gas Project: Internal Corrosion Verification

Line 147 Mile Point 0.52 San Carlos

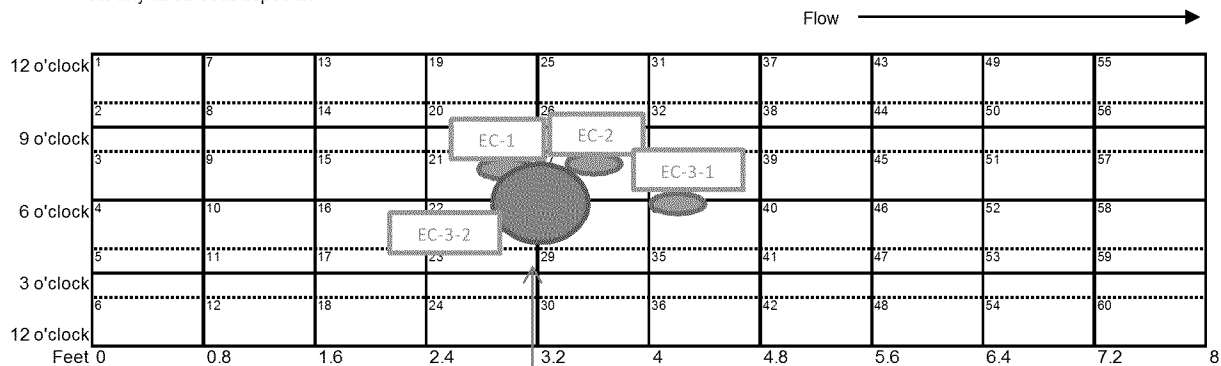
2.8 Overview Map of Corroded Area*
 *See Pit Depth Measurement Grid for additional information **Zero Reference Point:** U/S Edge of coating removal
 *Note any calcareous deposits.

degree elbow that goes North into a Vaccing fitting. There were 4 Corrosion cells that were manually gridded, the most severe of these corrosion cells was
EC-3-1 (73 mils Depth).
