**Form H: Direct Examination Data Sheet**  
**Event 72298 on L-147 @97+70 M-147**

Route Number/MP Examination Date	L-147 @97+70 M-147 11/4/2013	N-Segment	147	ILI Log Distance (ft.)	0.000 Feet
Exam Performed By	Redacted	IMA Number	N/A	RMP-11 Ref. Section	N/A
Project Manager		Region Number	1	Reference Girth Weld	N
Order Number	41976828	Sub # (ICDA)	N/A	Dist. From Girth Weld (ft.)	0.000 Feet
		Stationing	97+70

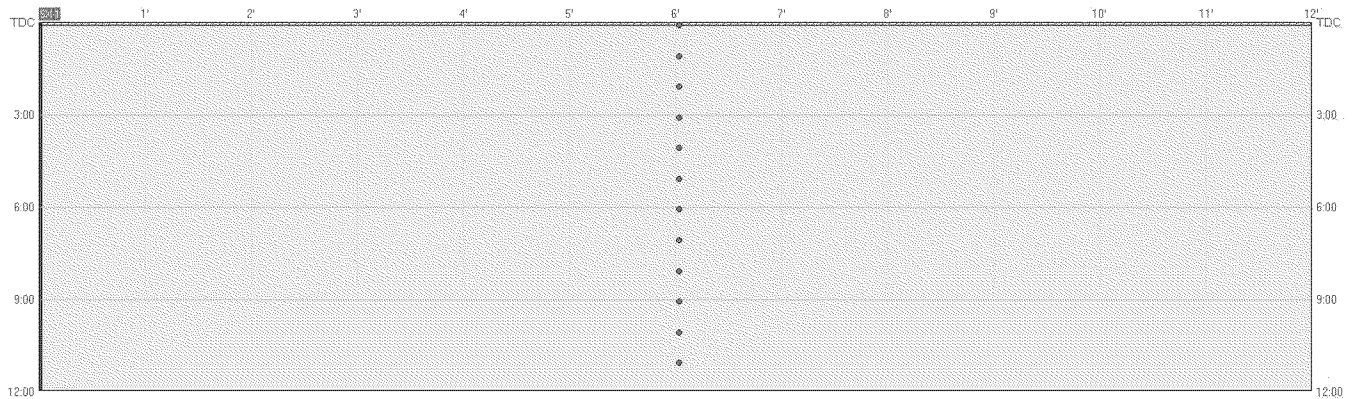
Pipe Temperature (F) 76.1 Measured Pipe Diameter (Inches) 20.212  
 Girth Weld Coordinates: Measured Pipe Circumference (Inches) 63.5  
 Northing (m) No Girth Weld present within excavation. Easting (m) No Girth Weld present within excavation.  
 Girth Weld Elevation (m) 0.000  
 Corrosion Damage Y Mechanical Damage N  
 Other Damage Notes No other damage was found at the time of inspection.  
 Wet Fluorescent Mag. Part. Test Performed? Y Were there any linear indications? Y  
 WFMT Comments WFMT was performed on 11/8/2013 on the 12' of exposed pipe, full circumference. 5 Linear Indications were found during the examination.

ID	Axial Location (Inches from Ref.)	Circ. Location (Inches from TDC)	Type	Length (Inches)	Width (Inches)	Max Depth (Inches)	Description/Notes	Image Link
EC-001	34.00	35.78 6:45	Localized	1.75	1.00	0.062	Maximum wall loss is 24.71%	
EC-002	143.00	37.04 7:00	Localized	0.50	0.50	0.036	Maximum wall loss is 13.432%

Repair Made	Y	Number of Repairs Made	5
Repair Type	Other	Damage Repaired	Other
Misc. Comments/Information	5 Linear Indications were removed via buffing.
