Pipe Characterization and Weld Assessment
San Carlos
Line 147
Mile Post 0.52

ATS Report #: 413.61-13.390

Gas Project: Internal Corrosion Verification

Line 147 Mile Point 0.52 San Carlos

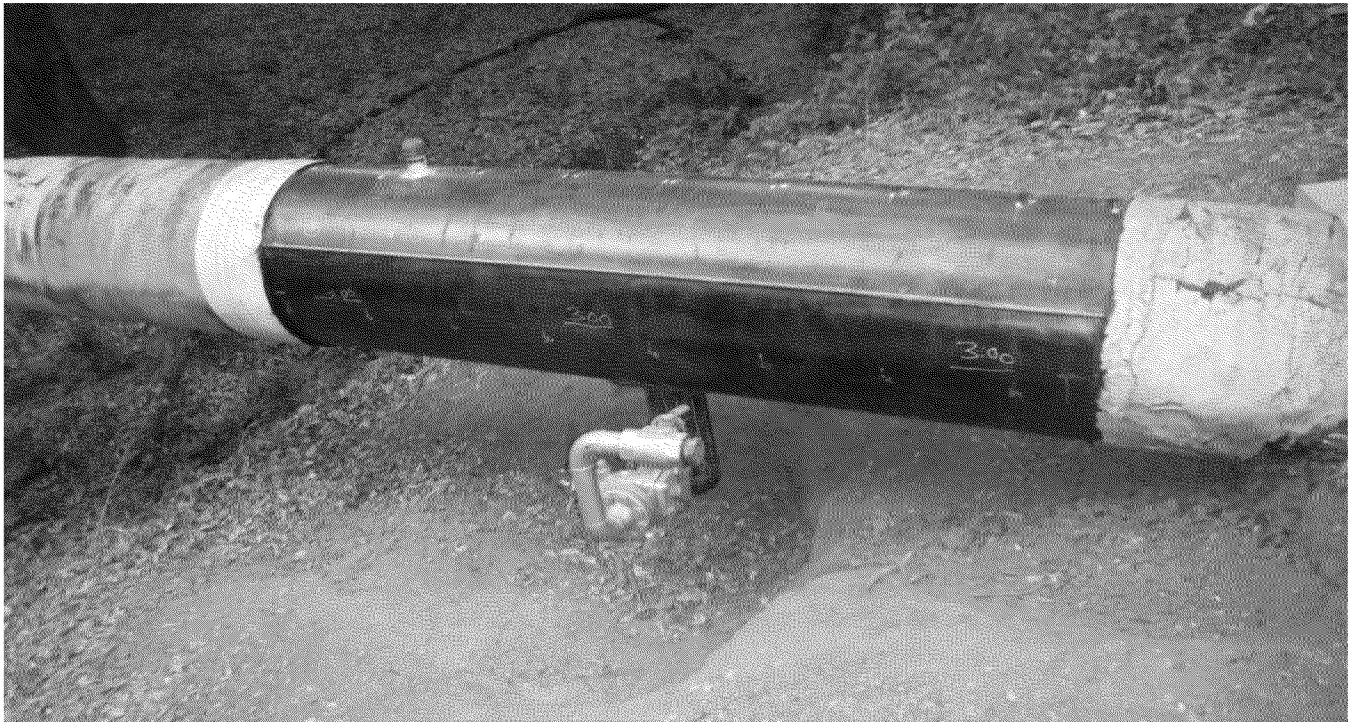
Main Line: ATS Radiographed from 3:00 to 9:00 the entire 8' exposed section of 24" pipe. No sign of internal corrosion, pitting, or debris were found. The 24" section of pipe has external corrosion cells on and around the reinforcement pad for the drip pot.

Performed radiography on the bottom 180° of the exposed section of pipe to look for any internal corrosion, pitting, and debris. Radiograph the 6" drip pot and 2" pipe between drip pot and valve to look for any liquids, or debris.

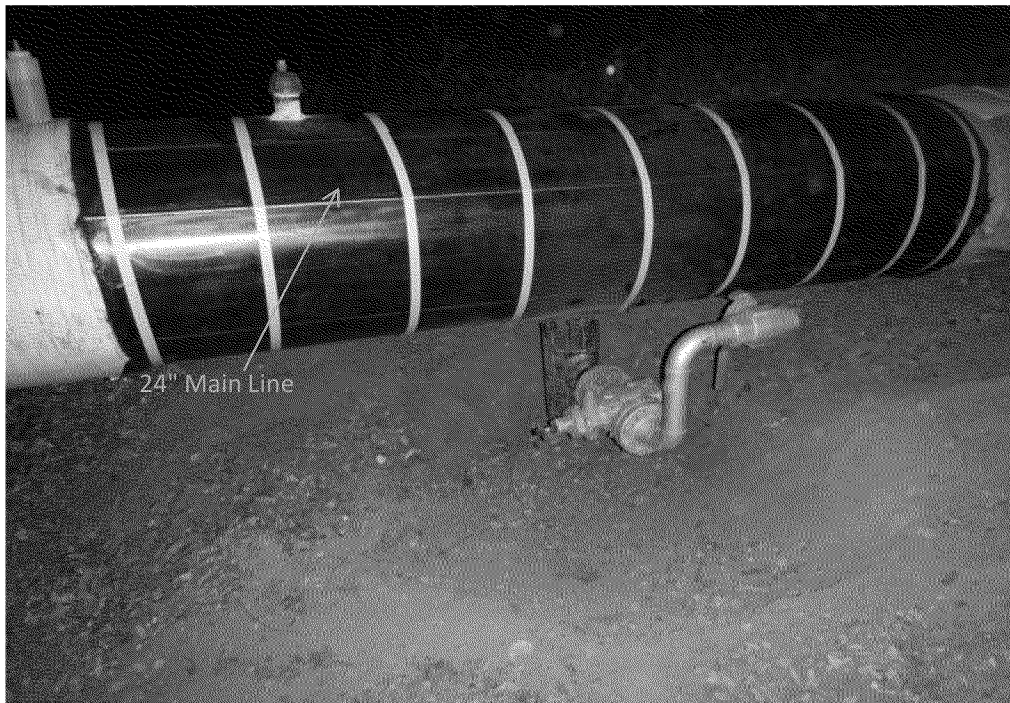
**24" Header: Exposed 4' either side of drip, 360-degrees, 8' total.
Performed 12 point UT thickness readings every foot.**

Maximum Found:	0.337	0.338	0.337	0.340	0.335	0.336	0.334	0.333	0.330
Minimum Found:	0.321	0.321	0.321	0.324	0.323	0.317	0.317	0.318	0.319
Average thickness:	0.331	0.332	0.330	0.332	0.329	0.328	0.328	0.327	0.325

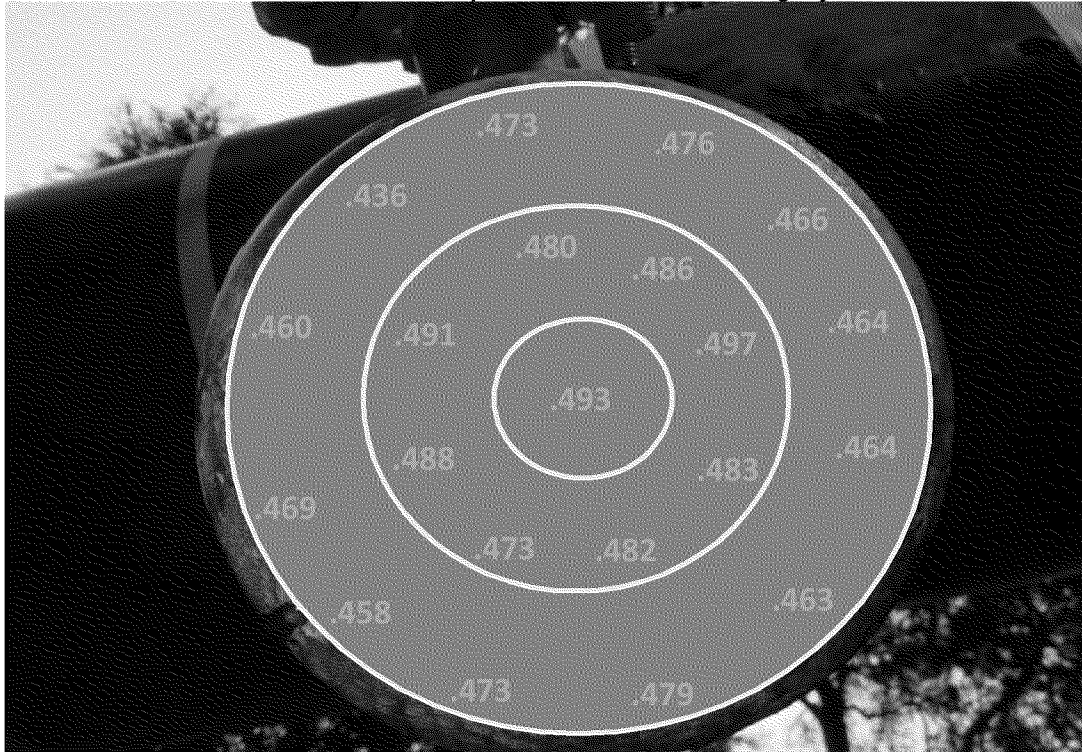
Bottom of the 6" Drip Pot UT thickness reading layout.

Maximum Found:	0.497
Minimum Found:	0.436
Average thickness:	0.474

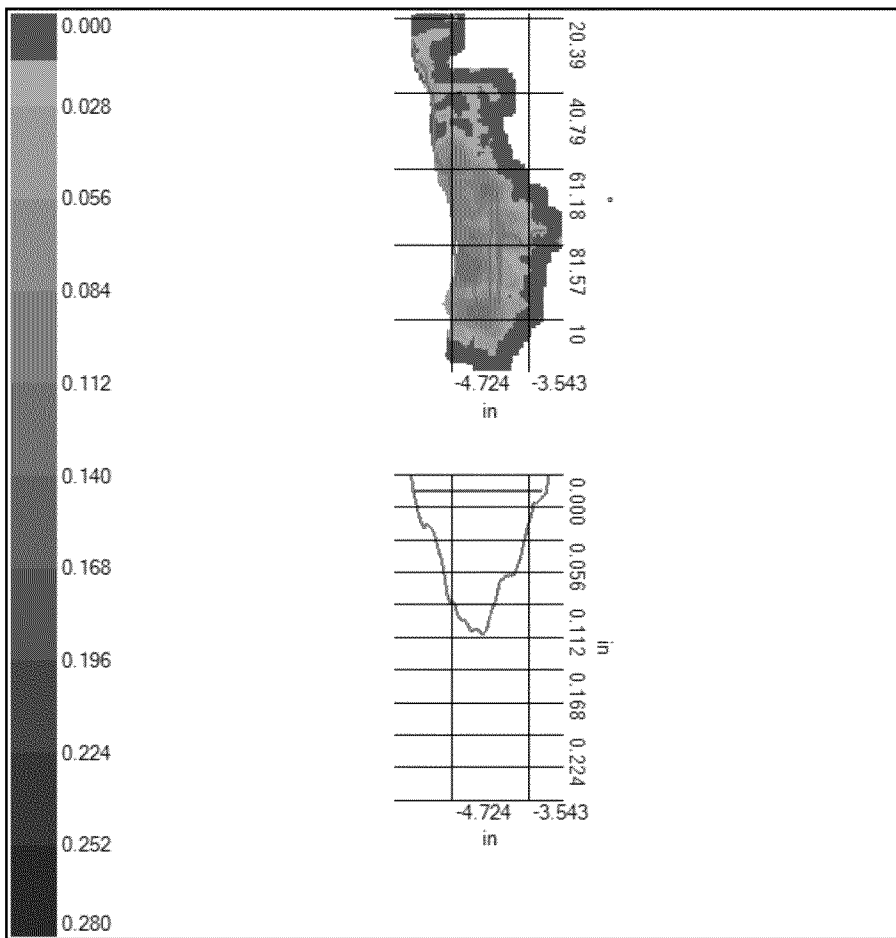
EC-3: Average Wall Thickness: 0.280", Min. 0.138" for 50.69% Wall Loss (Per Laser Scanner see attached Report) Impression Casting of the corroded weld (IC 3-3 area) which was difficult to obtain using multiple methods was: 4.00" width X 0.800" Long and approximately 0.150"-0.200" metal loss.

Results for Feature 1

Axial Start	-5.354 in
Axial End	-3.268 in
Axial Length	2.087 in
Circ. Start	23.090 °
Circ. End	111.400 °
Circ. Length	88.300 °
Max. Depth	0.138 in
Axial Pos.	-4.272 in
Circ. Pos.	100.190 °
