**Form H: Direct Examination Data Sheet**  
**Event 72298 on L-147 @97+70 M-147**

Route Number/MP	L-147 @97+70 M-147	N-Segment	147	ILI Log Distance (ft.)	0.000 Feet
Examination Date	11/4/2013	IMA Number	N/A	RMP-11 Ref. Section	N/A
Exam Performed By	Redacted	Region Number	1	Reference Girth Weld	N
Project Manager		Sub # (ICDA)	N/A	Dist. From Girth Weld (ft.)	0.000 Feet
Order Number	41976828	Stationing	97+70

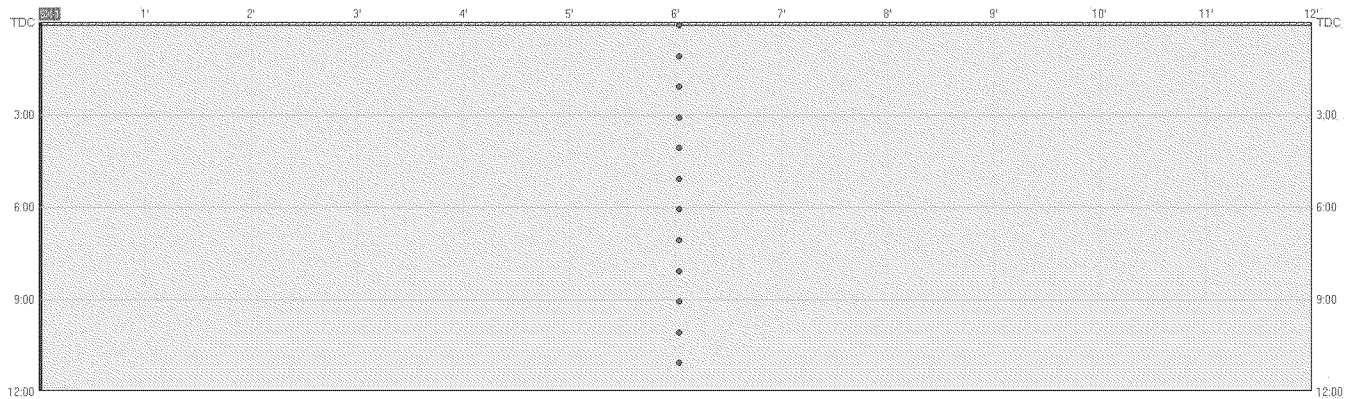
ID	Axial Location (Inches from Ref.)	Circ. Location (Inches from TDC)	Type	Length (Inches)	Width (Inches)	Max Depth (Inches)	Description/Notes	Image Link
EC-001	34.00	35.78 6:45	Localized	1.75	1.00	0.062	Maximum wall loss is 24.71%	
EC-002	143.00	37.04 7:00	Localized	0.50	0.50	0.036	Maximum wall loss is 13.432%
