Final Report

Pipe Characterization and Weld Assessment
San Carlos
Line 147
Mile Post 0.52

ATS Report #: 413.61-13.390

Gas Project: Internal Corrosion Verification

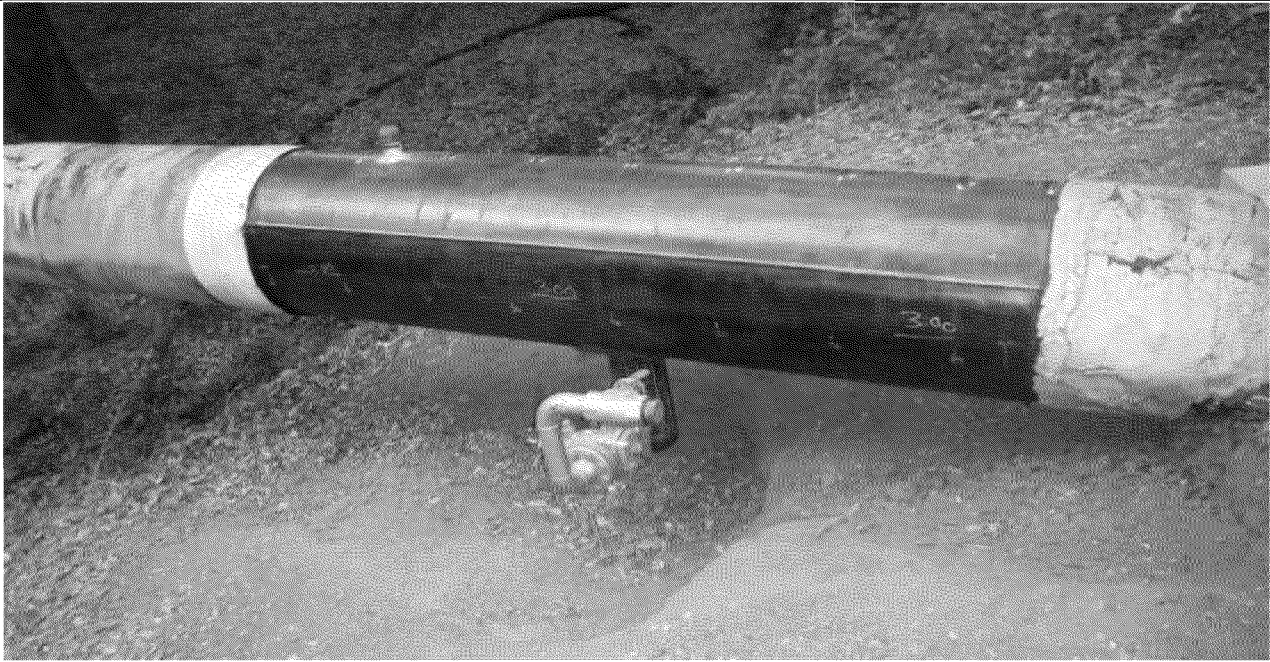
**24" Header: Exposed 4' either side of drip, 360-degrees, 8' total.
Performed 12 point UT thickness readings every foot.**

0'	1'	2'	3'	4'	5'	6'	7'	8'
12:00	0.332	0.337	0.323	0.334	0.332	0.330	0.330	0.330	0.328
1:00	0.323	0.327	0.325	0.325	0.324	0.322	0.320	0.320	0.319
2:00	0.325	0.321	0.321	0.324	0.323	0.318	0.317	0.318	0.319
3:00	0.321	0.323	0.322	0.324	0.324	0.317	0.319	0.320	0.319
4:00	0.328	0.332	0.330	0.331	0.325	0.326	0.326	0.331	0.327
5:00	0.336	0.338	0.337	0.336	0.331	0.334	0.332	0.332	0.327
6:00	0.333	0.335	0.332	0.331	0.331	0.329	0.331	0.328	0.327
7:00	0.331	0.331	0.331	0.330	0.328	0.330	0.328	0.328	0.325
8:00	0.333	0.332	0.334	0.335	0.330	0.331	0.331	0.327	0.326
9:00	0.333	0.333	0.333	0.334	0.329	0.333	0.330	0.329	0.329
10:00	0.334	0.334	0.336	0.340	0.331	0.331	0.332	0.330	0.328
11:00	0.337	0.337	0.337	0.337	0.335	0.336	0.334	0.333	0.330

Maximum Found:	0.337	0.338	0.337	0.340	0.335	0.336	0.334	0.333	0.330
Minimum Found:	0.321	0.321	0.321	0.324	0.323	0.317	0.317	0.318	0.319
Average thickness:	0.331	0.332	0.330	0.332	0.329	0.328	0.328	0.327	0.325

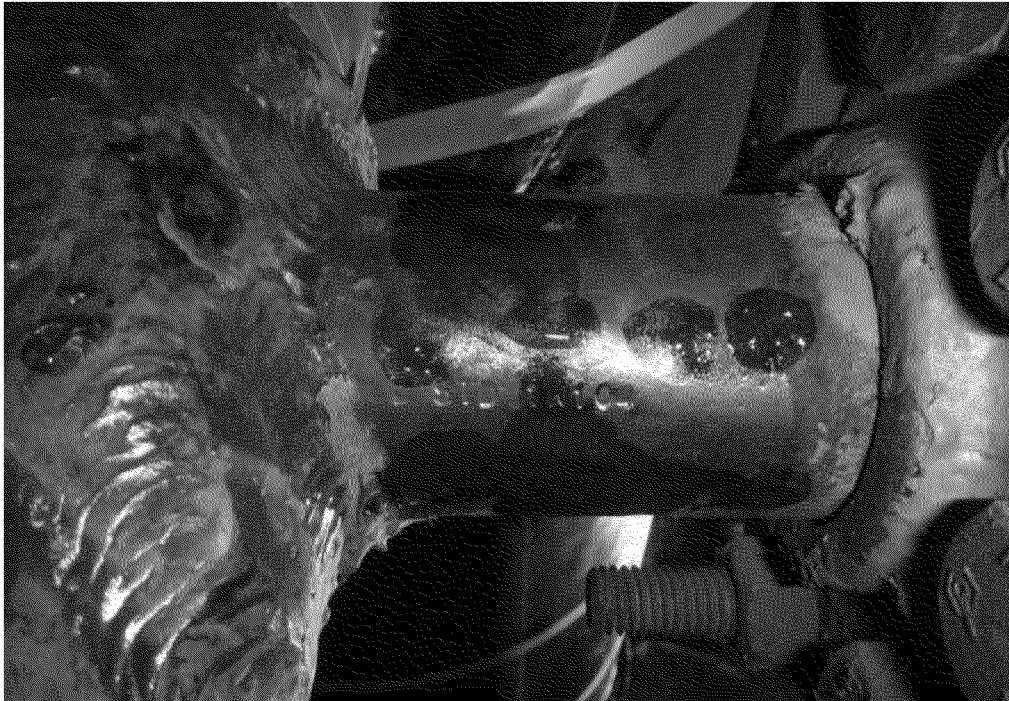
2" pipe between drip pot and valve.

12 top	1:30	3:00 North	4:30	6:00 Bottom	7:30	9:00 South	10:30
Loc 1	0.158	0.165	0.156	0.166	0.146	0.160	0.158	0.160
Loc 2	0.162	0.162	0.158	0.169	0.163	0.153	0.160	0.159
Loc 3	0.157	0.158	0.162	0.153	0.148	0.150	0.166	0.149
Loc 4	0.156	0.157	0.158	0.161	0.155	0.160	0.168	0.152

Maximum Found:	0.162	0.165	0.162	0.169	0.163	0.160	0.168	0.160
Minimum Found:	0.156	0.157	0.156	0.153	0.146	0.150	0.158	0.149
Average thickness:	0.158	0.161	0.159	0.162	0.153	0.156	0.163	0.155
