Re: Update - Oakland Incident of December 10, 2013

Investigation Status Update
12/16/2013

Exponent[®]
Failure Analysis Associates[®]

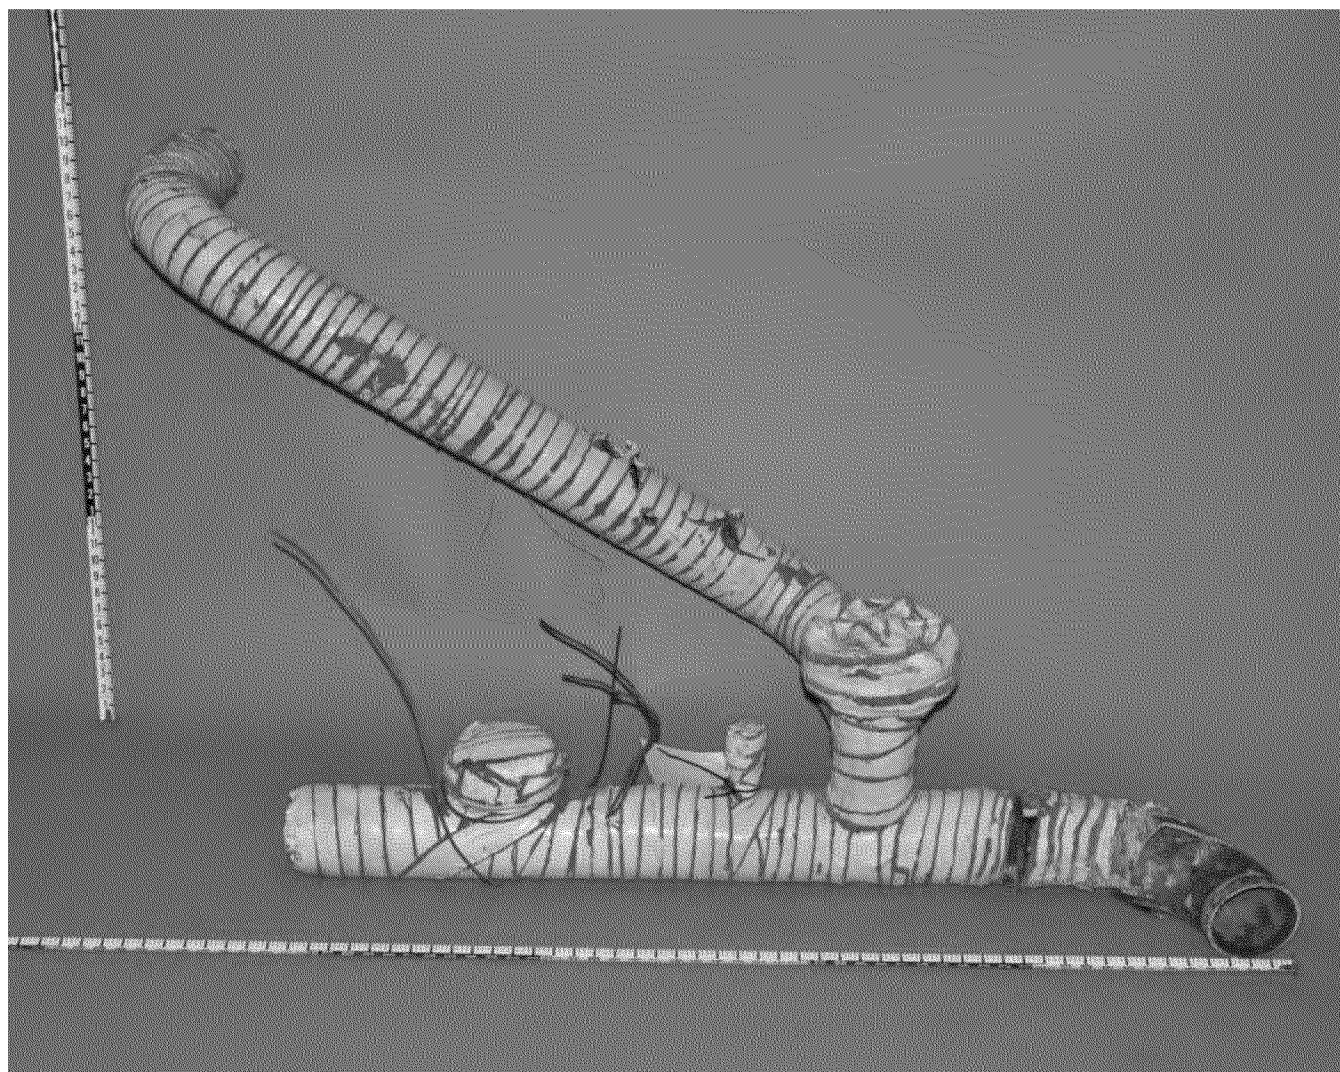
Evidence at Exponent

- The failure of the 4-inch steel elbow resulted from a single, significant external force to the pipeline. The elbow failed at the inner radius due to an external load to the pipe. The cause of the external force is not known at this time. The elbow failed in a brittle failure mode with no indications of yielding or fatigue. Yielding is the point where a material starts to deform due to the loading. In this case, the steel fractured with no indications of deformation.

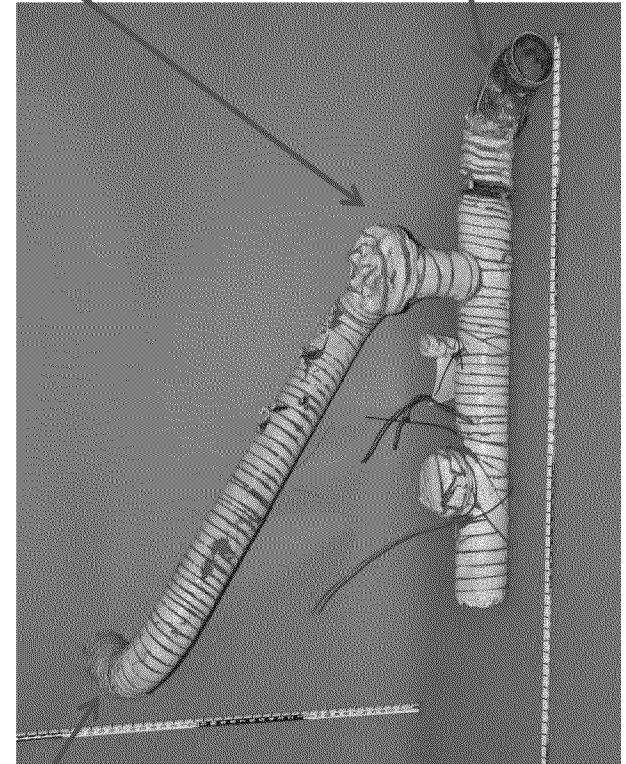
Installed flanged tee (1987)

Existing elbow (1946)

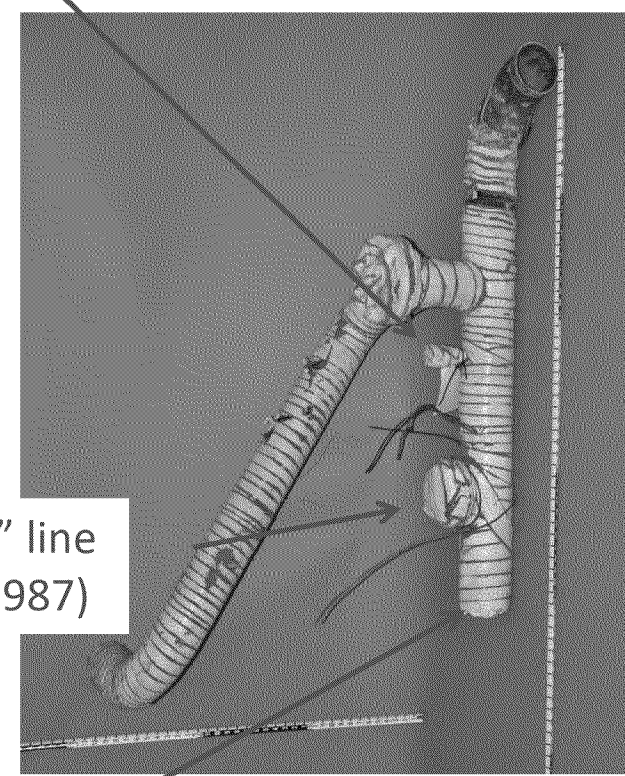
As built construction drawing from GM 4564829 (1987) /

Existing 4" line deactivated in 1987

Installed 4" line and elbows (1987)

Installed sav-a-valve (1987)

Installed 4" line stopper (1987)

Installed 4" cap (1987)

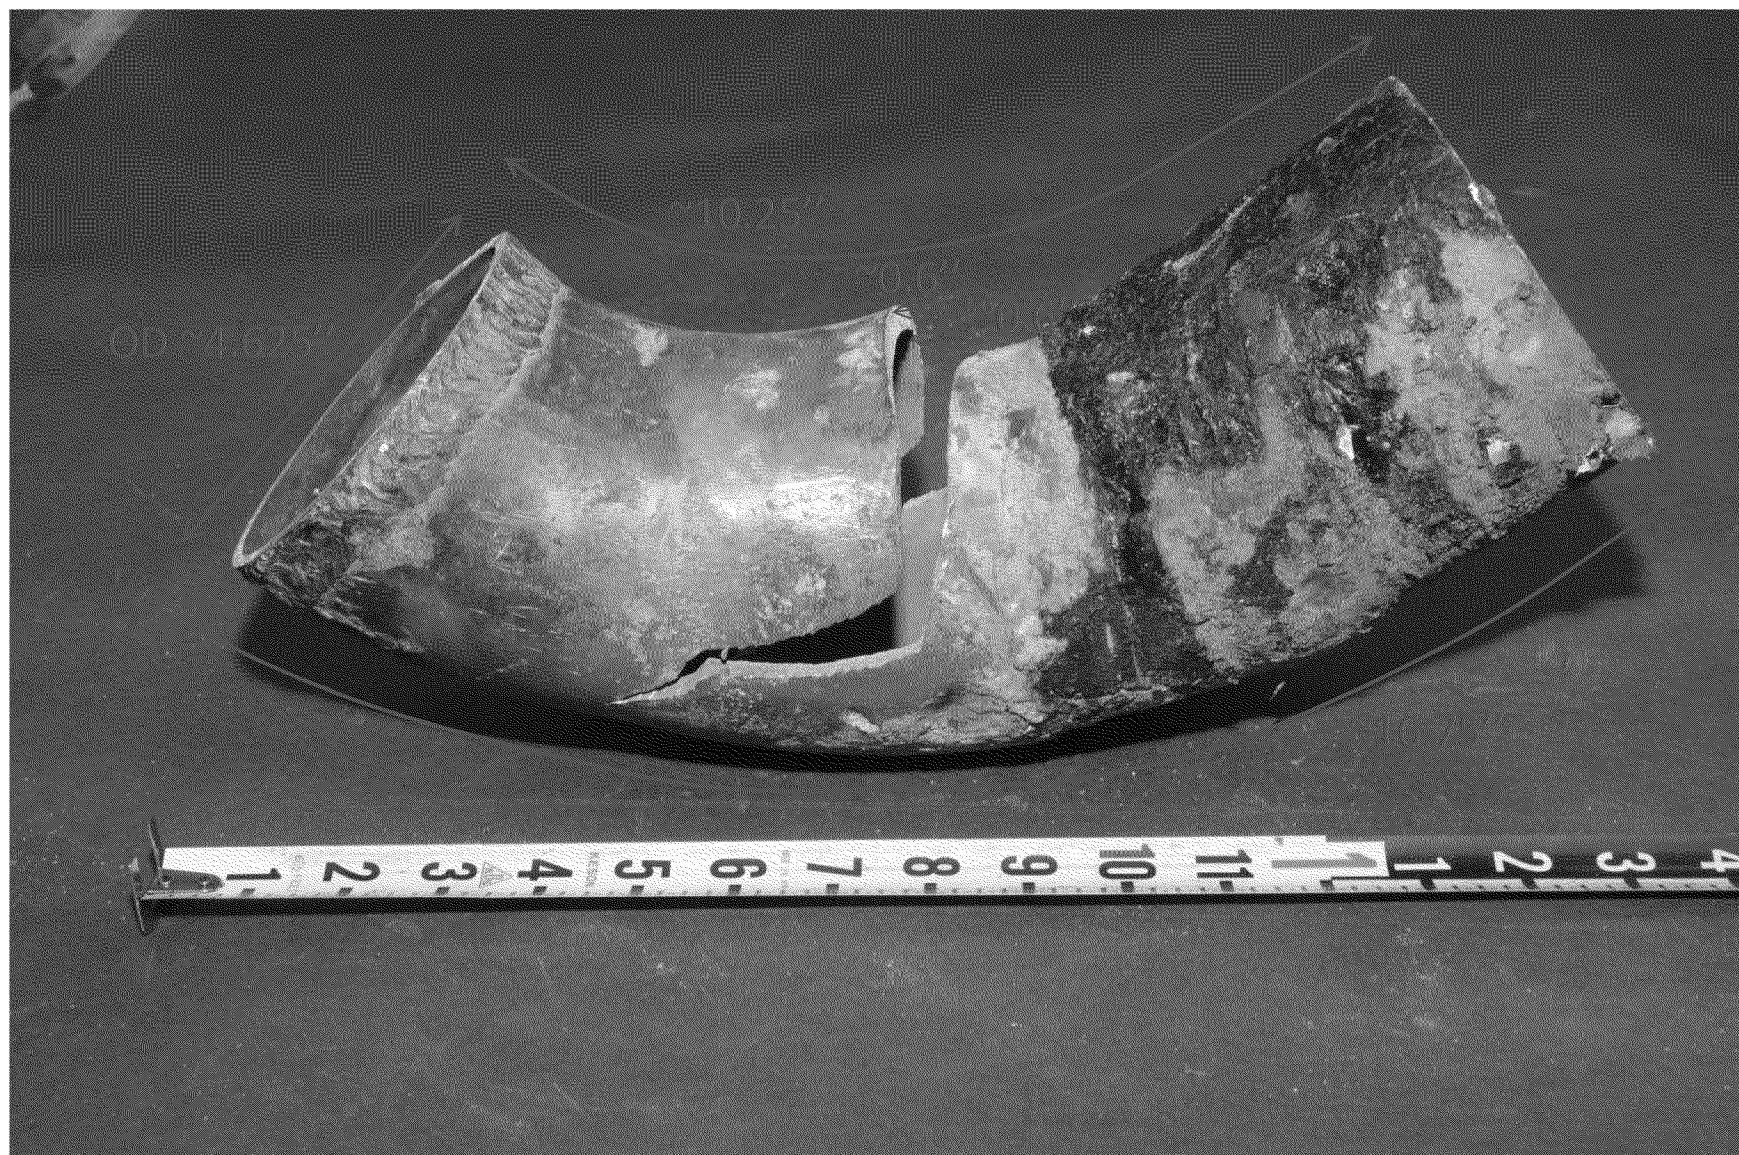
Dimensional Analysis

- The affected pipe was installed in 1946 with a Maximum Allowable Operating Pressure of 54 psig and a Normal Operating Pressure of 48 psig. The elbow is seamless and showed limited evidence of corrosion or prior mechanical damage, neither of which contributed to the failure. The materials and configuration of the pipelines in the exposed area are consistent with our as-built records of the pipe installed at the location.

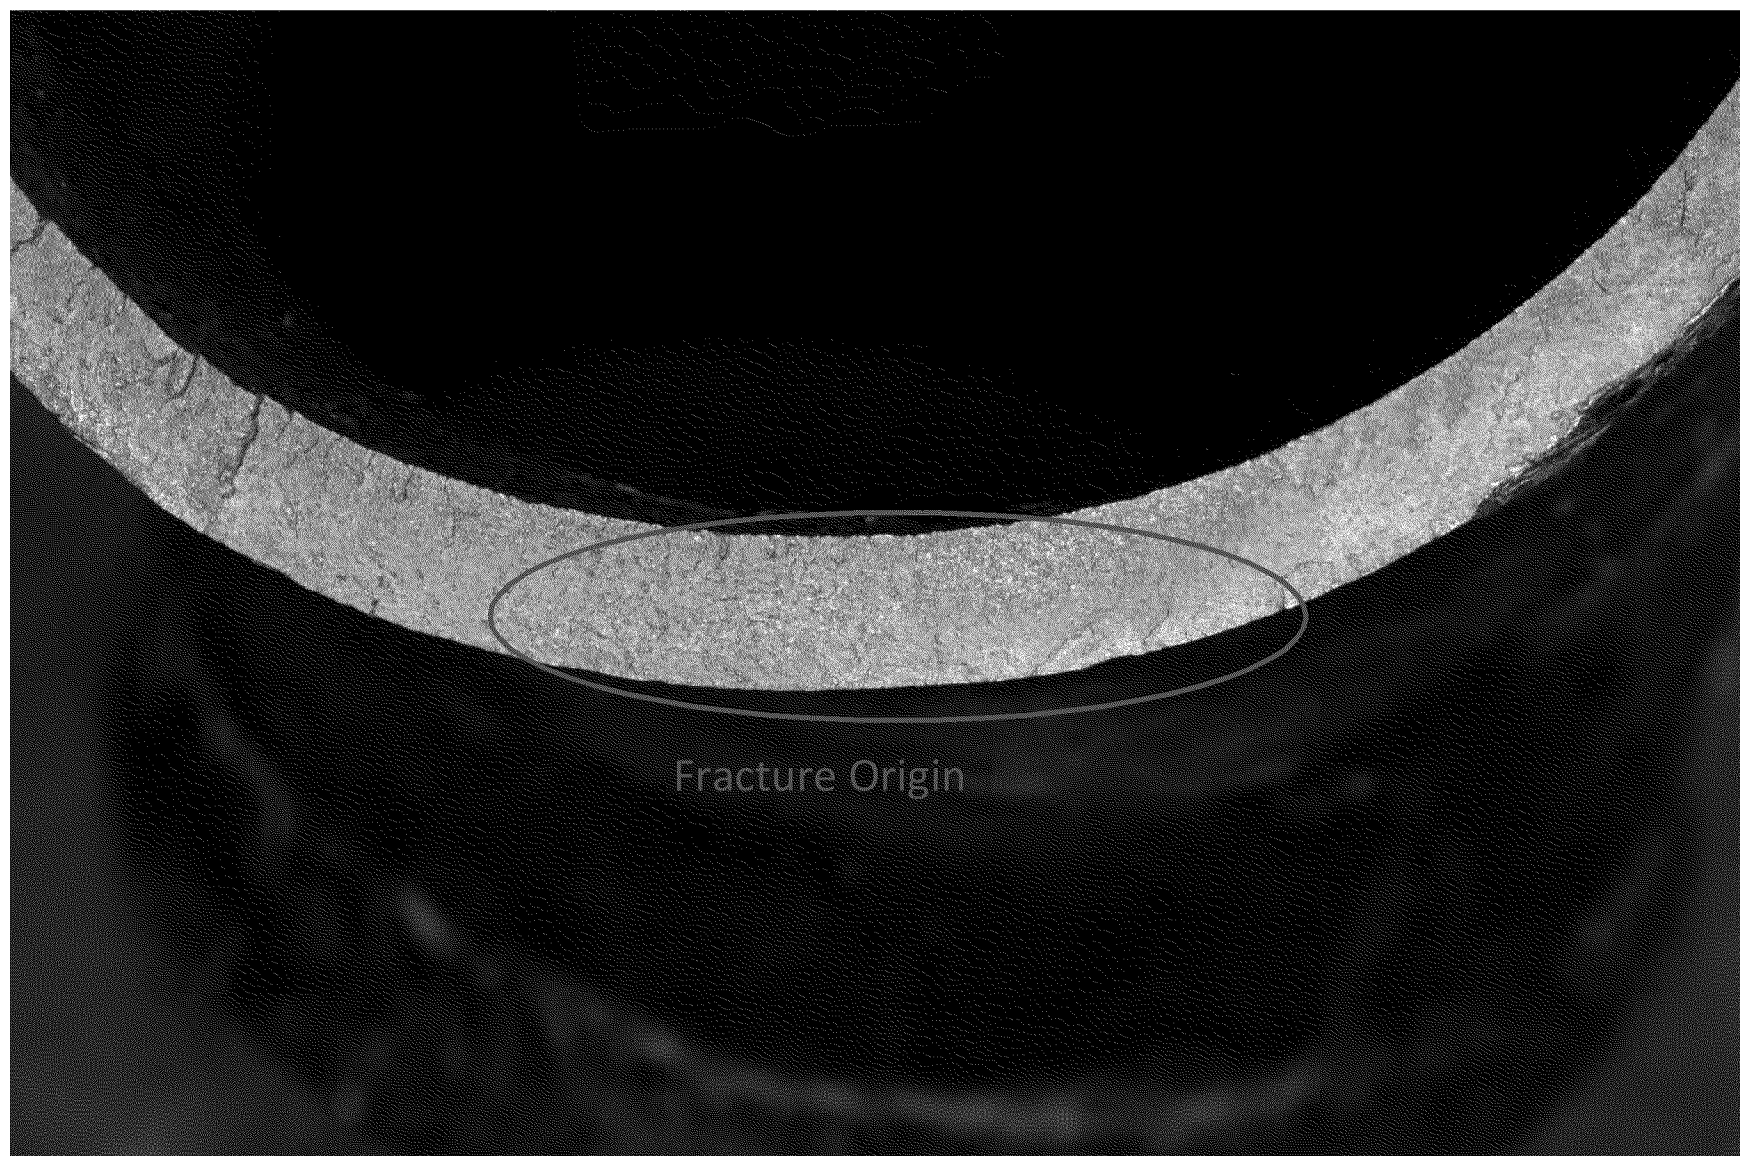
Visual Inspection

- External forces acting on the pipeline resulted in stresses that exceeded the subject elbow's tensile strength, resulting in its fracture
- The source of these external forces is currently being investigated
- Brittle (cleavage) fracture morphology was observed
- No evidence of progressive fracture (such as fatigue or stress corrosion cracking) was observed
- The fracture was not associated with a mechanical, corrosion-induced, or metallurgical defect
- The elbow exhibited the expected "ferrite-pearlite" microstructure
- The elbow hardness was measured to be 193 HV, roughly equivalent to a UTS of 92 ksi
