Re: Update - Oakland Incident of December 10, 2013

PG&E Golf Links Road Release

Investigation Status Update

Exponent[®]
Failure Analysis Associates[®]

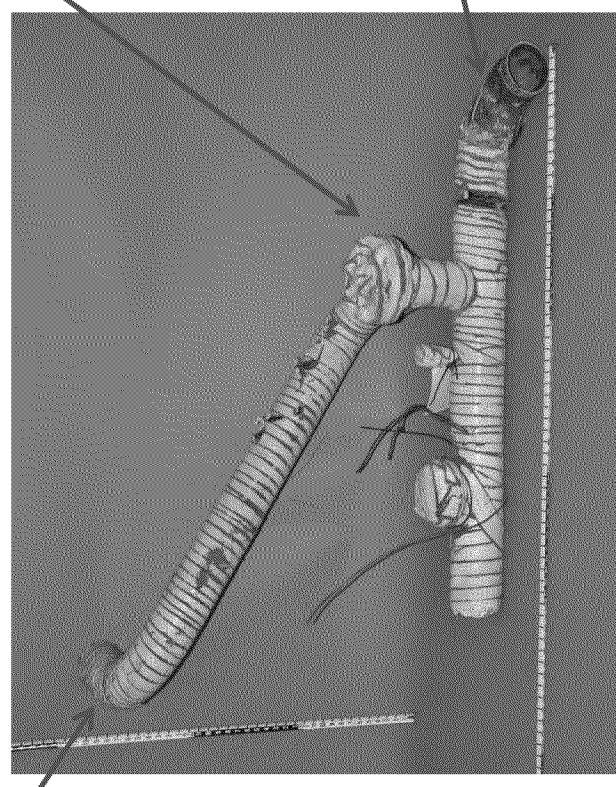
Existing 4" line deactivated in 1987

Installed 4" line and elbows (1987)

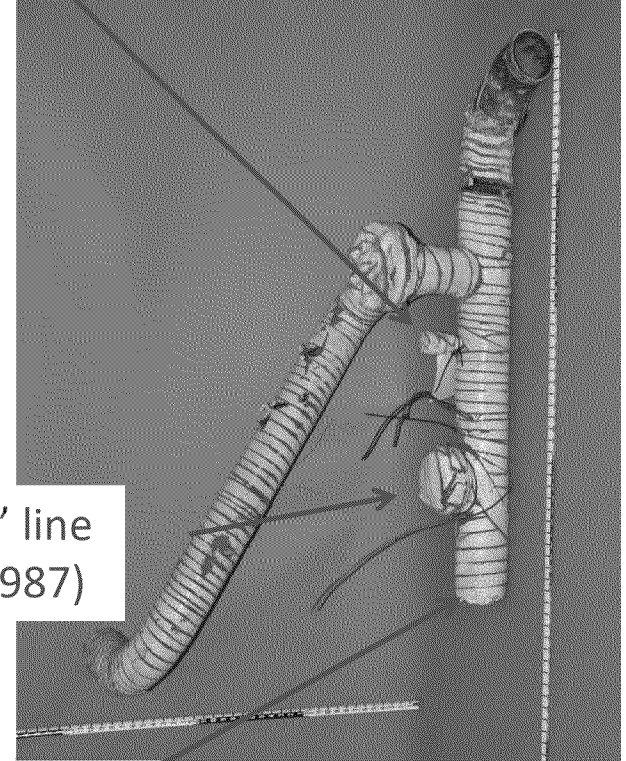
As built construction drawing from GM 4564829 (1987) /

Installed 4" line
cap (1987)

Installed 4" cap (1987)

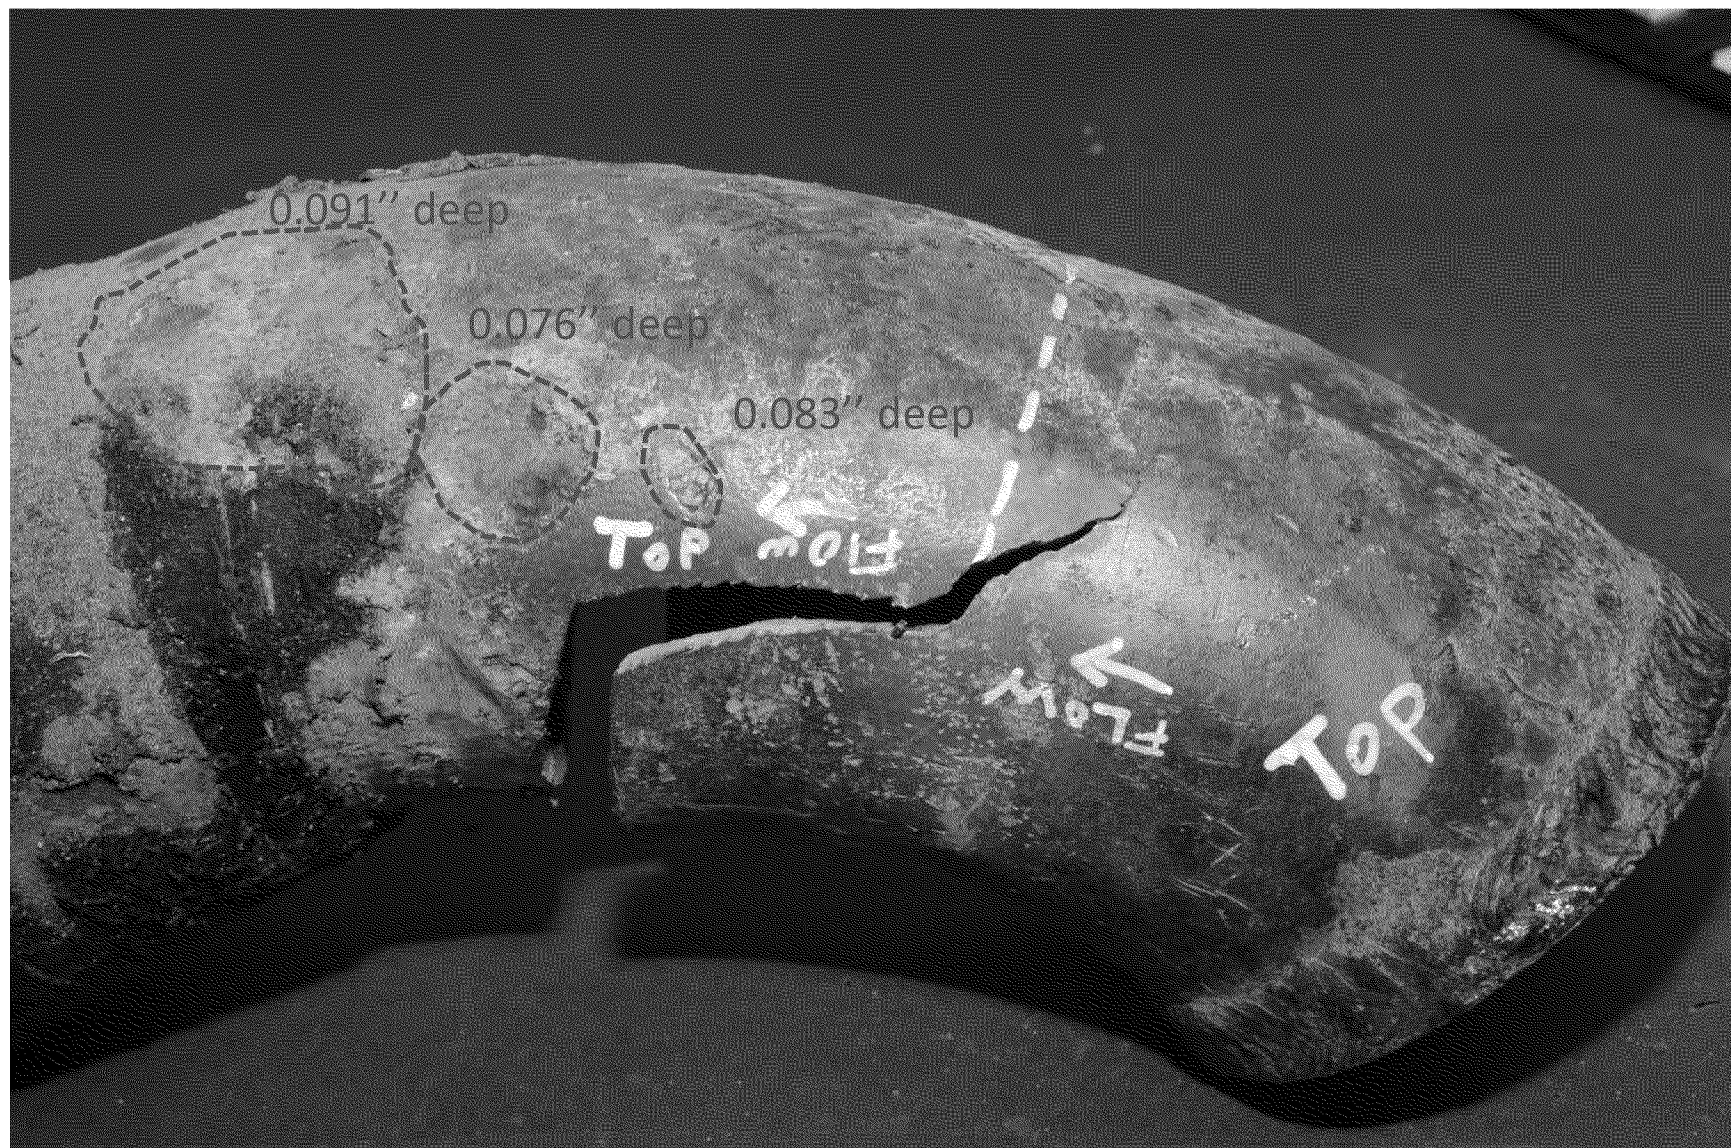
Dimensional Analysis: Corrosion

- The affected pipe was installed in 1946 with a Maximum Allowable Operating Pressure of 54 psig and a Normal Operating Pressure of 48 psig. The elbow is seamless and showed limited evidence of corrosion or prior mechanical damage, neither of which contributed to the failure. The materials and configuration of the pipelines in the exposed area are consistent with our as-built records of the pipe installed at the location.

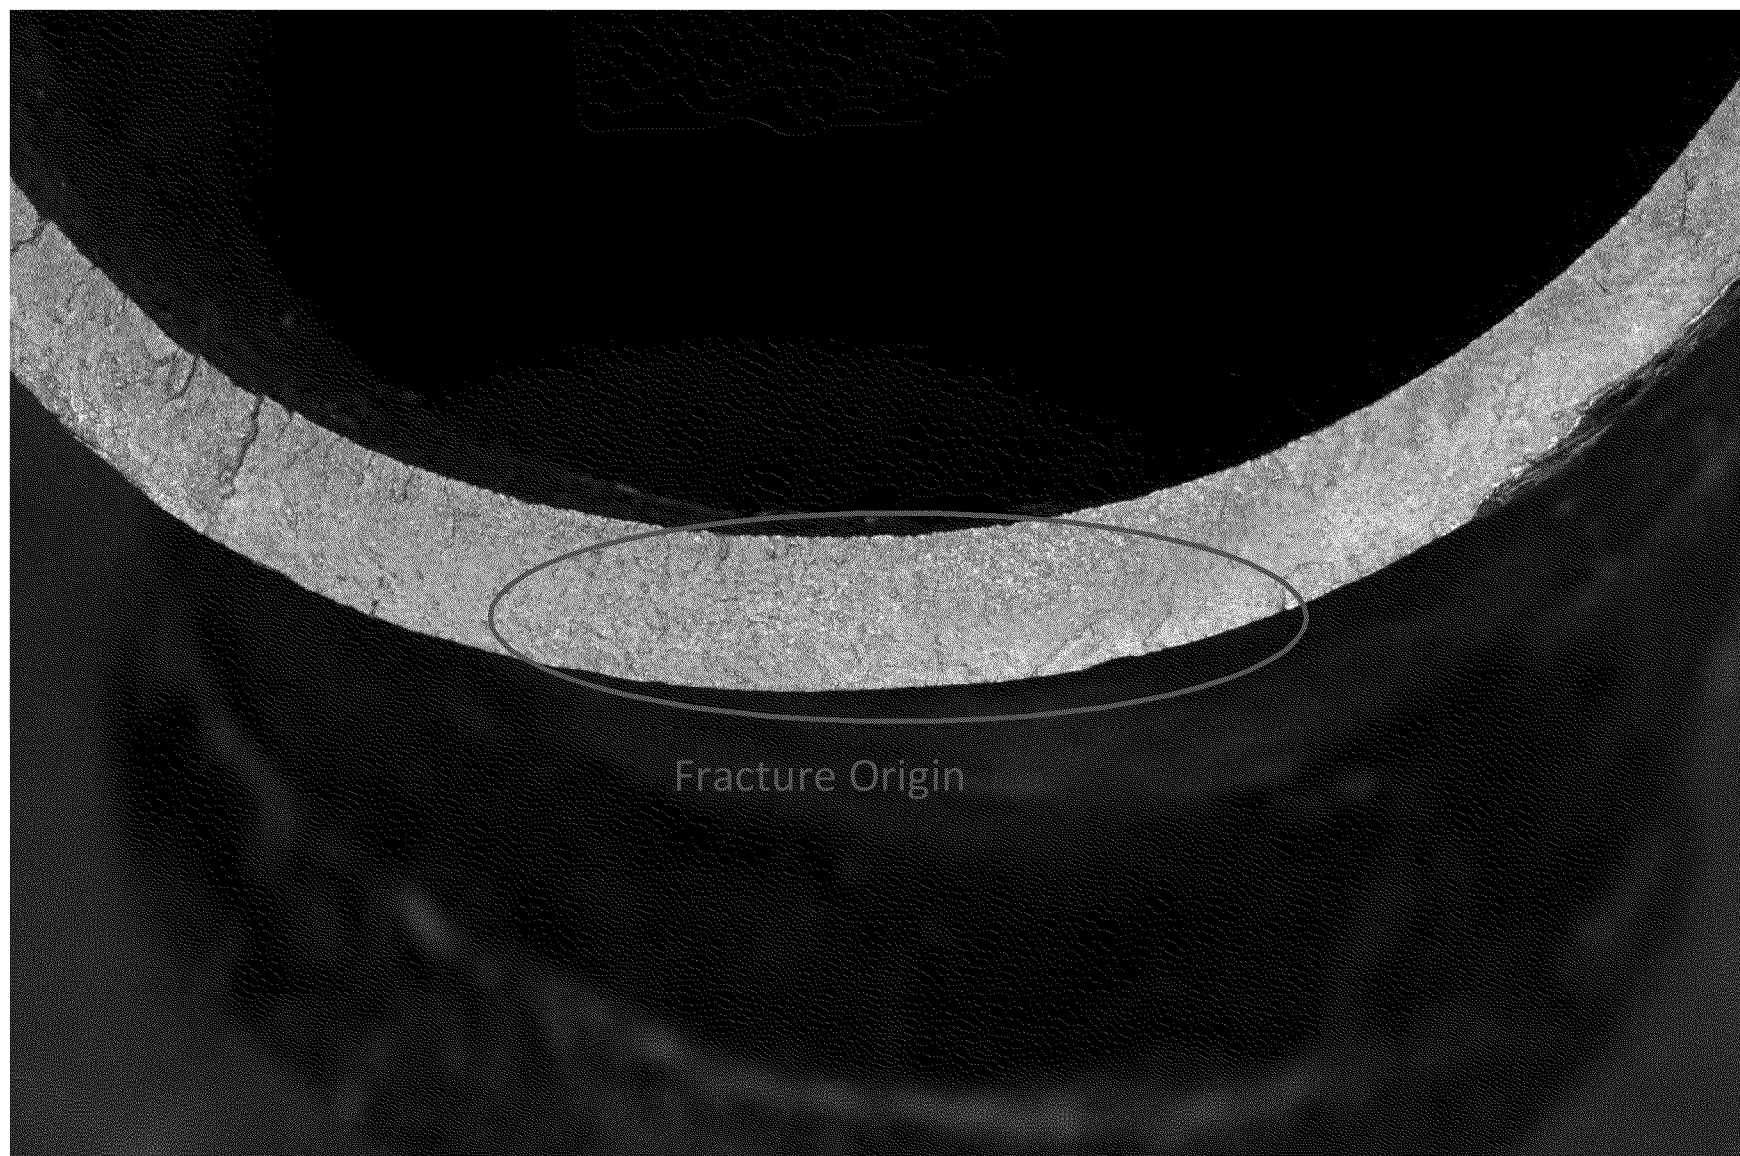
Visual Inspection

- The failure of the 4-inch steel elbow resulted from a single, significant external force to the pipeline. The elbow failed at the inner radius due to an external load to the pipe. The cause of the external force is not known at this time. The elbow failed in a brittle failure mode with no indications of yielding or fatigue. Yielding is the point where a material starts to deform due to the loading. In this case, the steel fractured with no indications of deformation.

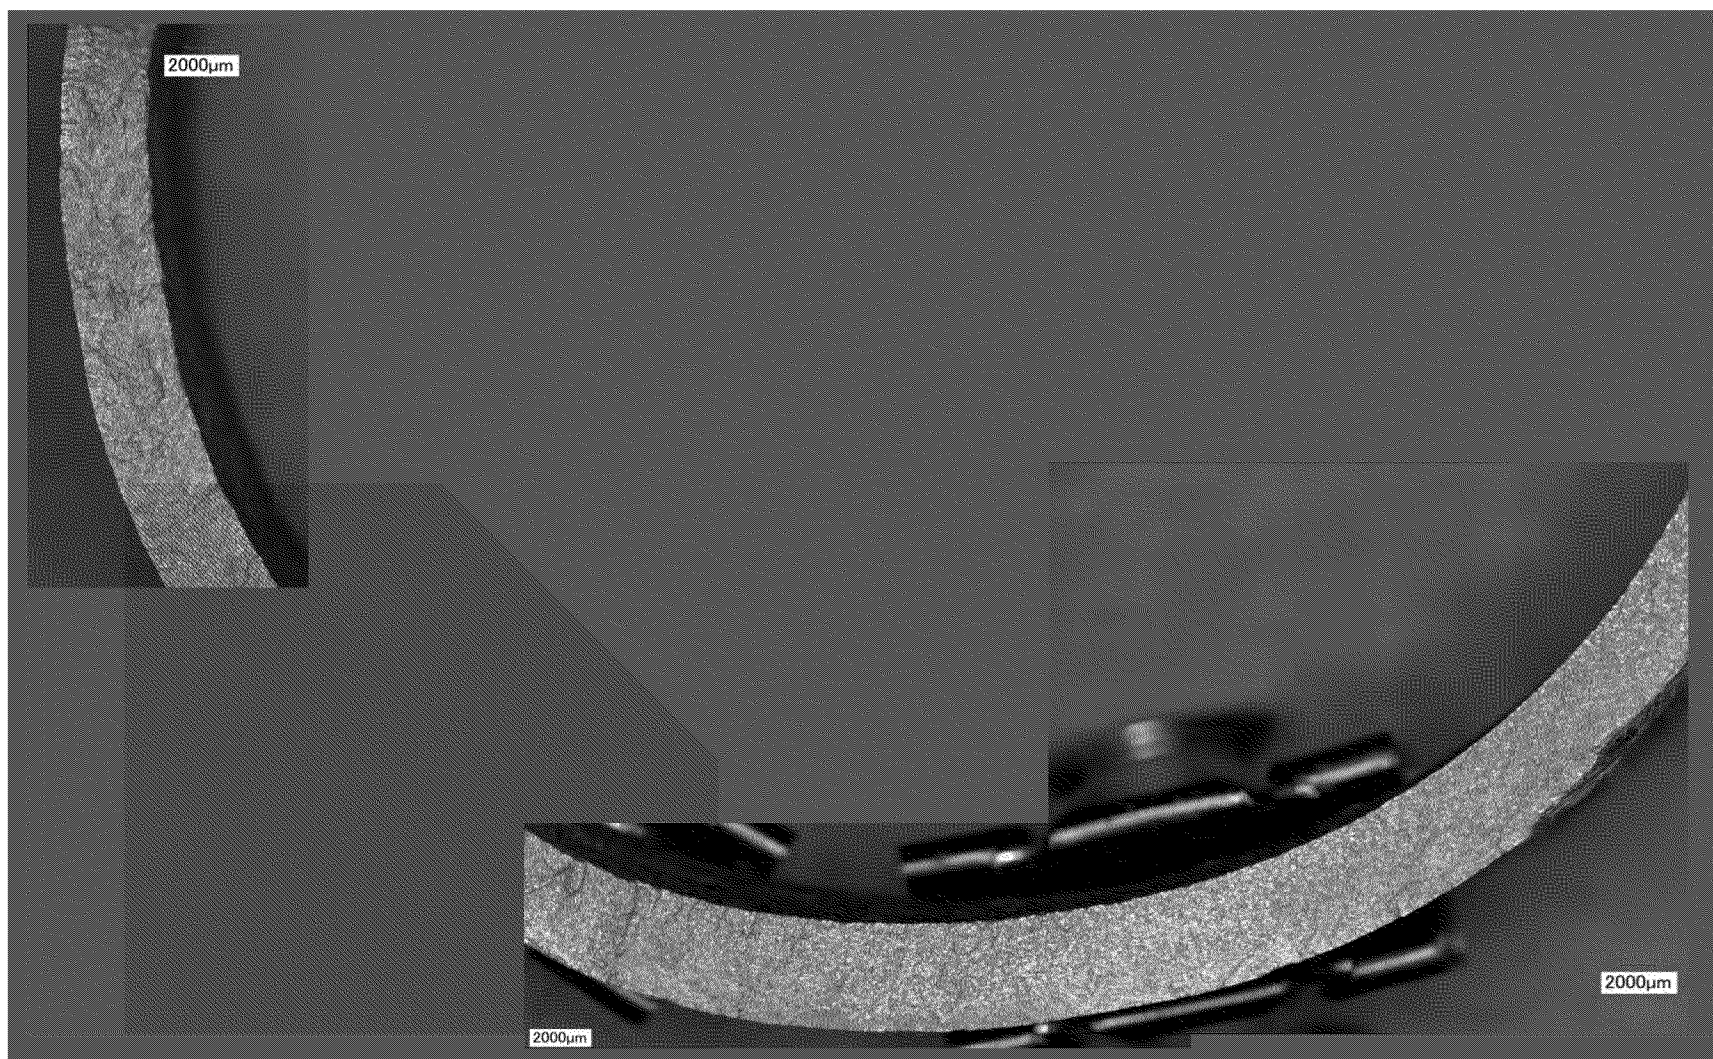
Optical Microscopy

- External forces acting on the pipeline resulted in stresses that exceeded the subject elbow's tensile strength, resulting in its fracture
- The source of these external forces is currently being investigated
- Brittle (cleavage) fracture morphology was observed
- No evidence of progressive fracture (such as fatigue or stress corrosion cracking) was observed
- The fracture was not associated with a mechanical, corrosion-induced, or metallurgical defect
- The elbow exhibited the expected "ferrite-pearlite" microstructure
- The elbow hardness was measured to be 193 HV, roughly equivalent to a UTS of 92 ksi
