PG&E Redacted Release

**Investigation Status Update 12/13/2013**

**Exponent**<sup>®</sup>  
*Failure Analysis Associates*<sup>®</sup>

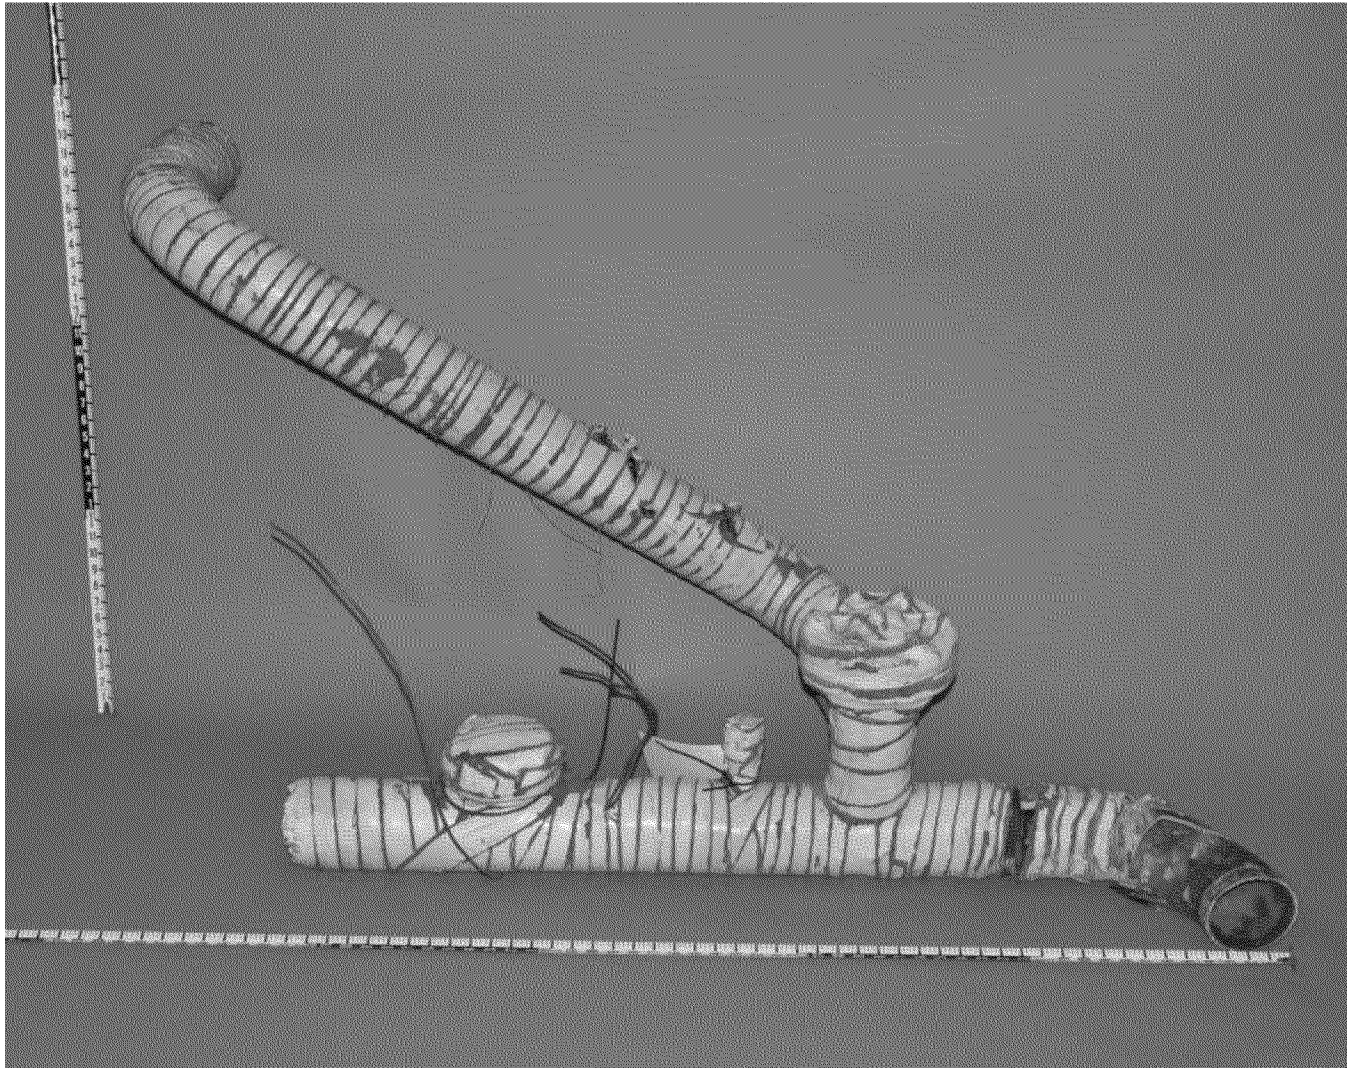
# Evidence at Exponent

- The component that failed is a 4” diameter, 90 degree manufactured steel elbow that was installed in 1946.
- Immediately upstream the failed elbow, a 3” diameter tee was installed in 1965 that fed the Fontaine Street main.
- Downstream of the failed elbow, the 4” line was cut and capped in 1987 and an upward transition was added to feed a plastic line that continued down Golf Links Road.
- The construction documents from 1946 and 1987 accurately reflect the as-installed conditions.

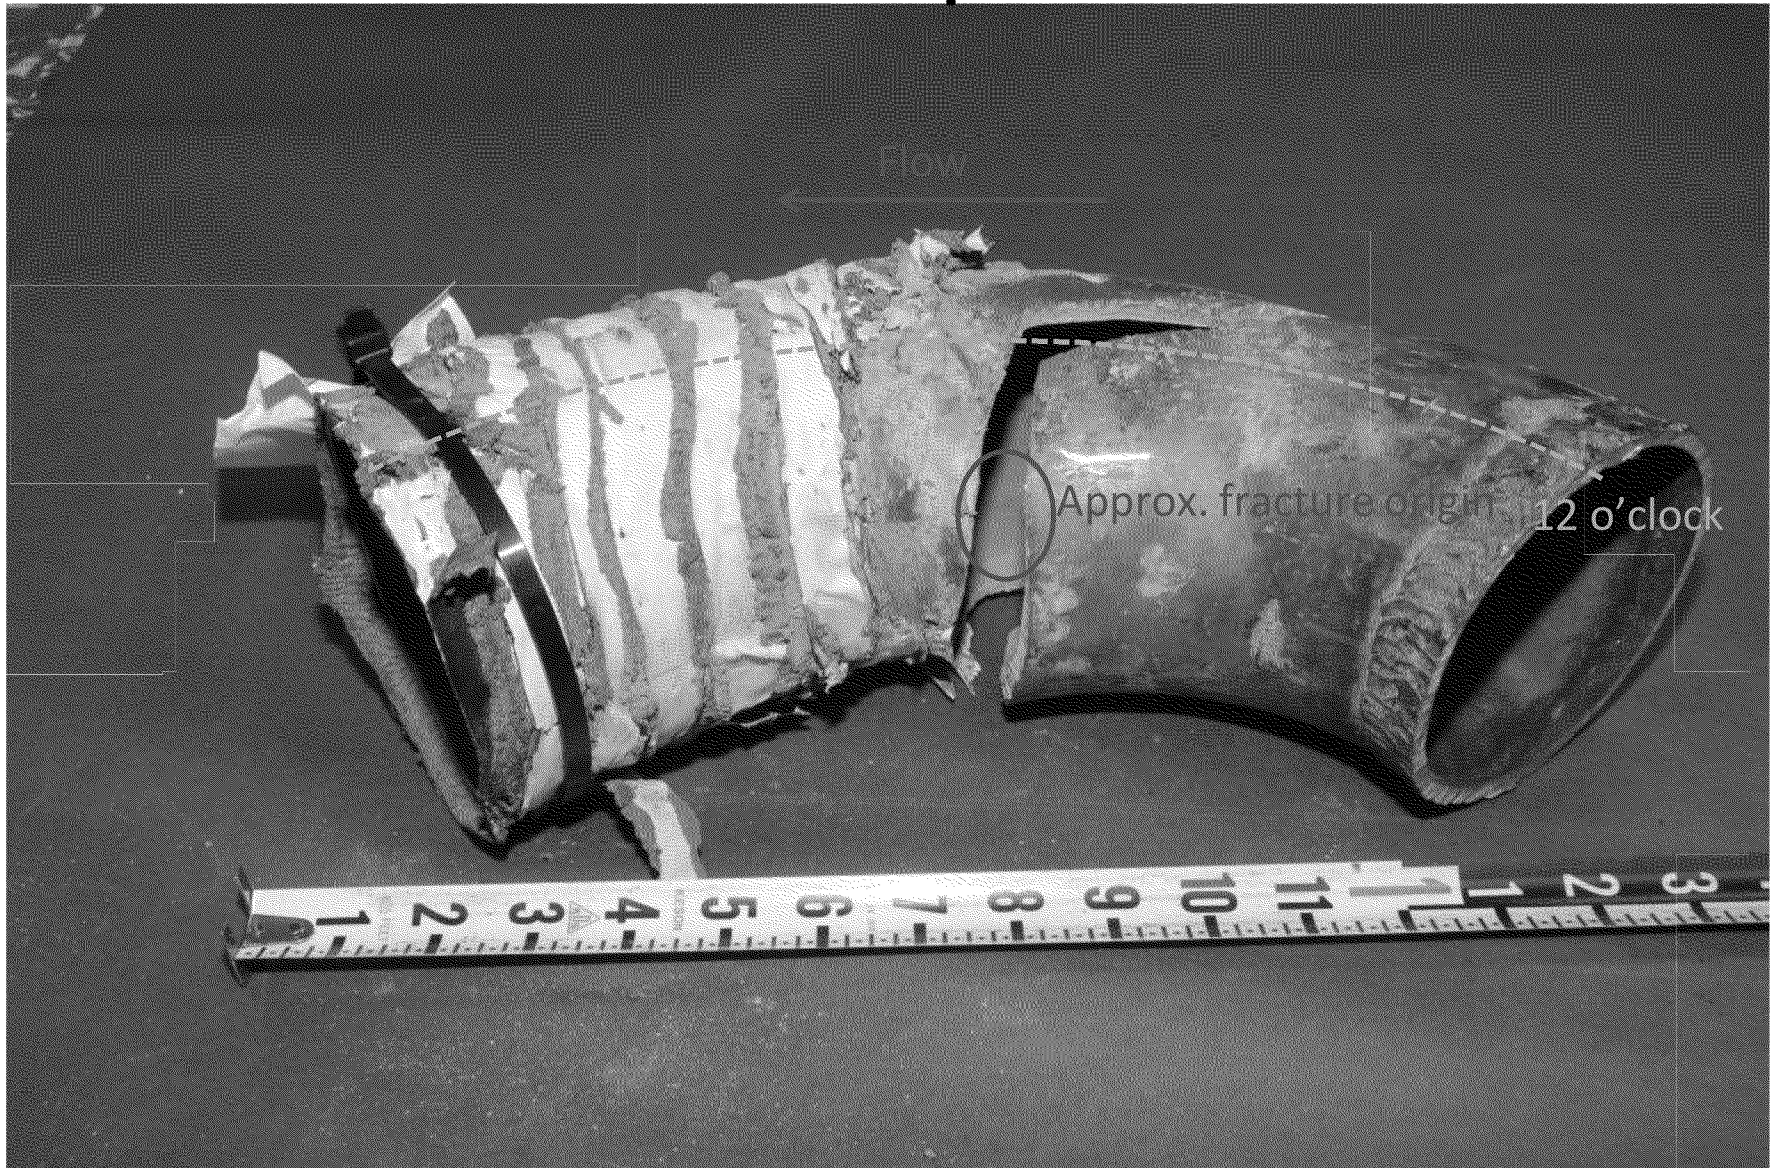
# Visual Inspection

- The subject elbow fracture was caused by a single, overload event
- Brittle (cleavage) fracture morphology was observed
- No evidence of progressive fracture (such as fatigue or stress corrosion cracking) was observed
- The fracture was not associated with a mechanical, corrosion-induced, or metallurgical defect
- The elbow exhibited the expected “ferrite-pearlite” microstructure
- The elbow hardness was measured to be 193 HV, roughly equivalent to a UTS of 92 ksi
