Re: Update - Oakland Incident of December 10, 2013

Pacific Gas and Electric (PG&E) has retained Exponent Failure Analysis Associates (Exponent) to conduct a failure analysis investigation of an elbow that fractured as part of a four-inch natural gas distribution line on December 10, 2013 [Redacted] [Redacted] in Oakland, California. Our investigation to-date has included inspection of the leak site, review of PG&E's historical construction documents, a fire cause and origin study, metallurgical analysis, geotechnical analysis, analysis of other leak locations within the immediate area, and finite element-based stress analyses of ground movement and stresses on the subject elbow and associated piping.

Exponent's analyses indicate that the most likely root cause of the subject elbow fracture was from stresses that developed over time due to creep along the Hayward Fault.

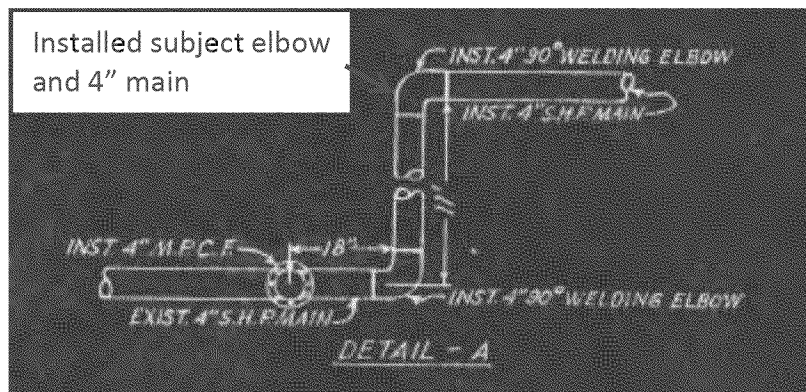
Figure 7. Cropped view of as-built construction drawing for job G.M.G. 82435 (1946) showing area of leak.

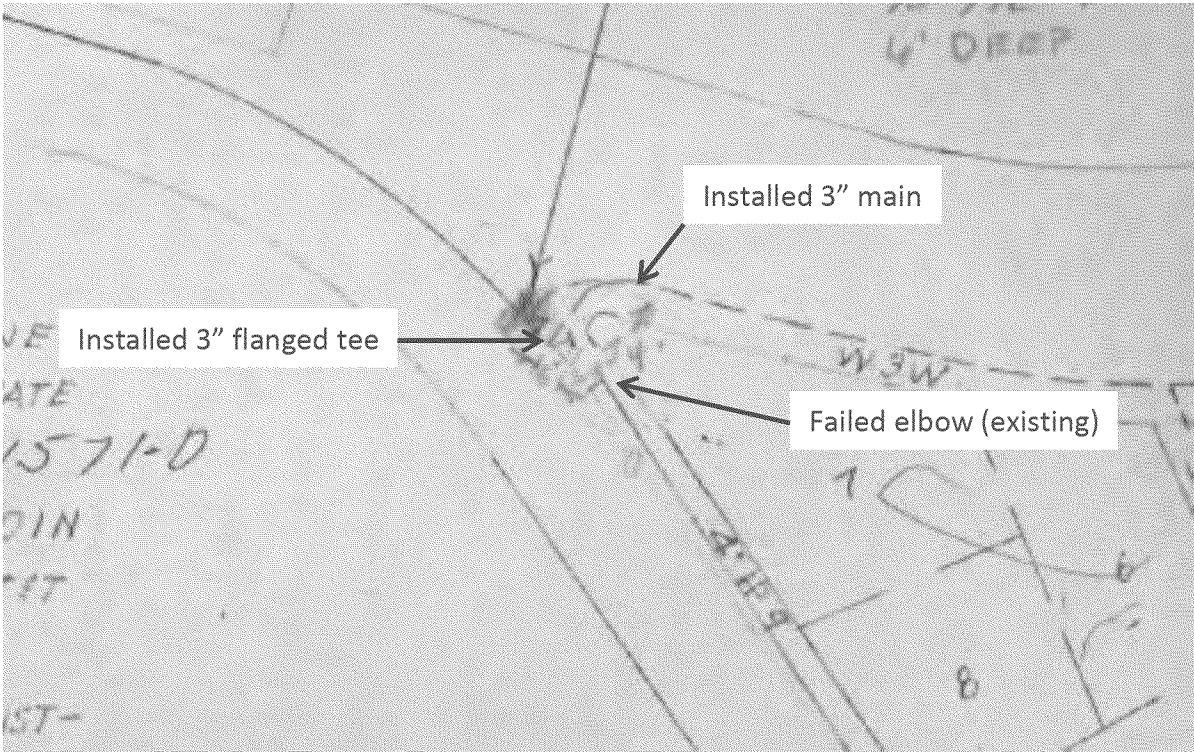
Figure 9. Cropped view of preliminary construction drawing for W.O. 4747 (1965) showing area of leak.

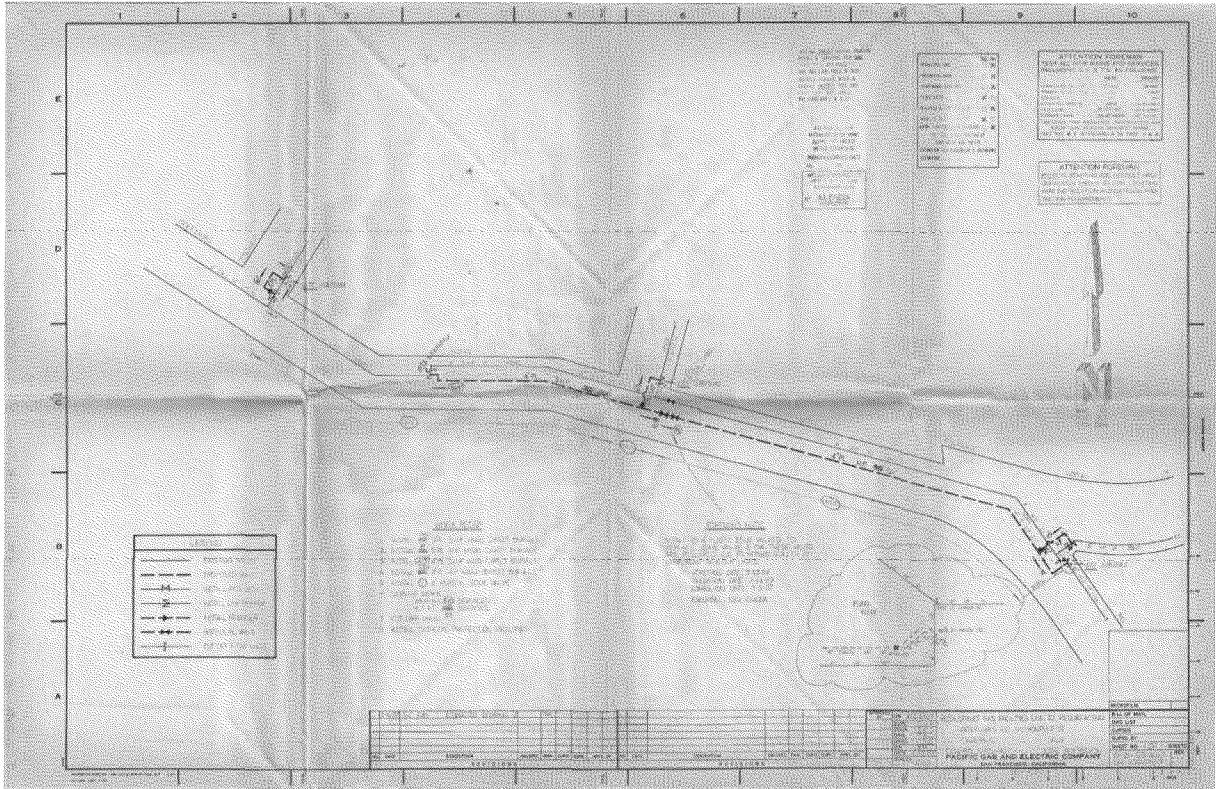
Figure 10. As-built construction drawing for G.M. 4564829 (1987).

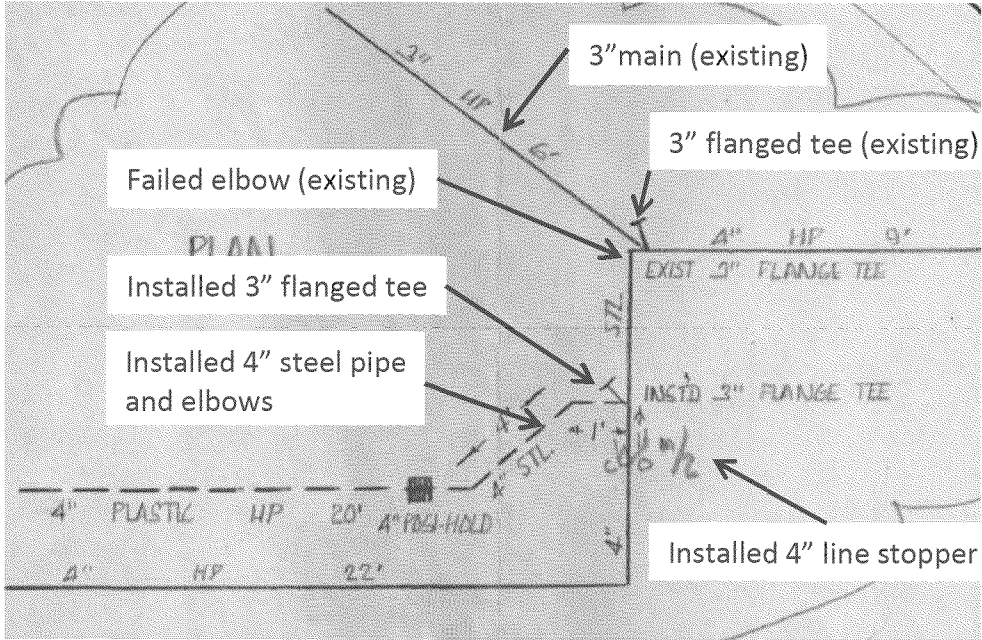
Figure 11. Cropped view of as-built construction drawing for G.M. 4564829 (1987) showing area of leak.

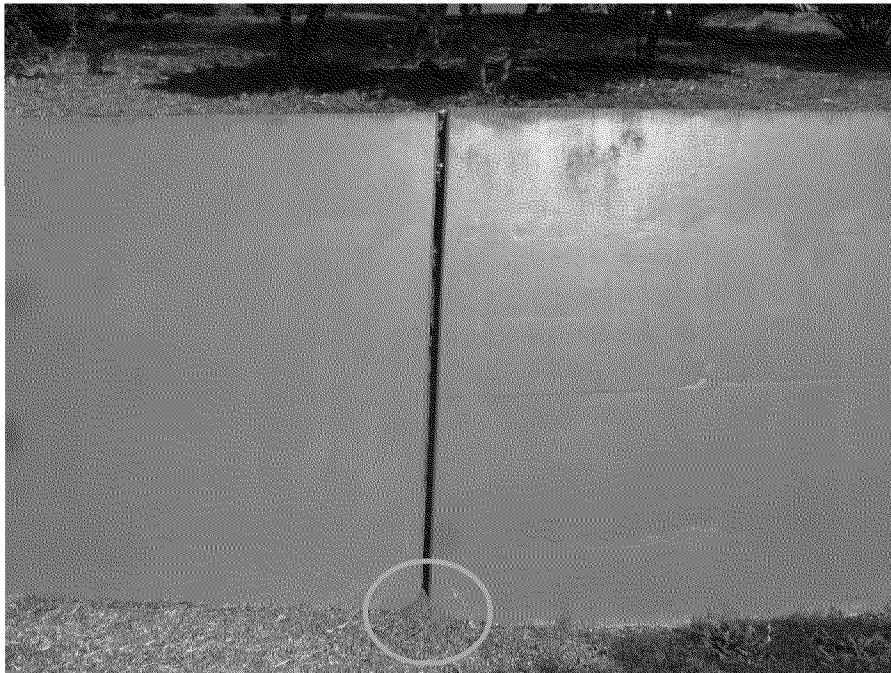
Exponent's project geologist and/or project civil engineer performed visits to the Site on December 13 and 17, 2013, and January 3, 2014 to look for surface evidence of ground movement, including fault creep. No definitive field evidence of creep was present at the Site or on nearby streets that cross the Hayward Fault. The southern portion of the retaining wall on the north side of [Redacted] (Figure 29), however, exhibited a prominent crack (Figure 31) and a separation at a joint (Figure 32), both of which had a right-lateral sense of displacement. In the case of the crack, the displacement was greater at the base of the wall (approximately ½-inch) than at the top. This configuration of retaining wall cracking may well represent displacement of the base of the wall by fault creep.

Figure 32. Displaced retaining wall joint. Oval encloses observed recent soil deposits near the base of the wall. Arrow indicates right-lateral displacement at top of wall. Photographs by Exponent, December 13, 2013.

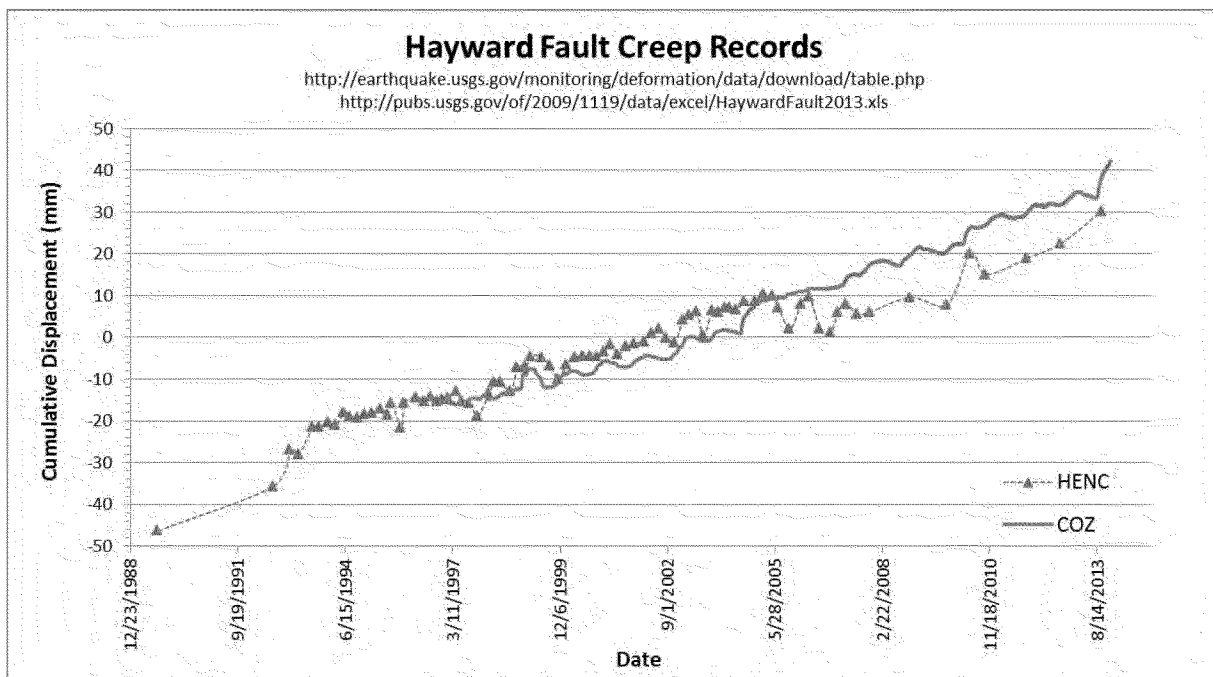
over 76 mm has been measured since 1989, for an average creep rate of 3.2 mm/yr. At the Oakland Zoo Station a total displacement of over 57 mm has been measured since 1996, for an average creep rate of 3.3 mm/yr. The figure shows an acceleration of creep movement measured at the Oakland Zoo Station starting in approximately August 2013. The timing of the gas release event may be related to this acceleration of creep movement. Additional creep data information is included in Appendix D.

Figure 34. Hayward Fault creep records [Redacted] (for available record interval). HENC = Encina Way Station. COZ = Oakland Zoo Station.

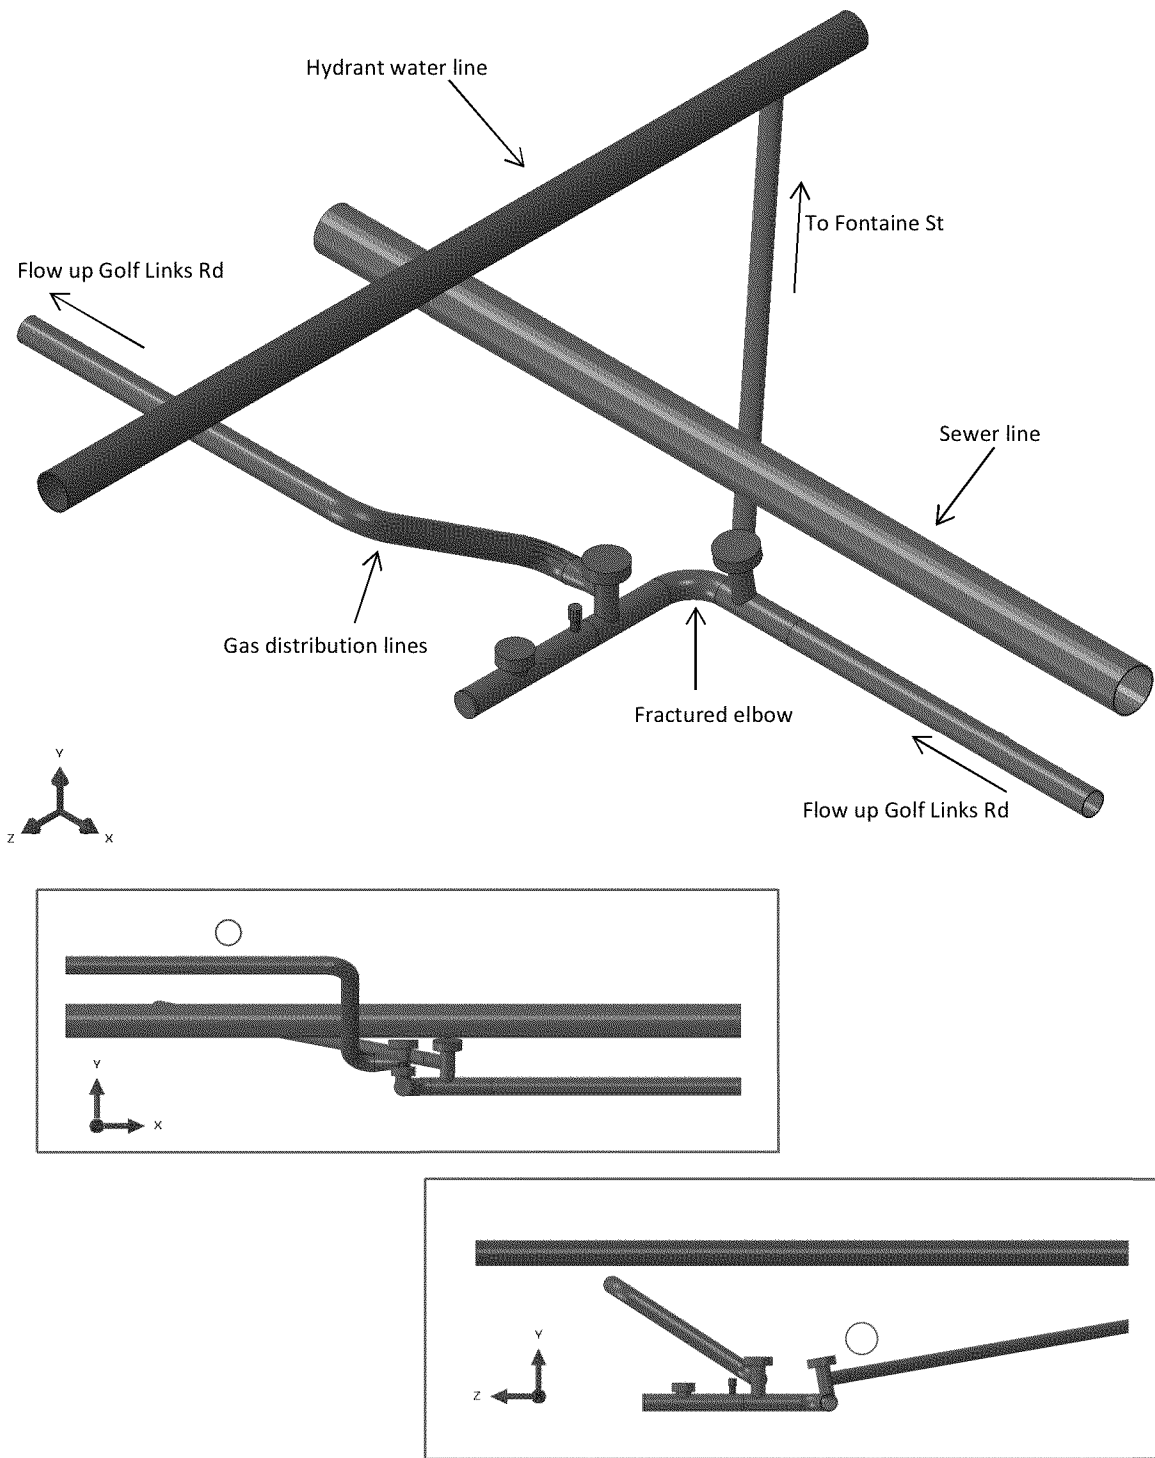
The Abaqus finite element software package was utilized to create a finite element model of the region near the incident to investigate loading scenarios that might have contributed to the subject elbow fracture. The region modeled is shown in Figure 37. Lines from three different utilities were included in the model: a network of gas distribution lines, a sewer line, and a hydrant water line. Surrounding soil was also included in the model, but is not shown in the figure.

Figure 37. Network of pipes included in the finite element analysis. Surrounding soil was also included, but is not shown in the figure. The model encompasses a region that is 14 feet by 14 feet, 12 feet deep, and centered near the fractured elbow.

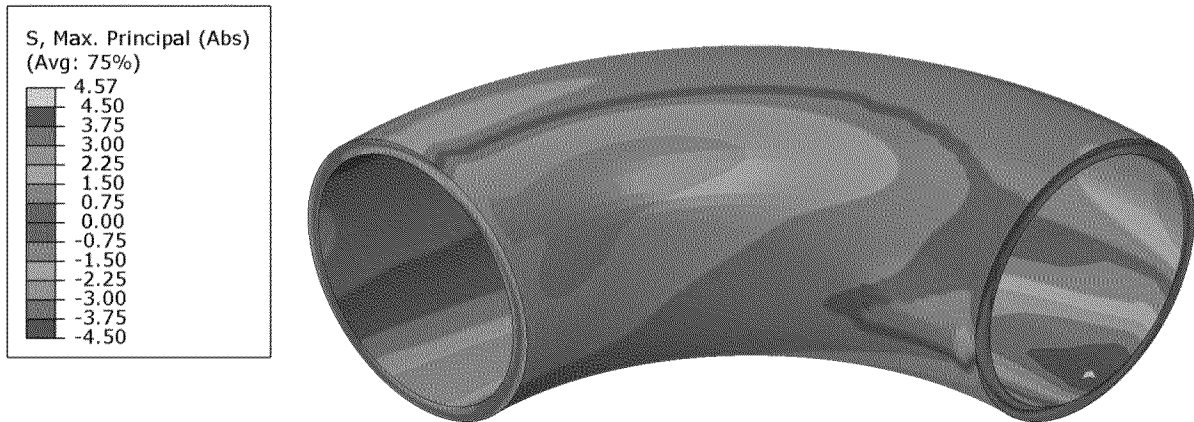
In order to determine the sensitivity of the elbow stresses to loading from heavy equipment on the road-surface, a load of 80,000 lbf was applied to the surface of the soil directly above the incident elbow in a patch of approximately 9” by 10”. This is approximately equivalent to a tractor trailer loaded to the legal limit, but carrying that load on just one tire instead of distributing the load over many tires.<sup>17,18</sup> The resulting tensile stresses in the elbow are shown in Figure 41. The peak tensile stress is approximately 4.5 ksi and is located on the lower surface of the inside of the elbow. Tensile stresses near the failure location are approximately 2 ksi; this is not a sufficient amount of stress to cause failure.

Figure 41. Tensile stresses in the elbow when subjected to an 80,000 lbf truck load on the surface of the soil above the elbow.

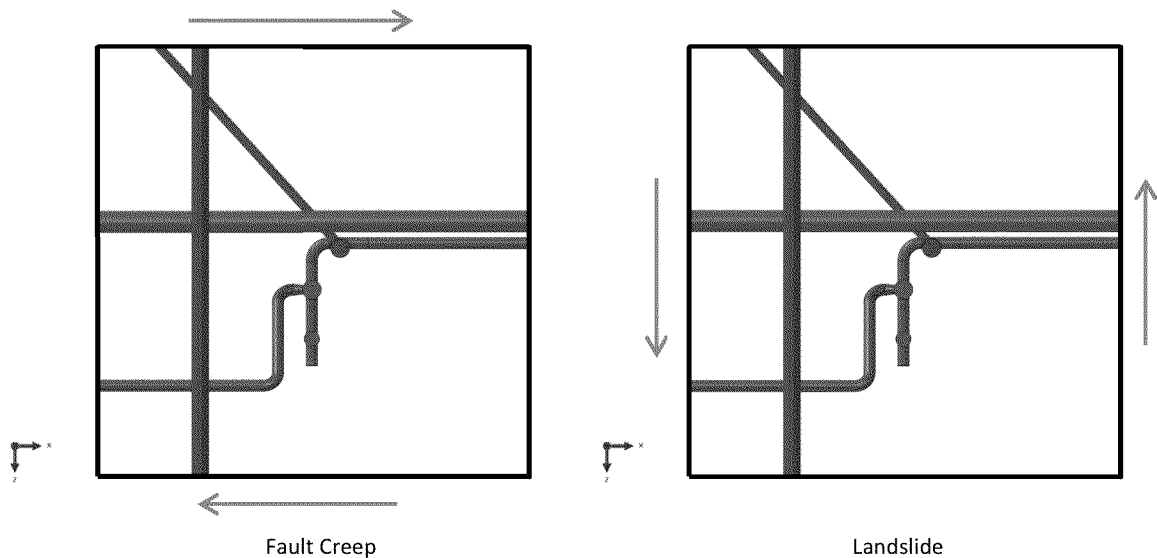
Because gravitational loading alone is not sufficient to achieve tensile stresses in the elbow that are consistent with the observed mode of failure, ground shearing movement was investigated as a possible source of stresses. After the model achieved equilibrium with gravitational loading, the soil was sheared in the horizontal plane to simulate ground movement associated with right-lateral strike-slip creep of the Hayward Fault or to simulate possible ground movement due to the ancient landslide. These two shearing directions are diagrammed in Figure 42. Two additional shearing directions were considered to investigate the sensitivity of the fault shearing direction; these directions were rotated  $\pm 10^\circ$  from the fault creep nominal condition shown in Figure 42.

Figure 42. The two primary ground movement shearing directions considered in the finite element model. The left image shows the shearing consistent with right-lateral strike-slip creep of the Hayward Fault, and the right image shows the shearing consistent with ground movement due to a nearby landslide.

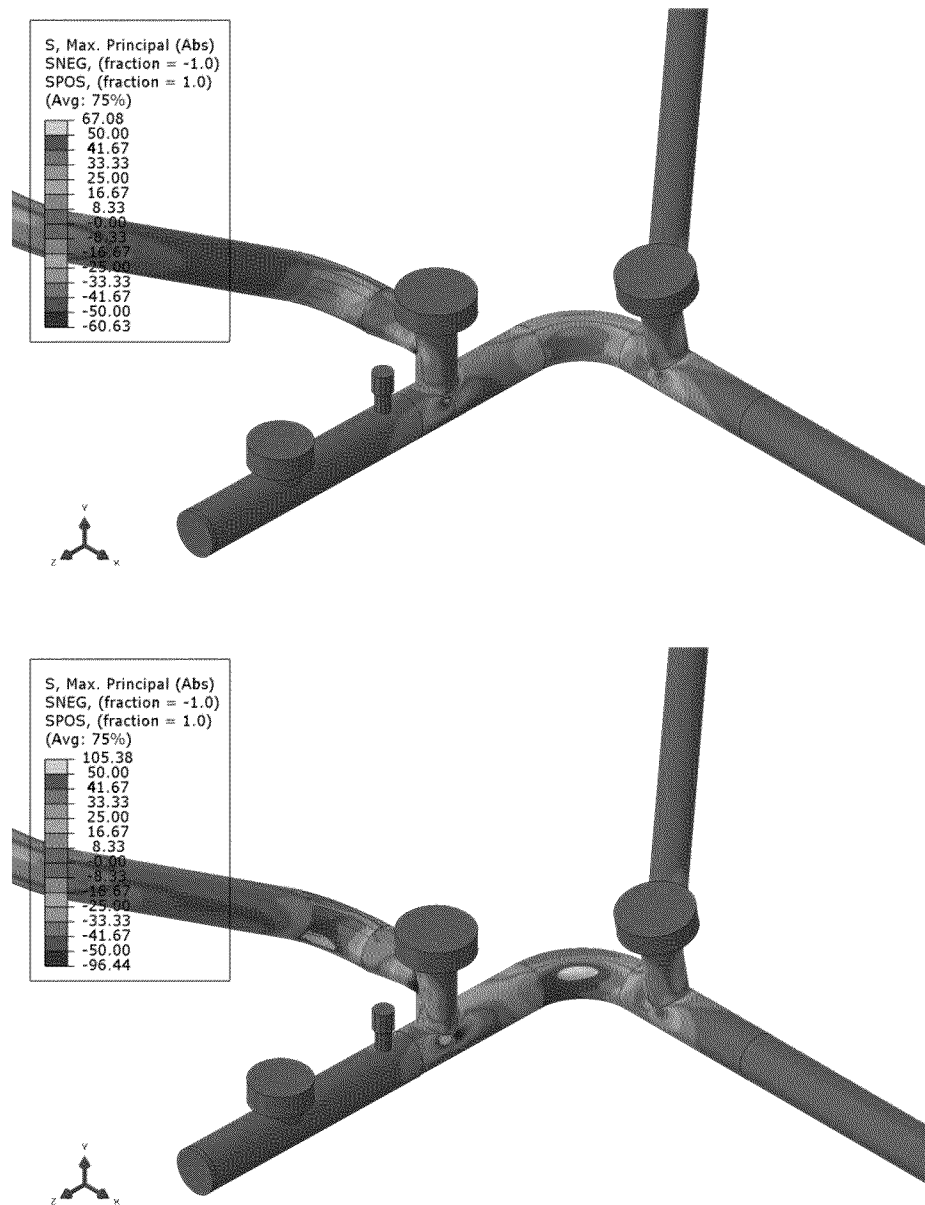
To investigate the sensitivity of soil modulus on the peak tensile stress magnitude, two other soil moduli were investigated, 200 atm and 1000 atm, as compared with the nominal value of 500 atm. Tensile stresses in the gas lines in the vicinity of the incident elbow are shown in Figure 49. The peak tensile stresses on the outside wall of the elbow intrados were 41.3 ksi and 55.2 ksi for the 200 atm and 1000 atm moduli soils, respectively. While the magnitude of stress varies for the different soil moduli, the location of the peak tensile stress on the outside wall of the elbow does not change. All of these stresses are summarized in Table 5, and all are approaching magnitudes that would be consistent with failure of the elbow.

Figure 49. Tensile stresses in the gas pipes when subjected to 0.2 in/ft of shear in the fault creep direction but with varying soil moduli, 200 atm (top) and 1000 atm (bottom). Units are ksi.

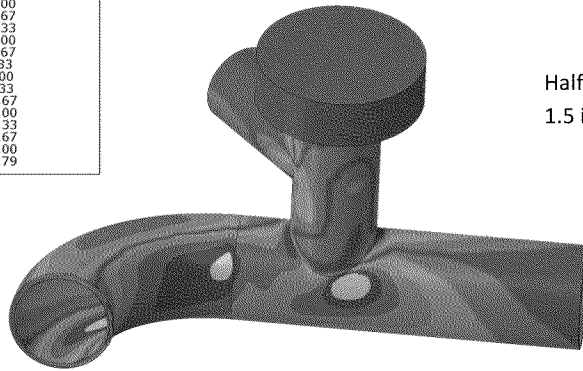
Fontaine pipe such that it cannot move axially and is forced into compression during the shearing, and a second model which provided a softer constraint that allowed the pipe to move only half the distance that it would if it were free to slide. The resulting tensile stresses in the region of the elbow and neighboring tee are shown in Figure 50. In all cases, the tensile stresses are near the magnitude to cause failure.

A summary of the peak tensile stress on the outside and inside walls of the elbow for the three boundary condition cases is presented in Table 6. It is important to note that decreasing levels of shear were applied to the models as the constraint was increased. The reduction in ground movement shearing reduces the stresses on the inside wall of the elbow. If the constraint on the end of the [Redacted] pipe were unchanged, then we would also expect the stress on the outside wall to be reduced in a constant ratio. However, the constraint on the end of the [Redacted] causes the stress on the outside of the elbow (as well as the neighboring tee) to increase, and therefore causes the peak tensile stress location to switch from the lower inside surface to the outside surface of the elbow intrados. The fully constrained condition is unrealistic and causes very high stresses in the tee; the true constraint condition is likely somewhere between the two extremes of free and fixed.

Figure 50. Tensile stresses in the incident elbow and neighboring tee for different boundary conditions on the Redacted pipe. Note that the models have decreasing amount of shear despite increasing stresses. Units are ksi.

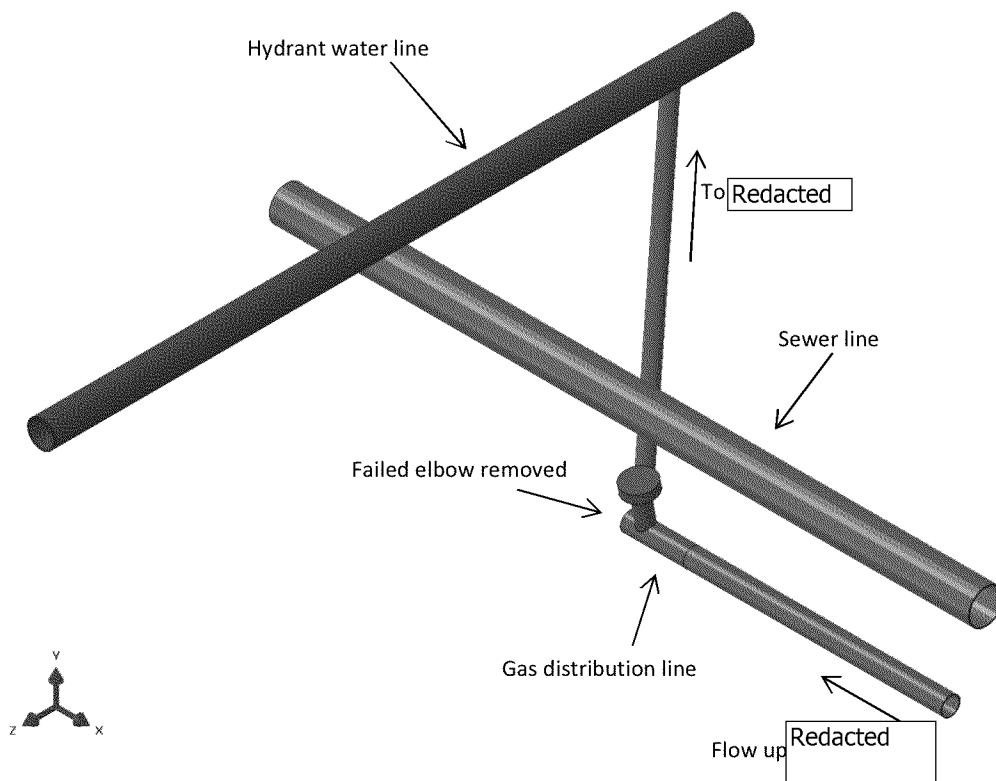
A finite element model was created to investigate the current stresses in the incident area following removal of the subject elbow and downstream piping. This new model is shown in Figure 51. The model was subjected to fault-creep shear of 0.2 in/ft consistent with the shear modeled in the subject elbow analysis. Tensile stresses in the repaired gas line near the location of the fractured elbow are shown in Figure 52; the stresses are reduced as compared with the stresses in the original configuration before the incident (upper image of Figure 50). Local stresses in the vicinity of the flange tee were predicted to be near 30 ksi. Thus, even after the removal of the subject elbow and associated downstream piping, stresses at the junction between the [Redacted] piping could be as high as 30 ksi.

Figure 51. Post-repair model.

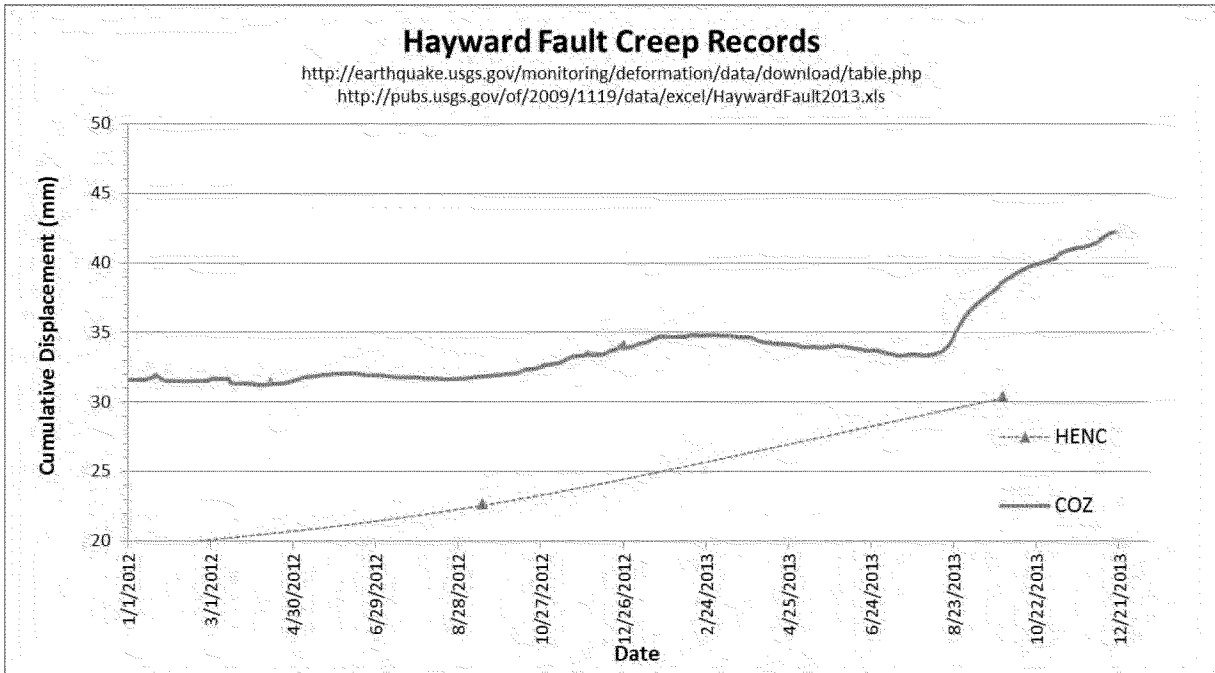
Figure D-4 shows the 2012 and 2013 portion of the data presented in Figure D-3. The figure shows an acceleration of creep movement measured at the Oakland Zoo Station starting in approximately August 2013. The timing of the gas release event may be related to this acceleration of creep movement.

Figure D-4. Hayward Fault creep records in the vicinity of Golf Links Road (for 2012 and 2013). [Redacted]. COZ = Oakland Zoo Station.
