**Golf Links Road (Oakland)
Incident Analysis**

Prepared for

Sumeet Singh
Pacific Gas and Electric Company
6111 Bollinger Canyon Road
San Ramon, CA 94583

January 2014
Revised January 20, 2014

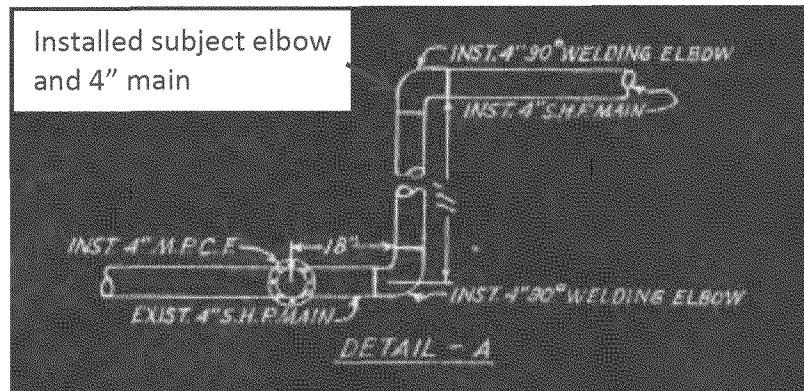
Figure 7. Cropped view of as-built construction drawing for job G.M.G. 82435 (1946) showing area of leak.

The construction journal voucher shown in Figure 12 indicates that two weld elbows with a material code of 02-2039 were installed on G.M.G. 82435. These are likely the elbows shown in Figure 7, one of which is the subject elbow. PG&E gas standards from 1952 show that this material code corresponds to a 4-inch weld elbow with a wall thickness of 0.237 inches. Measurements of the wall thickness of the incident elbow were taken at multiple locations. The minimum measured wall thickness was 0.215 inches and the maximum measured wall thickness was 0.297 inches.

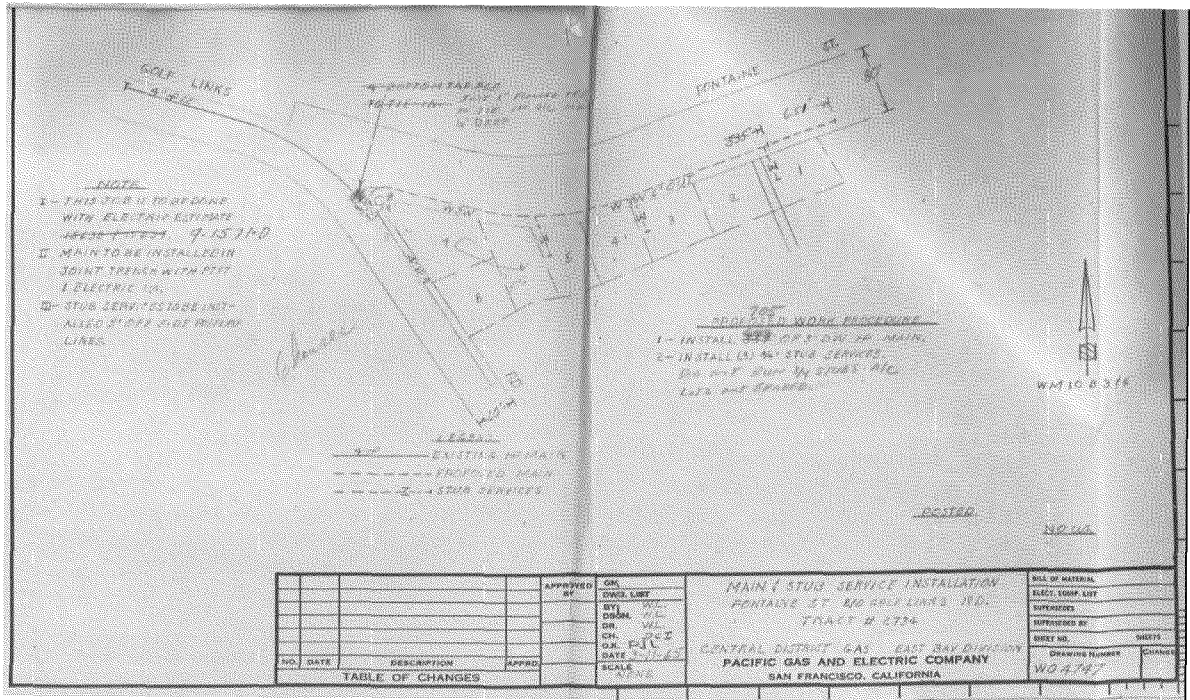
Figure 8. Preliminary construction drawing for W.O. 4747 (1965).

- W.O. 4747 (1965) - Installed a 3-inch diameter steel main extending along Fontaine Street. The 3-inch steel main was connected to the existing 4-inch steel main using a 3-inch flanged tee. A preliminary construction drawing from W.O. 4747 is shown in Figure 8 and Figure 9. This construction drawing has a very low level of detail in the area of the leak. As-built construction drawings for W.O. 4747 were not available to Exponent at the time that this report was issued.

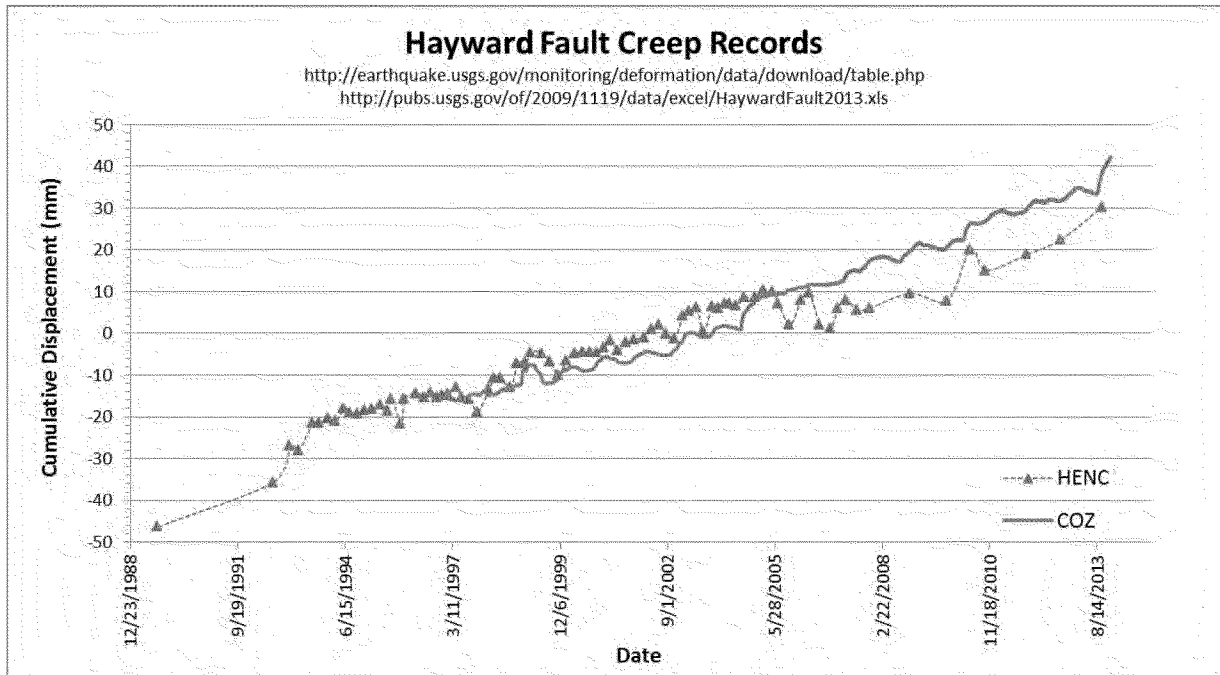
over 76 mm has been measured since 1989, for an average creep rate of 3.2 mm/yr. At the Oakland Zoo Station a total displacement of over 57 mm has been measured since 1996, for an average creep rate of 3.3 mm/yr. The figure shows an acceleration of creep movement measured at the Oakland Zoo Station starting in approximately August 2013. The timing of the gas release event may be related to this acceleration of creep movement. Additional creep data information is included in Appendix D.

Figure 34. Hayward Fault creep records in the vicinity of Golf Links Road (for available record interval). HENC = Encina Way Station. COZ = Oakland Zoo Station.

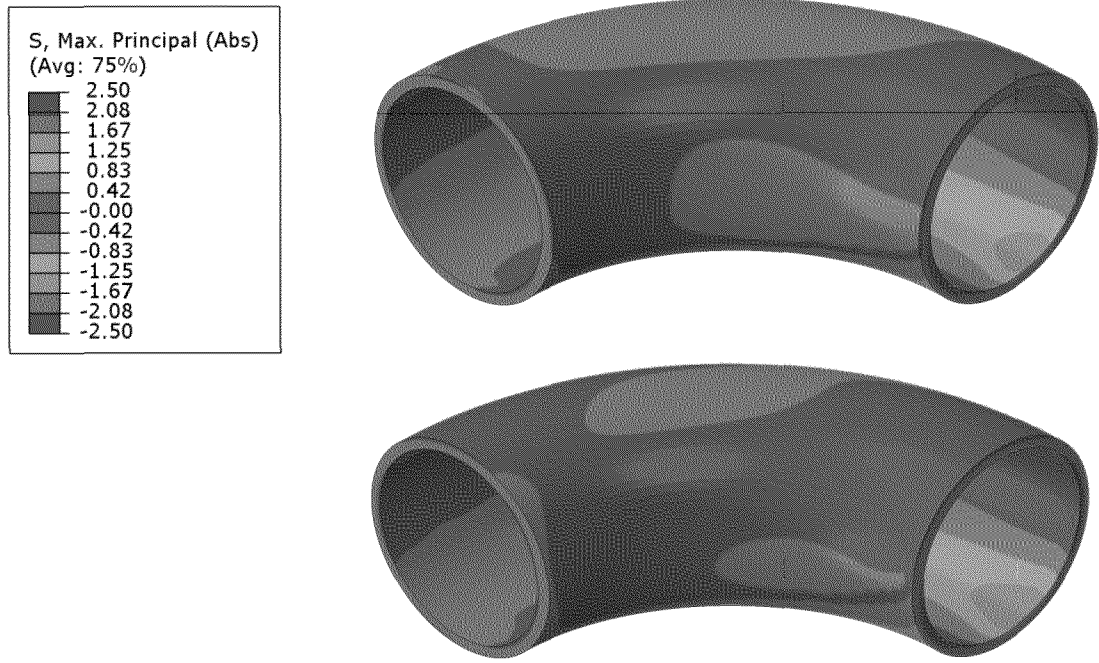
One uncertainty in the model geometry was the vertical distance between the water line and the gas line and the support condition beneath the water line near the gas line. It is possible that the water line was resting directly on the gas line and was not fully supported by soil in this vicinity. To determine the sensitivity of the stresses in the subject elbow to the water line support condition, a second model was built such that six feet of the water line in the vicinity of the gas line was unsupported by soil. For this condition, a larger load from the water line is transferred directly to the gas line. The tensile stresses calculated in the incident elbow are shown in the lower half of Figure 40; the largest tensile stresses were approximately 1.5 ksi, which was only slightly larger than the nominal condition and not large enough to cause failure. Thus, the support condition of the water line in the vicinity of the gas line was determined to have a negligible contribution to the failure.

Figure 40. Tensile stresses in the incident elbow subjected to gravitational loading with nominal water pipe support (top) and 6 ft unsupported water pipe (below). Units are ksi.

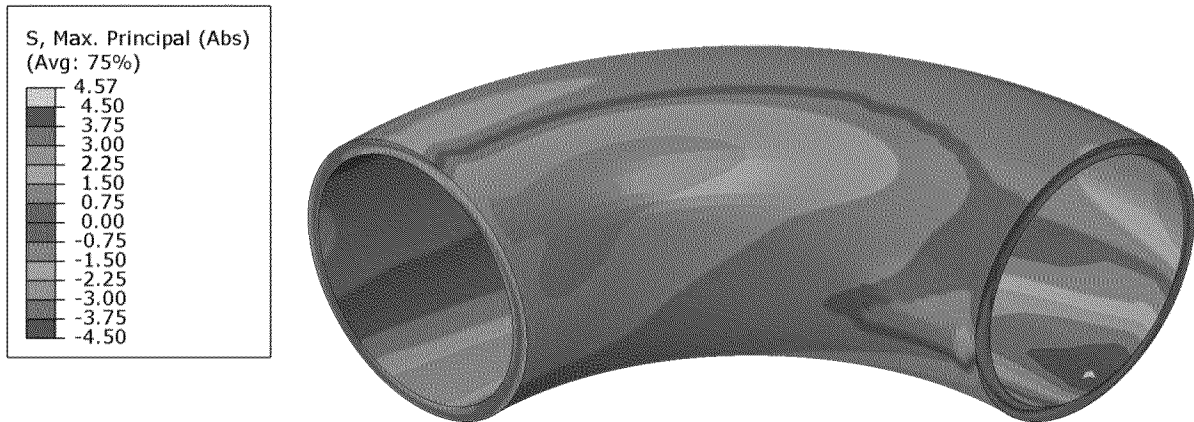
In order to determine the sensitivity of the elbow stresses to loading from heavy equipment on the road-surface, a load of 80,000 lbf was applied to the surface of the soil directly above the incident elbow in a patch of approximately 9” by 10”. This is approximately equivalent to a tractor trailer loaded to the legal limit, but carrying that load on just one tire instead of distributing the load over many tires.^{18,19} The resulting tensile stresses in the elbow are shown in Figure 41. The peak tensile stress is approximately 4.5 ksi and is located on the lower surface of the inside of the elbow. Tensile stresses near the failure location are approximately 2 ksi; this is not a sufficient amount of stress to cause failure.

Figure 41. Tensile stresses in the elbow when subjected to an 80,000 lbf truck load on the surface of the soil above the elbow.

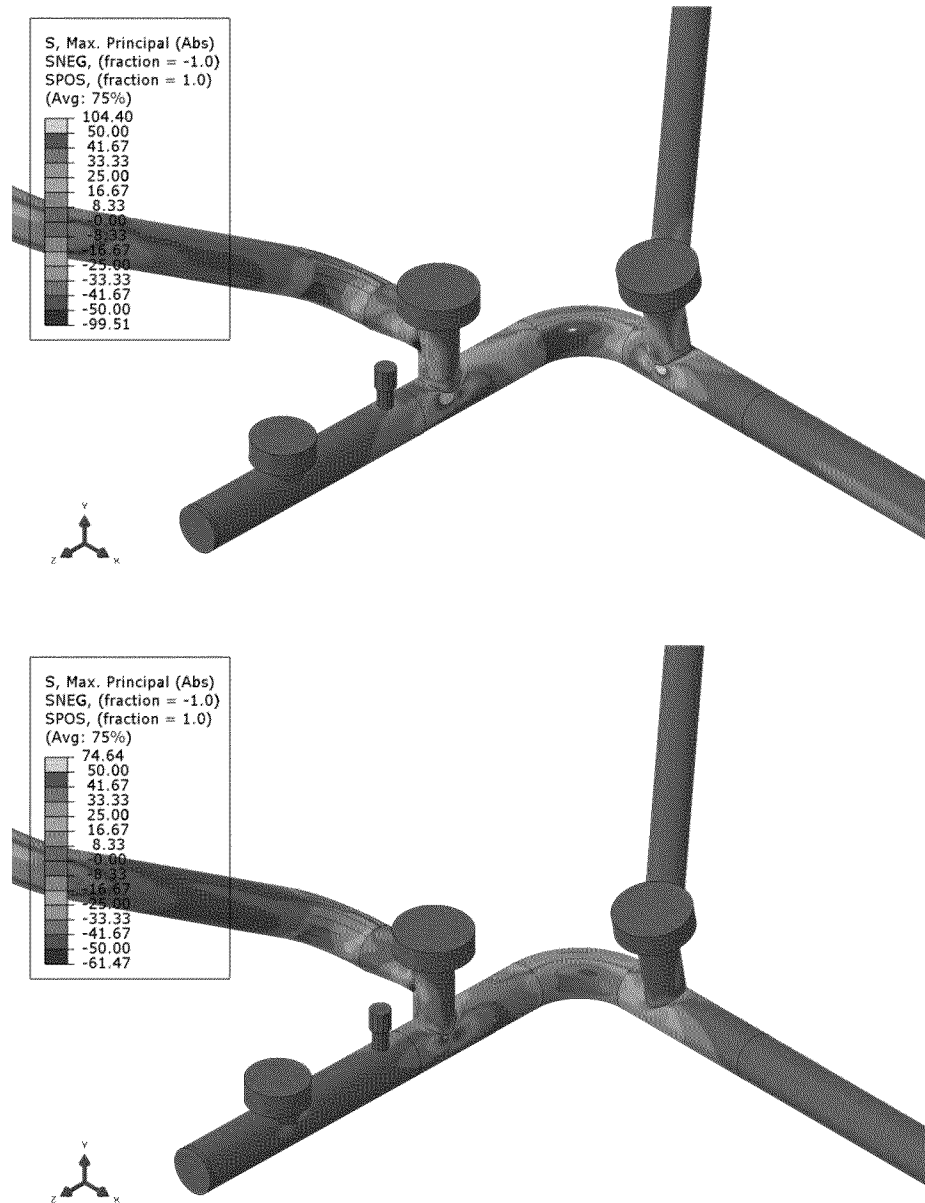
To further investigate the sensitivity to shearing direction on the peak tensile stress magnitude and location, the fault creep shearing direction was varied by $\pm 10^\circ$. Tensile stresses in the gas lines in the vicinity of the incident elbow are shown in Figure 48. The peak tensile stresses on the outside wall of the elbow intrados were slightly higher for the $+10^\circ$ shearing direction and lower for the -10° direction (50.2 ksi and 42.7 ksi respectively) as compared with the nominal fault creep condition in Figure 46. The location of the peak stress also shifted along the axial position of the elbow.

Figure 48. Tensile stresses in the gas pipes when subjected to 0.2 in/ft of shear in the fault creep +10° direction (top) and the fault creep -10° direction (bottom). Rotation angles are with respect to the model's y-axis. Units are ksi.

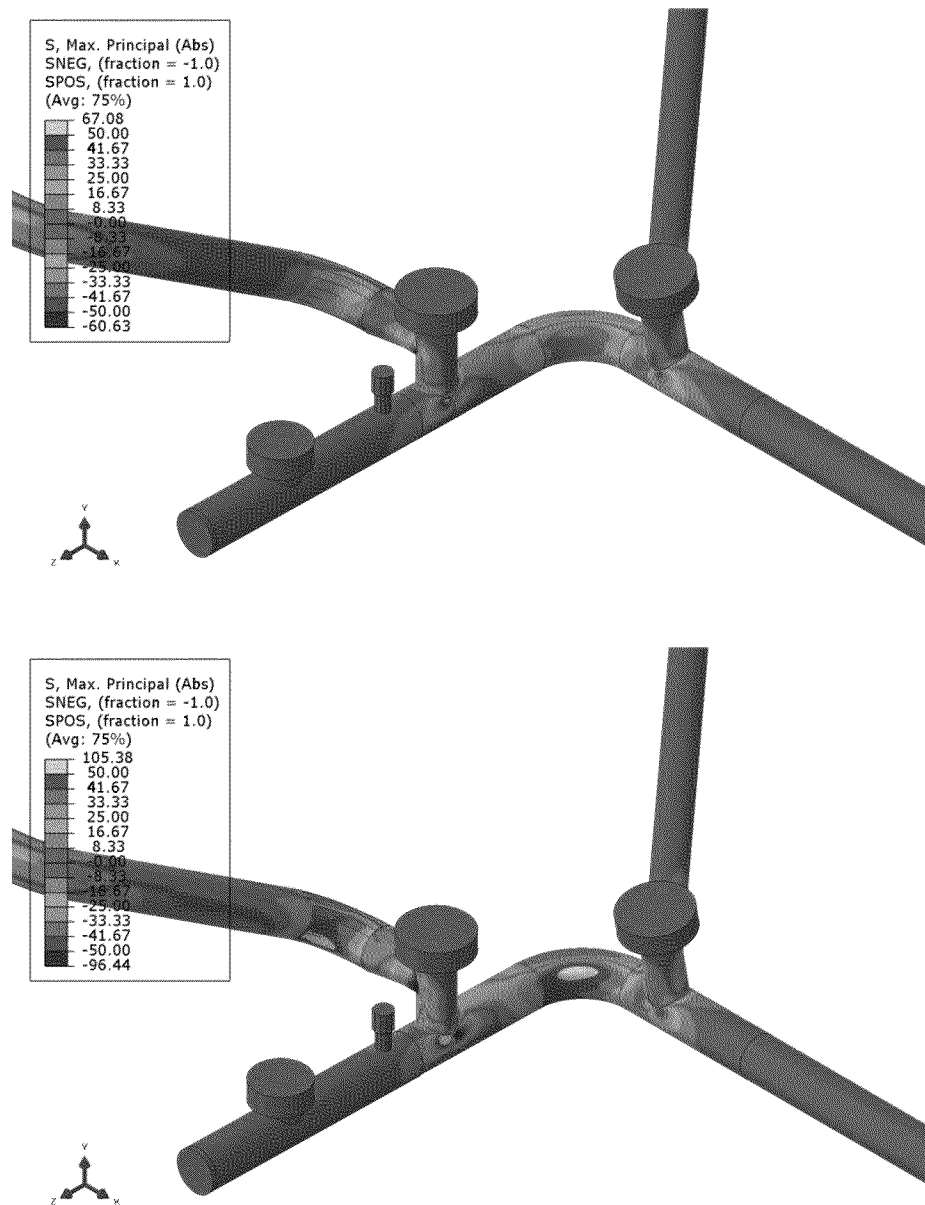
To investigate the sensitivity of soil modulus on the peak tensile stress magnitude, two other soil moduli were investigated, 200 atm and 1000 atm, as compared with the nominal value of 500 atm. Tensile stresses in the gas lines in the vicinity of the incident elbow are shown in Figure 49. The peak tensile stresses on the outside wall of the elbow intrados were 41.3 ksi and 55.2 ksi for the 200 atm and 1000 atm moduli soils, respectively. While the magnitude of stress varies for the different soil moduli, the location of the peak tensile stress on the outside wall of the elbow does not change. All of these stresses are summarized in Table 5, and all are approaching magnitudes that would be consistent with failure of the elbow.

Figure 49. Tensile stresses in the gas pipes when subjected to 0.2 in/ft of shear in the fault creep direction but with varying soil moduli, 200 atm (top) and 1000 atm (bottom). Units are ksi.

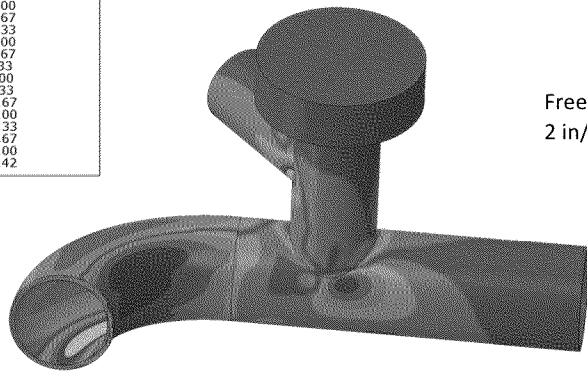
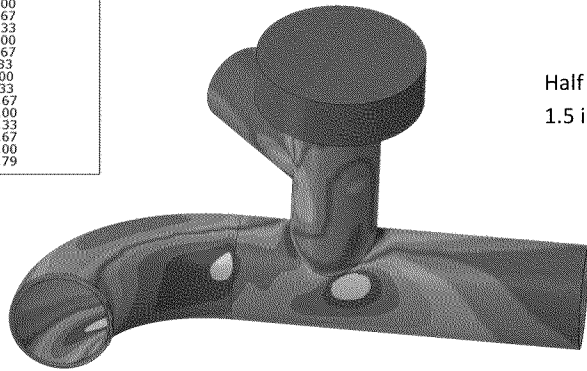
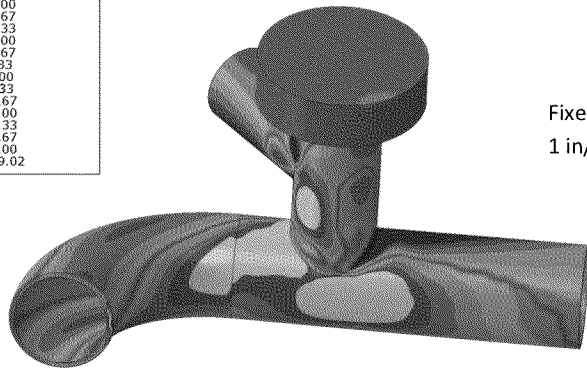
Fontaine pipe such that it cannot move axially and is forced into compression during the shearing, and a second model which provided a softer constraint that allowed the pipe to move only half the distance that it would if it were free to slide. The resulting tensile stresses in the region of the elbow and neighboring tee are shown in Figure 50. In all cases, the tensile stresses are large enough to cause failure of the elbow.

A summary of the peak tensile stress on the outside and inside walls of the elbow for the three boundary condition cases is presented in Table 6. It is important to note that decreasing levels of shear were applied to the models as the constraint was increased. The reduction in ground movement shearing reduces the stresses on the inside wall of the elbow. If the constraint on the end of the Fontaine Street pipe were unchanged, then we would also expect the stress on the outside wall to be reduced in a constant ratio. However, the constraint on the end of the Fontaine pipe causes the stress on the outside of the elbow (as well as the neighboring tee) to increase, and therefore causes the peak tensile stress location to switch from the lower inside surface to the outside surface of the elbow intrados. The fully constrained condition is unrealistic and causes very high stresses in the tee; the true constraint condition is likely somewhere between the two extremes of free and fixed.

Figure 50. Tensile stresses in the incident elbow and neighboring tee for different boundary conditions on the Fontaine Street pipe. Note that the models have decreasing amount of shear despite increasing stresses. Units are ksi.

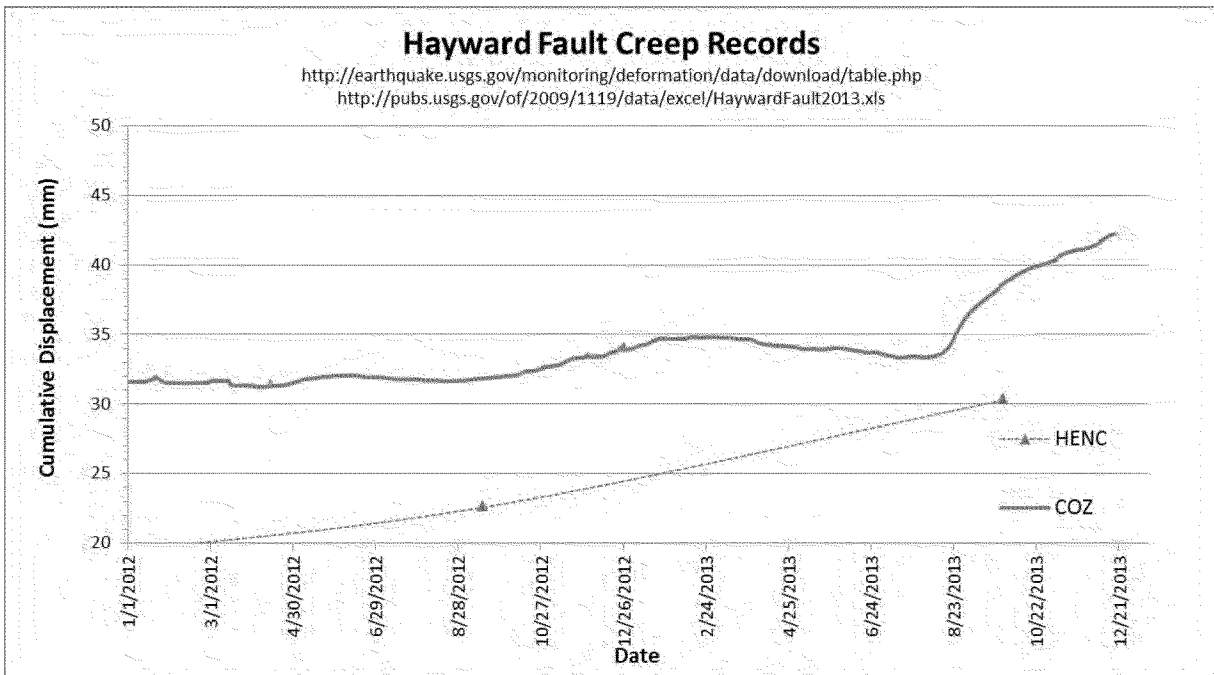
Figure D-4 shows the 2012 and 2013 portion of the data presented in Figure D-3. The figure shows an acceleration of creep movement measured at the Oakland Zoo Station starting in approximately August 2013. The timing of the gas release event may be related to this acceleration of creep movement.

Figure D-4. Hayward Fault creep records in the vicinity of Golf Links Road (for 2012 and 2013). HENC = Encina Way Station. COZ = Oakland Zoo Station.
