Re: Update - Oakland Incident of December 10, 2013

Failure Analysis Associates

Pacific Gas and Electric (PG&E) has retained Exponent Failure Analysis Associates (Exponent) to conduct a failure analysis investigation of an elbow that fractured as part of a four-inch natural gas distribution line on December 10, 2013 near the intersection of [Redacted] and [Redacted] in Oakland, California. Our investigation to-date has included inspection of the leak site, review of PG&E's historical construction documents, a fire cause and origin study, metallurgical analysis, geotechnical analysis, analysis of other leak locations within the immediate area, and finite element-based stress analyses of ground movement and stresses on the subject elbow and associated piping.

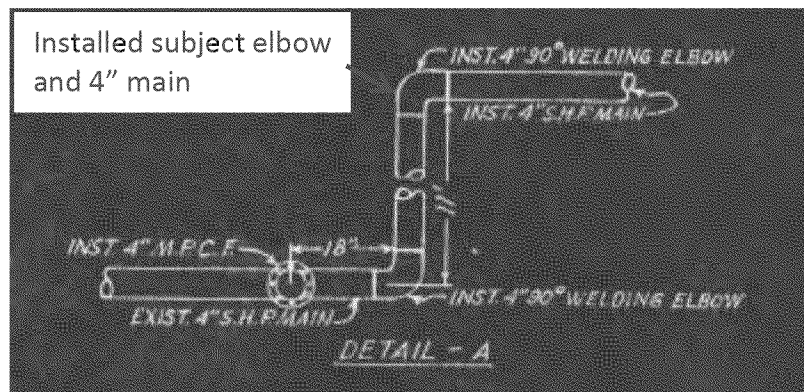
Figure 7. Cropped view of as-built construction drawing for job G.M.G. 82435 (1946) showing area of leak.

- G.M.G. 82435 (1946) - Installed a 4-inch diameter steel main along Redacted. This main included two 4-inch steel weld elbows at the location of the leak. One of these weld elbows installed in 1946 failed on December 10, 2013. An as-built construction drawing from G.M.G. 82435 is shown in Figure 6 and Figure 7. The

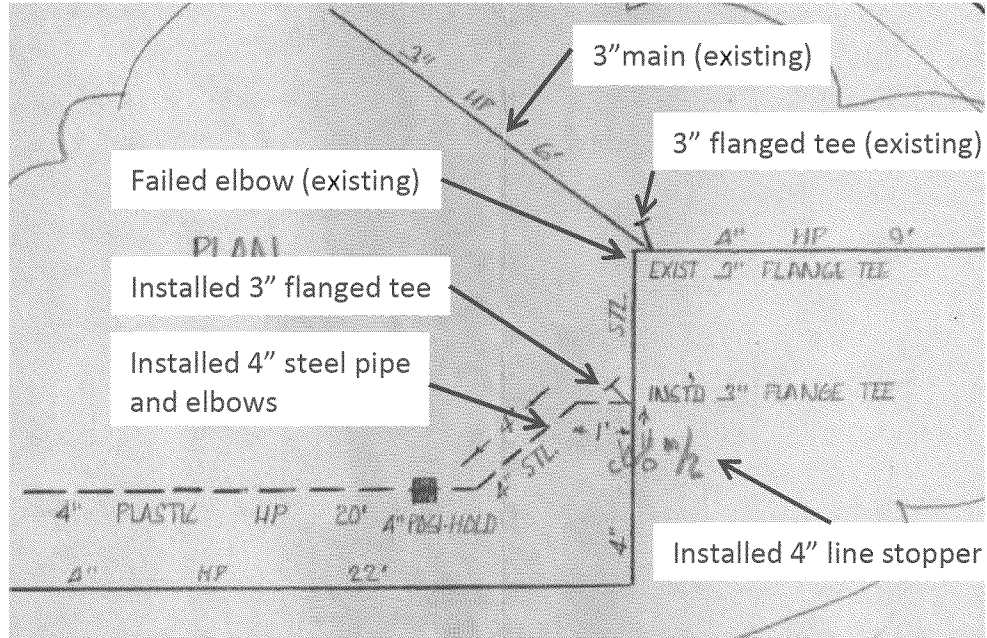
Figure 11. Cropped view of as-built construction drawing for G.M. 4564829 (1987) showing area of leak.

- G.M. 4564829 (1987) - Installed a 4-inch diameter plastic distribution main along [Redacted] [Redacted] starting near the leak site and extending northwest. This main was installed to replace an existing 4-inch steel main. During this job, a piece of 4-inch pipe that was installed in 1946 in the immediate vicinity of the gas release was cut and capped. The 4-inch plastic distribution main was installed with a steel-to-plastic transition, two elbows, and approximately four feet of steel pipe that connected to the existing 1946 4-inch steel main using a 3-inch flanged tee. An as-built construction drawing for G.M. 4564829 is shown in Figure 10 and Figure 11. The pipeline features and locations shown in this drawing were consistent with the features in the ground.

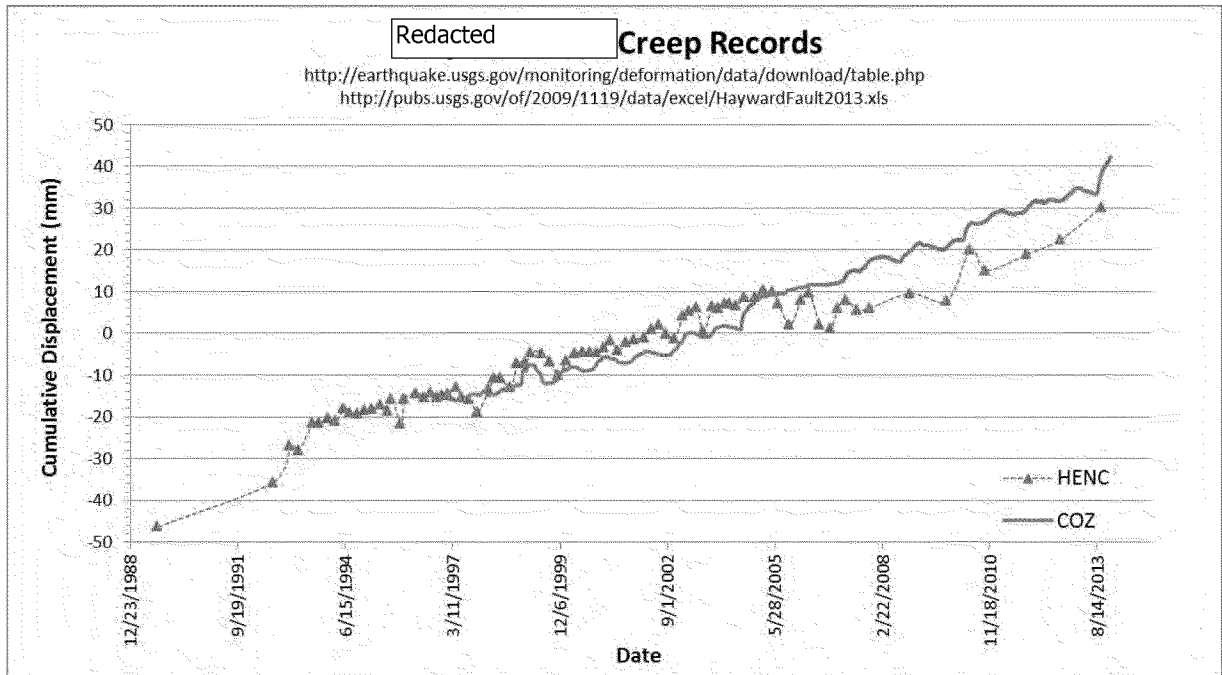
over 76 mm has been measured since 1989, for an average creep rate of 3.2 mm/yr. At the Oakland Zoo Station a total displacement of over 57 mm has been measured since 1996, for an average creep rate of 3.3 mm/yr. The figure shows an acceleration of creep movement measured at the Oakland Zoo Station starting in approximately August 2013. The timing of the gas release event may be related to this acceleration of creep movement. Additional creep data information is included in Appendix D.

Figure 34. [Redacted] creep records in the vicinity of [Redacted] (for available record interval). HENC = [Redacted] Station. COZ = [Redacted] Station.

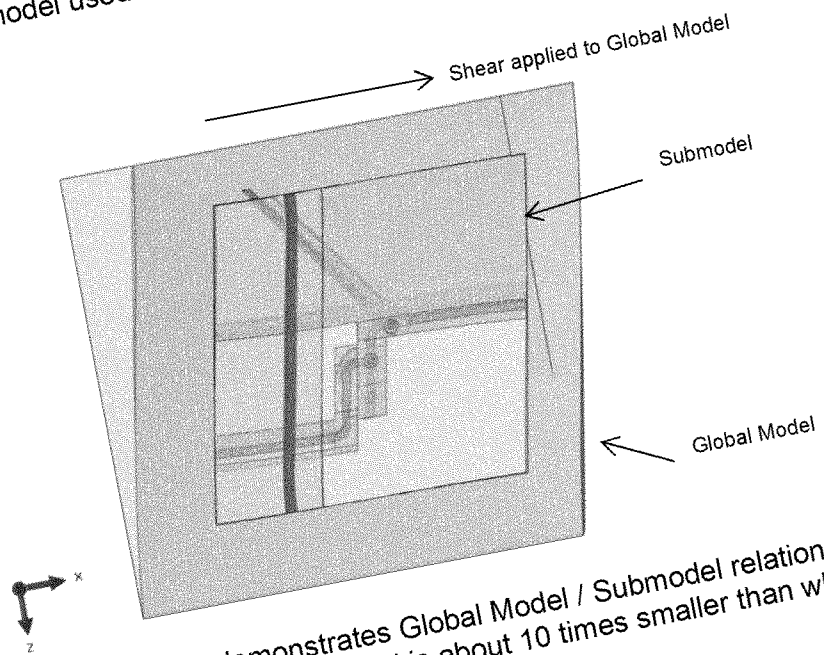
Figure 44. Schematic that demonstrates Global Model / Submodel relation. Actual shearing applied in model is about 10 times smaller than what is shown here.

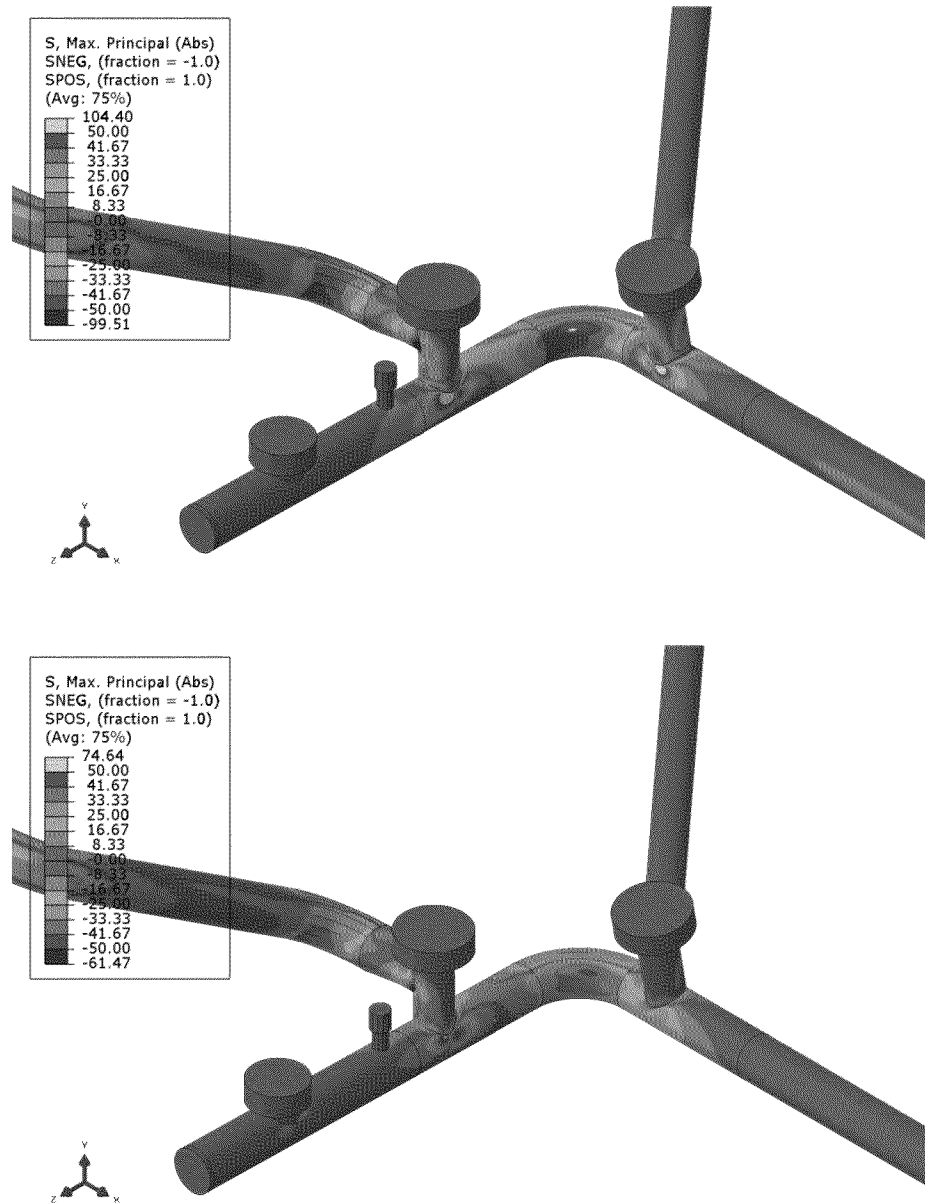
To further investigate the sensitivity to shearing direction on the peak tensile stress magnitude and location, the fault creep shearing direction was varied by $\pm 10^\circ$. Tensile stresses in the gas lines in the vicinity of the incident elbow are shown in Figure 48. The peak tensile stresses on the outside wall of the elbow intrados were slightly higher for the $+10^\circ$ shearing direction and lower for the -10° direction (50.2 ksi and 42.7 ksi respectively) as compared with the nominal fault creep condition in Figure 46. The location of the peak stress also shifted along the axial position of the elbow.

Figure 48. Tensile stresses in the gas pipes when subjected to 0.2 in/ft of shear in the fault creep +10° direction (top) and the fault creep -10° direction (bottom). Rotation angles are with respect to the model's y-axis. Units are ksi.

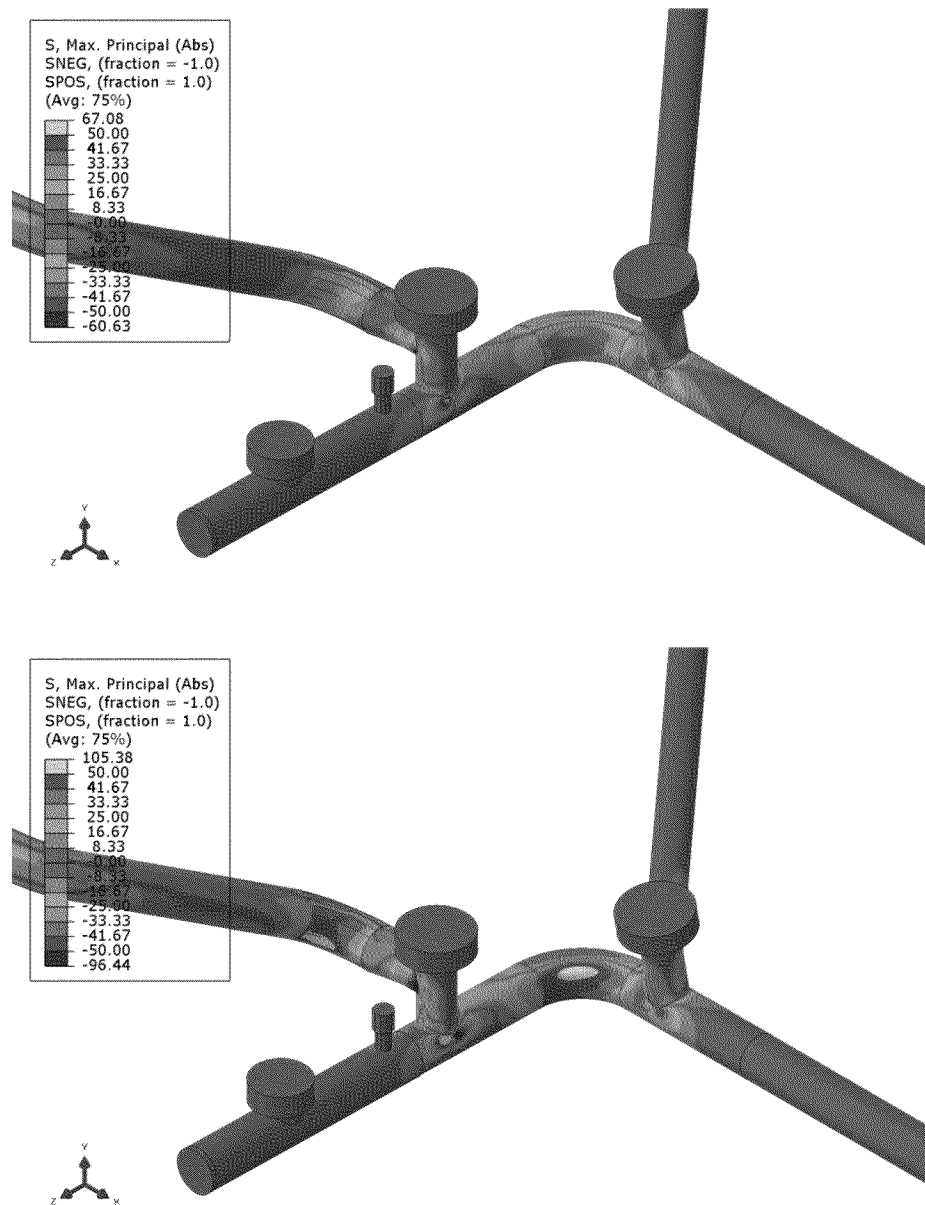
To investigate the sensitivity of soil modulus on the peak tensile stress magnitude, two other soil moduli were investigated, 200 atm and 1000 atm, as compared with the nominal value of 500 atm. Tensile stresses in the gas lines in the vicinity of the incident elbow are shown in Figure 49. The peak tensile stresses on the outside wall of the elbow intrados were 41.3 ksi and 55.2 ksi for the 200 atm and 1000 atm moduli soils, respectively. While the magnitude of stress varies for the different soil moduli, the location of the peak tensile stress on the outside wall of the elbow does not change. All of these stresses are summarized in Table 5, and all are approaching magnitudes that would be consistent with failure of the elbow.

Figure 49. Tensile stresses in the gas pipes when subjected to 0.2 in/ft of shear in the fault creep direction but with varying soil moduli, 200 atm (top) and 1000 atm (bottom). Units are ksi.

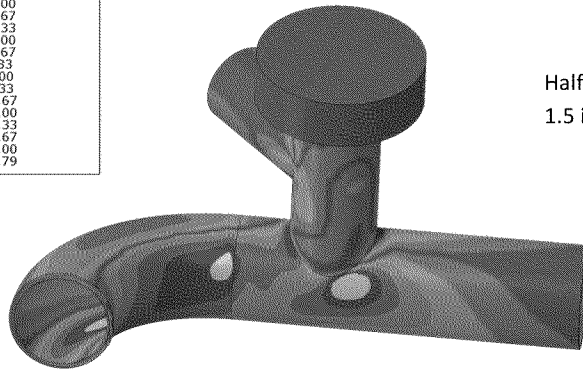
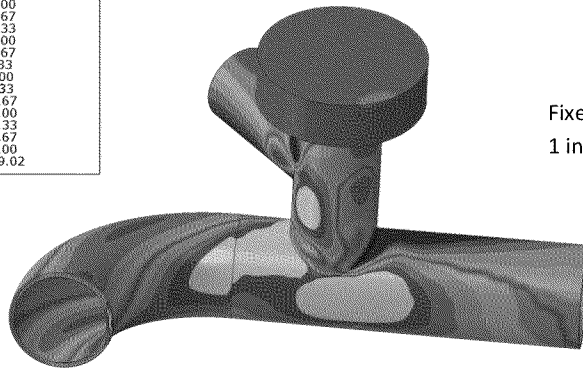
Fontaine pipe such that it cannot move axially and is forced into compression during the shearing, and a second model which provided a softer constraint that allowed the pipe to move only half the distance that it would if it were free to slide. The resulting tensile stresses in the region of the elbow and neighboring tee are shown in Figure 50. In all cases, the tensile stresses are near the magnitude to cause failure.

A summary of the peak tensile stress on the outside and inside walls of the elbow for the three boundary condition cases is presented in Table 6. It is important to note that decreasing levels of shear were applied to the models as the constraint was increased. The reduction in ground movement shearing reduces the stresses on the inside wall of the elbow. If the constraint on the end of the Fontaine Street pipe were unchanged, then we would also expect the stress on the outside wall to be reduced in a constant ratio. However, the constraint on the end of the Fontaine pipe causes the stress on the outside of the elbow (as well as the neighboring tee) to increase, and therefore causes the peak tensile stress location to switch from the lower inside surface to the outside surface of the elbow intrados. The fully constrained condition is unrealistic and causes very high stresses in the tee; the true constraint condition is likely somewhere between the two extremes of free and fixed.

Figure 50. Tensile stresses in the incident elbow and neighboring tee for different boundary conditions on the Fontaine Street pipe. Note that the models have decreasing amount of shear despite increasing stresses. Units are ksi.

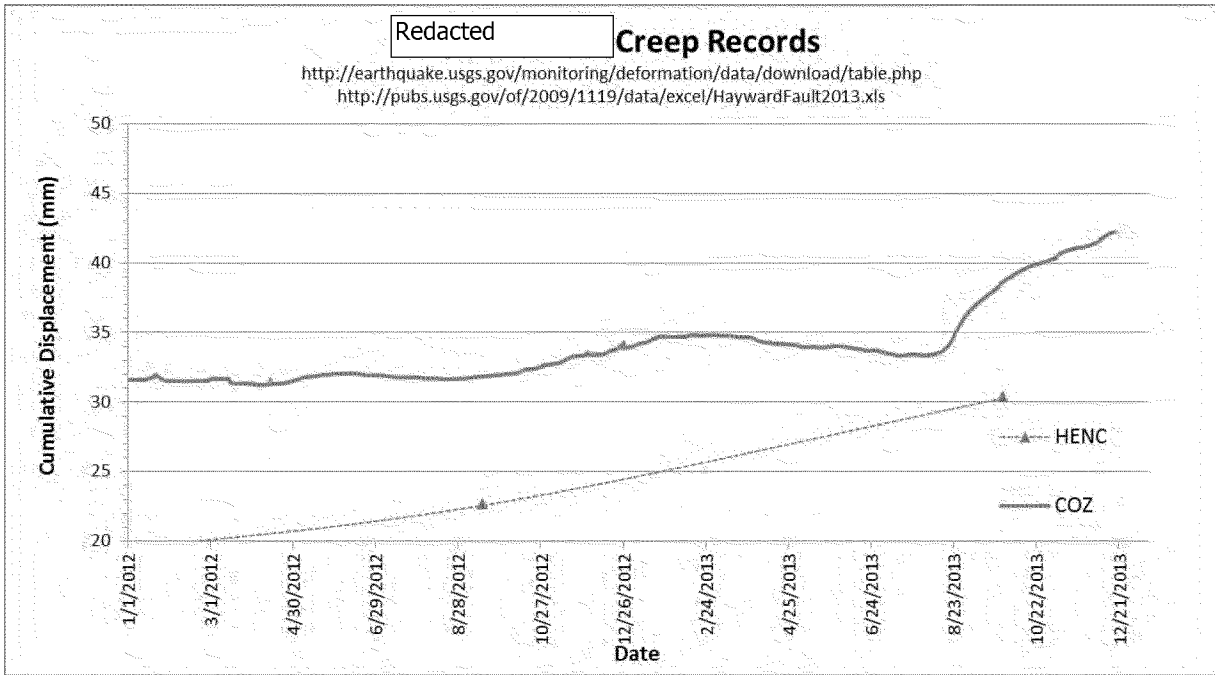
Figure D-4 shows the 2012 and 2013 portion of the data presented in Figure D-3. The figure shows an acceleration of creep movement measured at the [Redacted] starting in approximately August 2013. The timing of the gas release event may be related to this acceleration of creep movement.

Figure D-4. Redacted creep records in the vicinity of Redacted for 2012 and 2013). HENC = Redacted COZ = Redacted
