**Golf Links Road (Oakland)
Incident Analysis**

Prepared for

Sumeet Singh
Pacific Gas and Electric Company
6111 Bollinger Canyon Road
San Ramon, CA 94583

January 2014
Revised January 20, 2014

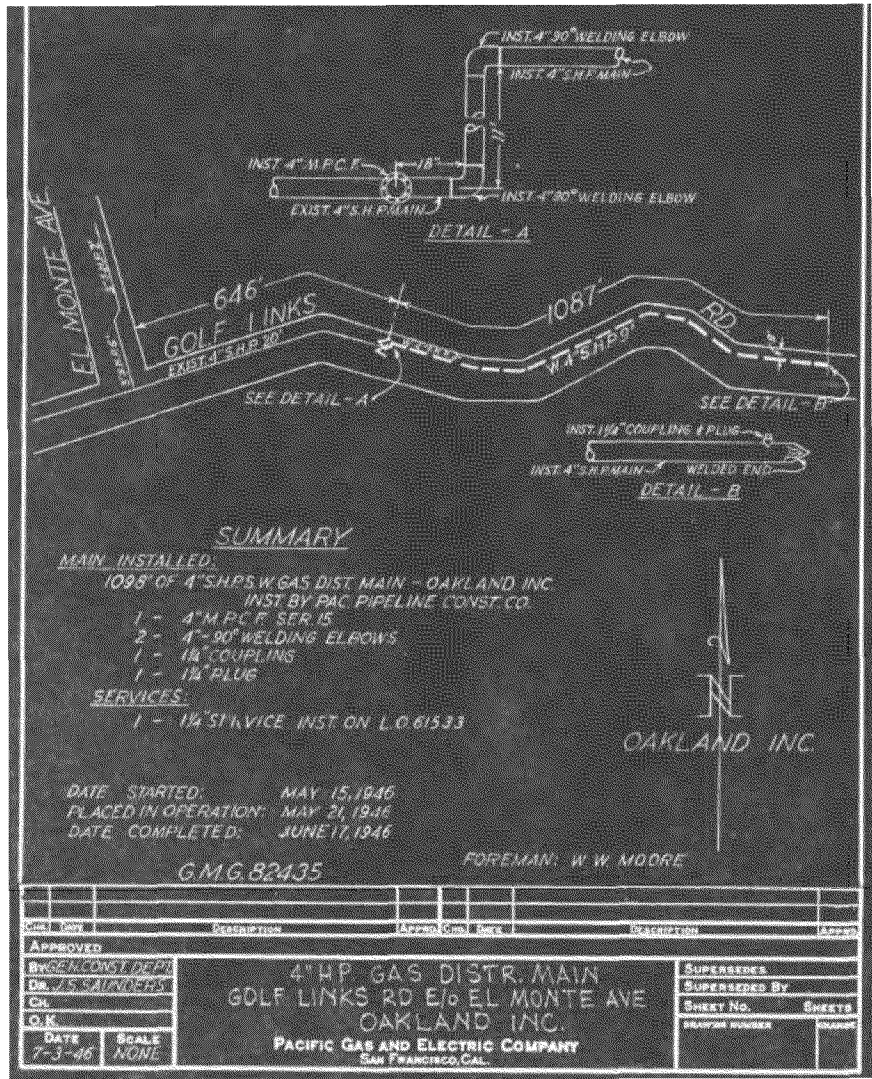
Figure 6. As-built construction drawing for job G.M.G. 82435 (1946).

- G.M.G. 82435 (1946) - Installed a 4-inch diameter steel main along Golf Links Road. This main included two 4-inch steel weld elbows at the location of the leak. One of these weld elbows installed in 1946 failed on December 10, 2013. An as-built construction drawing from G.M.G. 82435 is shown in Figure 6 and Figure 7. The

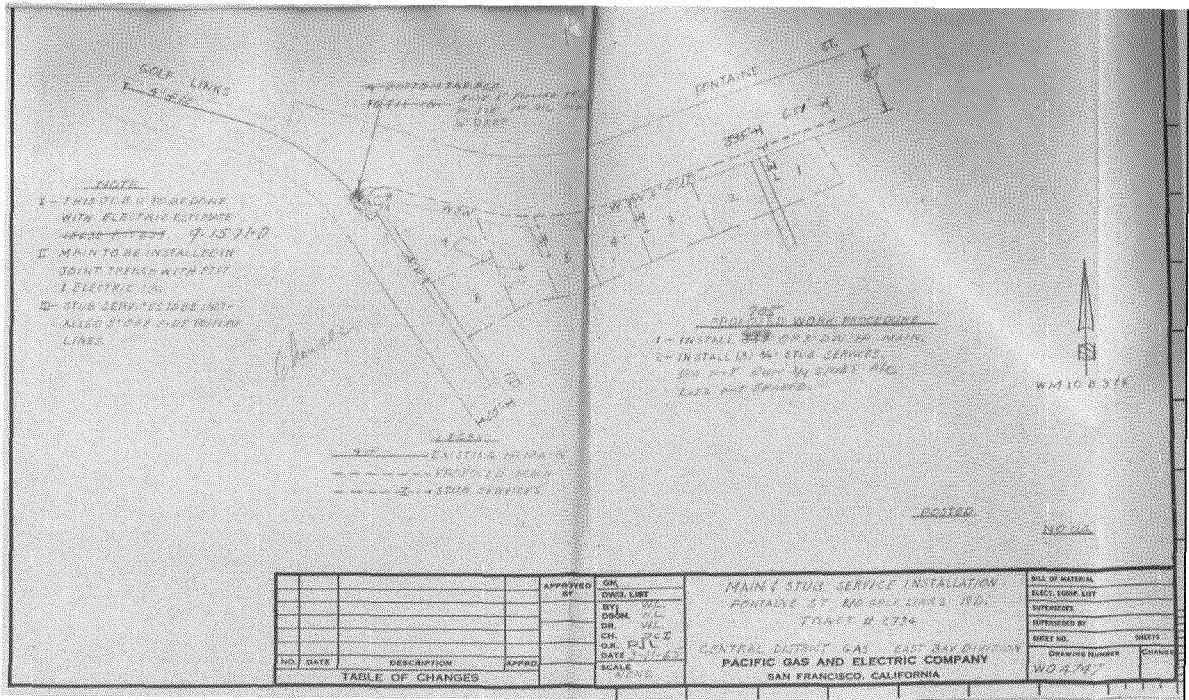
Figure 8. Preliminary construction drawing for W.O. 4747 (1965).

- W.O. 4747 (1965) - Installed a 3-inch diameter steel main extending along Fontaine Street. The 3-inch steel main was connected to the existing 4-inch steel main using a 3-inch flanged tee. A preliminary construction drawing from W.O. 4747 is shown in Figure 8 and Figure 9. This construction drawing has a very low level of detail in the area of the leak. As-built construction drawings for W.O. 4747 were not available to Exponent at the time that this report was issued.

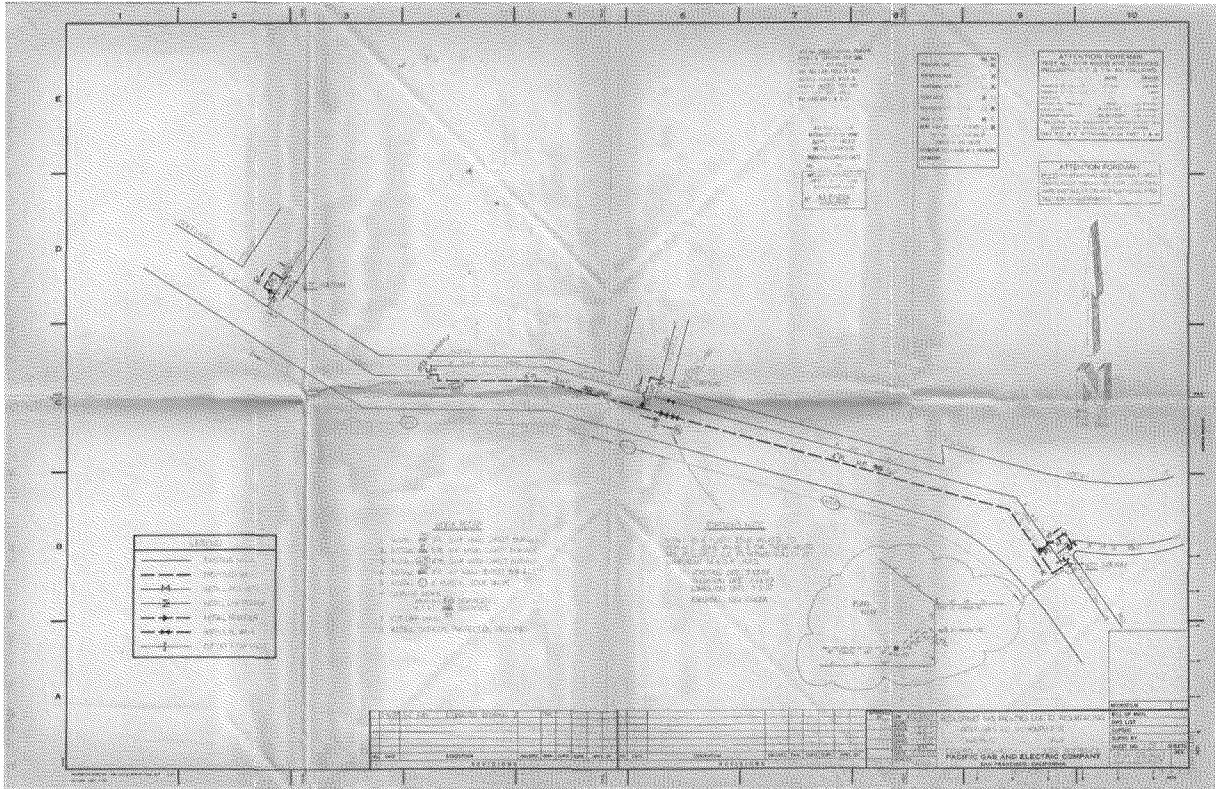
Figure 10. As-built construction drawing for G.M. 4564829 (1987).

- G.M. 4564829 (1987) - Installed a 4-inch diameter plastic distribution main along Golf Links Road starting near the leak site and extending northwest. This main was installed to replace an existing 4-inch steel main. During this job, a piece of 4-inch pipe that was installed in 1946 in the immediate vicinity of the gas release was cut and capped. The 4-inch plastic distribution main was installed with a steel-to-plastic transition, two elbows, and approximately four feet of steel pipe that connected to the existing 1946 4-inch steel main using a 3-inch flanged tee. An as-built construction drawing for G.M. 4564829 is shown in Figure 10 and Figure 11. The pipeline features and locations shown in this drawing were consistent with the features in the ground.

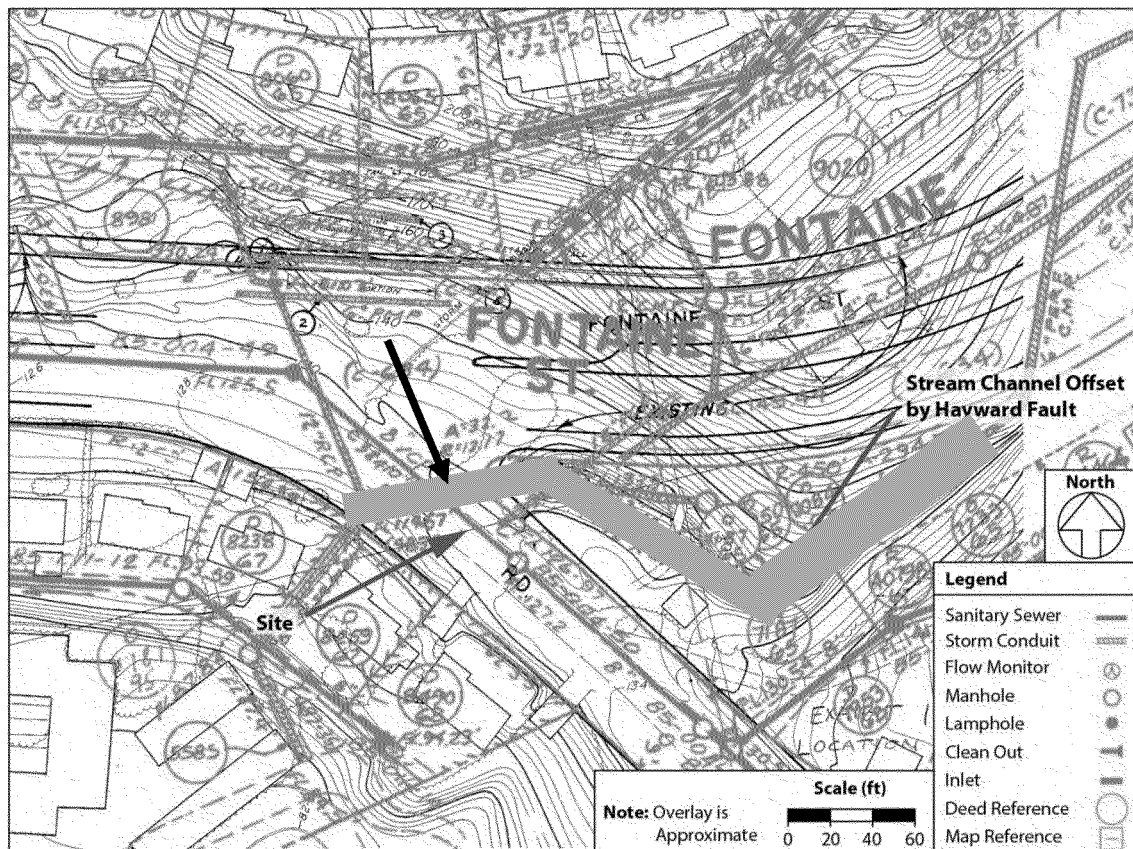
One piece of evidence of the location of the Hayward Fault at the Site is a right-lateral offset of a tributary stream channel (see Appendix C) emphasized by the storm-drain alignments following the old stream channel in Figure 27. The stream offset likely represents the location of one trace of the Hayward Fault, but not necessarily the active trace, which will be discussed in the next section.

Figure 27. City sewer map overlaid on pre-Fontaine-Street topography (see Appendix C). Black arrow indicates culvert under Golf Links Road. Yellow highlighting indicates storm-drain segments along offset stream channel. Sources: City of Oakland Underground Sewer Maps, Sheets 92 and 93, last revised 8-25-2004, scale unknown; City of Oakland topographic map excerpt; title, date, and scale unknown; from Building Services Division Land Stability File 92 L/4, "Grading, 8467 & 8475 Ney Avenue, 1 of 2."

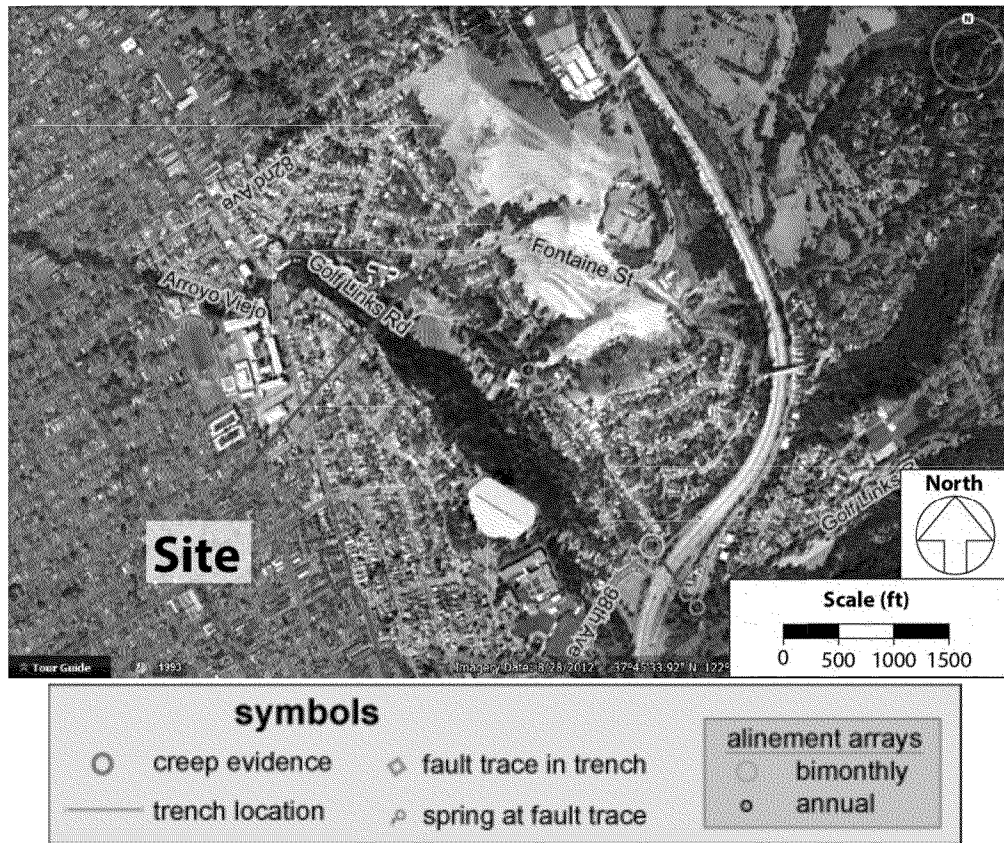
Lienkaemper (2006, revised 2008) stated that the accuracy of the mapped location of active fault traces varies throughout the mapped fault zone. In the vicinity of the Site, the actual active trace of the Hayward Fault is interpreted to be within 60 meters of the line shown on the map. Figure 29 shows the approximate area in which the active trace of the Hayward Fault is interpreted to be located, according to the Lienkaemper map. As shown on this figure, the Site is well within the mapped location of the active Hayward Fault trace. Figure 29 also shows the approximate direction of right-lateral displacement of the Hayward Fault in the vicinity of the Site. Figure 30 shows a plan view of the approximate configuration of the pipe system exposed during repairs and the pipe rupture location. The figure also shows the approximate direction of right-lateral movement of the Hayward Fault in the vicinity of the Site.

Figure 28. Map showing recently active trace of Hayward Fault in vicinity of Site. Sources: Lienkaemper, J.J., 2006, revised 2008, Digital database of recently active traces of the Hayward Fault, California: USGS DS-177, <http://pubs.usgs.gov/ds/2006/177/> overlain on 2012 Google Earth air photo.

Figure 28 shows the location of a creep monitoring station (alinement array) next to the freeway. This station (Encina Way Station) is located approximately 3,000 feet southeast of the Site. This station is currently being monitored annually by San Francisco State University with theodolite surveys of the alinement array.⁹ The USGS also monitors creep in the vicinity of the site, at the Oakland Zoo. This station is located approximately 3,900 feet southeast of the Site (i.e., approximately 900 feet southeast of the Encina Way Station). The Oakland Zoo Station is currently being monitored every 10 minutes by an installed creepmeter.¹⁰ Additional details of the creep monitoring stations are included in Appendix D.

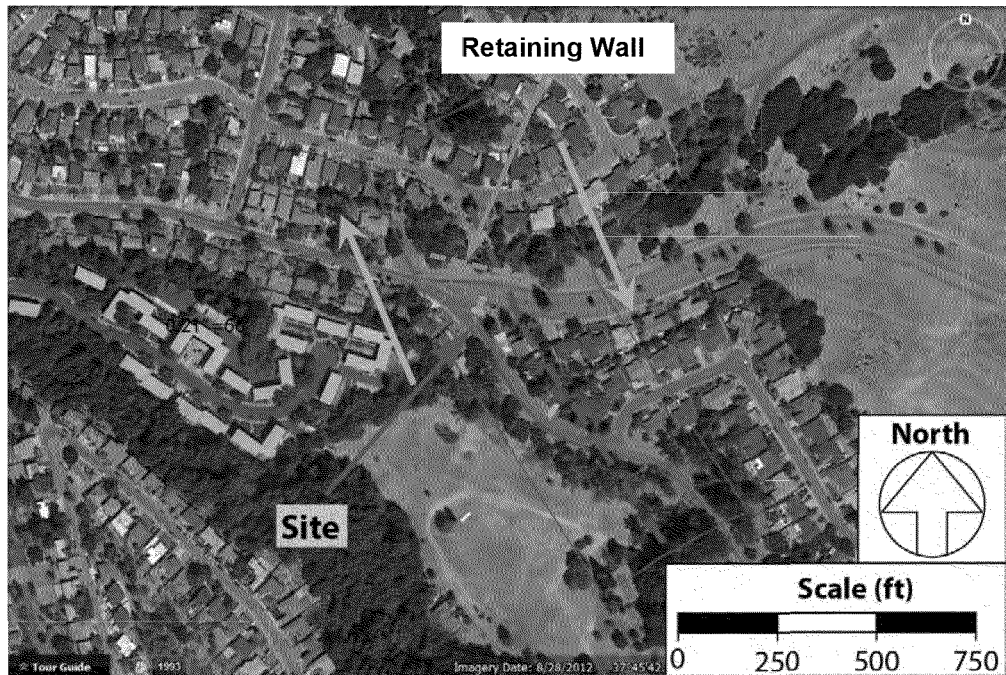
As discussed later in this report, the presence of a large ancient landslide near the Site obscures some surface traces of the Hayward Fault. The presence of this landslide likely contributed to the relatively large uncertainty in the location of the Hayward Fault near the Site (i.e., actual active trace of the fault within 60 meters of the line shown on the map).

Figure 29. Aerial photograph showing approximate location of recently active trace of Hayward Fault in immediate vicinity of Site. Red box indicates width of zone of uncertainty within which the active fault trace is interpreted to be located. Sources: Google Earth; Lienkaemper (2006, revised 2008) <http://pubs.usgs.gov/ds/2006/177/>.

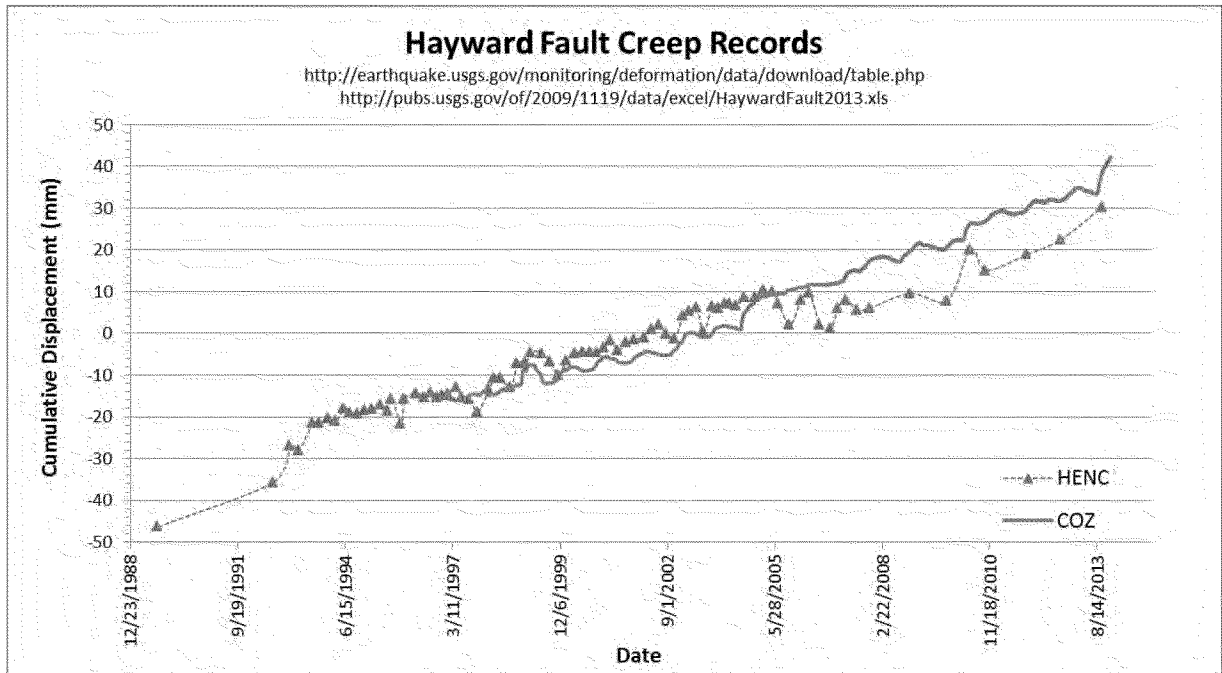
For the Encina Way Station (HENC), McFarland et al. (2009, revised 2013)¹² published creep data that have been recorded since 1989. For the Oakland Zoo Station (COZ), the USGS published creep data that have been recorded since 1996. Figure 34 shows the available data for these two stations. As shown in this figure, at the Encina Way Station a total displacement of

over 76 mm has been measured since 1989, for an average creep rate of 3.2 mm/yr. At the Oakland Zoo Station a total displacement of over 57 mm has been measured since 1996, for an average creep rate of 3.3 mm/yr. The figure shows an acceleration of creep movement measured at the Oakland Zoo Station starting in approximately August 2013. The timing of the gas release event may be related to this acceleration of creep movement. Additional creep data information is included in Appendix D.

Figure 34. Hayward Fault creep records in the vicinity of Golf Links Road (for available record interval). HENC = Encina Way Station. COZ = Oakland Zoo Station.

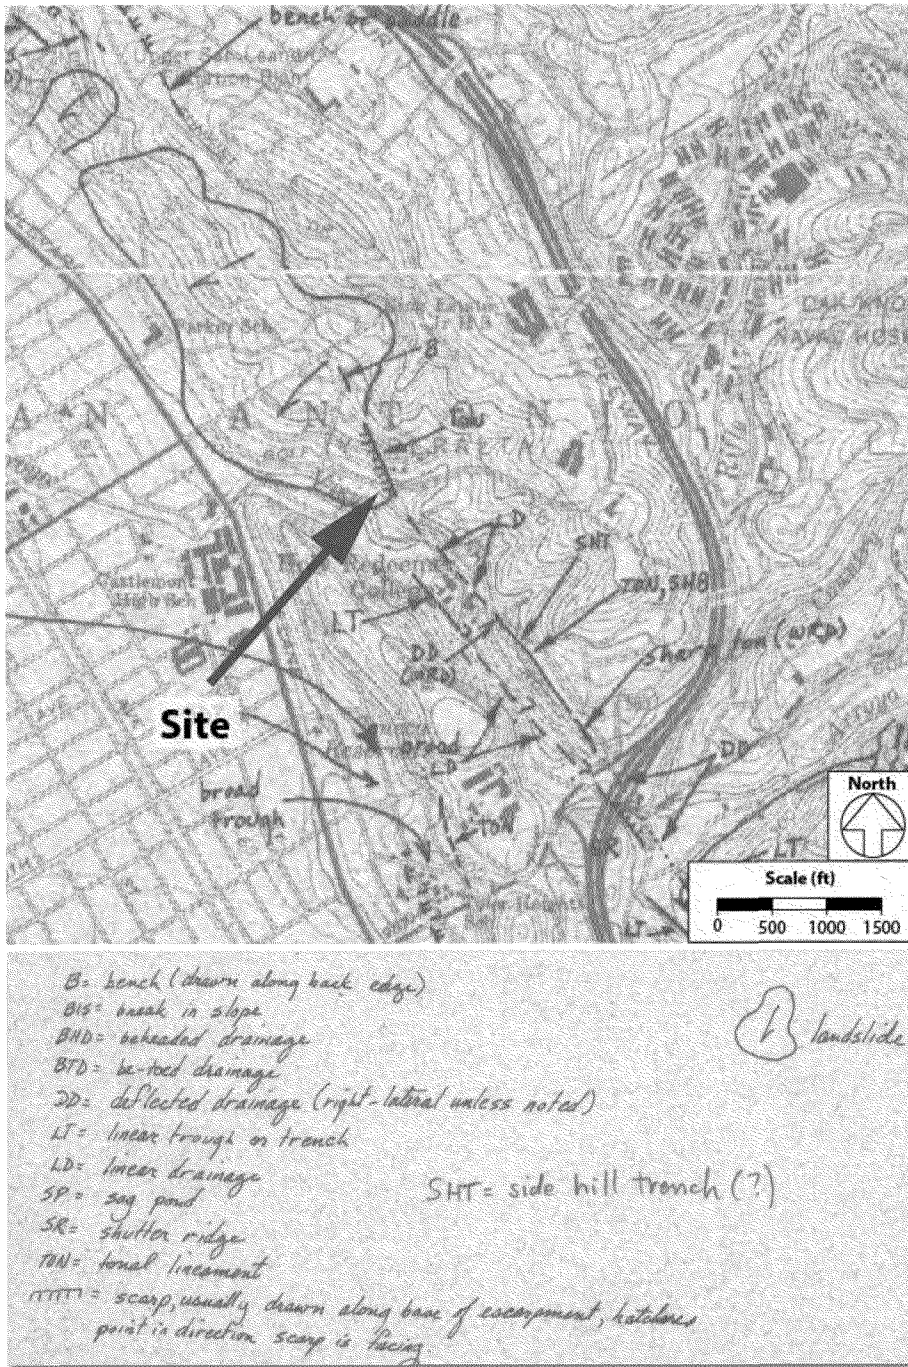
Exponent assessed the likelihood of landslide movement causing external forces on the pipe at the Site. As shown in Figure 36, the Site is located on the edge of a large ancient landslide. Exponent observed evidence of this landslide on topographic maps, aerial photographs, and in the field. In addition, a steep slope below Golf Links Road is potentially susceptible to landsliding.

Figure 36. Map showing geomorphic and tonal features along recently active traces of the Hayward Fault. Based on 1939 (pre-development) aerial photographs. Source: California Division of Mines and Geology (now California Geological Survey), 1980, Fault Evaluation Report FER-102, Hayward fault (Oakland segment), Figure 4. Geomorphic and tonal features along recently-active traces of the Hayward fault, scale 1:24,000.

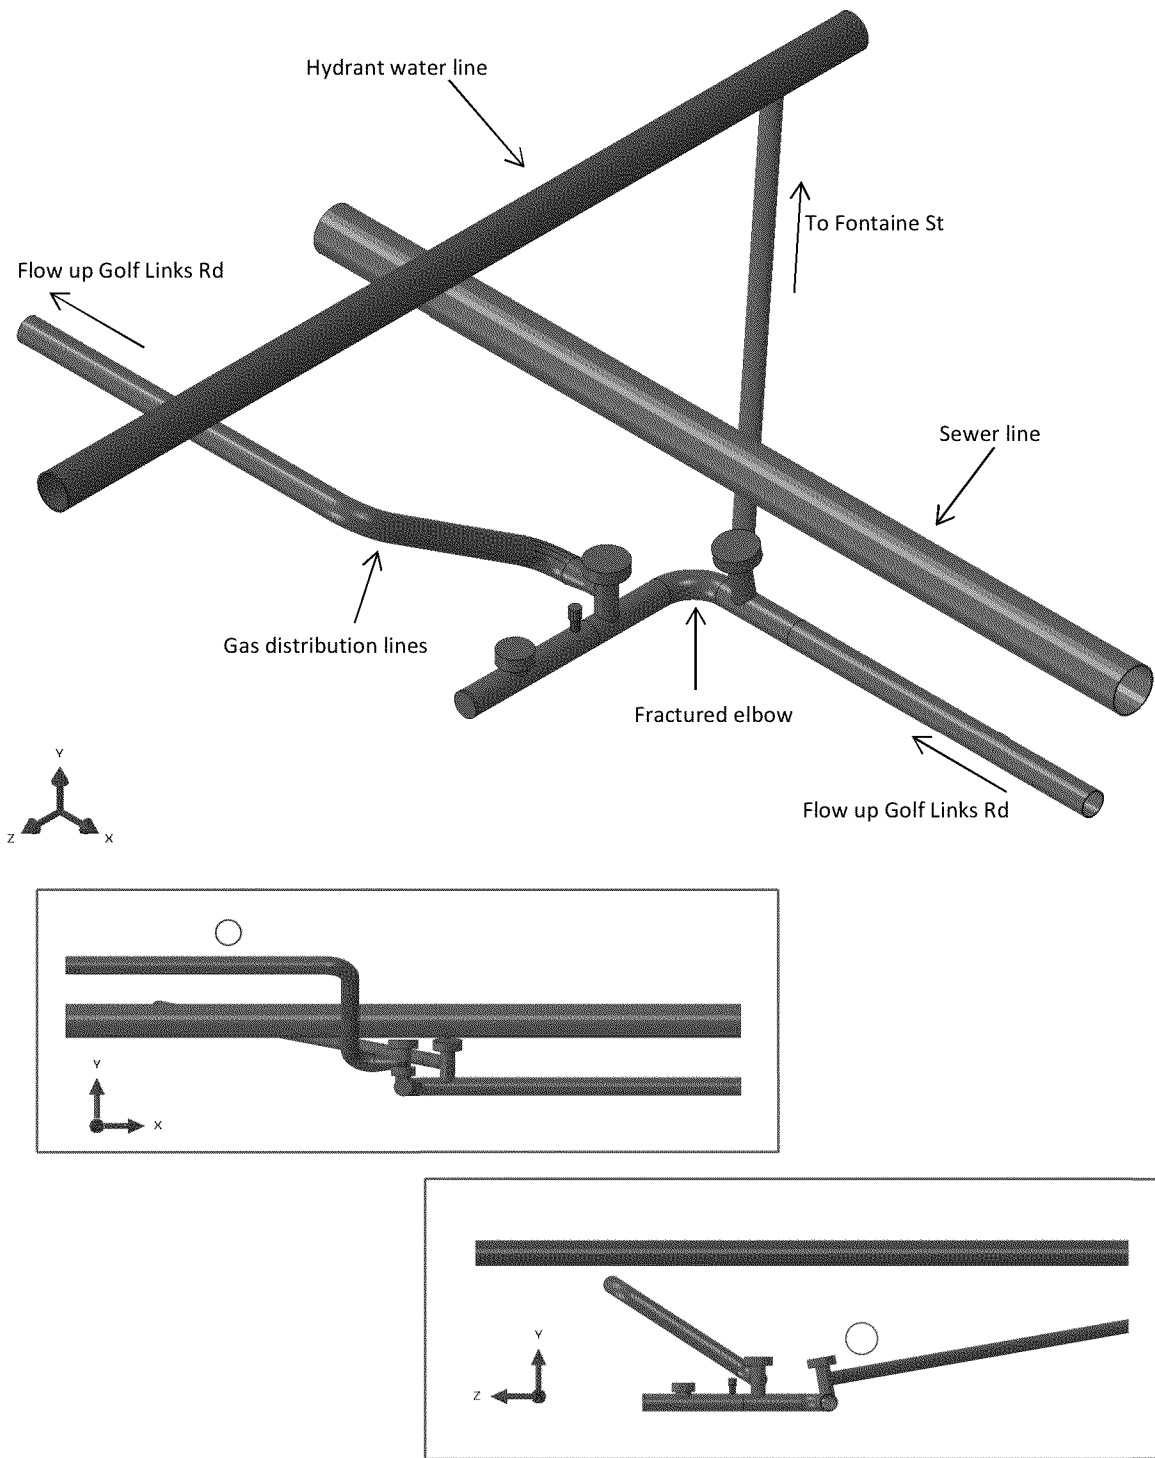
The Abaqus finite element software package was utilized to create a finite element model of the region near the incident to investigate loading scenarios that might have contributed to the subject elbow fracture. The region modeled is shown in Figure 37. Lines from three different utilities were included in the model: a network of gas distribution lines, a sewer line, and a hydrant water line. Surrounding soil was also included in the model, but is not shown in the figure.

The model encompasses a region that is 14 feet by 14 feet, 12 feet deep, and centered near the fractured elbow. The geometry of the gas piping shown to the left of the elbow in the figure was created from measurements of the pieces extracted after the repair. The tee to the right of the elbow was assumed to be identical to the one on the left (i.e. the one extracted after the repair). The gas lines traveling towards Fontaine Street and up and down Golf Links Road were assumed to have nominal dimensions (three and four-inches respectively). The hydrant water line was assumed to be a six-inch Schedule 40 steel pipe filled with water. The sewer line was assumed to be an empty eight-inch PVC pipe. The gas lines were assumed to be pressurized to 54 psig.

Figure 37. Network of pipes included in the finite element analysis. Surrounding soil was also included, but is not shown in the figure. The model encompasses a region that is 14 feet by 14 feet, 12 feet deep, and centered near the fractured elbow.

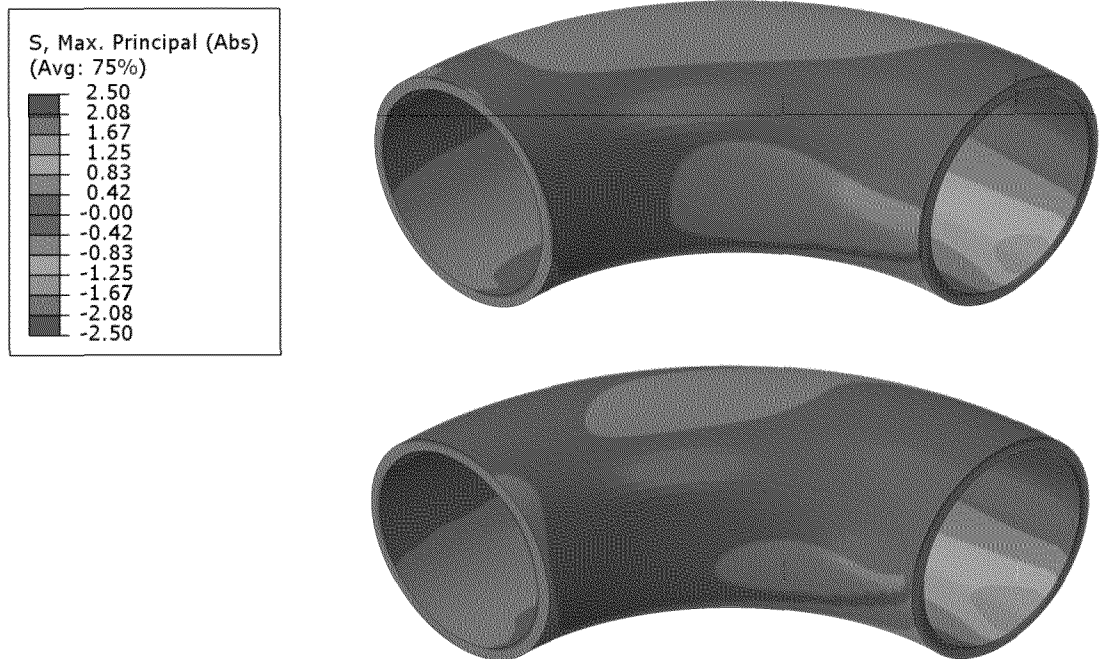
One uncertainty in the model geometry was the vertical distance between the water line and the gas line and the support condition beneath the water line near the gas line. It is possible that the water line was resting directly on the gas line and was not fully supported by soil in this vicinity. To determine the sensitivity of the stresses in the subject elbow to the water line support condition, a second model was built such that six feet of the water line in the vicinity of the gas line was unsupported by soil. For this condition, a larger load from the water line is transferred directly to the gas line. The tensile stresses calculated in the incident elbow are shown in the lower half of Figure 40; the largest tensile stresses were approximately 1.5 ksi, which was only slightly larger than the nominal condition and not large enough to cause failure. Thus, the support condition of the water line in the vicinity of the gas line was determined to have a negligible contribution to the failure.

Figure 40. Tensile stresses in the incident elbow subjected to gravitational loading with nominal water pipe support (top) and 6 ft unsupported water pipe (below). Units are ksi.

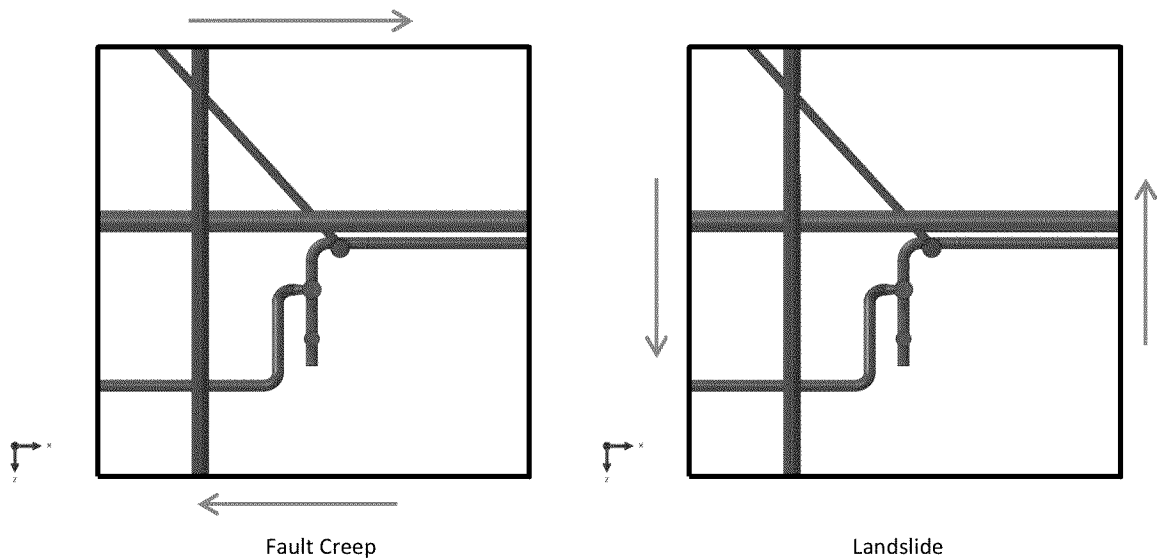
Because gravitational loading alone is not sufficient to achieve tensile stresses in the elbow that are consistent with the observed mode of failure, ground shearing movement was investigated as a possible source of stresses. After the model achieved equilibrium with gravitational loading, the soil was sheared in the horizontal plane to simulate ground movement associated with right-lateral strike-slip creep of the Hayward Fault or to simulate possible ground movement due to the ancient landslide. These two shearing directions are diagrammed in Figure 42. Two additional shearing directions were considered to investigate the sensitivity of the fault shearing direction; these directions were rotated $\pm 10^\circ$ from the fault creep nominal condition shown in Figure 42.

Figure 42. The two primary ground movement shearing directions considered in the finite element model. The left image shows the shearing consistent with right-lateral strike-slip creep of the Hayward Fault, and the right image shows the shearing consistent with ground movement due to a nearby landslide.

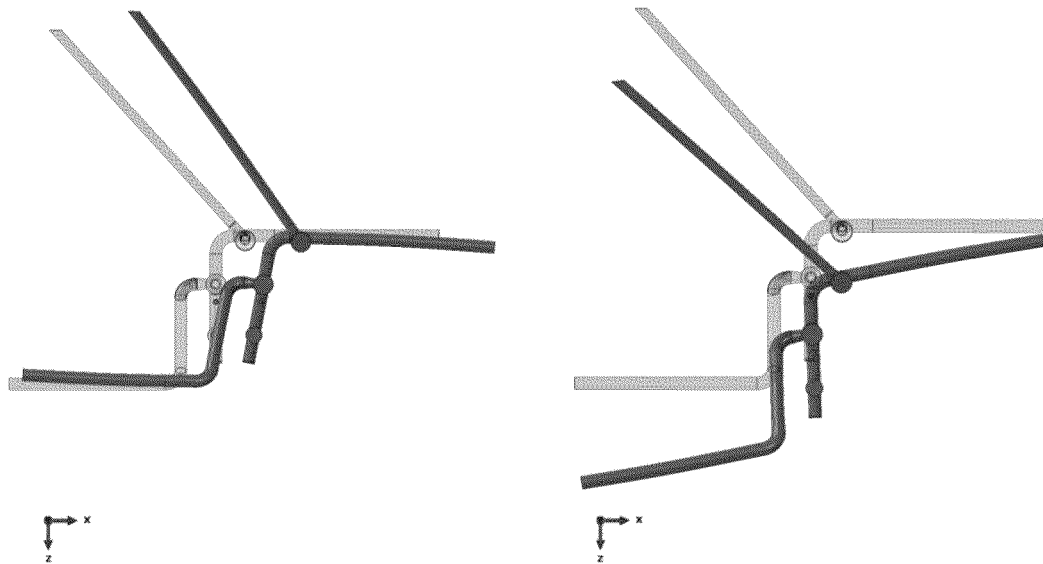
The resulting deflections of the gas pipe network when subjected to 0.2 in/ft of horizontal shear in the fault creep and landslide directions are shown in Figure 45. Tensile stresses in the gas lines in the vicinity of the incident elbow are shown in Figure 46. In both shearing conditions, tensile stresses were concentrated in the incident elbow near the failure location, i.e. on the outside surface of the elbow intrados, and have nearly the same tensile stresses for the same amount of ground shearing. The peak tensile stresses on the outside surface of the elbow intrados are 49.1 ksi for both the fault creep and landslide cases, and are shown on the left side of Figure 47. This stress approaches the magnitudes necessary to cause failure. However, note that the peak elbow stress occurred on the lower inside surface of the elbow, as indicated by the gray region in the left images of Figure 47, not on the outside wall of the elbow intrados. This point will be revisited later. Nonetheless, the magnitude, location and direction of peak tensile stress on the outside wall of the elbow intrados were consistent with the fractured incident elbow. Plots of the tensile stress direction on the outside surface of the elbow for the fault-creep and landslide-shear cases are shown on the right side of Figure 47.

Figure 45. Deformed shapes of the gas pipe network when subjected to fault-creep shear (left) and landslide shear (right). The total shearing applied is 0.2 in/ft, but the deformations are scaled by a factor of 10.

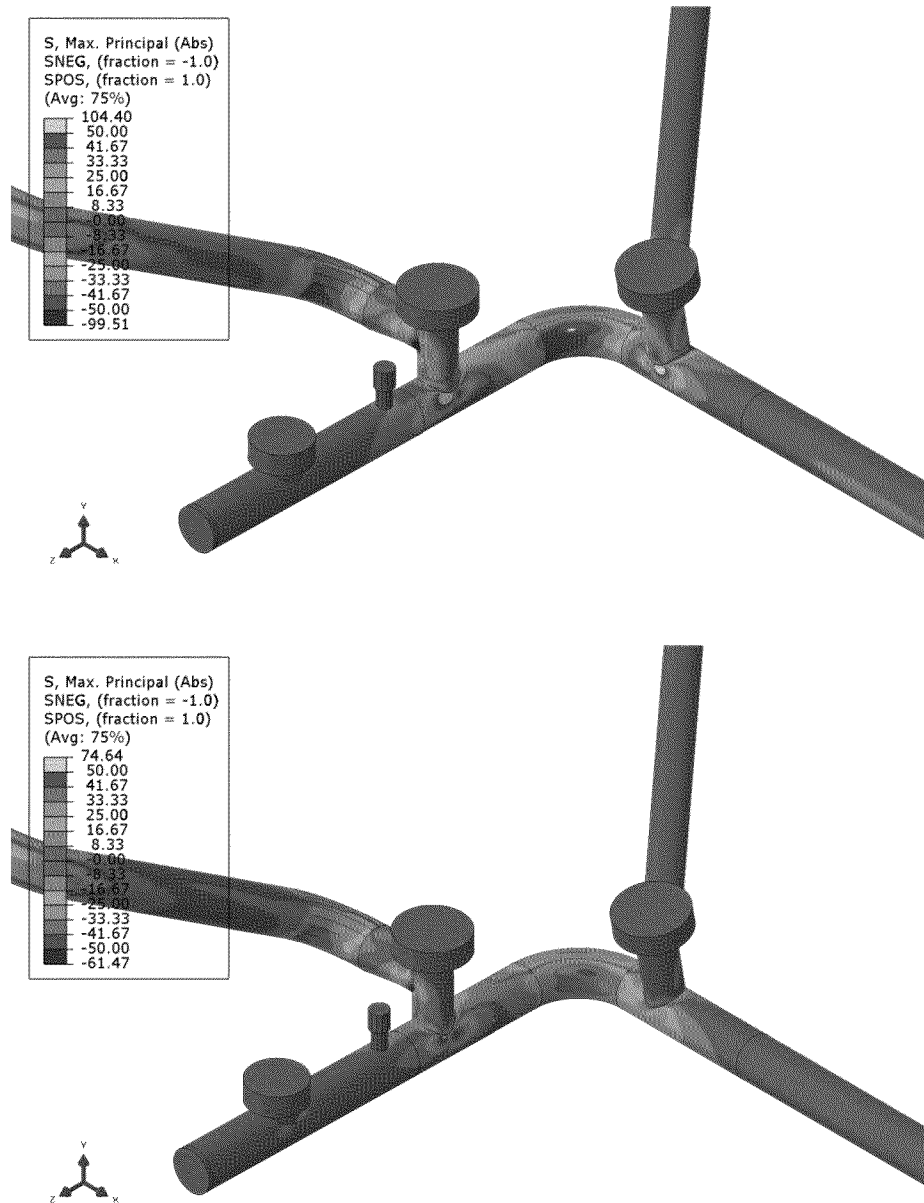
To further investigate the sensitivity to shearing direction on the peak tensile stress magnitude and location, the fault creep shearing direction was varied by $\pm 10^\circ$. Tensile stresses in the gas lines in the vicinity of the incident elbow are shown in Figure 48. The peak tensile stresses on the outside wall of the elbow intrados were slightly higher for the $+10^\circ$ shearing direction and lower for the -10° direction (50.2 ksi and 42.7 ksi respectively) as compared with the nominal fault creep condition in Figure 46. The location of the peak stress also shifted along the axial position of the elbow.

Figure 48. Tensile stresses in the gas pipes when subjected to 0.2 in/ft of shear in the fault creep +10° direction (top) and the fault creep -10° direction (bottom). Rotation angles are with respect to the model's y-axis. Units are ksi.

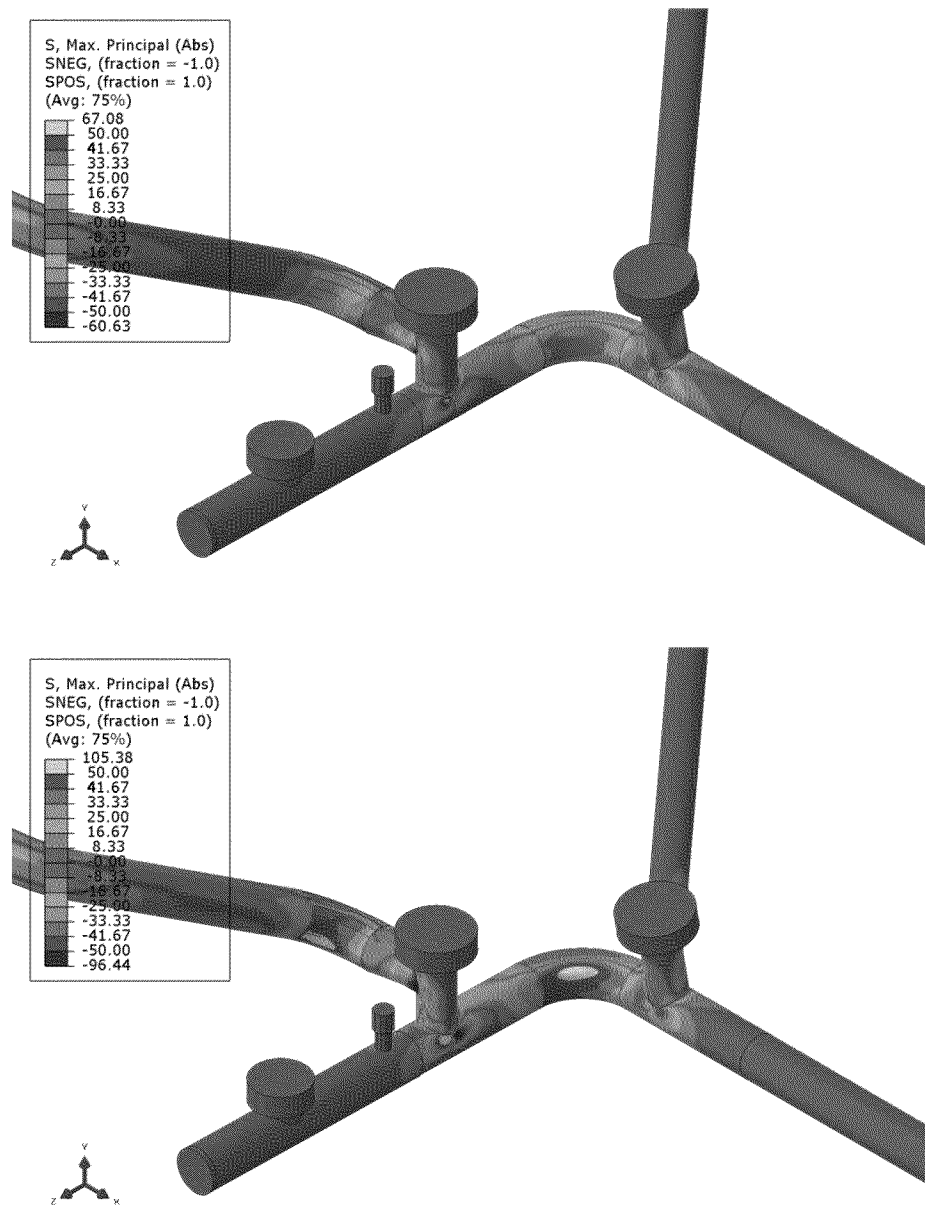
To investigate the sensitivity of soil modulus on the peak tensile stress magnitude, two other soil moduli were investigated, 200 atm and 1000 atm, as compared with the nominal value of 500 atm. Tensile stresses in the gas lines in the vicinity of the incident elbow are shown in Figure 49. The peak tensile stresses on the outside wall of the elbow intrados were 41.3 ksi and 55.2 ksi for the 200 atm and 1000 atm moduli soils, respectively. While the magnitude of stress varies for the different soil moduli, the location of the peak tensile stress on the outside wall of the elbow does not change. All of these stresses are summarized in Table 5, and all are approaching magnitudes that would be consistent with failure of the elbow.

Figure 49. Tensile stresses in the gas pipes when subjected to 0.2 in/ft of shear in the fault creep direction but with varying soil moduli, 200 atm (top) and 1000 atm (bottom). Units are ksi.

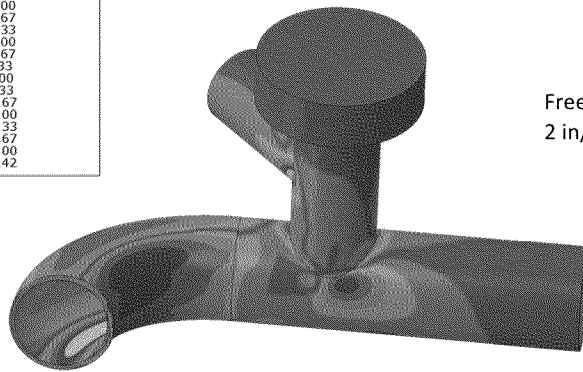
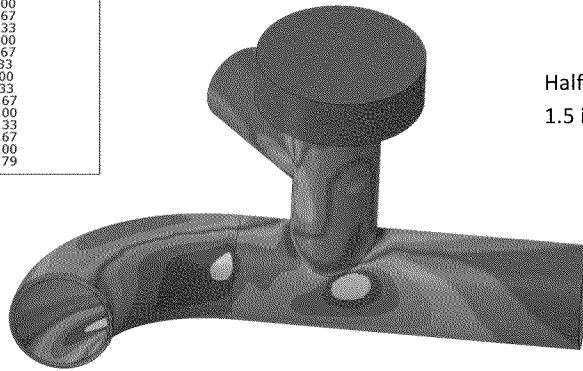
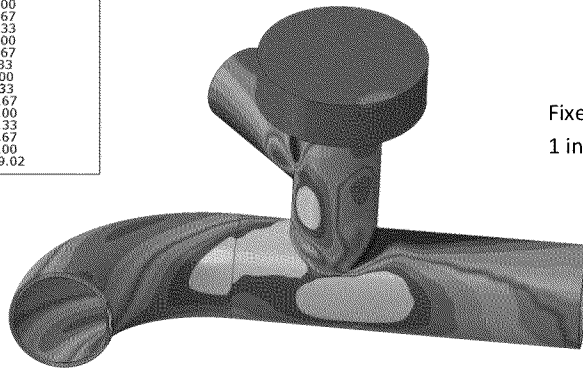
Fontaine pipe such that it cannot move axially and is forced into compression during the shearing, and a second model which provided a softer constraint that allowed the pipe to move only half the distance that it would if it were free to slide. The resulting tensile stresses in the region of the elbow and neighboring tee are shown in Figure 50. In all cases, the tensile stresses are large enough to cause failure of the elbow.

A summary of the peak tensile stress on the outside and inside walls of the elbow for the three boundary condition cases is presented in Table 6. It is important to note that decreasing levels of shear were applied to the models as the constraint was increased. The reduction in ground movement shearing reduces the stresses on the inside wall of the elbow. If the constraint on the end of the Fontaine Street pipe were unchanged, then we would also expect the stress on the outside wall to be reduced in a constant ratio. However, the constraint on the end of the Fontaine pipe causes the stress on the outside of the elbow (as well as the neighboring tee) to increase, and therefore causes the peak tensile stress location to switch from the lower inside surface to the outside surface of the elbow intrados. The fully constrained condition is unrealistic and causes very high stresses in the tee; the true constraint condition is likely somewhere between the two extremes of free and fixed.

Figure 50. Tensile stresses in the incident elbow and neighboring tee for different boundary conditions on the Fontaine Street pipe. Note that the models have decreasing amount of shear despite increasing stresses. Units are ksi.

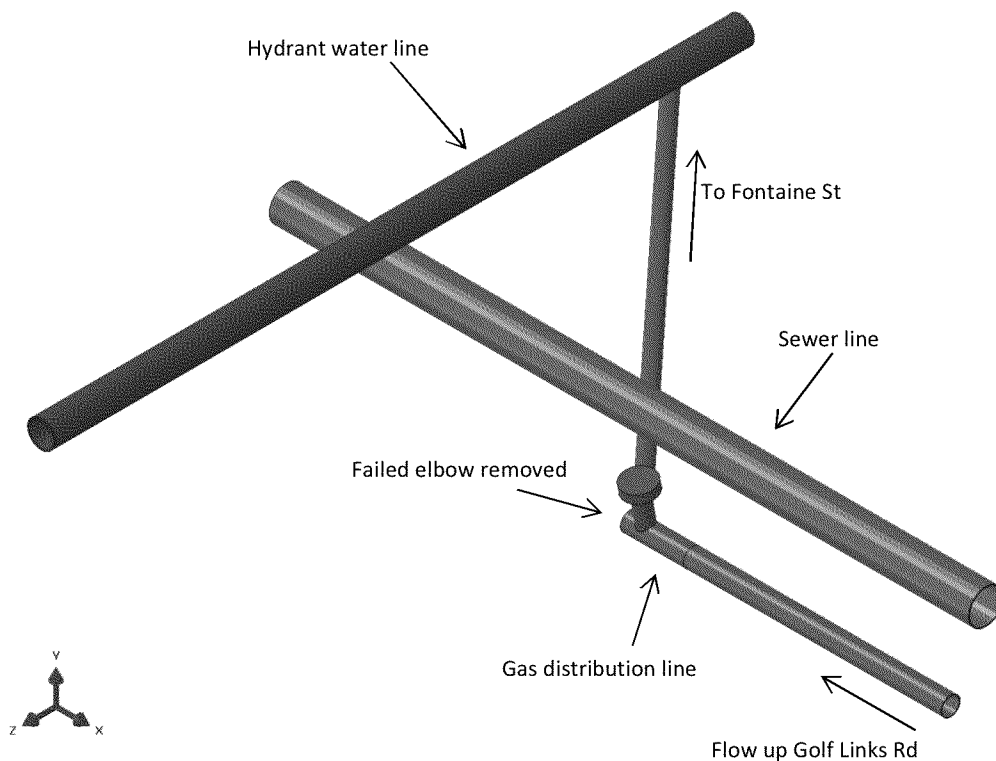
A finite element model was created to investigate the current stresses in the incident area following removal of the subject elbow and downstream piping. This new model is shown in Figure 51. The model was subjected to fault-creep shear of 0.2 in/ft consistent with the shear modeled in the subject elbow analysis. Tensile stresses in the repaired gas line near the location of the fractured elbow are shown in Figure 52; the stresses are reduced as compared with the stresses in the original configuration before the incident (upper image of Figure 50). Local stresses in the vicinity of the flange tee were predicted to be near 30 ksi. Thus, even after the removal of the subject elbow and associated downstream piping, stresses at the junction between the Golf Links Road and Fontaine Street piping could be as high as 30 ksi.

As in the earlier models, the stresses in the tee are highly dependent on the constraint of the Fontaine Street pipe. The excavation likely allowed local displacement and relief of some bending and compressive stresses at the Golf Links Road and Fontaine Street junction, but the rotational-induced stresses from fault-creep shear likely remains, consistent with the image shown in Figure 52. These stresses will increase with further creep of the Hayward fault at this location.

Figure 51. Post-repair model.

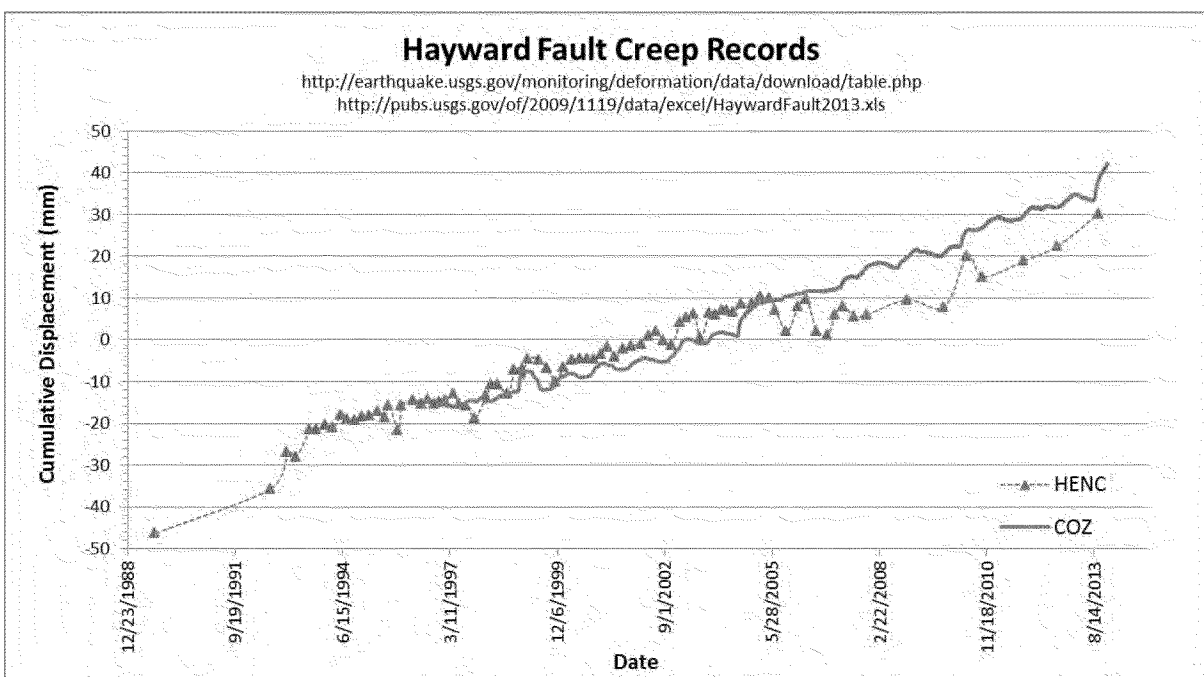
Figure D-3. Hayward Fault creep records in the vicinity of Golf Links Road (for available record interval). HENC = Encina Way Station. COZ = Oakland Zoo Station.

As previously noted, at the Encina Way Station a total displacement of over 76 mm has been measured since 1989, for an average creep rate of 3.2 mm/yr. At the Oakland Zoo Station a total displacement of over 57 mm has been measured since 1996, for an average creep rate of 3.3 mm/yr.

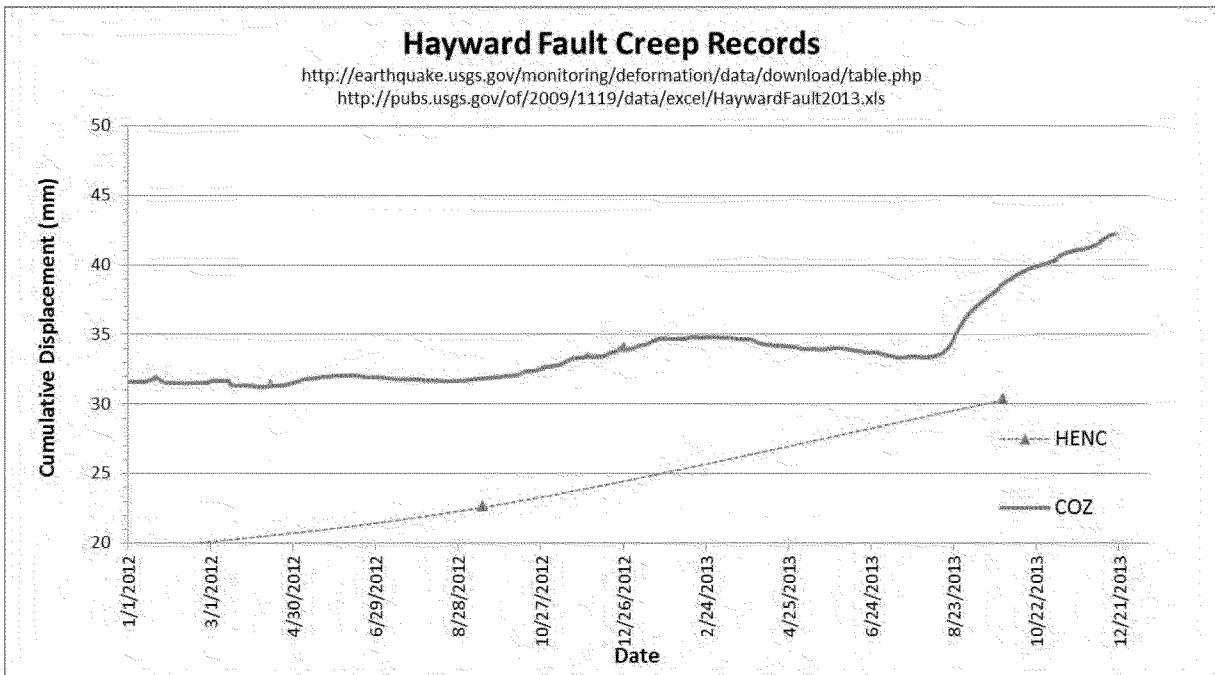
Figure D-4 shows the 2012 and 2013 portion of the data presented in Figure D-3. The figure shows an acceleration of creep movement measured at the Oakland Zoo Station starting in approximately August 2013. The timing of the gas release event may be related to this acceleration of creep movement.

Figure D-4. Hayward Fault creep records in the vicinity of Golf Links Road (for 2012 and 2013). HENC = Encina Way Station. COZ = Oakland Zoo Station.
