Re: Update - Oakland Incident of December 10, 2013

Pacific Gas and Electric (PG&E) has retained Exponent Failure Analysis Associates (Exponent) to conduct a failure analysis investigation of an elbow that fractured as part of a four-inch natural gas distribution line on December 10, 2013 near the intersection of [Redacted] and [Redacted] in Oakland, California. Our investigation to-date has included inspection of the leak site, review of PG&E's historical construction documents, a fire cause and origin study, metallurgical analysis, geotechnical analysis, analysis of other leak locations within the immediate area, and finite element-based stress analyses of ground movement and stresses on the subject elbow and associated piping.

Exponent's analyses indicate that the most likely root cause of the subject elbow fracture was from stresses that developed over time due to creep along the Hayward Fault.

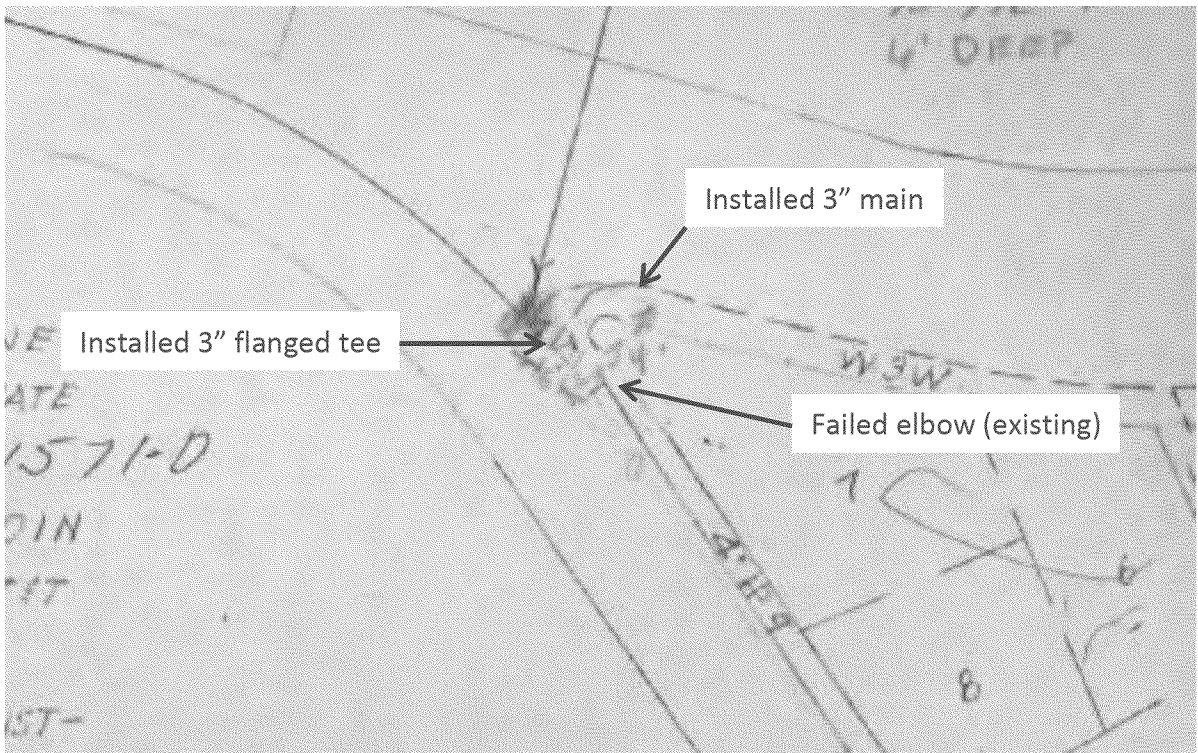
Figure 9. Cropped view of preliminary construction drawing for W.O. 4747 (1965) showing area of leak.

- W.O. 4747 (1965) - Installed a 3-inch diameter steel main extending along [Redacted] [Redacted] The 3-inch steel main was connected to the existing 4-inch steel main using a 3-inch flanged tee. A preliminary construction drawing from W.O. 4747 is shown in Figure 8 and Figure 9. This construction drawing has a very low level of detail in the area of the leak. As-built construction drawings for W.O. 4747 were not available to Exponent at the time that this report was issued.

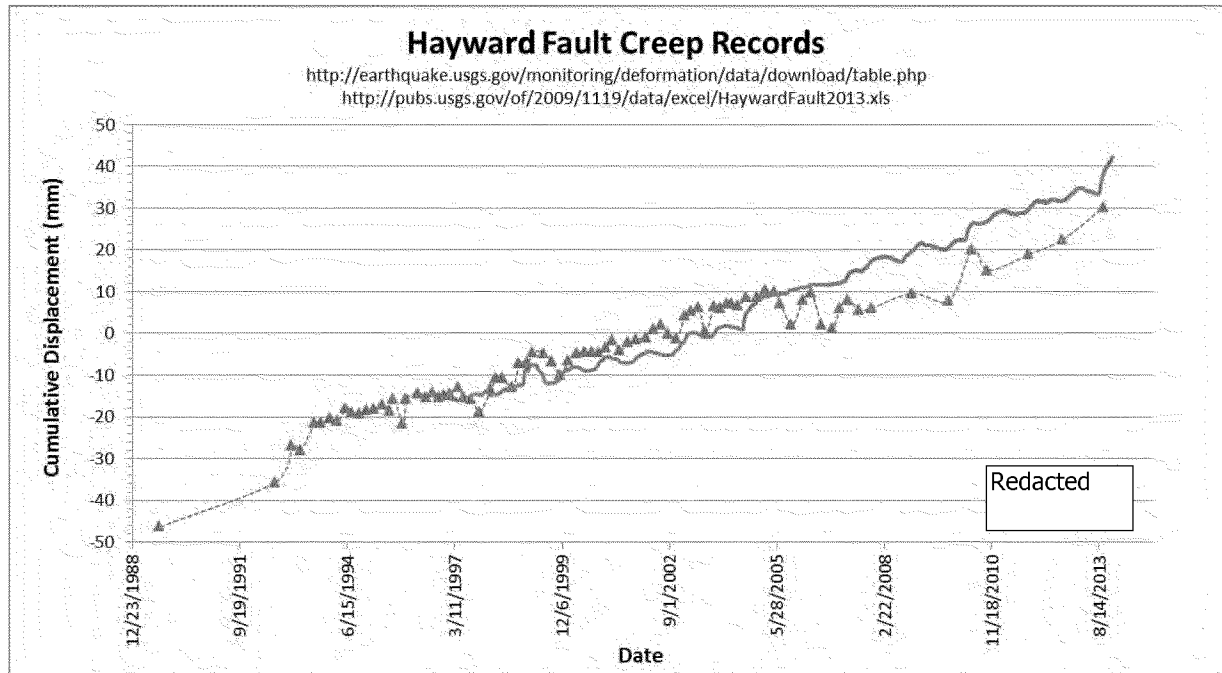
over 76 mm has been measured since 1989, for an average creep rate of 3.2 mm/yr. At the [Redacted] Station a total displacement of over 57 mm has been measured since 1996, for an average creep rate of 3.3 mm/yr. The figure shows an acceleration of creep movement measured at the [Redacted] Station starting in approximately August 2013. The timing of the gas release event may be related to this acceleration of creep movement. Additional creep data information is included in Appendix D.

Figure 34. Hayward Fault creep records in the vicinity of [Redacted] (for available record interval). [Redacted]

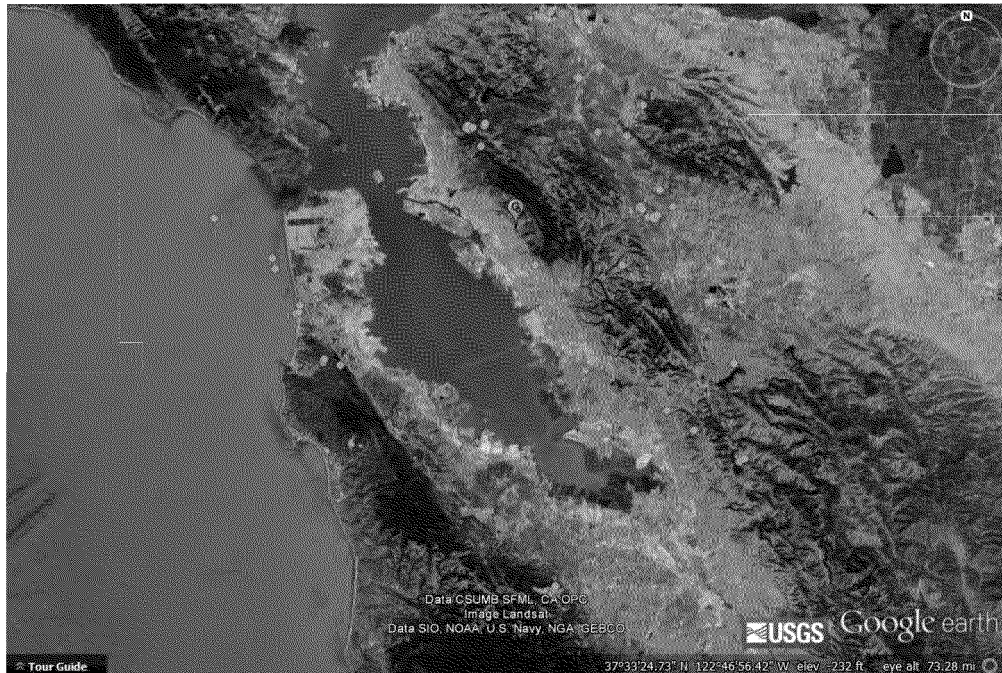
Figure 35 shows the recorded seismic events that occurred in the vicinity of the Site between August 1, 2013 and December 10, 2013. No significant events were recorded within a 50 km radius from the Site.¹² The closest event to the Site was a magnitude 2.0 earthquake approximately 3.5 miles southeast of the Site. The largest event was a magnitude 3.3 earthquake more than 10 miles east of the Site. Ground motions from these events did not cause significant loading of the pipe system at the Site.

Figure 35. Earthquakes within a 50-km radius from Site, and magnitude greater than 2.0, recorded between August 1, 2013 and December 10, 2013. Source: USGS: <http://earthquake.usgs.gov/earthquakes/map/>

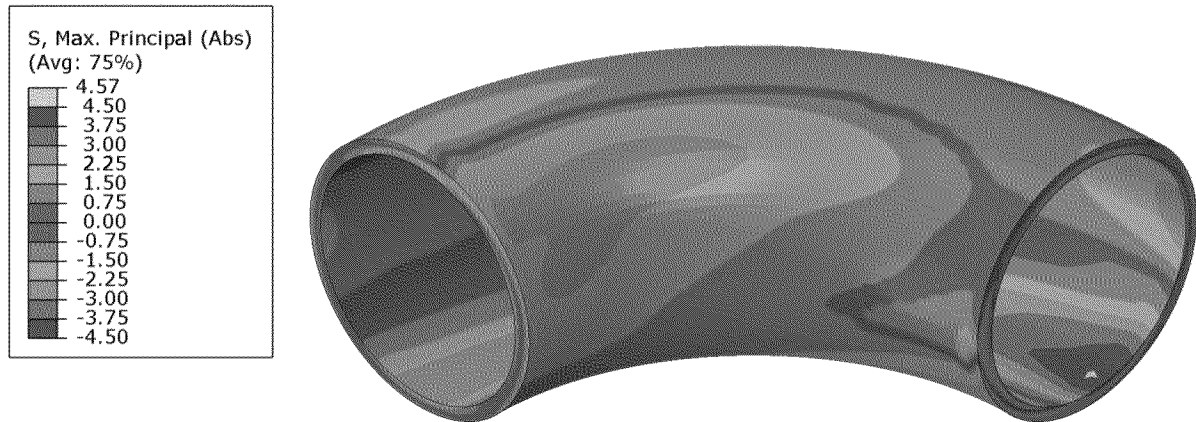
In order to determine the sensitivity of the elbow stresses to loading from heavy equipment on the road-surface, a load of 80,000 lbf was applied to the surface of the soil directly above the incident elbow in a patch of approximately 9” by 10”. This is approximately equivalent to a tractor trailer loaded to the legal limit, but carrying that load on just one tire instead of distributing the load over many tires.^{17,18} The resulting tensile stresses in the elbow are shown in Figure 41. The peak tensile stress is approximately 4.5 ksi and is located on the lower surface of the inside of the elbow. Tensile stresses near the failure location are approximately 2 ksi; this is not a sufficient amount of stress to cause failure.

Figure 41. Tensile stresses in the elbow when subjected to an 80,000 lbf truck load on the surface of the soil above the elbow.

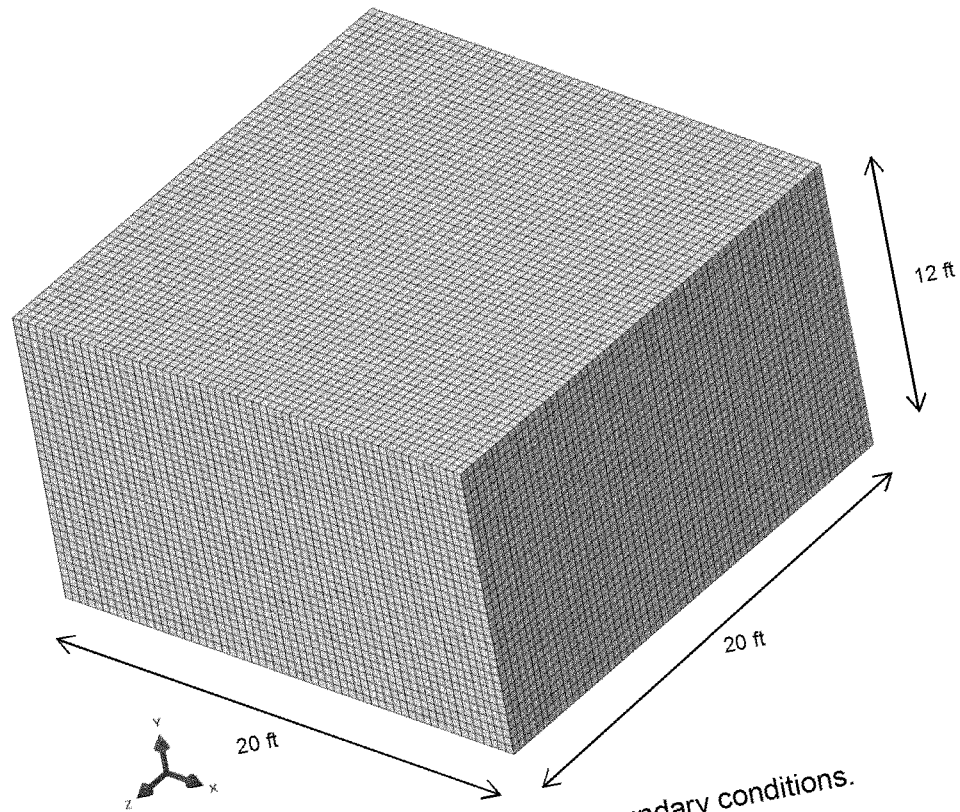
Figure 43. Global model used to apply shearing boundary conditions.

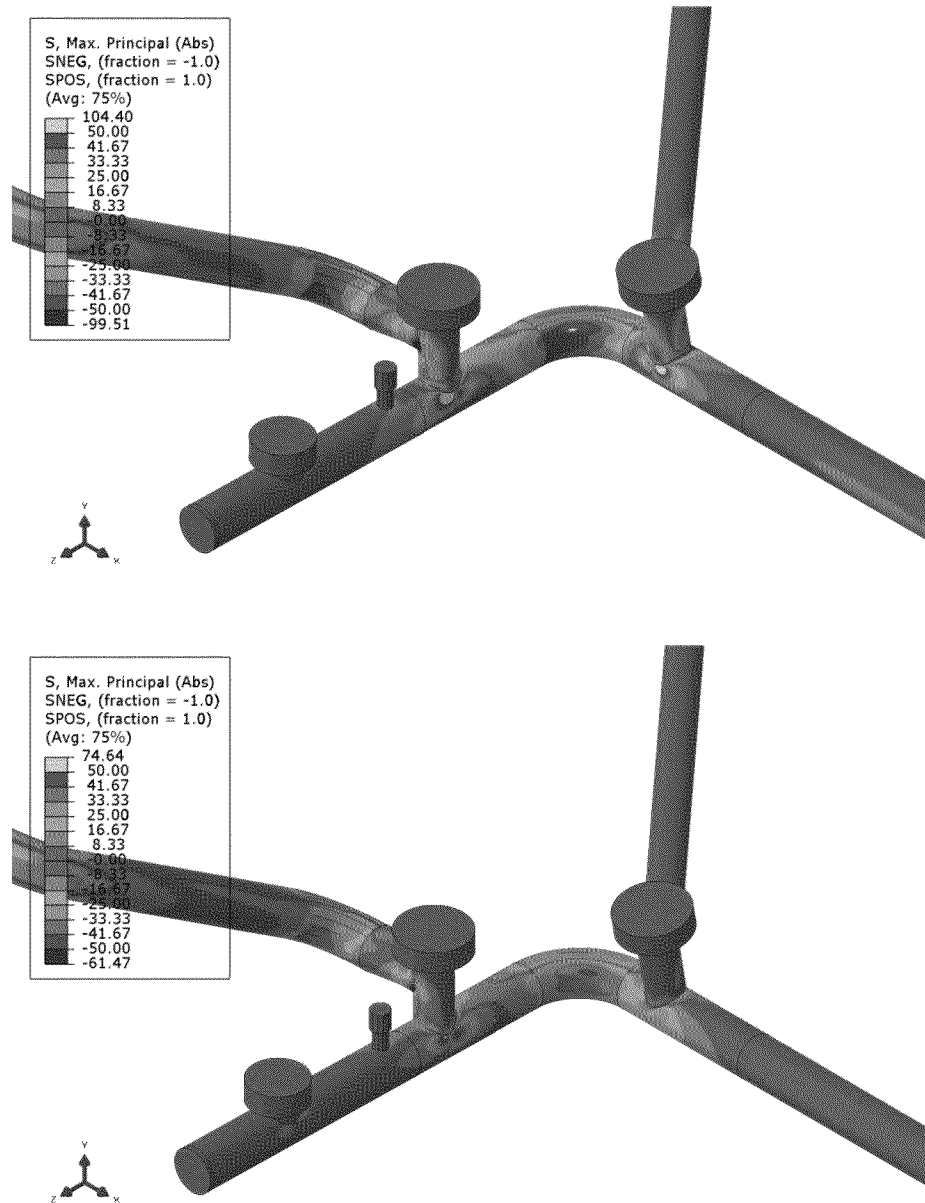
To further investigate the sensitivity to shearing direction on the peak tensile stress magnitude and location, the fault creep shearing direction was varied by $\pm 10^\circ$. Tensile stresses in the gas lines in the vicinity of the incident elbow are shown in Figure 48. The peak tensile stresses on the outside wall of the elbow intrados were slightly higher for the $+10^\circ$ shearing direction and lower for the -10° direction (50.2 ksi and 42.7 ksi respectively) as compared with the nominal fault creep condition in Figure 46. The location of the peak stress also shifted along the axial position of the elbow.

Figure 48. Tensile stresses in the gas pipes when subjected to 0.2 in/ft of shear in the fault creep +10° direction (top) and the fault creep -10° direction (bottom). Rotation angles are with respect to the model's y-axis. Units are ksi.

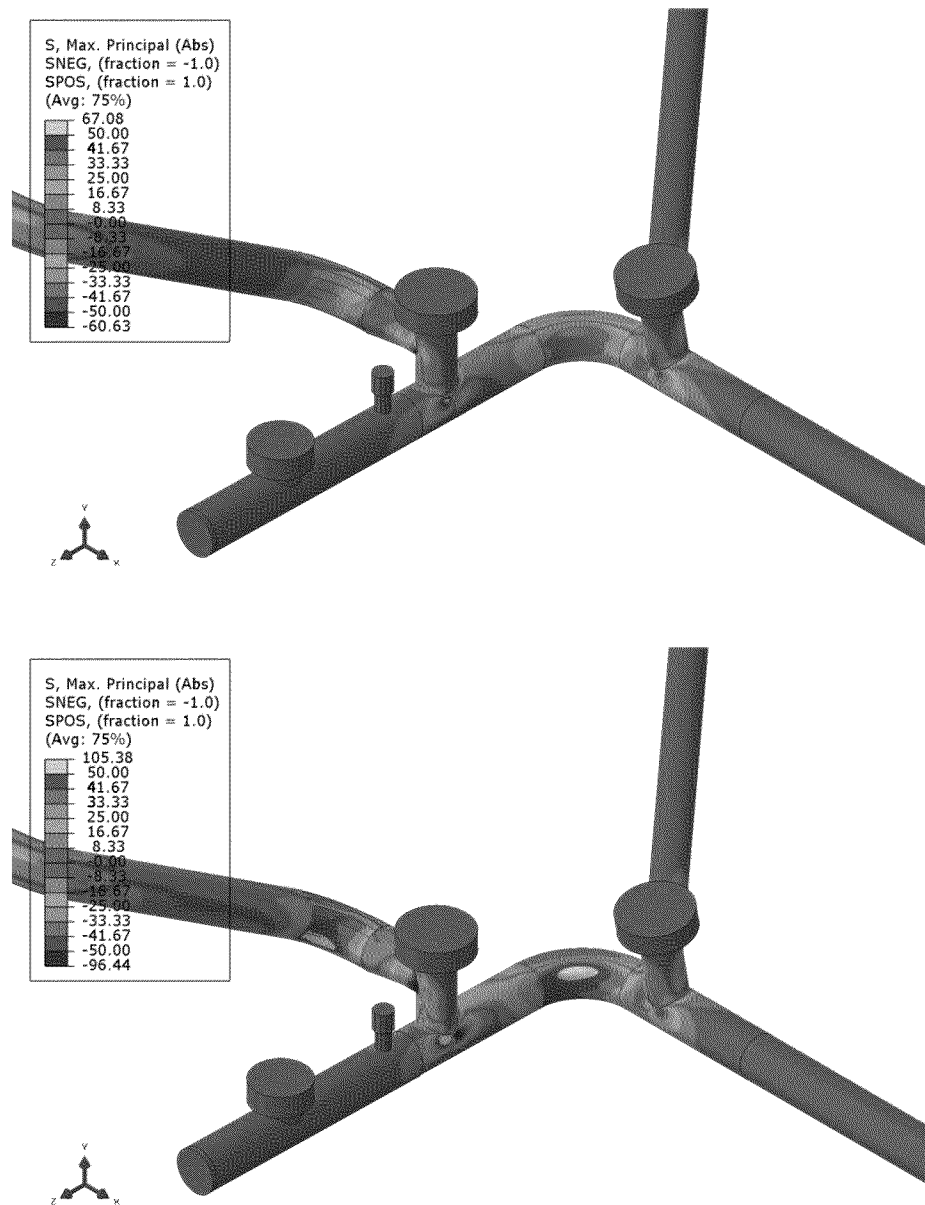
To investigate the sensitivity of soil modulus on the peak tensile stress magnitude, two other soil moduli were investigated, 200 atm and 1000 atm, as compared with the nominal value of 500 atm. Tensile stresses in the gas lines in the vicinity of the incident elbow are shown in Figure 49. The peak tensile stresses on the outside wall of the elbow intrados were 41.3 ksi and 55.2 ksi for the 200 atm and 1000 atm moduli soils, respectively. While the magnitude of stress varies for the different soil moduli, the location of the peak tensile stress on the outside wall of the elbow does not change. All of these stresses are summarized in Table 5, and all are approaching magnitudes that would be consistent with failure of the elbow.

Figure 49. Tensile stresses in the gas pipes when subjected to 0.2 in/ft of shear in the fault creep direction but with varying soil moduli, 200 atm (top) and 1000 atm (bottom). Units are ksi.

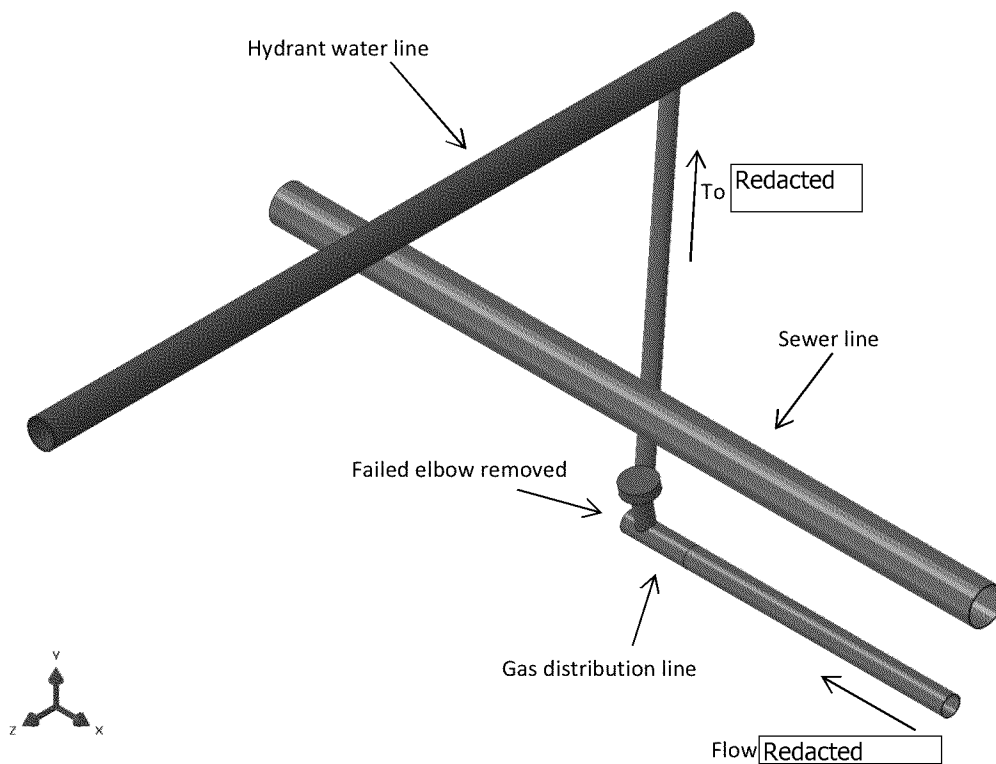
A finite element model was created to investigate the current stresses in the incident area following removal of the subject elbow and downstream piping. This new model is shown in Figure 51. The model was subjected to fault-creep shear of 0.2 in/ft consistent with the shear modeled in the subject elbow analysis. Tensile stresses in the repaired gas line near the location of the fractured elbow are shown in Figure 52; the stresses are reduced as compared with the stresses in the original configuration before the incident (upper image of Figure 50). Local stresses in the vicinity of the flange tee were predicted to be near 30 ksi. Thus, even after the removal of the subject elbow and associated downstream piping, stresses at the junction between the [Redacted] piping could be as high as 30 ksi.

As in the earlier models, the stresses in the tee are highly dependent on the constraint of the [Redacted] pipe. The excavation likely allowed local displacement and relief of some bending and compressive stresses at the [Redacted] junction, but the rotational-induced stresses from fault-creep shear likely remains, consistent with the image shown in Figure 52. These stresses will increase with further creep of the Hayward fault at this location.

Figure 51. Post-repair model.

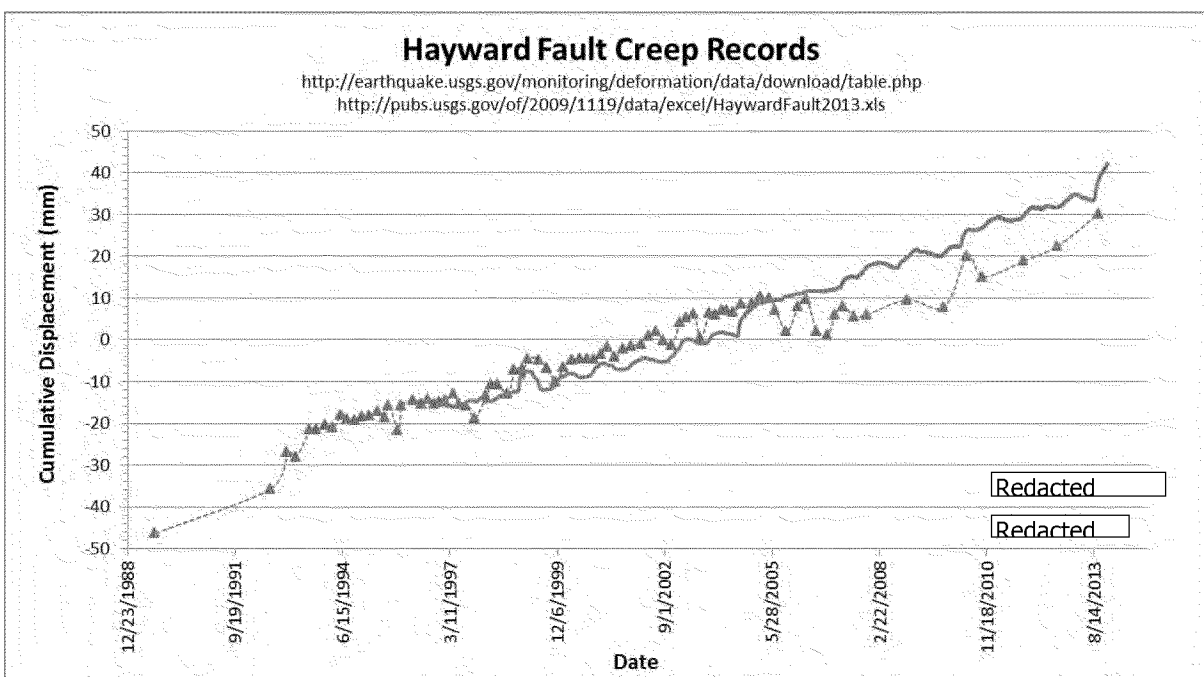
Figure D-3. Hayward Fault creep records in the vicinity of [Redacted] (for available record interval). [Redacted]

As previously noted, at the [Redacted] Station a total displacement of over 76 mm has been measured since 1989, for an average creep rate of 3.2 mm/yr. At the [Redacted] Station a total displacement of over 57 mm has been measured since 1996, for an average creep rate of 3.3 mm/yr.

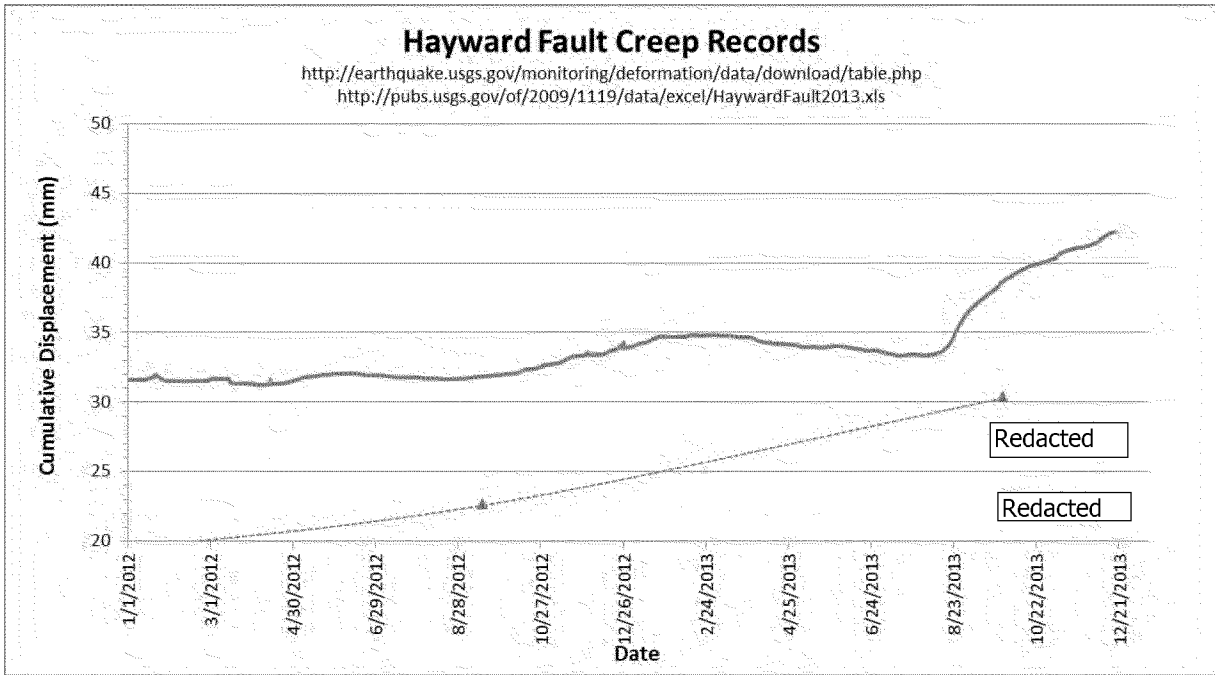
Figure D-4 shows the 2012 and 2013 portion of the data presented in Figure D-3. The figure shows an acceleration of creep movement measured at the [Redacted] station starting in approximately August 2013. The timing of the gas release event may be related to this acceleration of creep movement.

Figure D-4. Hayward Fault creep records in the vicinity of [Redacted] (for 2012 and 2013). [Redacted]
