Re: Update - Oakland Incident of December 10, 2013

This letter is to provide an update on the incident that occurred on December 10, 2013, near [Redacted] and [Redacted] in Oakland. PG&E provided the first update regarding this incident on December 20, 2013. PG&E is now providing a second update to summarize Exponent, Inc.'s final report findings and analysis of the incident, as well as PG&E's next steps. The report, "[Redacted] (Oakland) Incident Analysis," includes an Executive Summary and is provided as an attachment to this letter.

*Failure Analysis Associates*

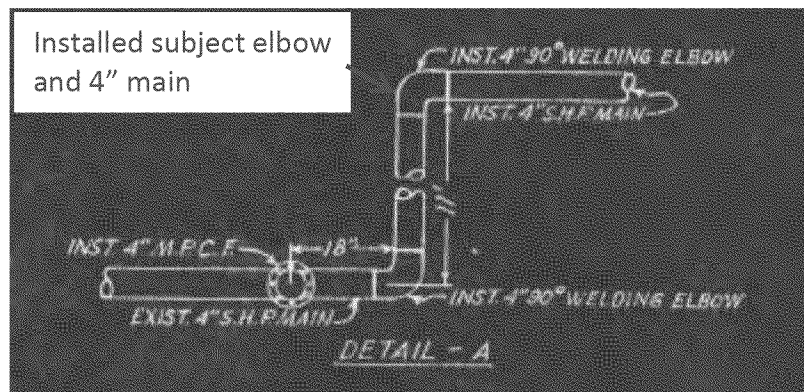
Figure 7. Cropped view of as-built construction drawing for job G.M.G. 82435 (1946) showing area of leak.

- G.M.G. 82435 (1946) - Installed a 4-inch diameter steel main along [Redacted]. This main included two 4-inch steel weld elbows at the location of the leak. One of these weld elbows installed in 1946 failed on December 10, 2013. An as-built construction drawing from G.M.G. 82435 is shown in Figure 6 and Figure 7. The

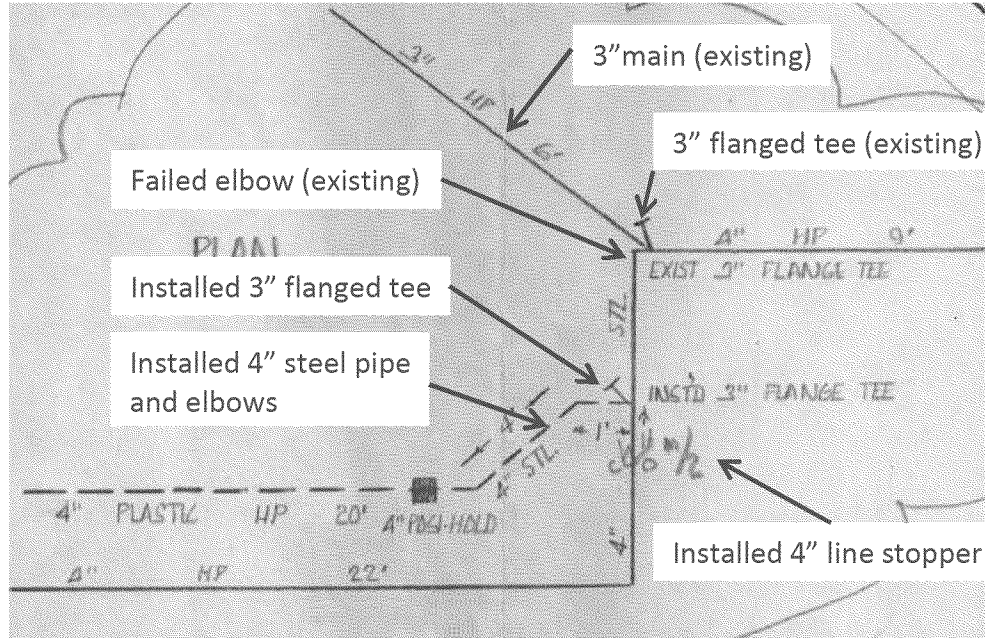
Figure 11. Cropped view of as-built construction drawing for G.M. 4564829 (1987) showing area of leak.

- G.M. 4564829 (1987) - Installed a 4-inch diameter plastic distribution main along Golf Links Road starting near the leak site and extending northwest. This main was installed to replace an existing 4-inch steel main. During this job, a piece of 4-inch pipe that was installed in 1946 in the immediate vicinity of the gas release was cut and capped. The 4-inch plastic distribution main was installed with a steel-to-plastic transition, two elbows, and approximately four feet of steel pipe that connected to the existing 1946 4-inch steel main using a 3-inch flanged tee. An as-built construction drawing for G.M. 4564829 is shown in Figure 10 and Figure 11. The pipeline features and locations shown in this drawing were consistent with the features in the ground.

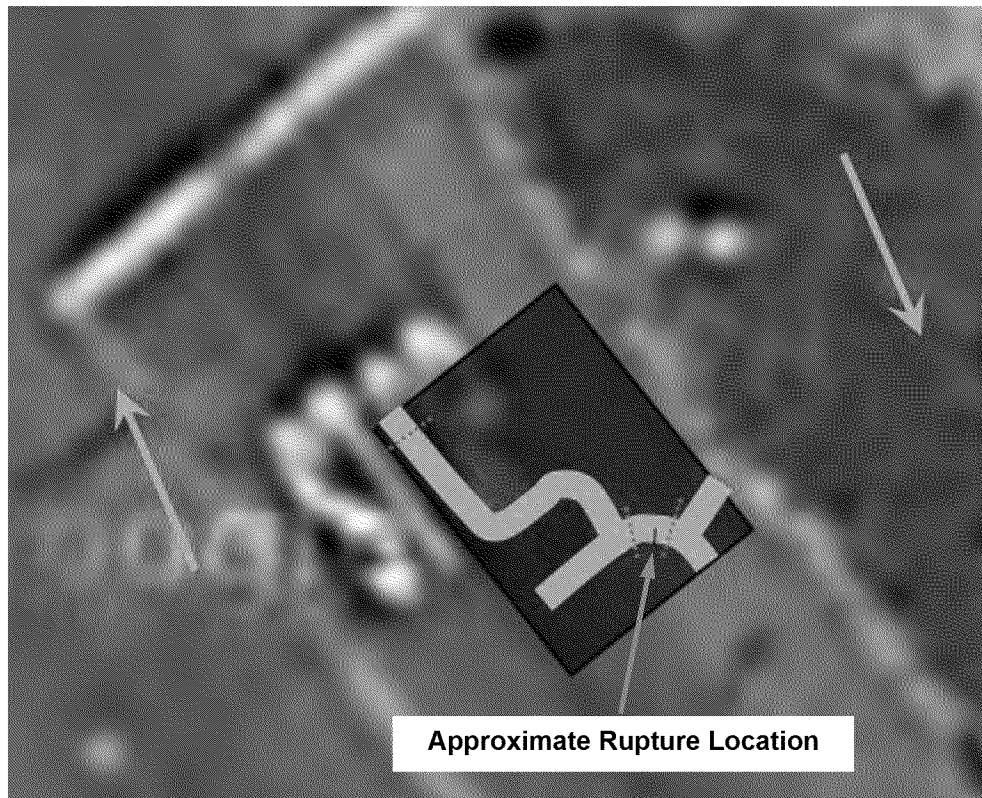
Figure 30. Plan view of pipe system exposed during repairs. Arrows indicate approximate direction of right-lateral movement of Hayward Fault in the vicinity of the Site. Photograph source: Google maps.

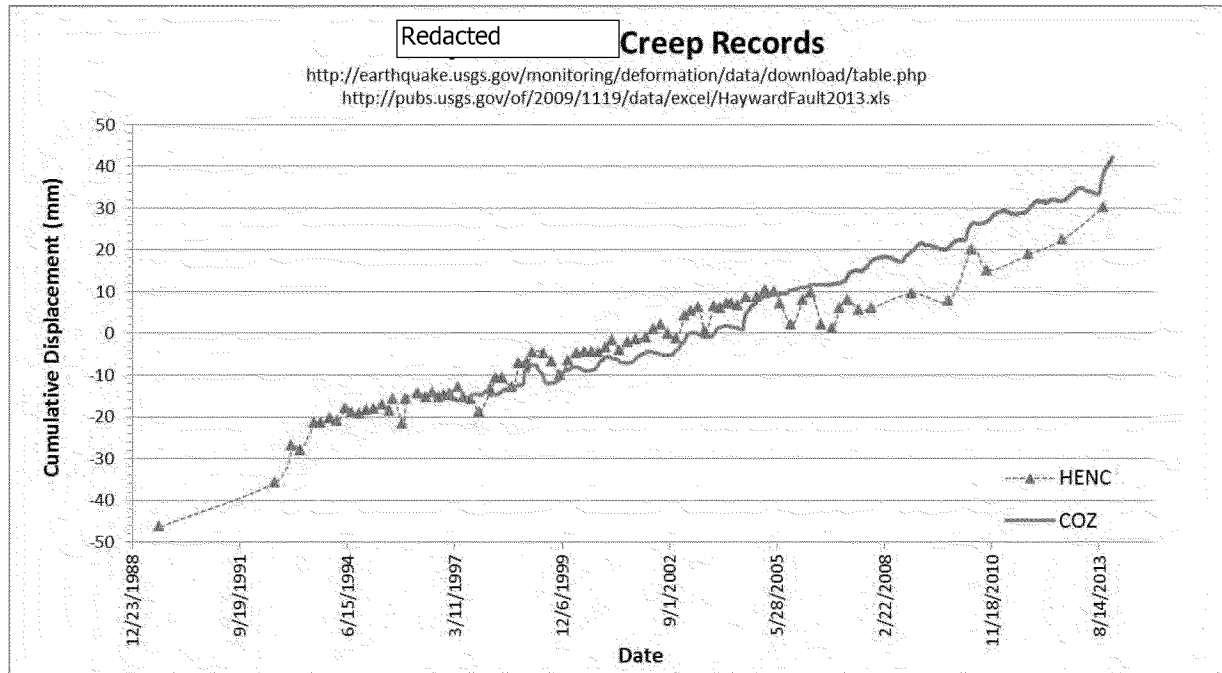
For the [Redacted] (HENC), McFarland et al. (2009, revised 2013)<sup>11</sup> published creep data that have been recorded since 1989. For the [Redacted] (COZ), the USGS published creep data that have been recorded since 1996. Figure 34 shows the available data for these two stations. As shown in this figure, at the Encina Way Station a total displacement of

over 76 mm has been measured since 1989, for an average creep rate of 3.2 mm/yr. At the [Redacted] a total displacement of over 57 mm has been measured since 1996, for an average creep rate of 3.3 mm/yr. The figure shows an acceleration of creep movement measured at the Oakland Zoo Station starting in approximately August 2013. The timing of the gas release event may be related to this acceleration of creep movement. Additional creep data information is included in Appendix D.

Figure 34. Hayward Fault creep records in the vicinity of Golf Links Road (for available record interval). HENC = Encina Way Station. COZ = Oakland Zoo Station.

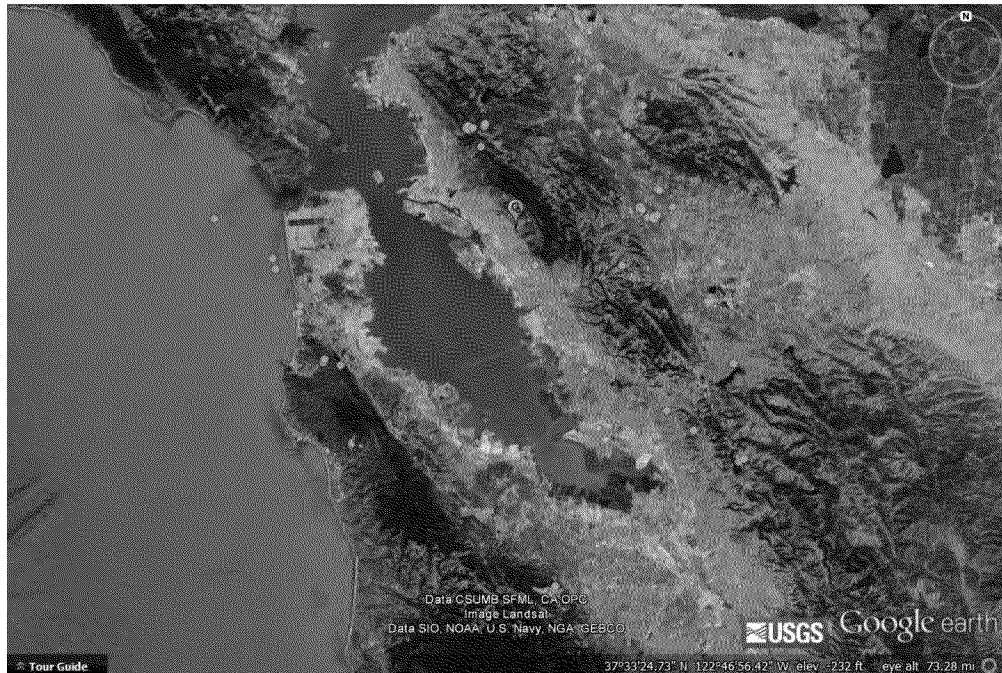
Figure 35 shows the recorded seismic events that occurred in the vicinity of the Site between August 1, 2013 and December 10, 2013. No significant events were recorded within a 50 km radius from the Site.<sup>12</sup> The closest event to the Site was a magnitude 2.0 earthquake approximately 3.5 miles southeast of the Site. The largest event was a magnitude 3.3 earthquake more than 10 miles east of the Site. Ground motions from these events did not cause significant loading of the pipe system at the Site.

Figure 35. Earthquakes within a 50-km radius from Site, and magnitude greater than 2.0, recorded between August 1, 2013 and December 10, 2013. Source: USGS: <http://earthquake.usgs.gov/earthquakes/map/>

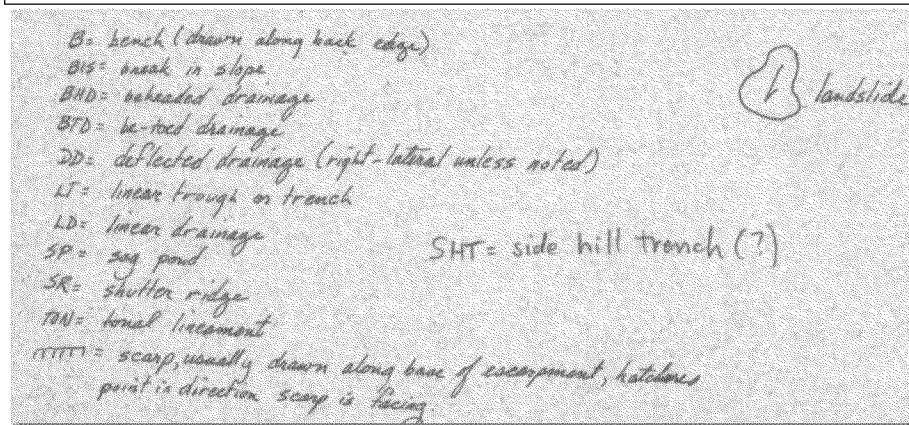
Exponent assessed the likelihood of landslide movement causing external forces on the pipe at the Site. As shown in Figure 36, the Site is located on the edge of a large ancient landslide. Exponent observed evidence of this landslide on topographic maps, aerial photographs, and in the field. In addition, a steep slope below Redacted is potentially susceptible to landsliding.

Figure 36. Map showing geomorphic and tonal features along recently active traces of the Redacted Based on 1939 (pre-development) aerial photographs. Source: California Division of Mines and Geology (now California Geological Survey), 1980, Fault Evaluation Report FER-102, Redacted (Oakland segment), Figure 4. Geomorphic and tonal features along recently-active traces of the Hayward fault, scale 1:24,000.

The large landslide occurred long before development of the neighborhood. Its boundary in the immediate vicinity of the Site is based on maps made by interpretation of aerial photographs taken in 1939.<sup>13</sup> Subsequent grading for construction of [Redacted] included excavation of a portion of the landslide mass northwest of the Site, changing the loads acting on the Site slope, likely reducing the potential for sliding at the Site.<sup>14</sup>

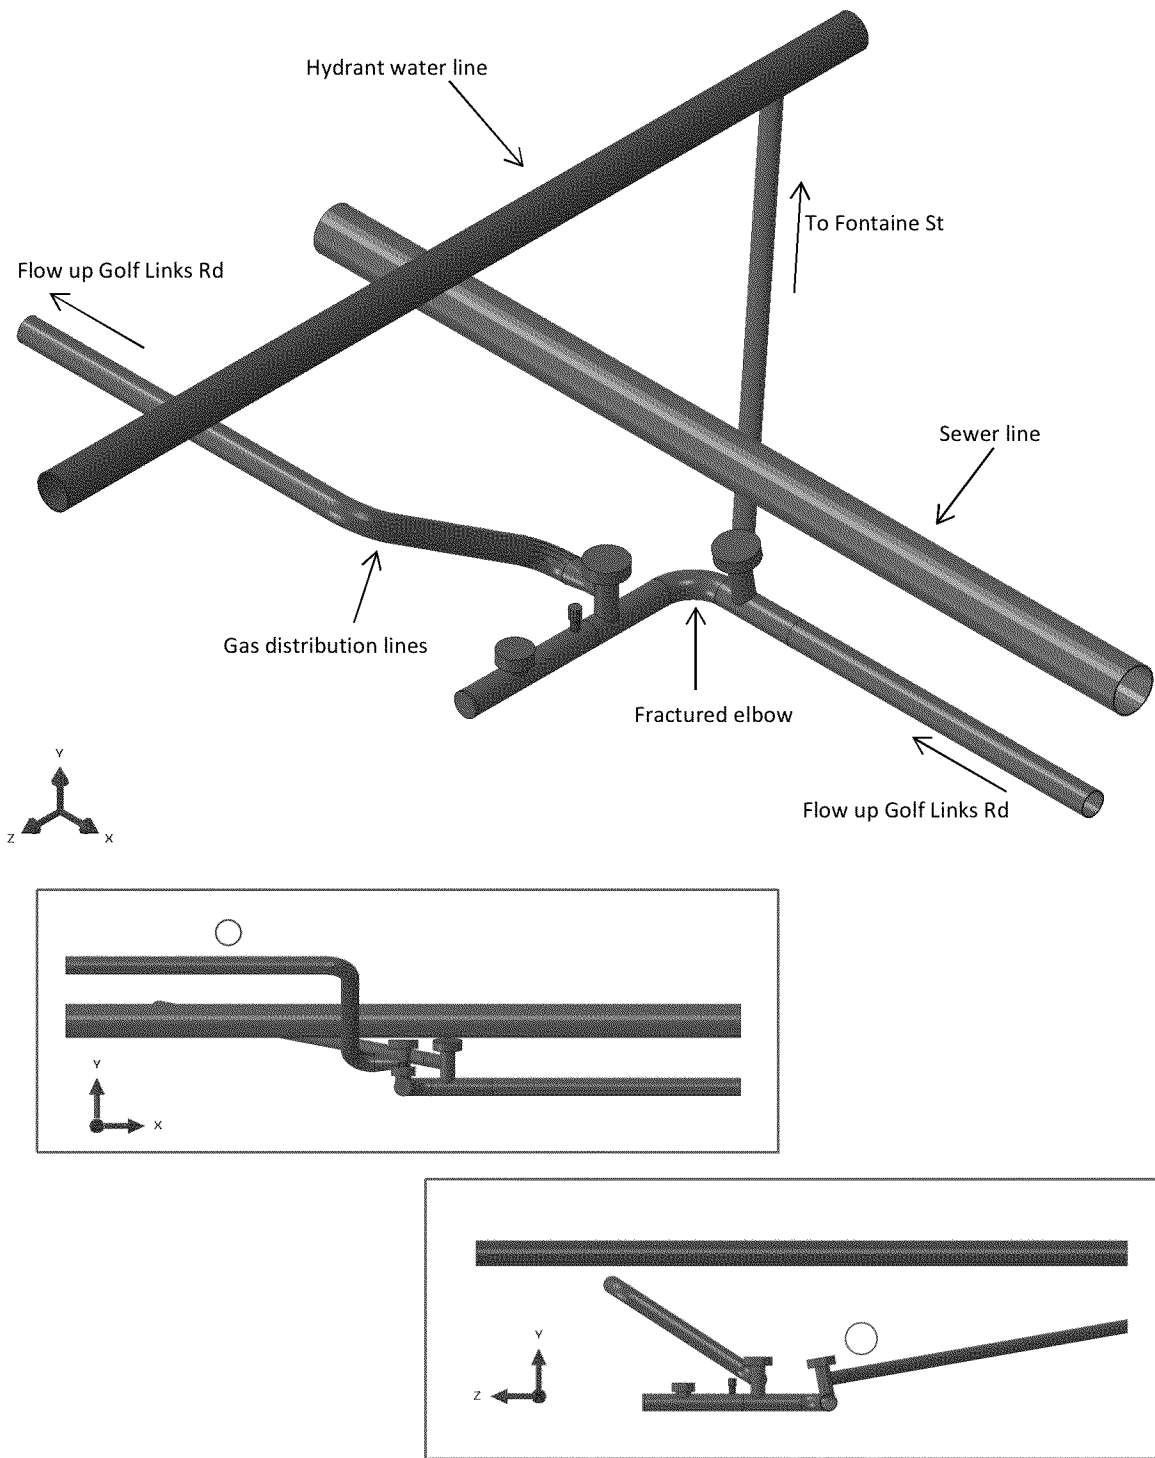
The Abaqus finite element software package was utilized to create a finite element model of the region near the incident to investigate loading scenarios that might have contributed to the subject elbow fracture. The region modeled is shown in Figure 37. Lines from three different utilities were included in the model: a network of gas distribution lines, a sewer line, and a hydrant water line. Surrounding soil was also included in the model, but is not shown in the figure.

The model encompasses a region that is 14 feet by 14 feet, 12 feet deep, and centered near the fractured elbow. The geometry of the gas piping shown to the left of the elbow in the figure was created from measurements of the pieces extracted after the repair. The tee to the right of the elbow was assumed to be identical to the one on the left (i.e. the one extracted after the repair). The gas lines traveling towards Fontaine Street and up and down Golf Links Road were assumed to have nominal dimensions (three and four-inches respectively). The hydrant water line was assumed to be a six-inch Schedule 40 steel pipe filled with water. The sewer line was assumed to be an empty eight-inch PVC pipe. The gas lines were assumed to be pressurized to 54 psig.

Figure 37. Network of pipes included in the finite element analysis. Surrounding soil was also included, but is not shown in the figure. The model encompasses a region that is 14 feet by 14 feet, 12 feet deep, and centered near the fractured elbow.

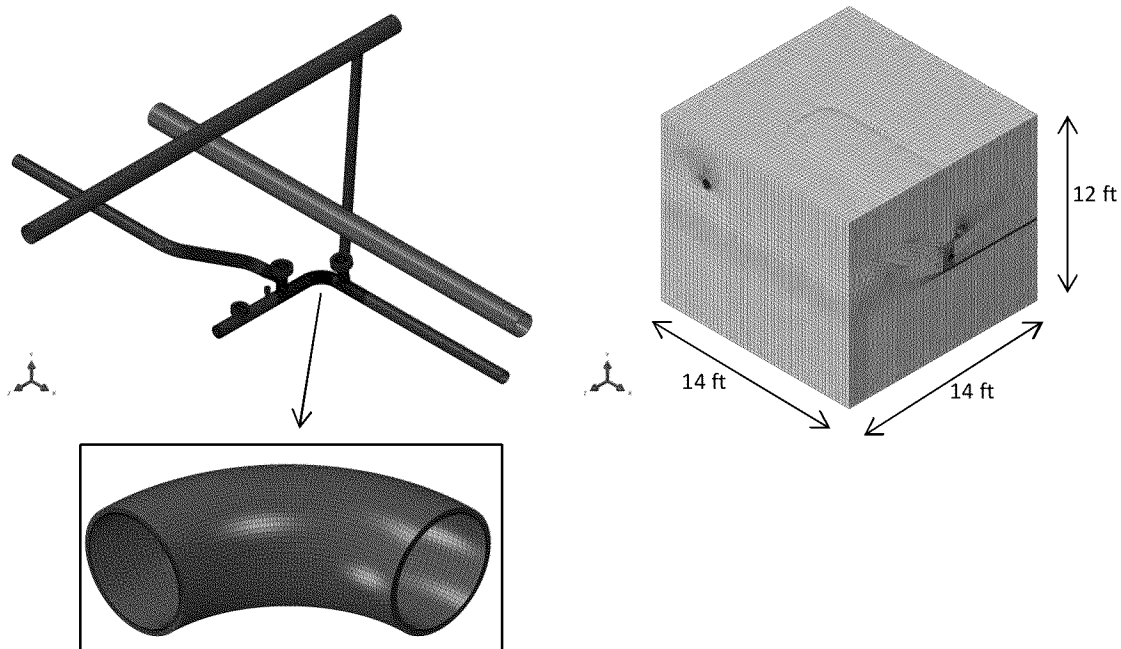
The finite element mesh used for the soil and pipes is shown in Figure 38. The subject elbow, the immediately adjacent pipes, the flange tees, and the soil were modeled with 3D hexahedral elements. The remaining gas pipes, the hydrant line, and the sewer line were all modeled with 3D continuum shell elements to reduce the numerical complexity. Approximately 560,000 elements were utilized in the model.

Figure 38. Mesh used in the finite element analysis. The failed elbow is shown in the lower left. The soil is shown in the upper right.

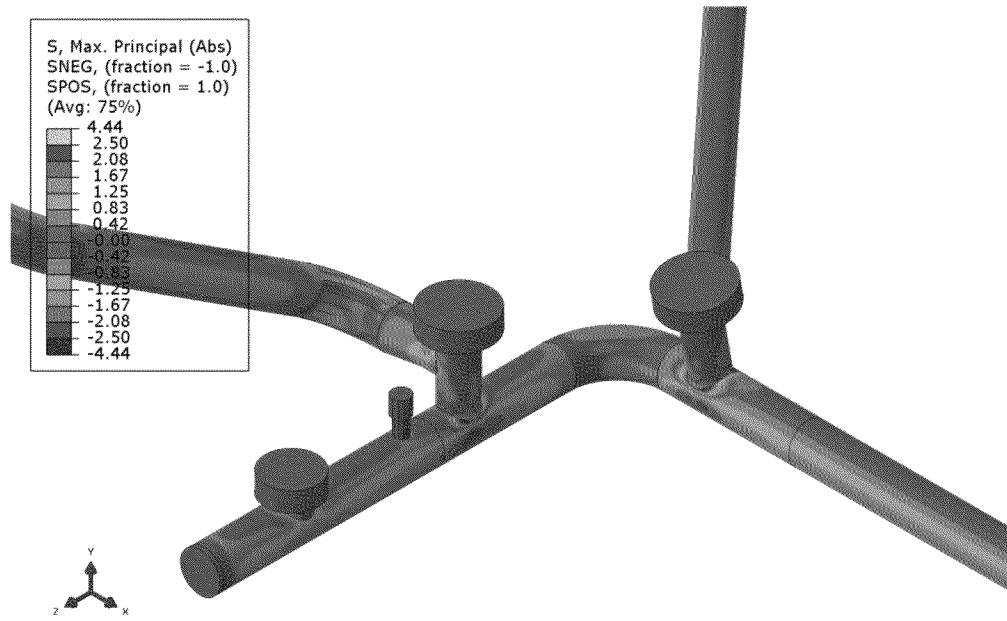
The first step of the model consists of applying gravity loading. The soil base was fixed in the vertical direction, and the four walls of the soil were fixed in the normal directions. The utility lines that intersect the model boundaries were constrained only by the surrounding soil and not by additional boundary conditions, so they may slide in or out of the soil walls. The top surface of the soil was coincident with the ground surface, so no loads or boundary conditions were applied to it. A uniform gravity load of 386 in/s<sup>2</sup> was applied to all elements, and the model was allowed to achieve geostatic equilibrium. The resulting tensile stresses in the pipe network and the incident elbow are shown in Figure 39 and Figure 40, respectively. Stresses were calculated to be less than 2 ksi for most of the network, with small localized regions as high as 4.4 ksi. The largest tensile stresses in the elbow were approximately 1.4 ksi; roughly one-fiftieth of the measured elbow tensile strength.

Figure 39. Tensile stresses in the pipe network subjected to gravitational loading. Units are ksi.

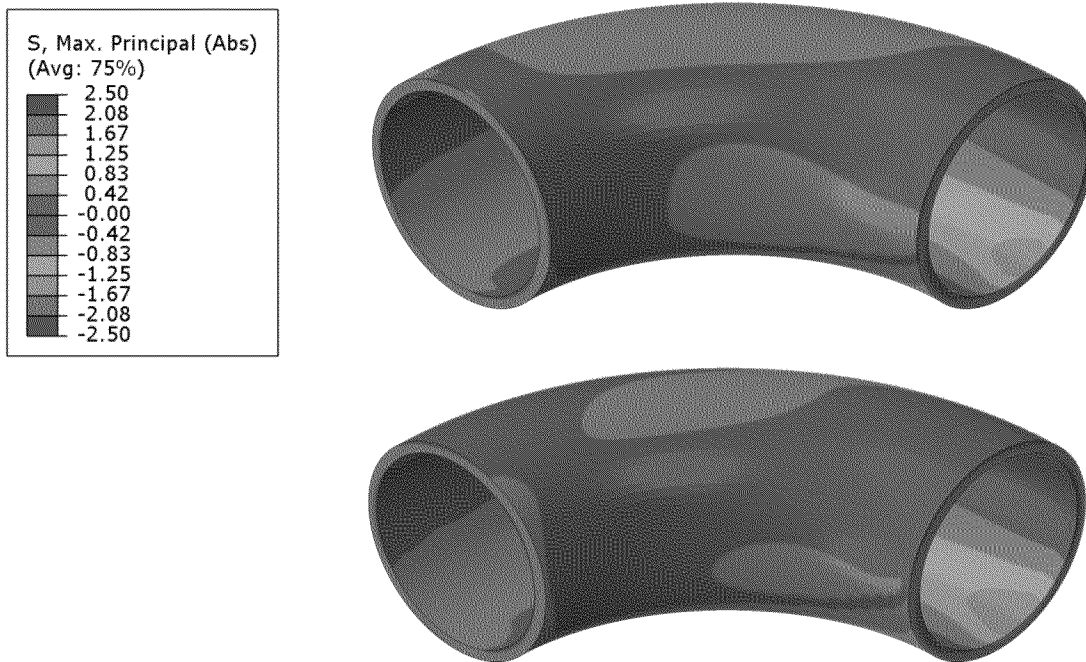
One uncertainty in the model geometry was the vertical distance between the water line and the gas line and the support condition beneath the water line near the gas line. It is possible that the water line was resting directly on the gas line and was not fully supported by soil in this vicinity. To determine the sensitivity of the stresses in the subject elbow to the water line support condition, a second model was built such that six feet of the water line in the vicinity of the gas line was unsupported by soil. For this condition, a larger load from the water line is transferred directly to the gas line. The tensile stresses calculated in the incident elbow are shown in the lower half of Figure 40; the largest tensile stresses were approximately 1.5 ksi, which was only slightly larger than the nominal condition and not large enough to cause failure. Thus, the support condition of the water line in the vicinity of the gas line was determined to have a negligible contribution to the failure.

Figure 40. Tensile stresses in the incident elbow subjected to gravitational loading with nominal water pipe support (top) and 6 ft unsupported water pipe (below). Units are ksi.

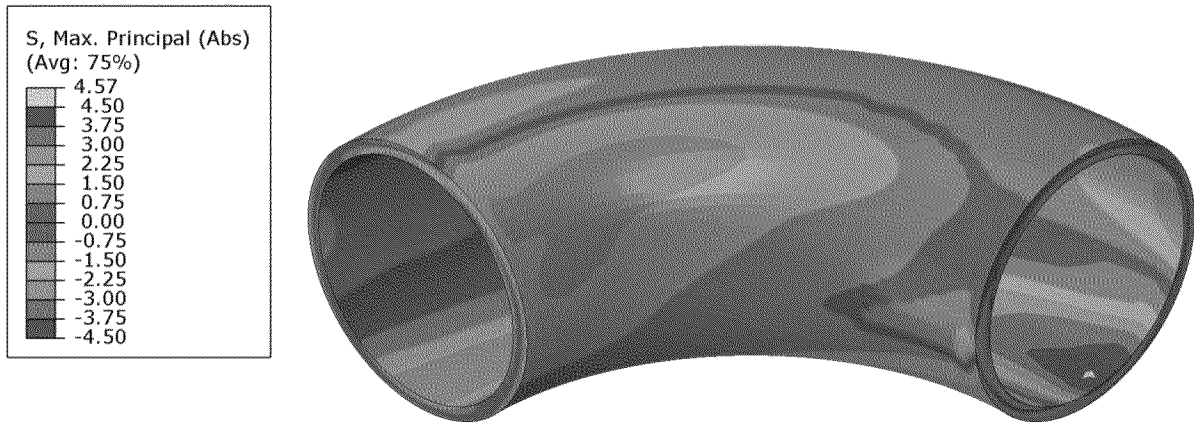
In order to determine the sensitivity of the elbow stresses to loading from heavy equipment on the road-surface, a load of 80,000 lbf was applied to the surface of the soil directly above the incident elbow in a patch of approximately 9” by 10”. This is approximately equivalent to a tractor trailer loaded to the legal limit, but carrying that load on just one tire instead of distributing the load over many tires.<sup>17,18</sup> The resulting tensile stresses in the elbow are shown in Figure 41. The peak tensile stress is approximately 4.5 ksi and is located on the lower surface of the inside of the elbow. Tensile stresses near the failure location are approximately 2 ksi; this is not a sufficient amount of stress to cause failure.

Figure 41. Tensile stresses in the elbow when subjected to an 80,000 lbf truck load on the surface of the soil above the elbow.

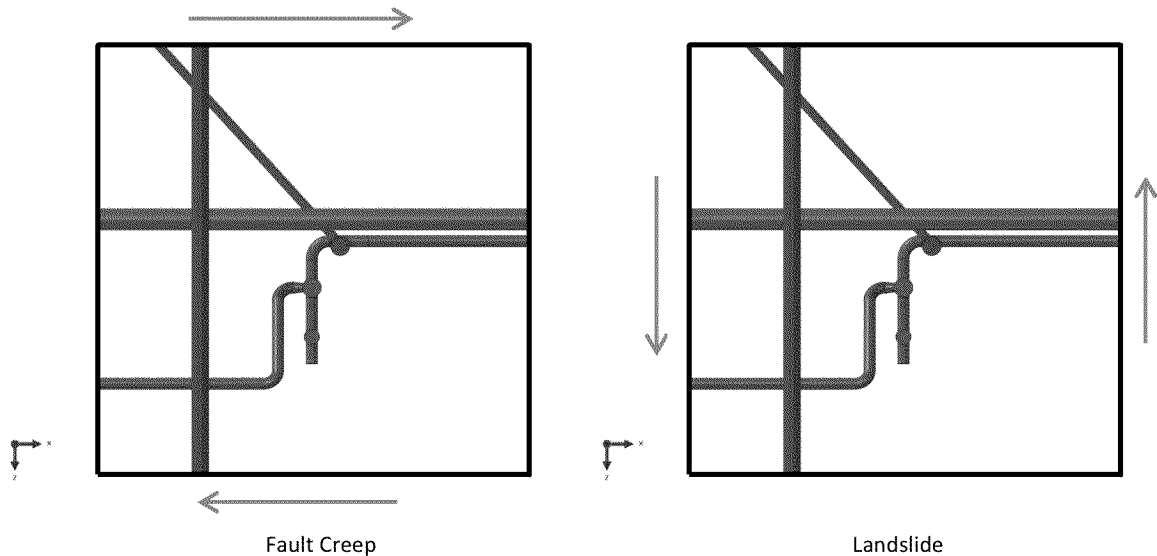
Because gravitational loading alone is not sufficient to achieve tensile stresses in the elbow that are consistent with the observed mode of failure, ground shearing movement was investigated as a possible source of stresses. After the model achieved equilibrium with gravitational loading, the soil was sheared in the horizontal plane to simulate ground movement associated with right-lateral strike-slip creep of the Hayward Fault or to simulate possible ground movement due to the ancient landslide. These two shearing directions are diagrammed in Figure 42. Two additional shearing directions were considered to investigate the sensitivity of the fault shearing direction; these directions were rotated  $\pm 10^\circ$  from the fault creep nominal condition shown in Figure 42.

Figure 42. The two primary ground movement shearing directions considered in the finite element model. The left image shows the shearing consistent with right-lateral strike-slip creep of the [Redacted], and the right image shows the shearing consistent with ground movement due to a nearby landslide.

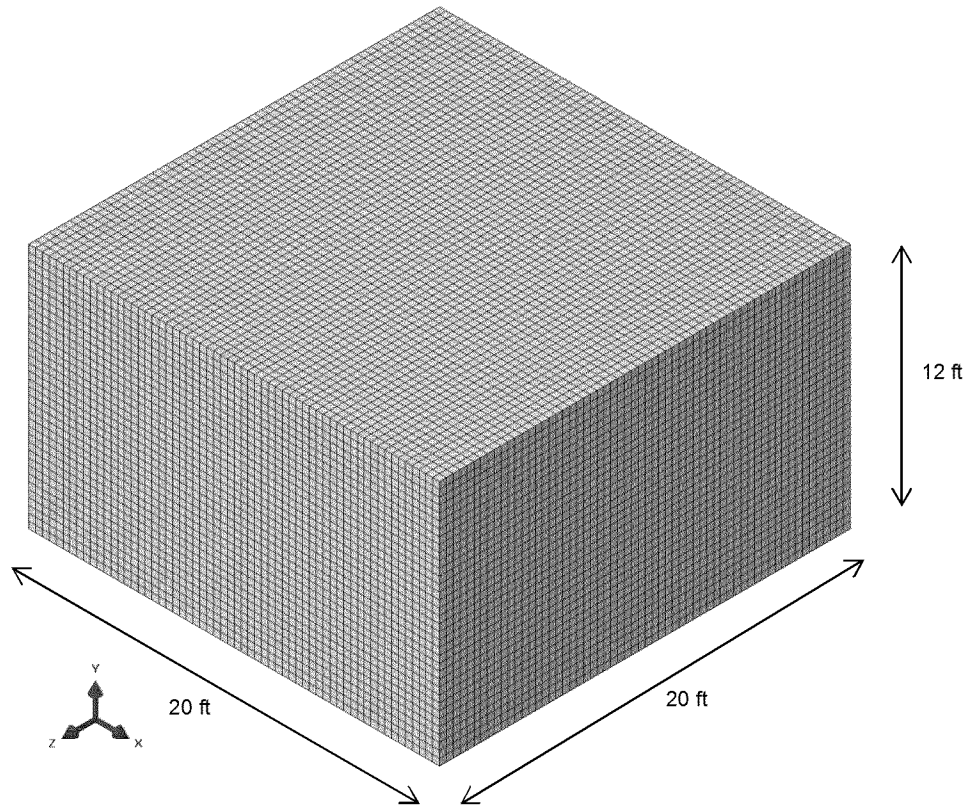
To allow for arbitrary shearing directions that might not correlate with the walls of the model (e.g. the perturbation directions for the fault creep), the shearing of the soil boundaries was achieved by using a global model / submodel configuration. The global model was a simple block of soil slightly larger than the model which contains the pipe network (this detailed model with the pipes is now referred to as the submodel). The global model is shown in Figure 43. The model was meshed with approximately 130,000 3D hexahedral elements. The global model can be easily rotated and sheared in a desired direction, and the soil walls of the submodel will then follow the resulting displacements from the global model without any modifications to the submodel geometry or mesh. This is demonstrated schematically for the fault-creep condition in Figure 44. For all models, four inches of shear was applied to the 20 foot-wide global model, which results in a gradient of 0.2 inch per foot of model width, or 2.8 inches (~71 mm) of shear for the 14-foot wide submodel; this applied shear is consistent with creep deformation data of the Hayward Fault in the vicinity of the site.<sup>19</sup>

Figure 43. Global model used to apply shearing boundary conditions.

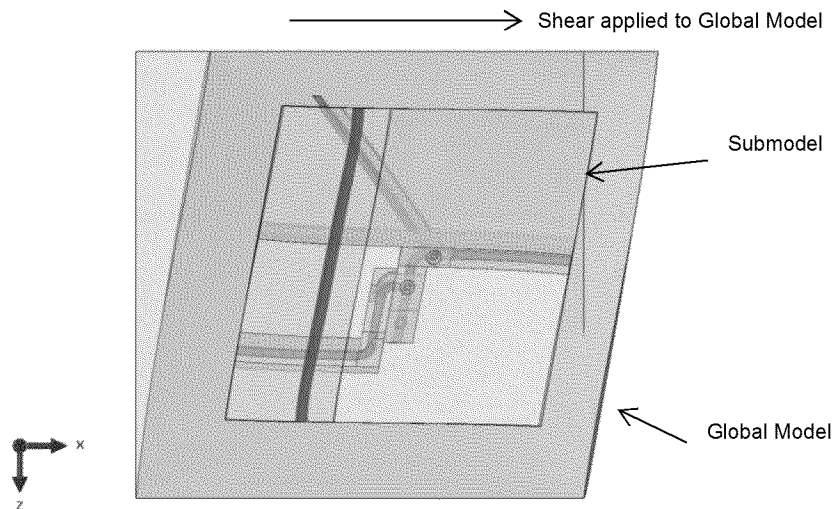
Figure 44. Schematic that demonstrates Global Model / Submodel relation. Actual shearing applied in model is about 10 times smaller than what is shown here.

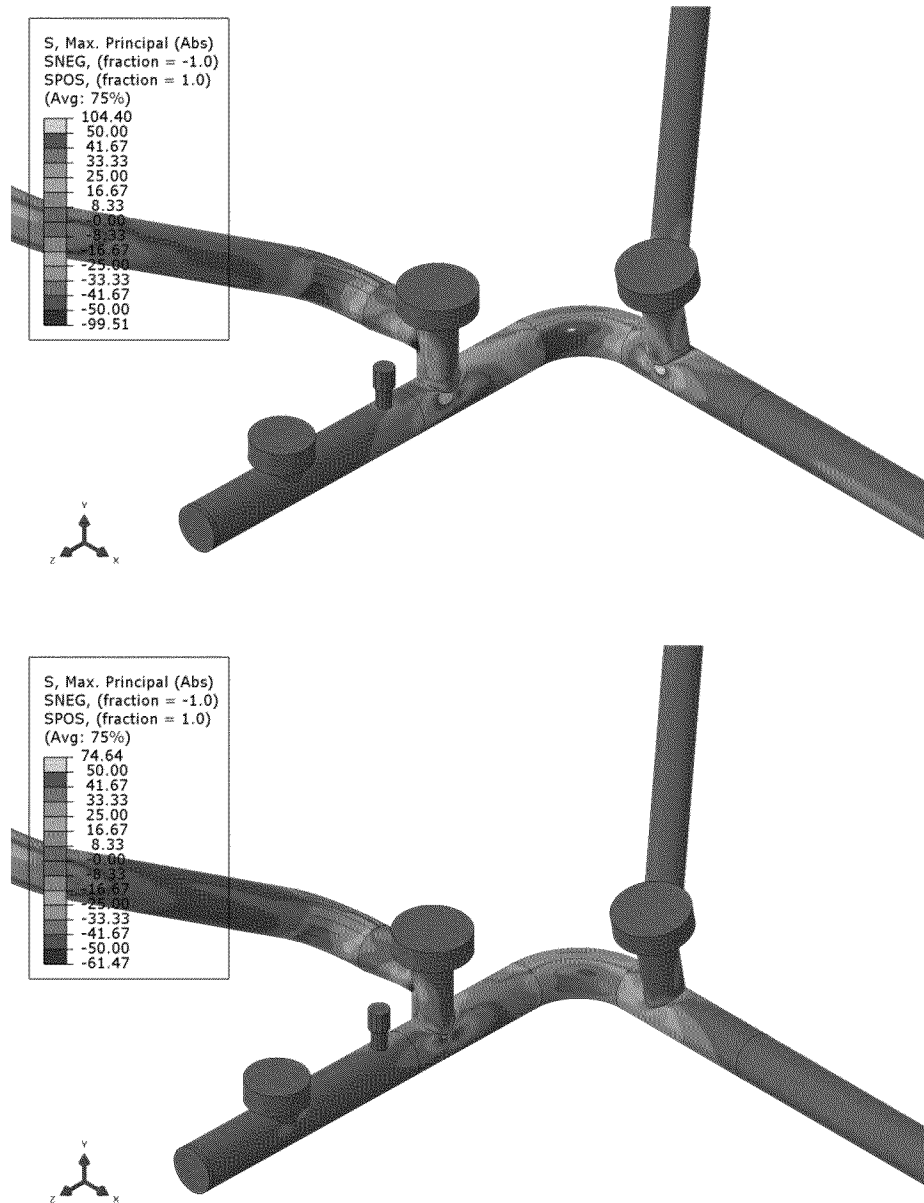
To further investigate the sensitivity to shearing direction on the peak tensile stress magnitude and location, the fault creep shearing direction was varied by  $\pm 10^\circ$ . Tensile stresses in the gas lines in the vicinity of the incident elbow are shown in Figure 48. The peak tensile stresses on the outside wall of the elbow intrados were slightly higher for the  $+10^\circ$  shearing direction and lower for the  $-10^\circ$  direction (50.2 ksi and 42.7 ksi respectively) as compared with the nominal fault creep condition in Figure 46. The location of the peak stress also shifted along the axial position of the elbow.

Figure 48. Tensile stresses in the gas pipes when subjected to 0.2 in/ft of shear in the fault creep +10° direction (top) and the fault creep -10° direction (bottom). Rotation angles are with respect to the model's y-axis. Units are ksi.

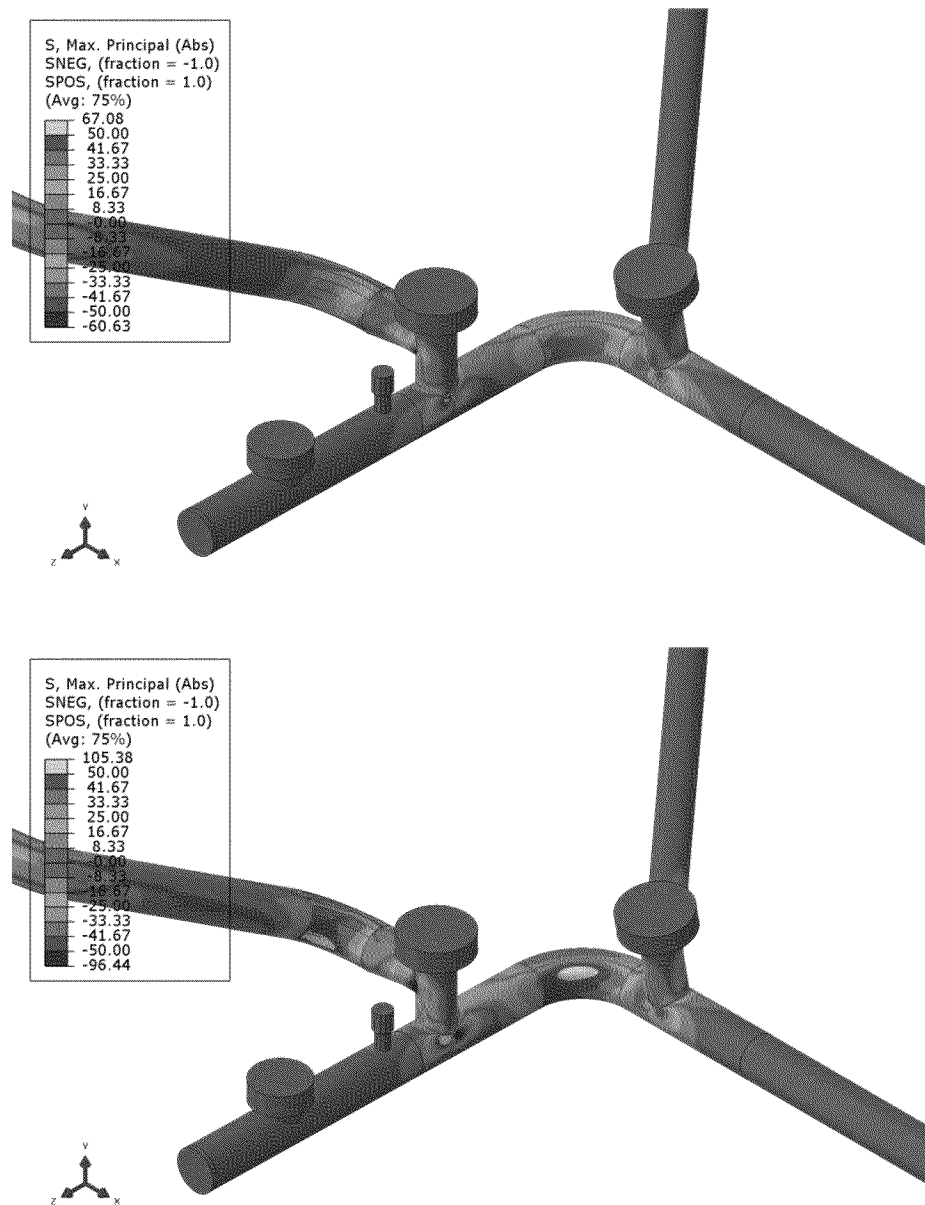
To investigate the sensitivity of soil modulus on the peak tensile stress magnitude, two other soil moduli were investigated, 200 atm and 1000 atm, as compared with the nominal value of 500 atm. Tensile stresses in the gas lines in the vicinity of the incident elbow are shown in Figure 49. The peak tensile stresses on the outside wall of the elbow intrados were 41.3 ksi and 55.2 ksi for the 200 atm and 1000 atm moduli soils, respectively. While the magnitude of stress varies for the different soil moduli, the location of the peak tensile stress on the outside wall of the elbow does not change. All of these stresses are summarized in Table 5, and all are approaching magnitudes that would be consistent with failure of the elbow.

Figure 49. Tensile stresses in the gas pipes when subjected to 0.2 in/ft of shear in the fault creep direction but with varying soil moduli, 200 atm (top) and 1000 atm (bottom). Units are ksi.

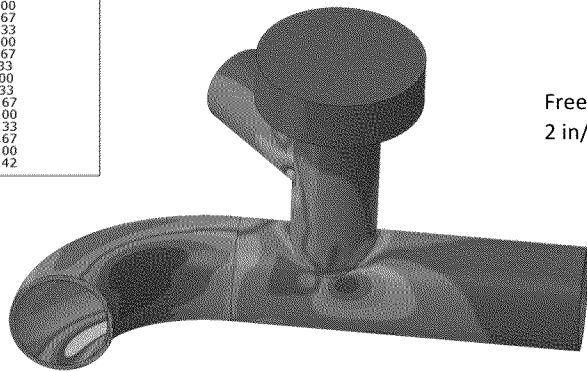
Free Boundary Condition  
2 in/ft fault creep shear

Fontaine pipe such that it cannot move axially and is forced into compression during the shearing, and a second model which provided a softer constraint that allowed the pipe to move only half the distance that it would if it were free to slide. The resulting tensile stresses in the region of the elbow and neighboring tee are shown in Figure 50. In all cases, the tensile stresses are near the magnitude to cause failure.

Figure 50. Tensile stresses in the incident elbow and neighboring tee for different boundary conditions on the Fontaine Street pipe. Note that the models have decreasing amount of shear despite increasing stresses. Units are ksi.

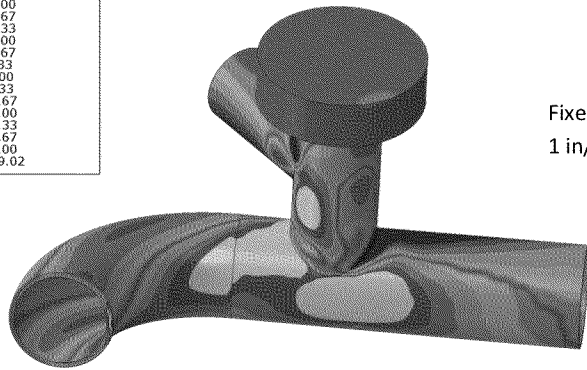
Fixed Boundary Condition  
1 in/ft fault creep shear

A summary of the peak tensile stress on the outside and inside walls of the elbow for the three boundary condition cases is presented in Table 6. It is important to note that decreasing levels of shear were applied to the models as the constraint was increased. The reduction in ground movement shearing reduces the stresses on the inside wall of the elbow. If the constraint on the end of the Fontaine Street pipe were unchanged, then we would also expect the stress on the outside wall to be reduced in a constant ratio. However, the constraint on the end of the Fontaine pipe causes the stress on the outside of the elbow (as well as the neighboring tee) to increase, and therefore causes the peak tensile stress location to switch from the lower inside surface to the outside surface of the elbow intrados. The fully constrained condition is unrealistic and causes very high stresses in the tee; the true constraint condition is likely somewhere between the two extremes of free and fixed.

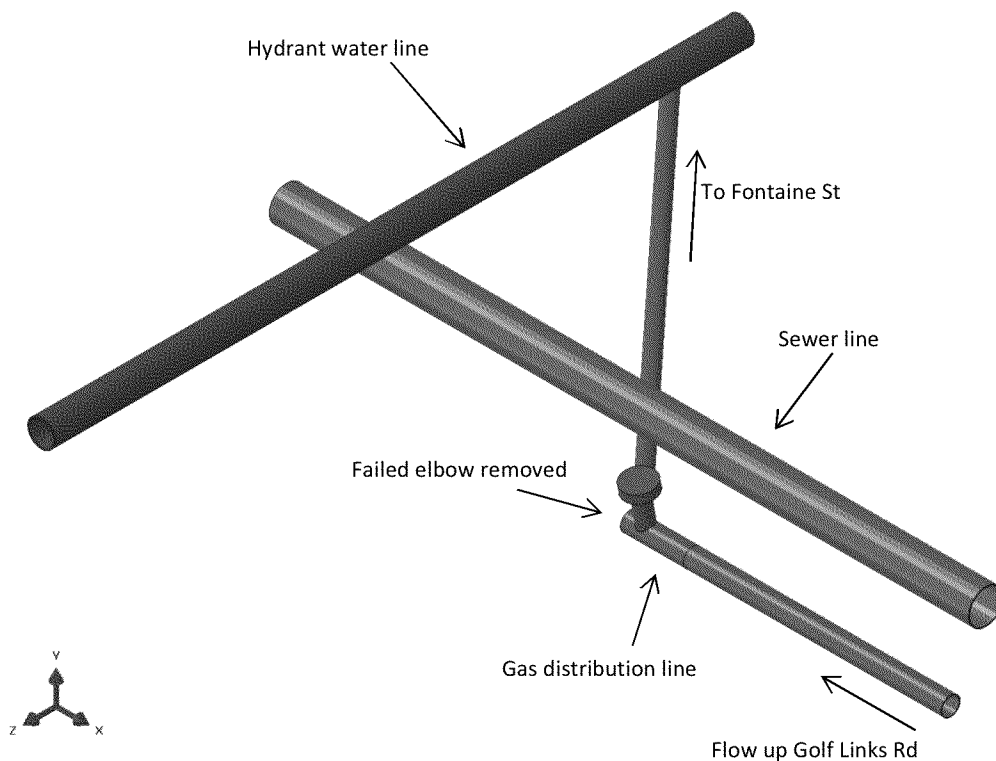
Figure 51. Post-repair model.

A finite element model was created to investigate the current stresses in the incident area following removal of the subject elbow and downstream piping. This new model is shown in Figure 51. The model was subjected to fault-creep shear of 0.2 in/ft consistent with the shear modeled in the subject elbow analysis. Tensile stresses in the repaired gas line near the location of the fractured elbow are shown in Figure 52; the stresses are reduced as compared with the stresses in the original configuration before the incident (upper image of Figure 50). Local stresses in the vicinity of the flange tee were predicted to be near 30 ksi. Thus, even after the removal of the subject elbow and associated downstream piping, stresses at the junction between the Golf Links Road and Fontaine Street piping could be as high as 30 ksi.

As in the earlier models, the stresses in the tee are highly dependent on the constraint of the Fontaine Street pipe. The excavation likely allowed local displacement and relief of some bending and compressive stresses at the Golf Links Road and Fontaine Street junction, but the rotational-induced stresses from fault-creep shear likely remains, consistent with the image shown in Figure 52. These stresses will increase with further creep of the Hayward fault at this location.

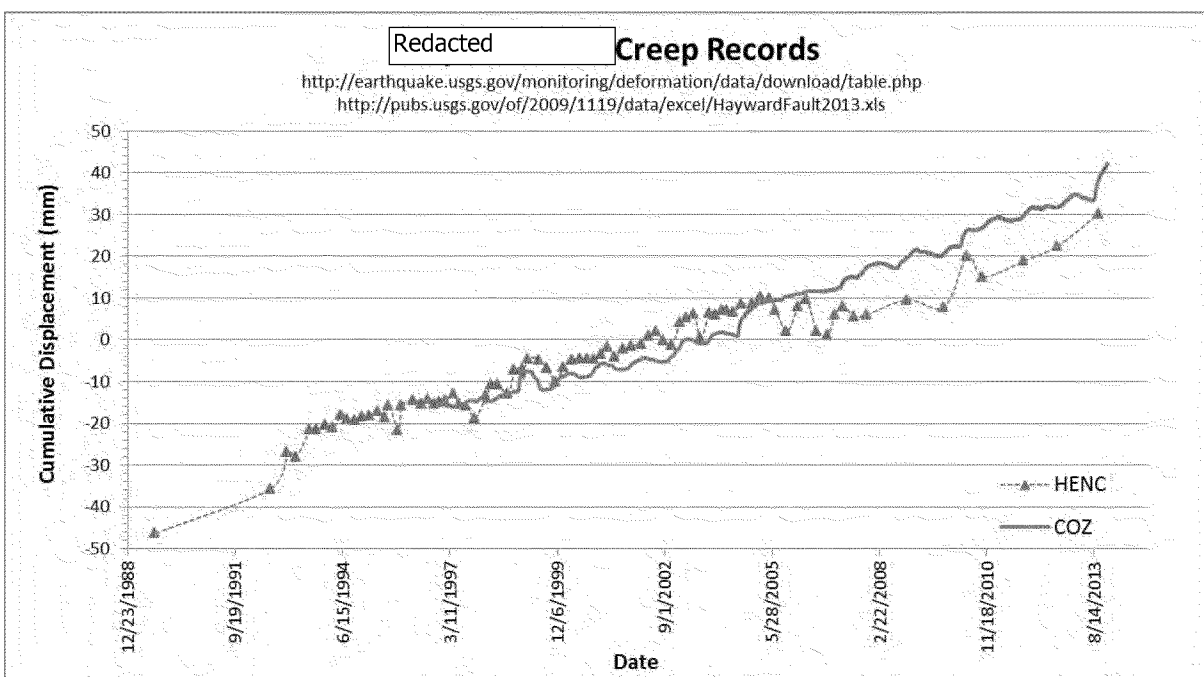
For the [Redacted] (HENC), McFarland et al. (2009, revised 2013)<sup>31</sup> published creep data that have been recorded since 1989. For the [Redacted] (COZ), the USGS published creep data that have been recorded since 1996. Figure D-3 shows the available data for these two stations.

Figure D-3. [Redacted] creep records in the vicinity of [Redacted] (or available record interval). HENC = [Redacted]. COZ = [Redacted]

As previously noted, at the Encina Way Station a total displacement of over 76 mm has been measured since 1989, for an average creep rate of 3.2 mm/yr. At the Oakland Zoo Station a total displacement of over 57 mm has been measured since 1996, for an average creep rate of 3.3 mm/yr.

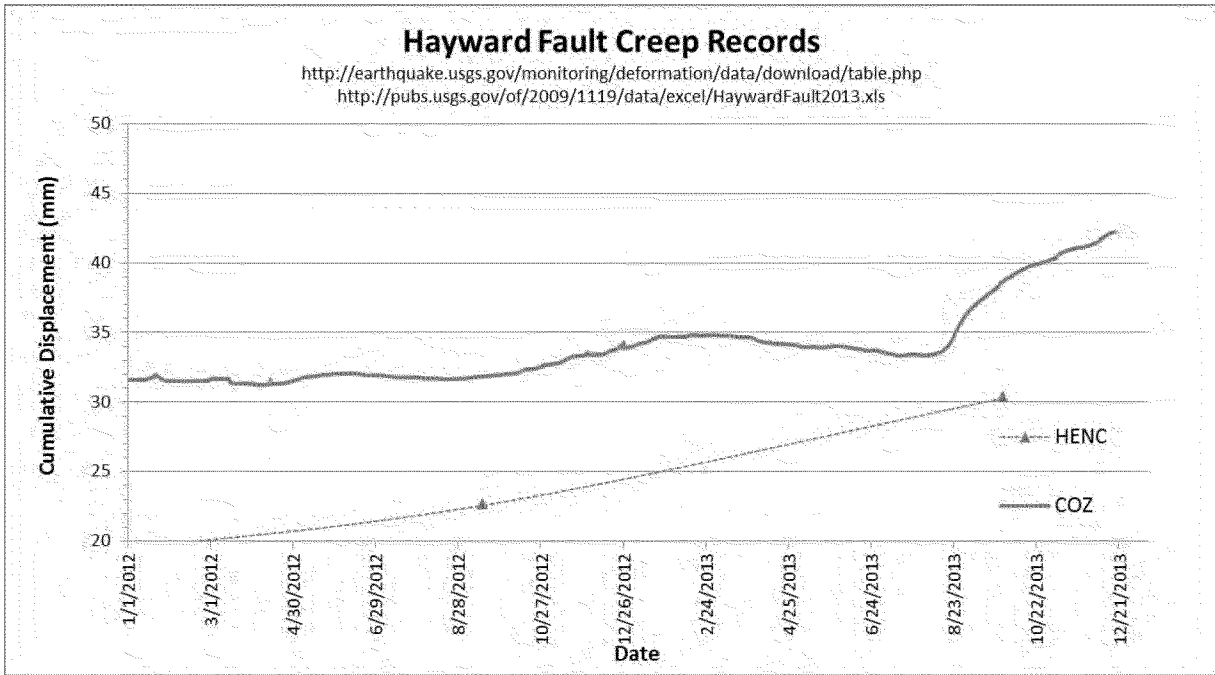
Figure D-4 shows the 2012 and 2013 portion of the data presented in Figure D-3. The figure shows an acceleration of creep movement measured at the Oakland Zoo Station starting in approximately August 2013. The timing of the gas release event may be related to this acceleration of creep movement.

Figure D-4. [Redacted] creep records in the vicinity of [Redacted] (for 2012 and 2013). HENC = [Redacted], COZ = [Redacted]
