**Golf Links Road (Oakland)
Incident Analysis**

Sumeet Singh
Pacific Gas and Electric Company
6111 Bollinger Canyon Road
San Ramon, CA 94583

January 2014
Revised January 20, 2014

Doc. no. 1308766.000 - 3956

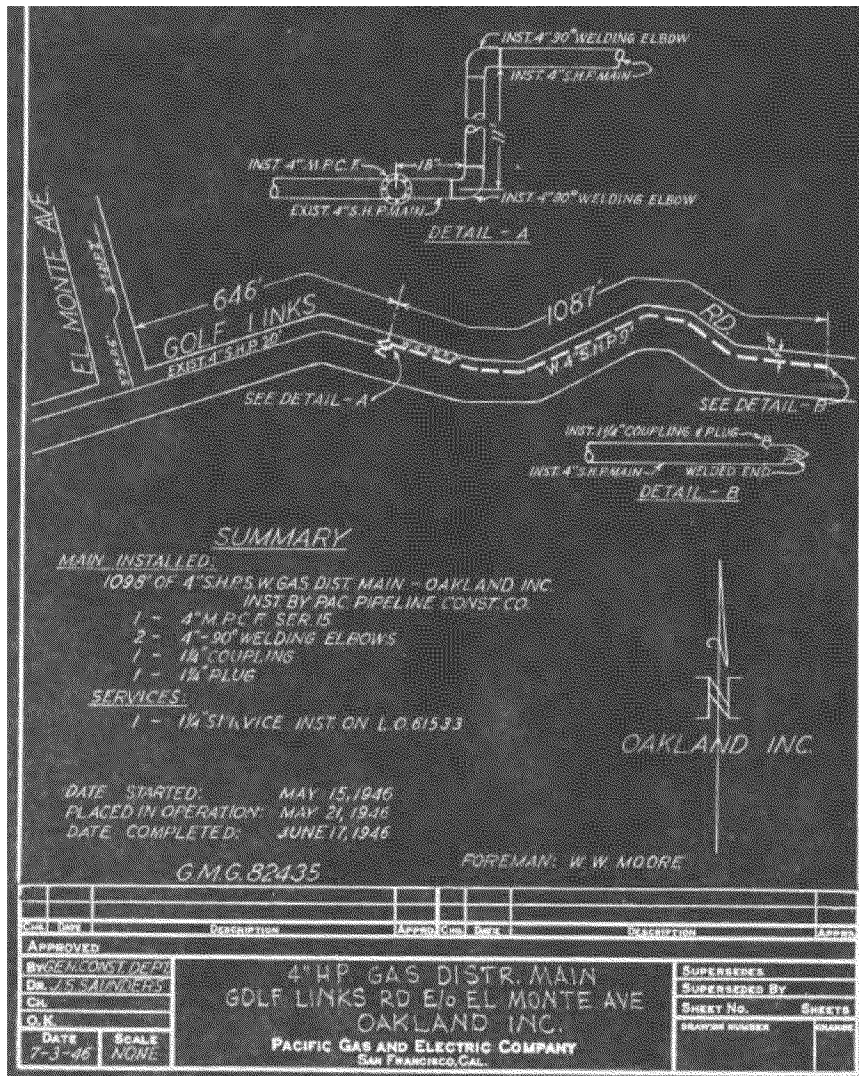
- G.M.G. 82435 (1946) - Installed a 4-inch diameter steel main along Golf Links Road. This main included two 4-inch steel weld elbows at the location of the leak. One of these weld elbows installed in 1946 failed on December 10, 2013. An as-built construction drawing from G.M.G. 82435 is shown in Figure 6 and Figure 7. The

Figure 6. As-built construction drawing for job G.M.G. 82435 (1946).

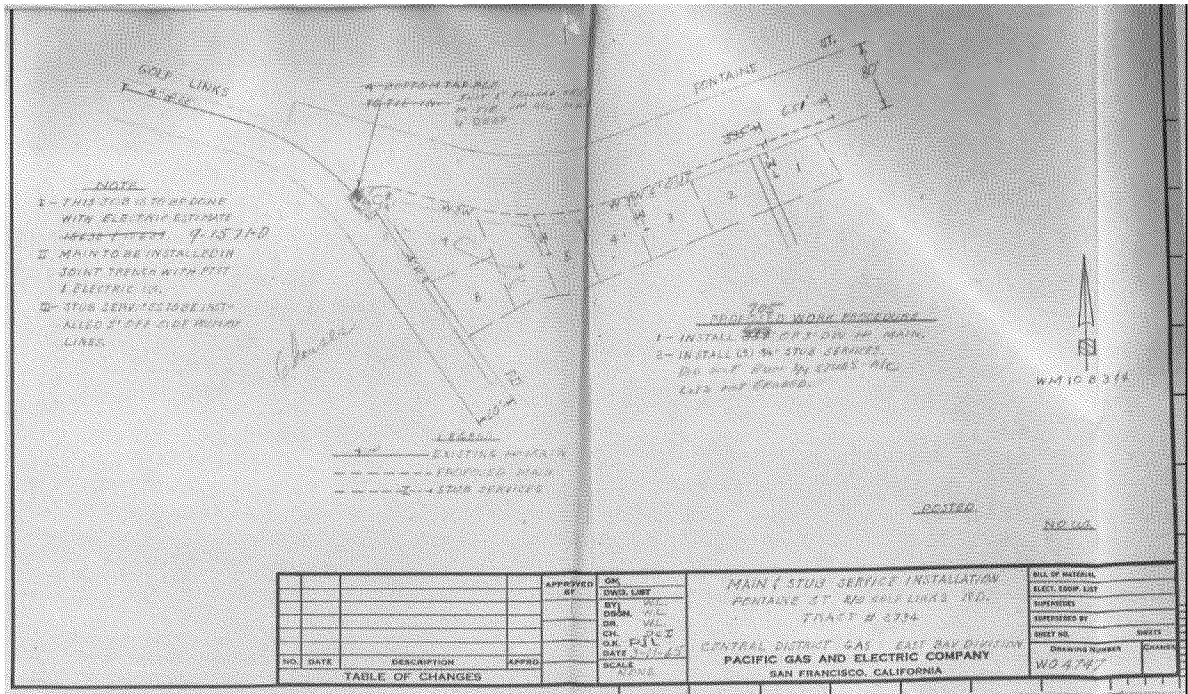
- W.O. 4747 (1965) - Installed a 3-inch diameter steel main extending along Fontaine Street. The 3-inch steel main was connected to the existing 4-inch steel main using a 3-inch flanged tee. A preliminary construction drawing from W.O. 4747 is shown in Figure 8 and Figure 9. This construction drawing has a very low level of detail in the area of the leak. As-built construction drawings for W.O. 4747 were not available to Exponent at the time that this report was issued.

Figure 8. Preliminary construction drawing for W.O. 4747 (1965).

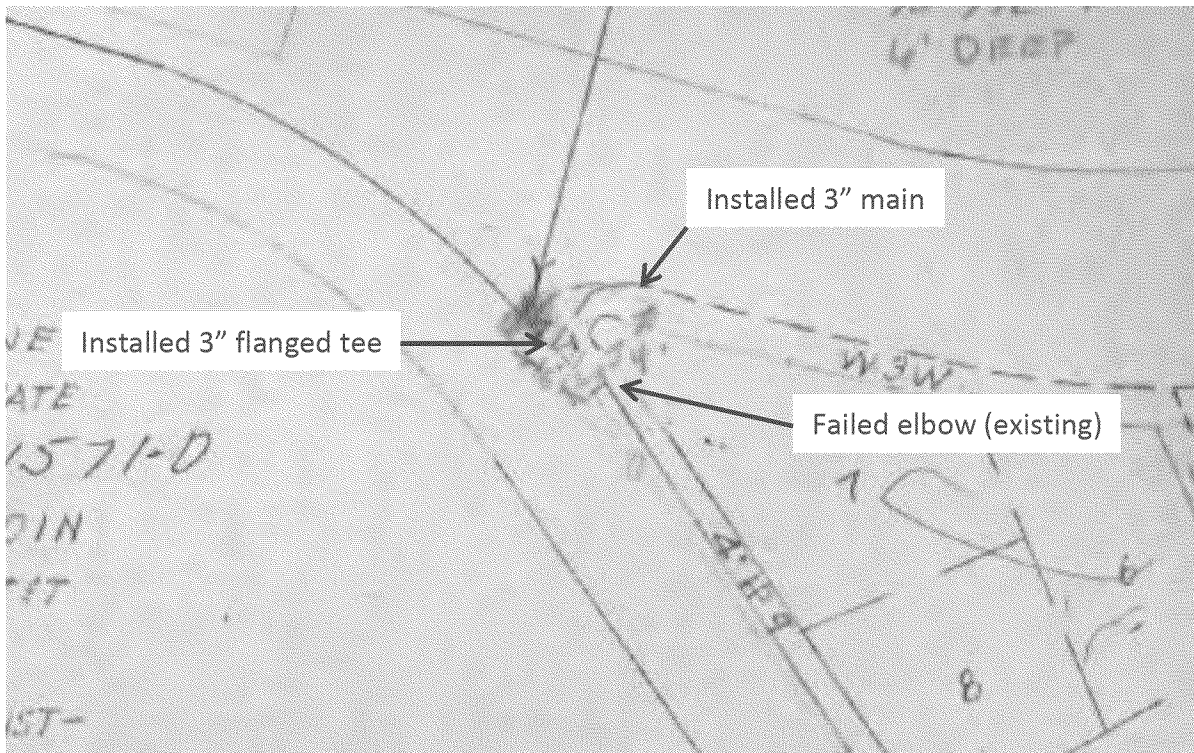
Figure 9. Cropped view of preliminary construction drawing for W.O. 4747 (1965) showing area of leak.

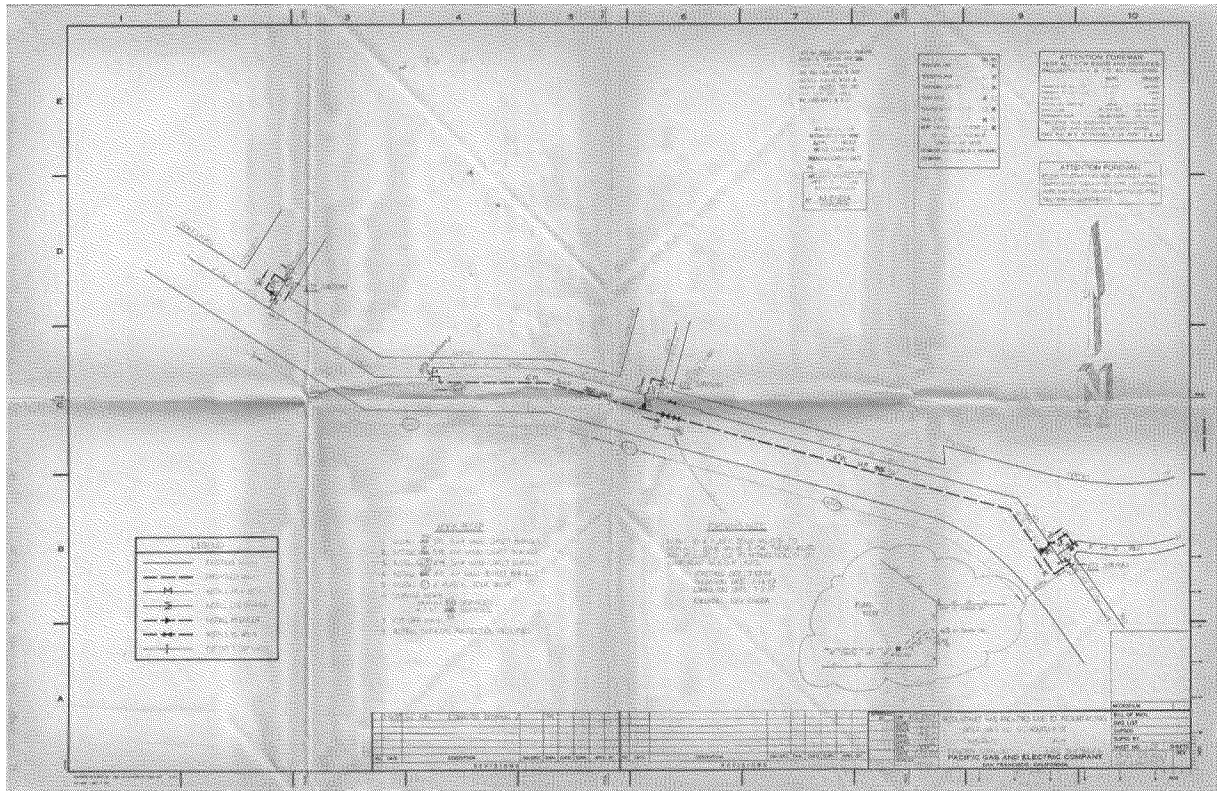
- G.M. 4564829 (1987) - Installed a 4-inch diameter plastic distribution main along Golf Links Road starting near the leak site and extending northwest. This main was installed to replace an existing 4-inch steel main. During this job, a piece of 4-inch pipe that was installed in 1946 in the immediate vicinity of the gas release was cut and capped. The 4-inch plastic distribution main was installed with a steel-to-plastic transition, two elbows, and approximately four feet of steel pipe that connected to the existing 1946 4-inch steel main using a 3-inch flanged tee. An as-built construction drawing for G.M. 4564829 is shown in Figure 10 and Figure 11. The pipeline features and locations shown in this drawing were consistent with the features in the ground.

Figure 10. As-built construction drawing for G.M. 4564829 (1987).

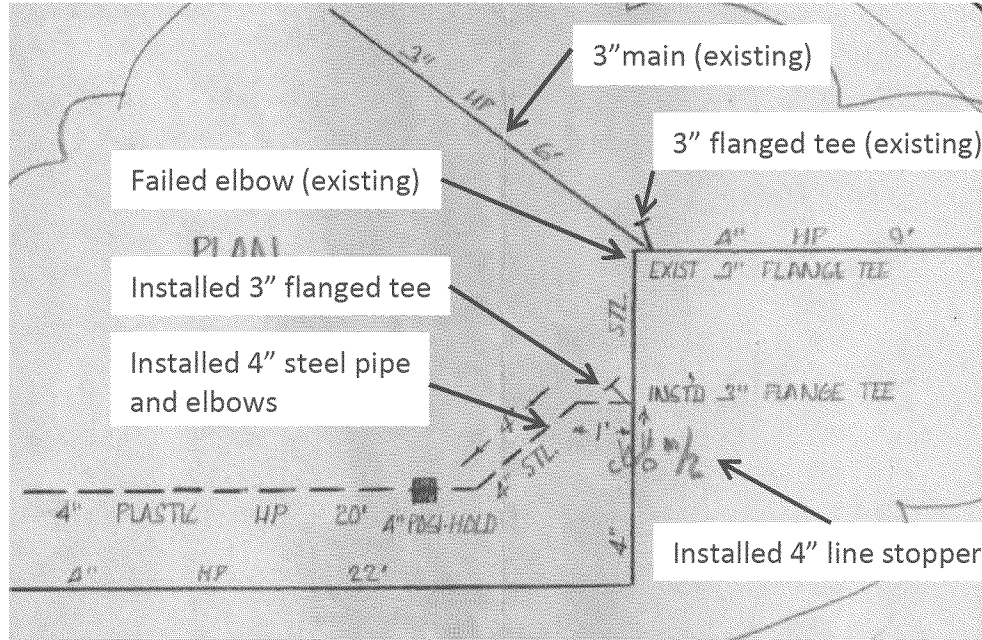
Figure 11. Cropped view of as-built construction drawing for G.M. 4564829 (1987) showing area of leak.

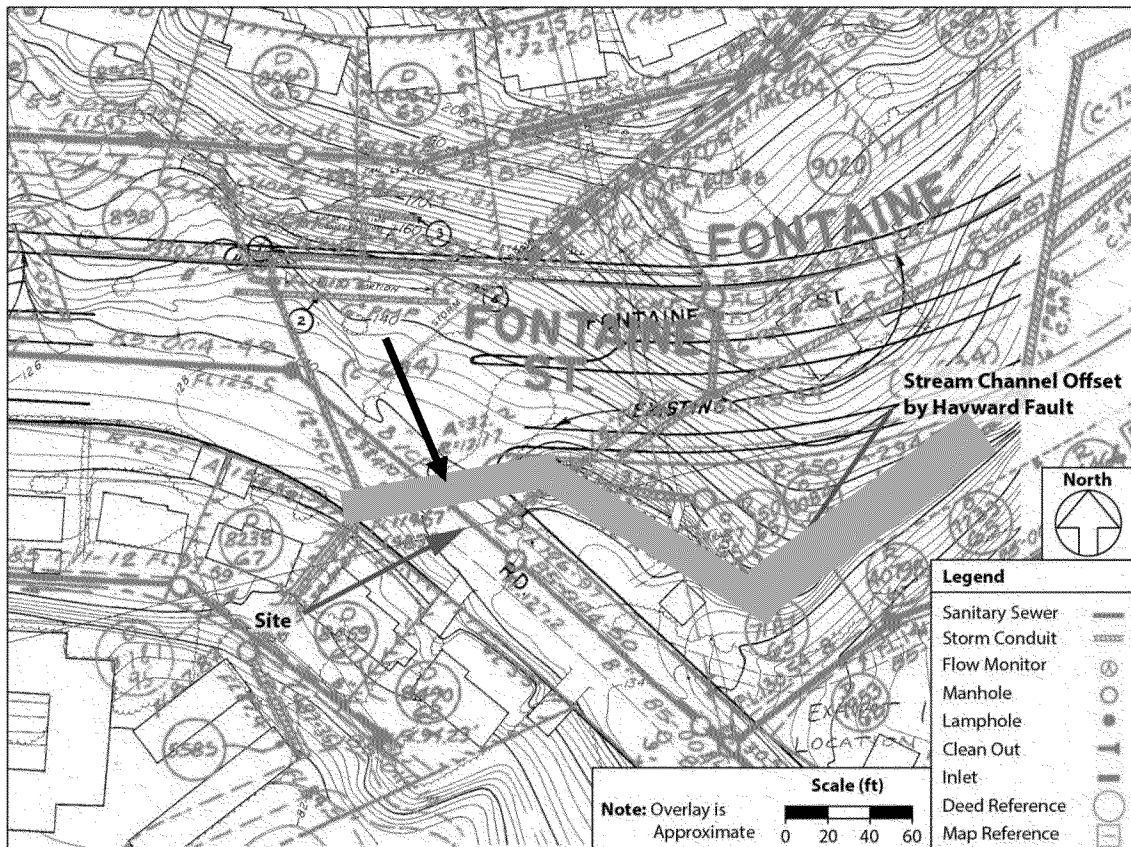
One piece of evidence of the location of the Hayward Fault at the Site is a right-lateral offset of a tributary stream channel (see Appendix C) emphasized by the storm-drain alignments following the old stream channel in Figure 27. The stream offset likely represents the location of one trace of the Hayward Fault, but not necessarily the active trace, which will be discussed in the next section.

Figure 27. City sewer map overlaid on pre-Fontaine-Street topography (see Appendix C). Black arrow indicates culvert under Golf Links Road. Yellow highlighting indicates storm-drain segments along offset stream channel. Sources: City of Oakland Underground Sewer Maps, Sheets 92 and 93, last revised 8-25-2004, scale unknown; City of Oakland topographic map excerpt; title, date, and scale unknown; from Building Services Division Land Stability File 92 L/4, "Grading, 8467 & 8475 Ney Avenue, 1 of 2."

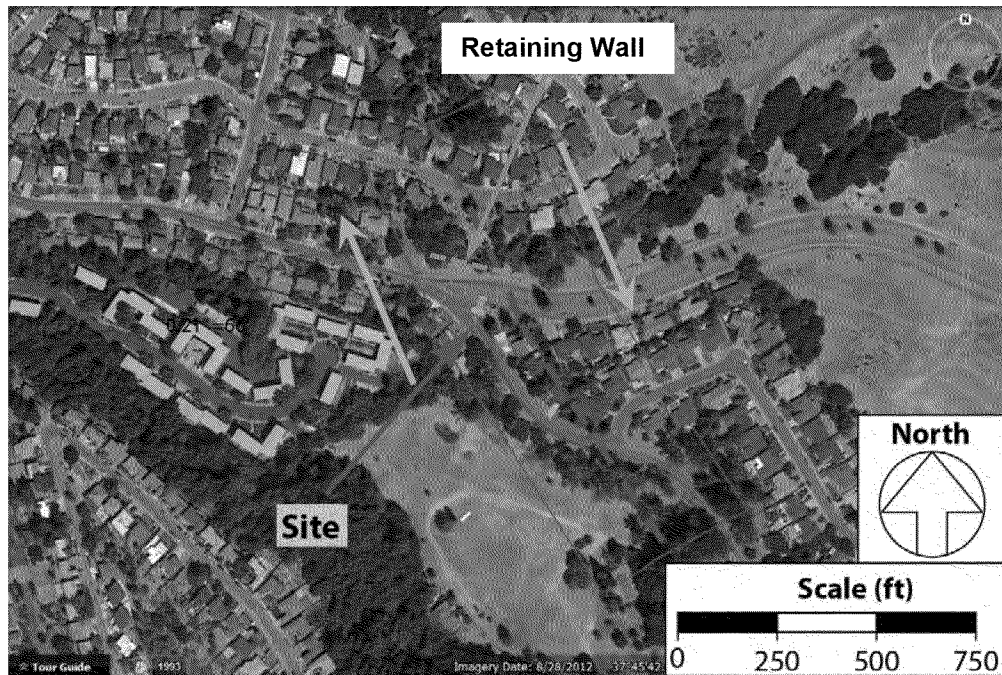
Lienkaemper (2006, revised 2008) stated that the accuracy of the mapped location of active fault traces varies throughout the mapped fault zone. In the vicinity of the Site, the actual active trace of the Hayward Fault is interpreted to be within 60 meters of the line shown on the map. Figure 29 shows the approximate area in which the active trace of the Hayward Fault is interpreted to be located, according to the Lienkaemper map. As shown on this figure, the Site is well within the mapped location of the active Hayward Fault trace. Figure 29 also shows the approximate direction of right-lateral displacement of the Hayward Fault in the vicinity of the Site. Figure 30 shows a plan view of the approximate configuration of the pipe system exposed during repairs and the pipe rupture location. The figure also shows the approximate direction of right-lateral movement of the Hayward Fault in the vicinity of the Site.

Figure 29. Aerial photograph showing approximate location of recently active trace of Hayward Fault in immediate vicinity of Site. Red box indicates width of zone of uncertainty within which the active fault trace is interpreted to be located. Sources: Google Earth; Lienkaemper (2006, revised 2008) <http://pubs.usgs.gov/ds/2006/177/>.

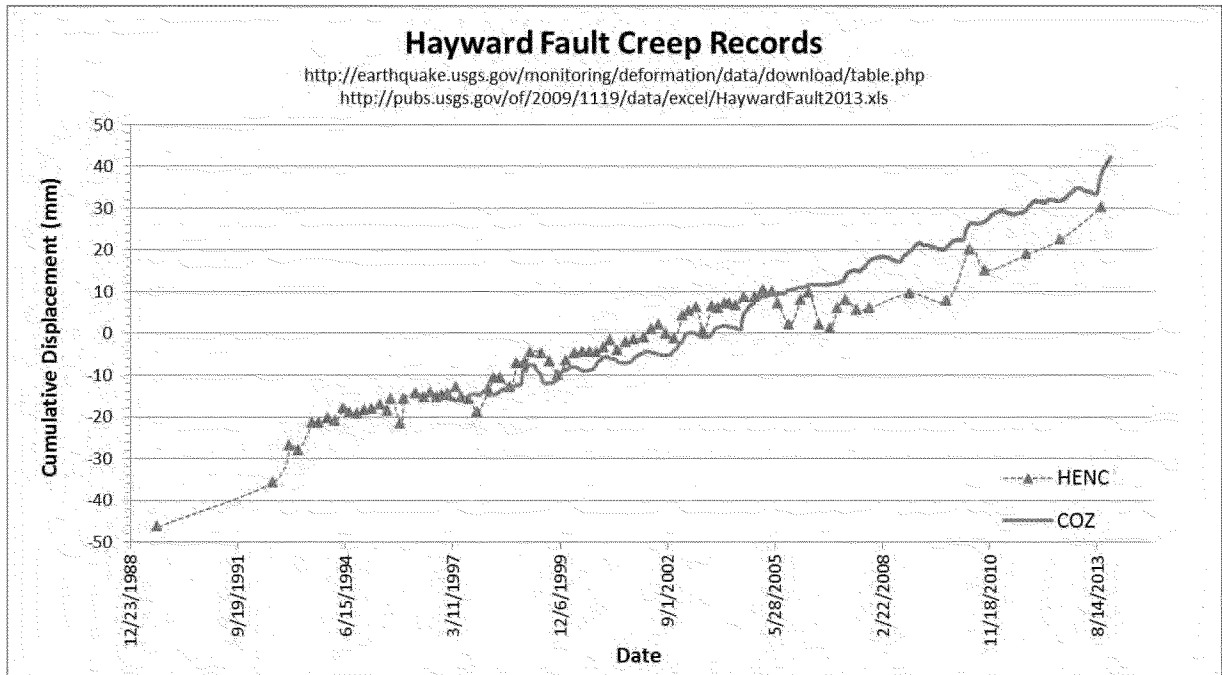
over 76 mm has been measured since 1989, for an average creep rate of 3.2 mm/yr. At the Oakland Zoo Station a total displacement of over 57 mm has been measured since 1996, for an average creep rate of 3.3 mm/yr. The figure shows an acceleration of creep movement measured at the Oakland Zoo Station starting in approximately August 2013. The timing of the gas release event may be related to this acceleration of creep movement. Additional creep data information is included in Appendix D.

Figure 34. Hayward Fault creep records in the vicinity of Golf Links Road (for available record interval). HENC = Encina Way Station. COZ = Oakland Zoo Station.

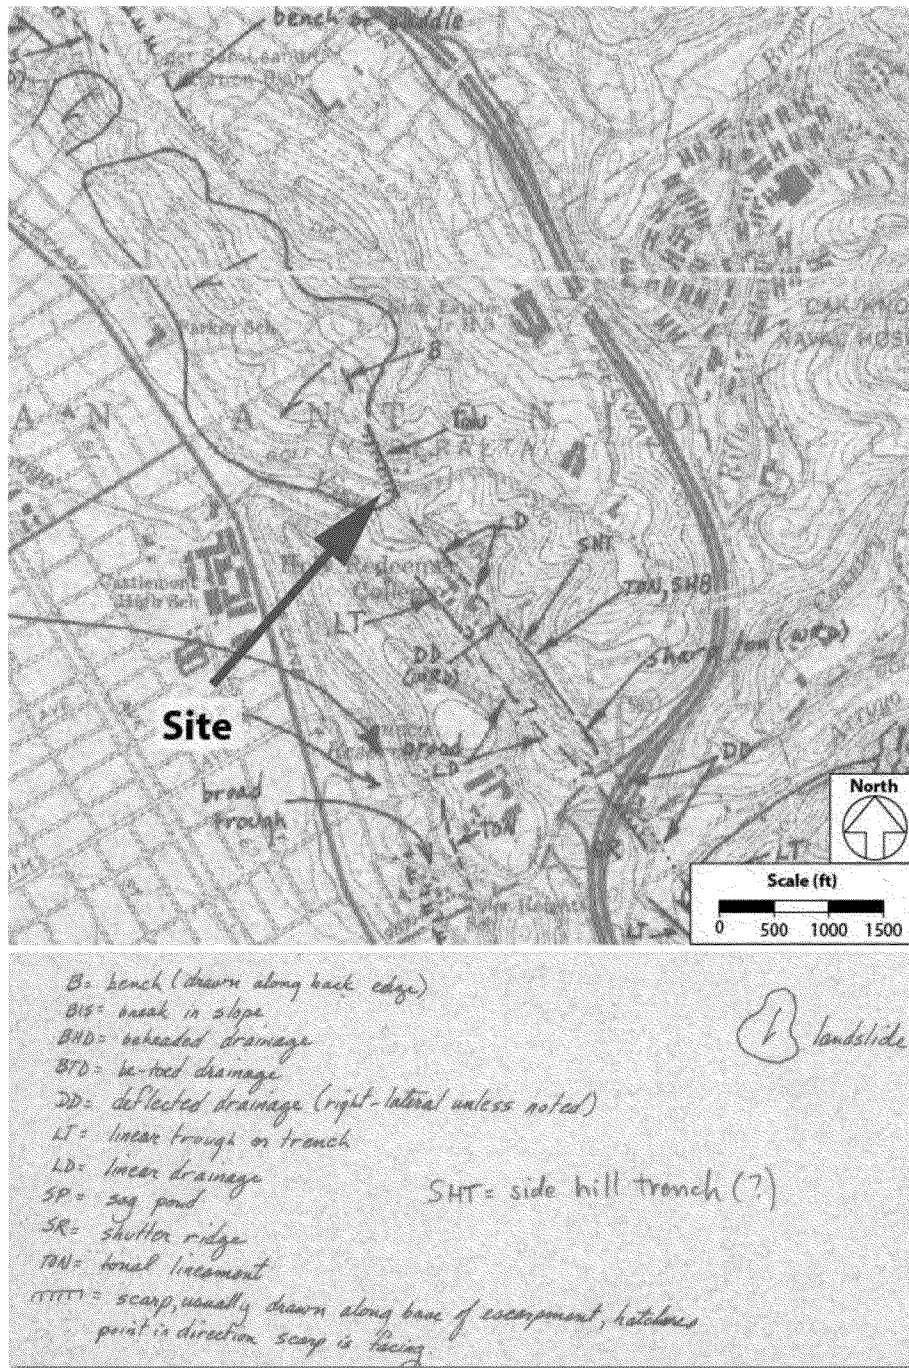
Exponent assessed the likelihood of landslide movement causing external forces on the pipe at the Site. As shown in Figure 36, the Site is located on the edge of a large ancient landslide. Exponent observed evidence of this landslide on topographic maps, aerial photographs, and in the field. In addition, a steep slope below Golf Links Road is potentially susceptible to landsliding.

Figure 36. Map showing geomorphic and tonal features along recently active traces of the Hayward Fault. Based on 1939 (pre-development) aerial photographs. Source: California Division of Mines and Geology (now California Geological Survey), 1980, Fault Evaluation Report FER-102, Hayward fault (Oakland segment), Figure 4. Geomorphic and tonal features along recently-active traces of the Hayward fault, scale 1:24,000.

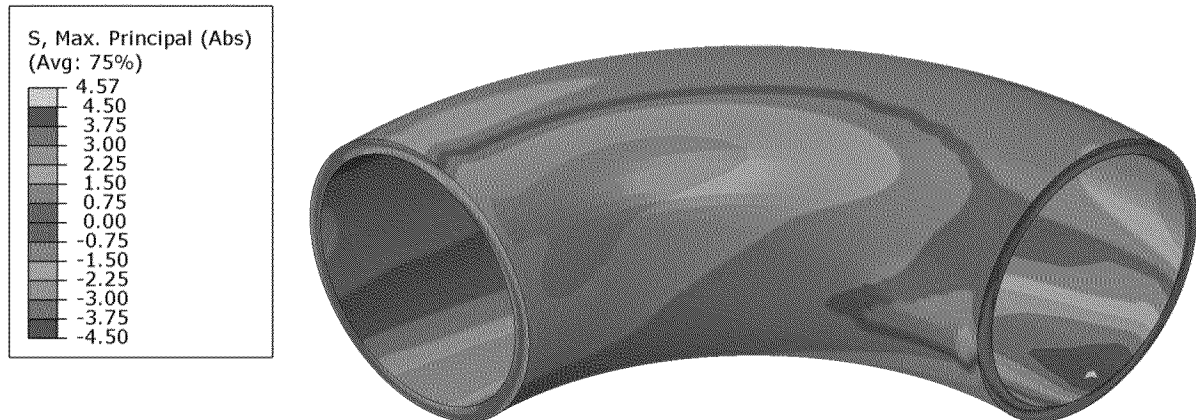
In order to determine the sensitivity of the elbow stresses to loading from heavy equipment on the road-surface, a load of 80,000 lbf was applied to the surface of the soil directly above the incident elbow in a patch of approximately 9” by 10”. This is approximately equivalent to a tractor trailer loaded to the legal limit, but carrying that load on just one tire instead of distributing the load over many tires.^{18,19} The resulting tensile stresses in the elbow are shown in Figure 41. The peak tensile stress is approximately 4.5 ksi and is located on the lower surface of the inside of the elbow. Tensile stresses near the failure location are approximately 2 ksi; this is not a sufficient amount of stress to cause failure.

Figure 41. Tensile stresses in the elbow when subjected to an 80,000 lbf truck load on the surface of the soil above the elbow.

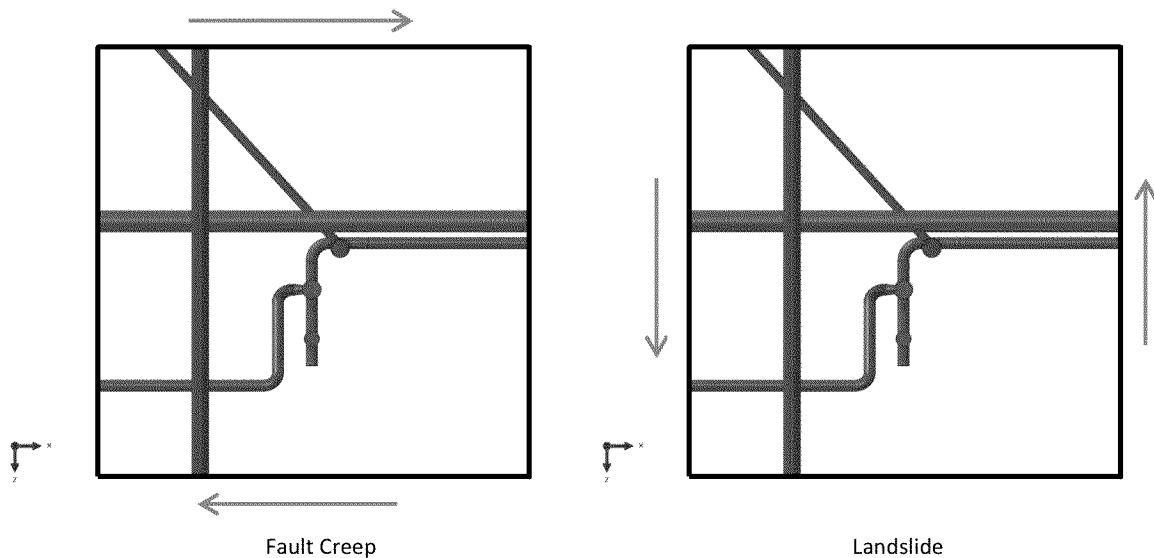
Because gravitational loading alone is not sufficient to achieve tensile stresses in the elbow that are consistent with the observed mode of failure, ground shearing movement was investigated as a possible source of stresses. After the model achieved equilibrium with gravitational loading, the soil was sheared in the horizontal plane to simulate ground movement associated with right-lateral strike-slip creep of the Hayward Fault or to simulate possible ground movement due to the ancient landslide. These two shearing directions are diagrammed in Figure 42. Two additional shearing directions were considered to investigate the sensitivity of the fault shearing direction; these directions were rotated $\pm 10^\circ$ from the fault creep nominal condition shown in Figure 42.

Figure 42. The two primary ground movement shearing directions considered in the finite element model. The left image shows the shearing consistent with right-lateral strike-slip creep of the Hayward Fault, and the right image shows the shearing consistent with ground movement due to a nearby landslide.

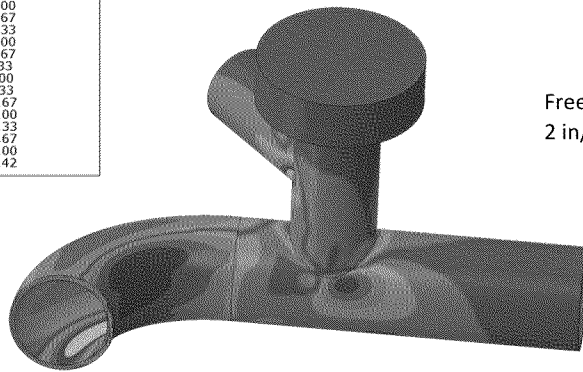
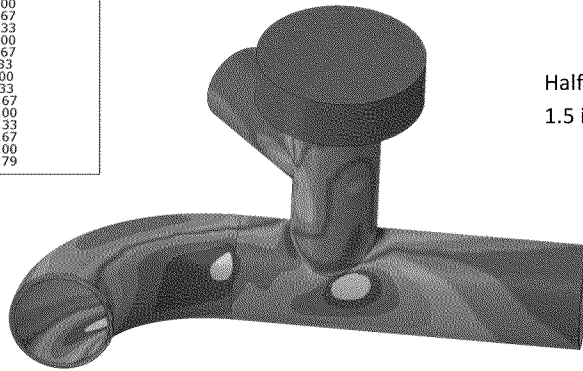
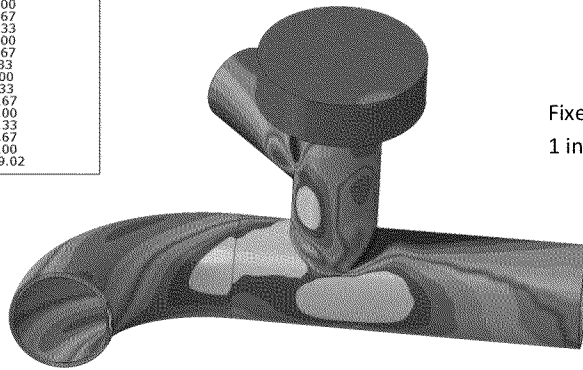
Fontaine pipe such that it cannot move axially and is forced into compression during the shearing, and a second model which provided a softer constraint that allowed the pipe to move only half the distance that it would if it were free to slide. The resulting tensile stresses in the region of the elbow and neighboring tee are shown in Figure 50. In all cases, the tensile stresses are large enough to cause failure of the elbow.

A summary of the peak tensile stress on the outside and inside walls of the elbow for the three boundary condition cases is presented in Table 6. It is important to note that decreasing levels of shear were applied to the models as the constraint was increased. The reduction in ground movement shearing reduces the stresses on the inside wall of the elbow. If the constraint on the end of the Fontaine Street pipe were unchanged, then we would also expect the stress on the outside wall to be reduced in a constant ratio. However, the constraint on the end of the Fontaine pipe causes the stress on the outside of the elbow (as well as the neighboring tee) to increase, and therefore causes the peak tensile stress location to switch from the lower inside surface to the outside surface of the elbow intrados. The fully constrained condition is unrealistic and causes very high stresses in the tee; the true constraint condition is likely somewhere between the two extremes of free and fixed.

Free Boundary Condition
2 in/ft fault creep shear

Half Constrained Boundary Condition
1.5 in/ft fault creep shear

Fixed Boundary Condition
1 in/ft fault creep shear

Figure 50. Tensile stresses in the incident elbow and neighboring tee for different boundary conditions on the Fontaine Street pipe. Note that the models have decreasing amount of shear despite increasing stresses. Units are ksi.

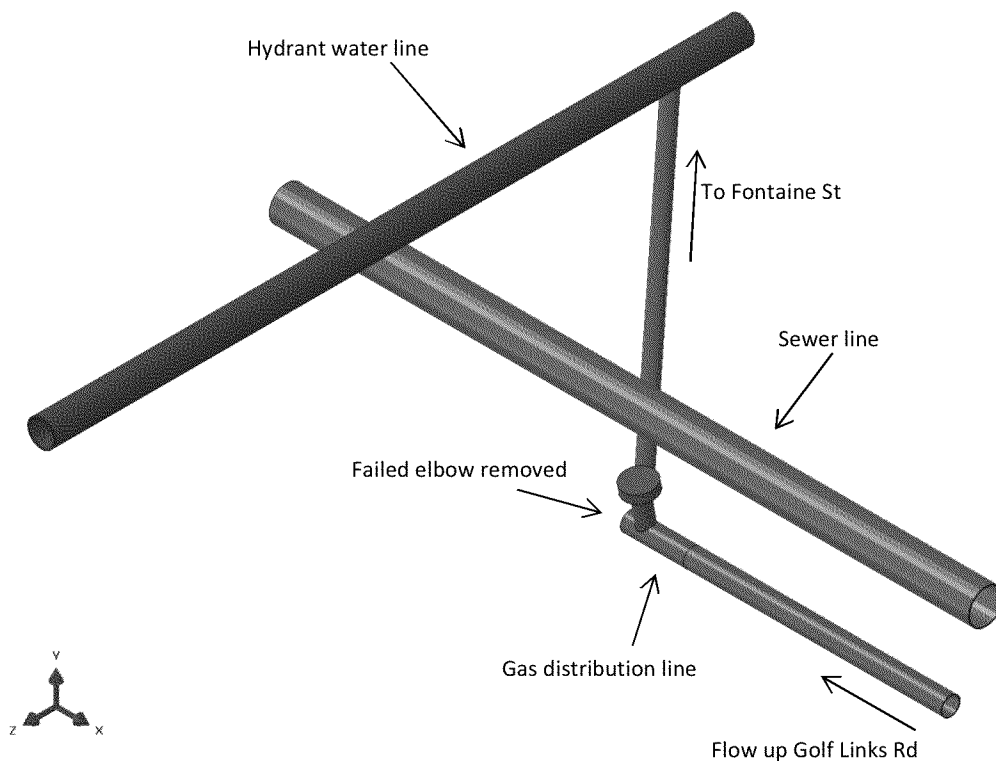
A finite element model was created to investigate the current stresses in the incident area following removal of the subject elbow and downstream piping. This new model is shown in Figure 51. The model was subjected to fault-creep shear of 0.2 in/ft consistent with the shear modeled in the subject elbow analysis. Tensile stresses in the repaired gas line near the location of the fractured elbow are shown in Figure 52; the stresses are reduced as compared with the stresses in the original configuration before the incident (upper image of Figure 50). Local stresses in the vicinity of the flange tee were predicted to be near 30 ksi. Thus, even after the removal of the subject elbow and associated downstream piping, stresses at the junction between the Golf Links Road and Fontaine Street piping could be as high as 30 ksi.

As in the earlier models, the stresses in the tee are highly dependent on the constraint of the Fontaine Street pipe. The excavation likely allowed local displacement and relief of some bending and compressive stresses at the Golf Links Road and Fontaine Street junction, but the rotational-induced stresses from fault-creep shear likely remains, consistent with the image shown in Figure 52. These stresses will increase with further creep of the Hayward fault at this location.

Figure 51. Post-repair model.

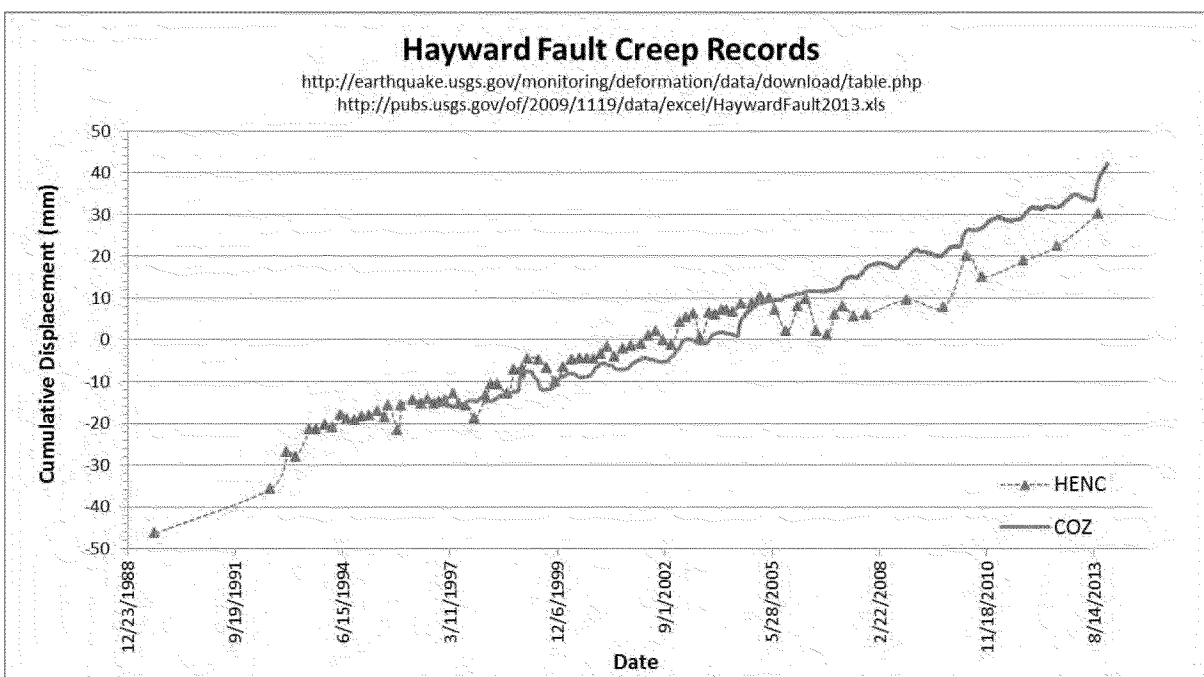
Figure D-3. Hayward Fault creep records in the vicinity of Golf Links Road (for available record interval). HENC = Encina Way Station. COZ = Oakland Zoo Station.

As previously noted, at the Encina Way Station a total displacement of over 76 mm has been measured since 1989, for an average creep rate of 3.2 mm/yr. At the Oakland Zoo Station a total displacement of over 57 mm has been measured since 1996, for an average creep rate of 3.3 mm/yr.

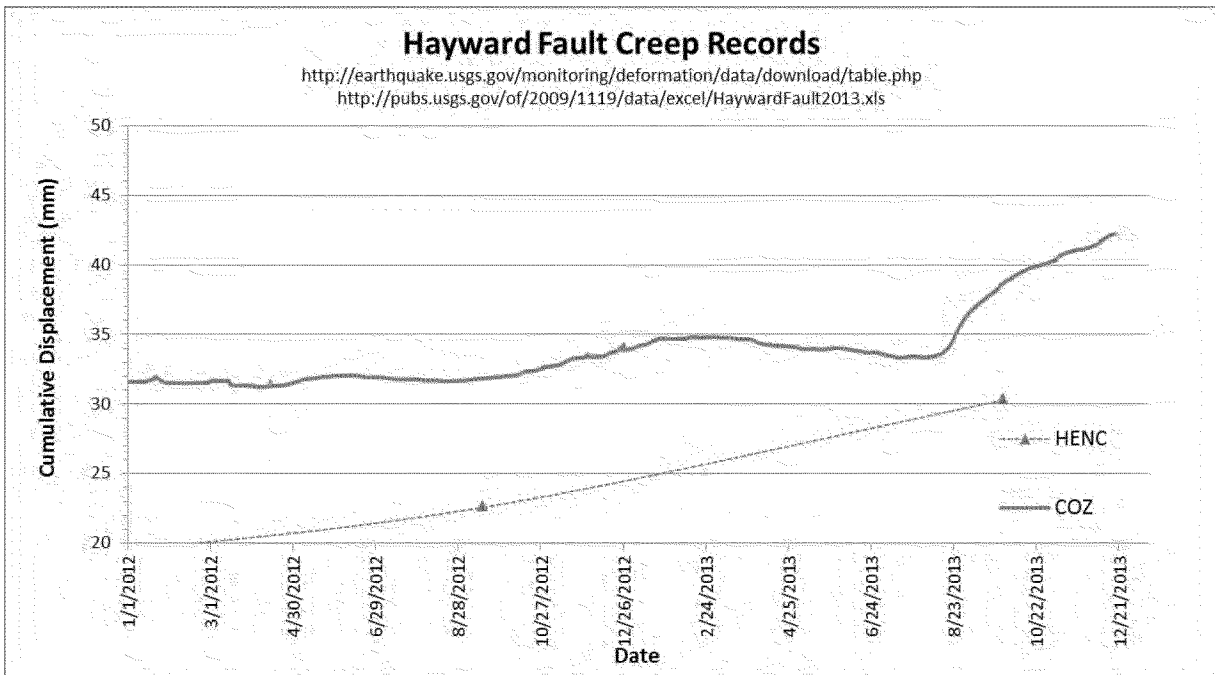
Figure D-4 shows the 2012 and 2013 portion of the data presented in Figure D-3. The figure shows an acceleration of creep movement measured at the Oakland Zoo Station starting in approximately August 2013. The timing of the gas release event may be related to this acceleration of creep movement.

Figure D-4. Hayward Fault creep records in the vicinity of Golf Links Road (for 2012 and 2013). HENC = Encina Way Station. COZ = Oakland Zoo Station.
