Jane Yura  
Vice President  
Asset & Risk Management  
Gas Operations

Re: Update - Oakland Incident of December 10, 2013

*Failure Analysis Associates*

Pacific Gas and Electric (PG&E) has retained Exponent Failure Analysis Associates (Exponent) to conduct a failure analysis investigation of an elbow that fractured as part of a four-inch natural gas distribution line on December 10, 2013 near the intersection of [Redacted] and [Redacted] in Oakland, California. Our investigation to-date has included inspection of the leak site, review of PG&E's historical construction documents, a fire cause and origin study, metallurgical analysis, geotechnical analysis, analysis of other leak locations within the immediate area, and finite element-based stress analyses of ground movement and stresses on the subject elbow and associated piping.

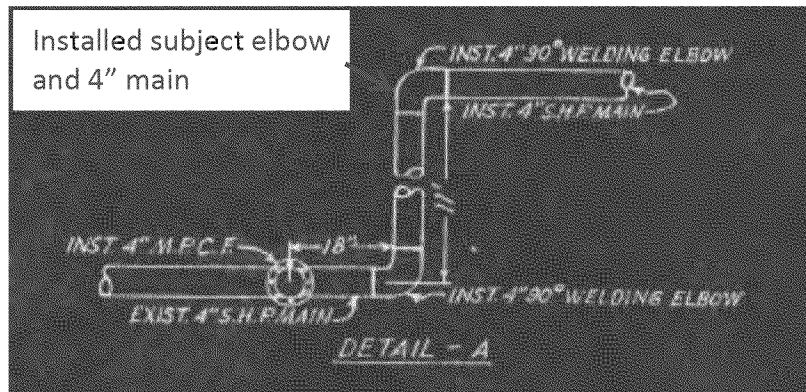
Figure 7. Cropped view of as-built construction drawing for job G.M.G. 82435 (1946) showing area of leak.

- G.M.G. 82435 (1946) - Installed a 4-inch diameter steel main along Redacted. This main included two 4-inch steel weld elbows at the location of the leak. One of these weld elbows installed in 1946 failed on December 10, 2013. An as-built construction drawing from G.M.G. 82435 is shown in Figure 6 and Figure 7. The

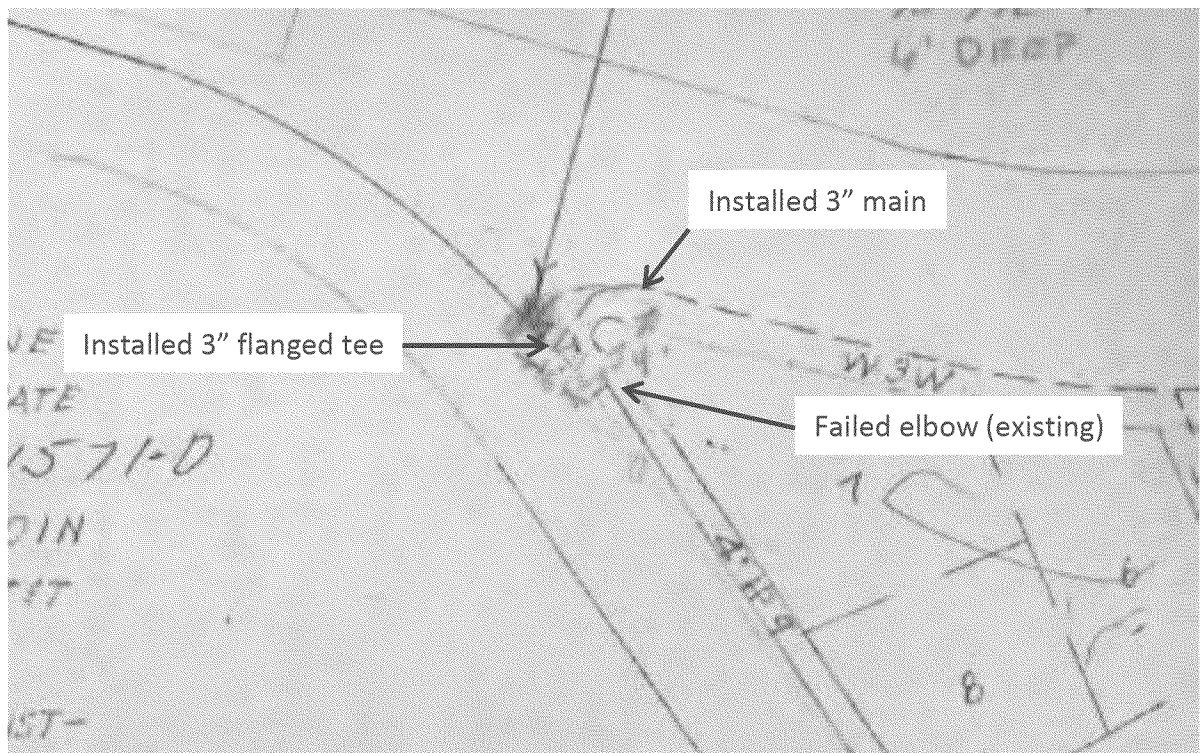
Figure 9. Cropped view of preliminary construction drawing for W.O. 4747 (1965) showing area of leak.

- W.O. 4747 (1965) - Installed a 3-inch diameter steel main extending along [Redacted] [Redacted]. The 3-inch steel main was connected to the existing 4-inch steel main using a 3-inch flanged tee. A preliminary construction drawing from W.O. 4747 is shown in Figure 8 and Figure 9. This construction drawing has a very low level of detail in the area of the leak. As-built construction drawings for W.O. 4747 were not available to Exponent at the time that this report was issued.

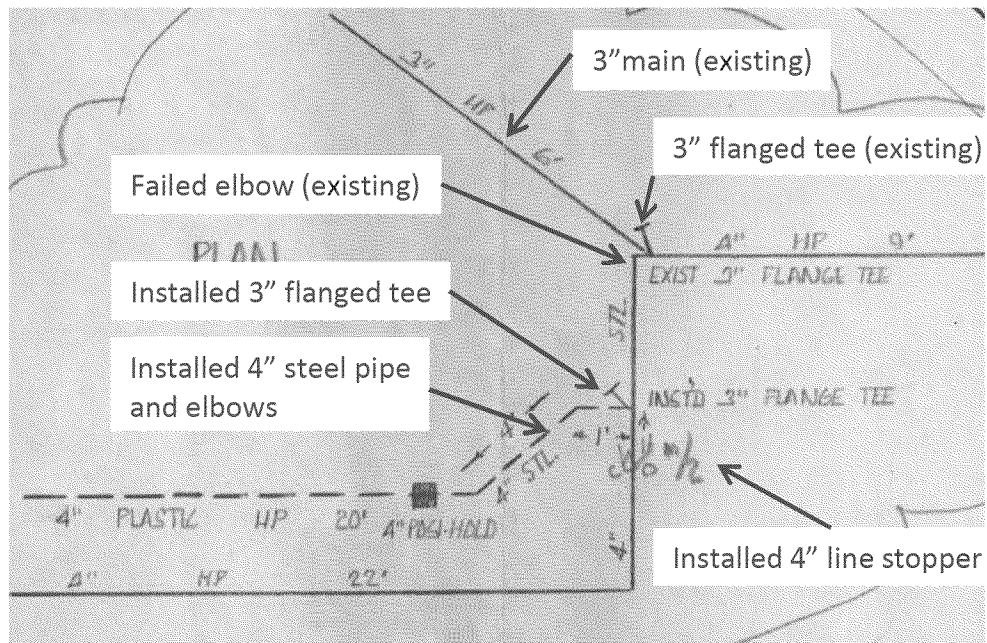
Figure 11. Cropped view of as-built construction drawing for G.M. 4564829 (1987) showing area of leak.

- G.M. 4564829 (1987) - Installed a 4-inch diameter plastic distribution main along [Redacted] [Redacted] starting near the leak site and extending northwest. This main was installed to replace an existing 4-inch steel main. During this job, a piece of 4-inch pipe that was installed in 1946 in the immediate vicinity of the gas release was cut and capped. The 4-inch plastic distribution main was installed with a steel-to-plastic transition, two elbows, and approximately four feet of steel pipe that connected to the existing 1946 4-inch steel main using a 3-inch flanged tee. An as-built construction drawing for G.M. 4564829 is shown in Figure 10 and Figure 11. The pipeline features and locations shown in this drawing were consistent with the features in the ground.

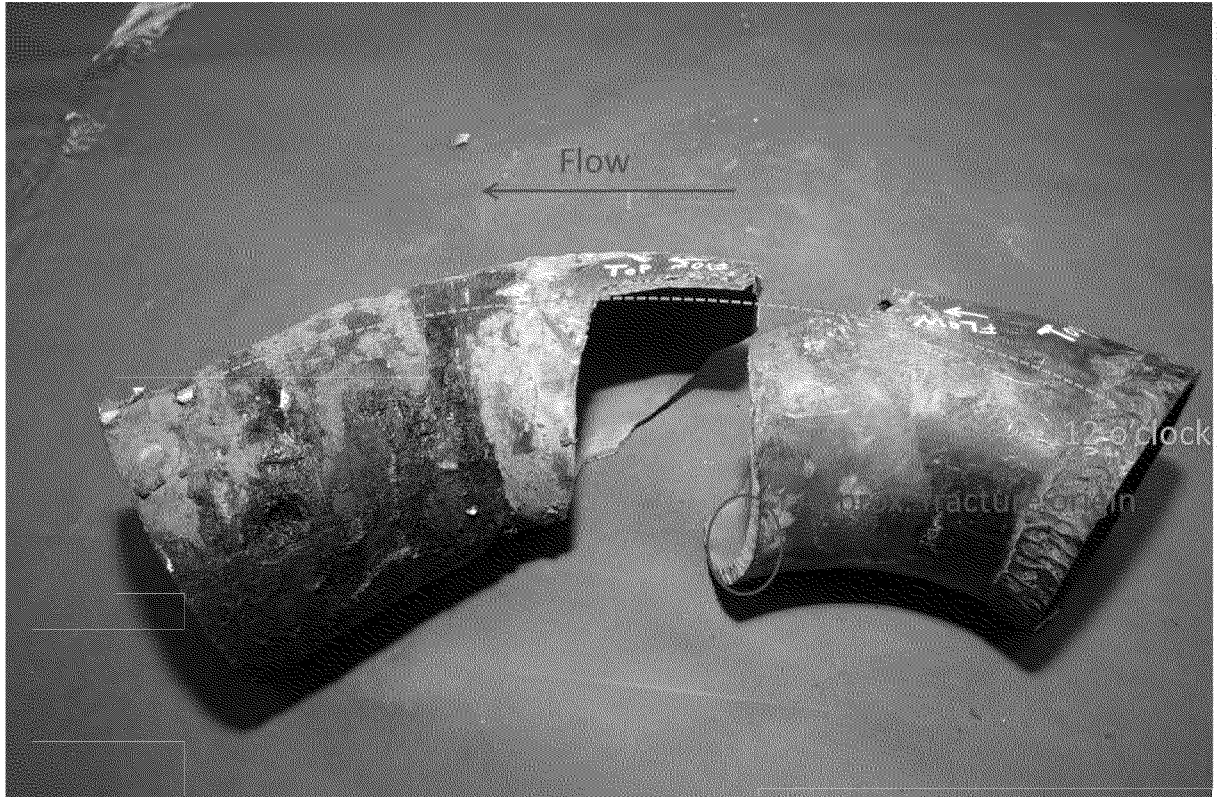
Fractographic analysis was conducted to help determine the cause of the rupture. The elbow was sectioned across the remaining intact area near the break to better expose the fracture surfaces for examination, as shown in Figure 18. To help remove the soil that obscured the surface, the fracture faces were cleaned in a warm Alconox (detergent and water) solution and scrubbed with a nylon brush. Following cleaning, the fracture surface was examined visually as well as using optical and scanning electron microscopy (SEM) techniques. A photograph of the cleaned fracture surface is shown in Figure 19. No dark areas, associated with long-term corrosion, or evidence of progressive fracture (such as beach marks) were observed. The fracture origin area was relatively flat with little ductility. Examination of tear ridges and chevron marks (which point back to the initiation point), shown in Figure 19 and Figure 20, indicated that the fracture origin was located at roughly the 10 o'clock position.

subject to leaking over time, and the amount of fracture surface erosion damage was consistent with the reported duration of the subject leak. The cleavage fracture observed is consistent with brittle fracture morphology in steel subjected to an overstress event.

Consistent with our visual and optical microscope fractographic analysis, no evidence of progressive fracture, such as fatigue or stress corrosion cracking (SCC) was observed. Energy dispersive spectroscopy (EDS) showed no evidence of anomalous elemental species (not shown).

Figure 18. Image that shows the elbow after sectioning. The piece on the right (upstream) was subjected to fractographic and metallographic examination.

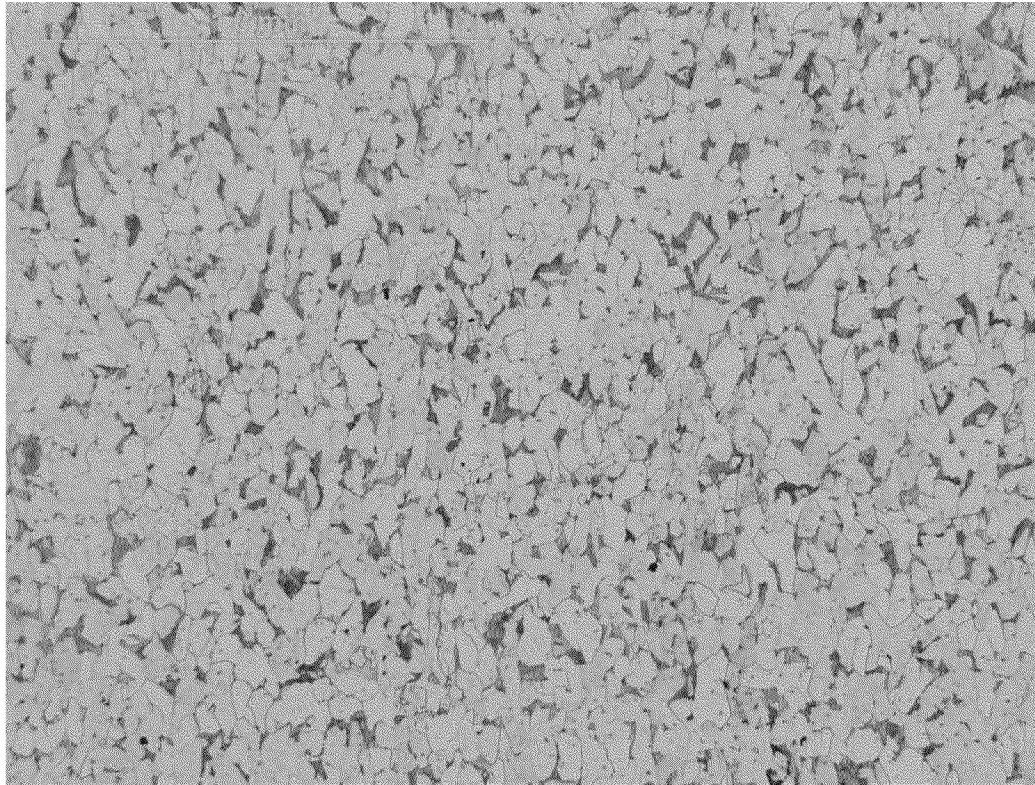
A portion of the fracture origin was sectioned to allow metallographic examination, shown in Figure 23. The sample was mounted perpendicular to the fracture plane (i.e., along the longitudinal direction along the elbow), and was ground, polished, and etched using typical metallographic procedures. The elbow exhibited a typical ferrite and pearlite microstructure, including at the fracture origin, as shown in Figure 24. Microhardness testing was conducted on the metallographic sample: the average hardness was measured to be 193 HV.

Figure 24. Metallographic image of the elbow ferrite-pearlite microstructure.

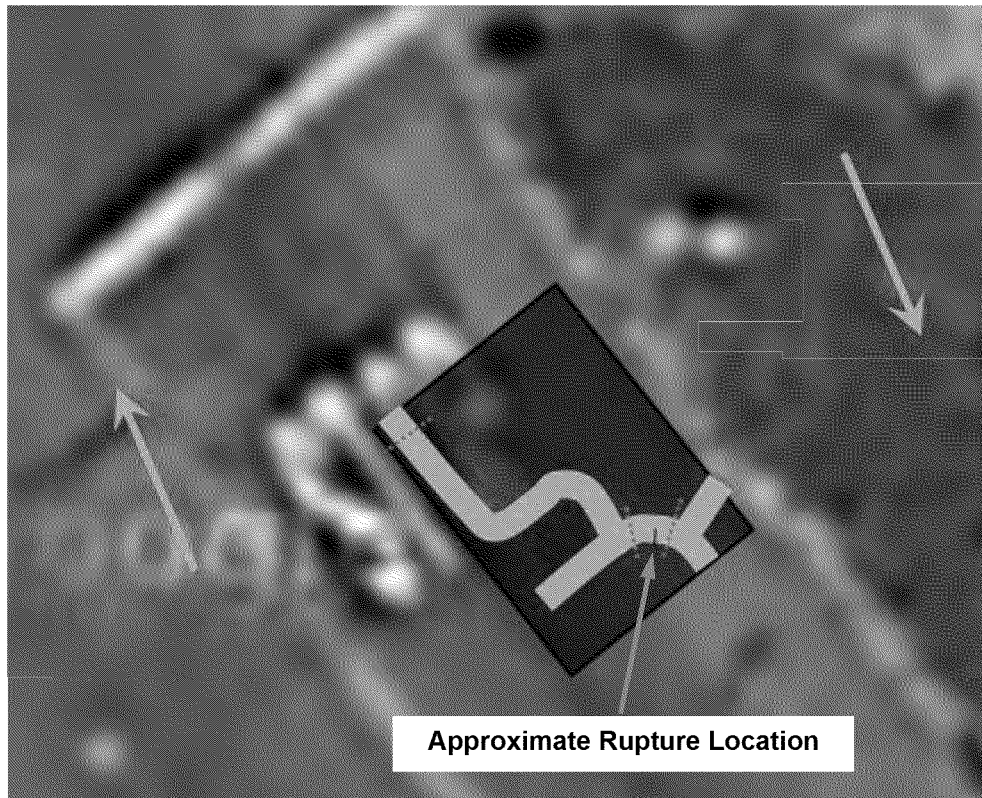
Figure 30. Plan view of pipe system exposed during repairs. Arrows indicate approximate direction of right-lateral movement of Hayward Fault in the vicinity of the Site. Photograph source: Google maps.

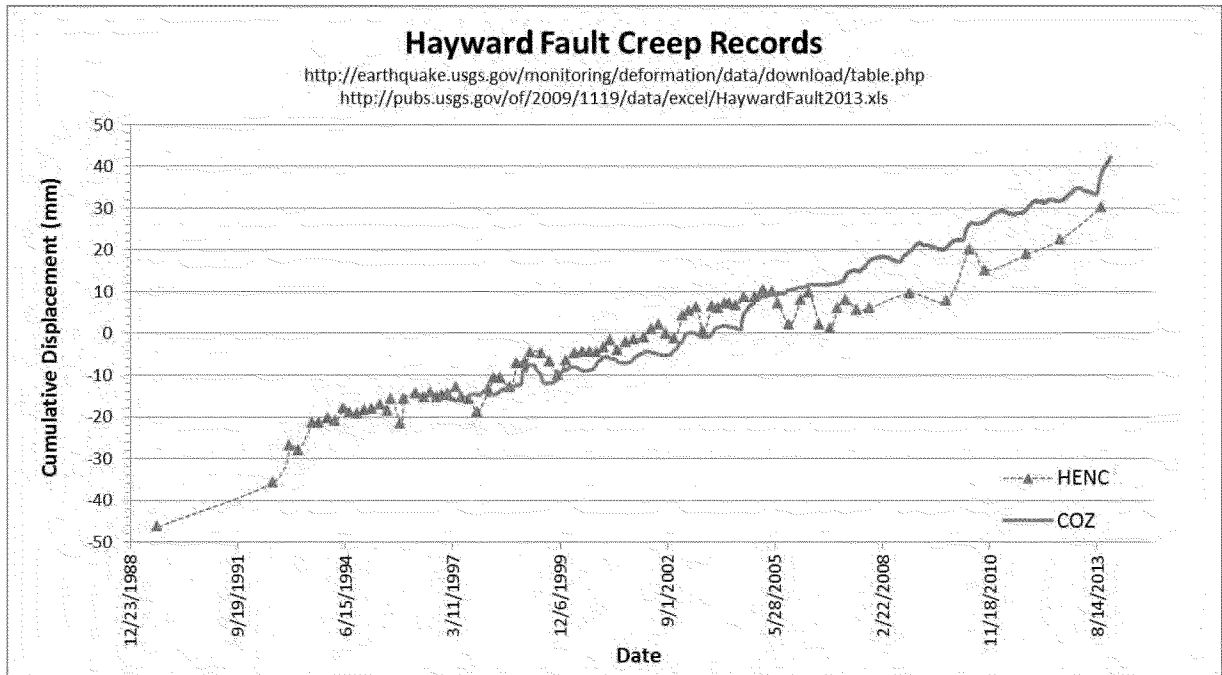
over 76 mm has been measured since 1989, for an average creep rate of 3.2 mm/yr. At the Oakland Zoo Station a total displacement of over 57 mm has been measured since 1996, for an average creep rate of 3.3 mm/yr. The figure shows an acceleration of creep movement measured at the Oakland Zoo Station starting in approximately August 2013. The timing of the gas release event may be related to this acceleration of creep movement. Additional creep data information is included in Appendix D.

Figure 34. Hayward Fault creep records in the vicinity of [Redacted] for available record interval). HENC = [Redacted] COZ = [Redacted].

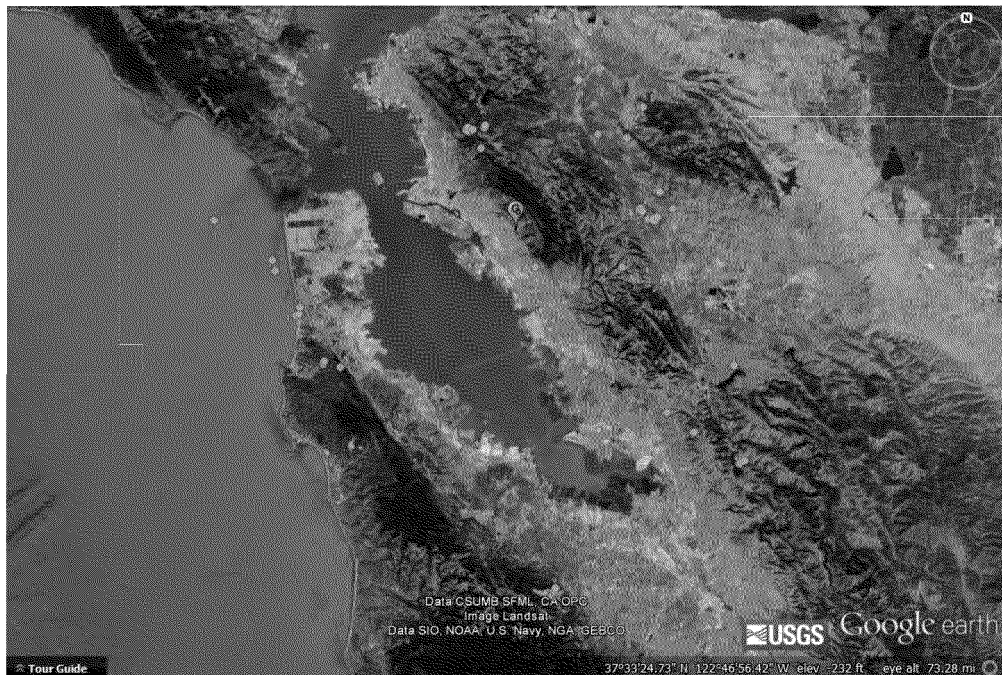
Figure 35 shows the recorded seismic events that occurred in the vicinity of the Site between August 1, 2013 and December 10, 2013. No significant events were recorded within a 50 km radius from the Site.<sup>12</sup> The closest event to the Site was a magnitude 2.0 earthquake approximately 3.5 miles southeast of the Site. The largest event was a magnitude 3.3 earthquake more than 10 miles east of the Site. Ground motions from these events did not cause significant loading of the pipe system at the Site.

Figure 35. Earthquakes within a 50-km radius from Site, and magnitude greater than 2.0, recorded between August 1, 2013 and December 10, 2013. Source: USGS: <http://earthquake.usgs.gov/earthquakes/map/>

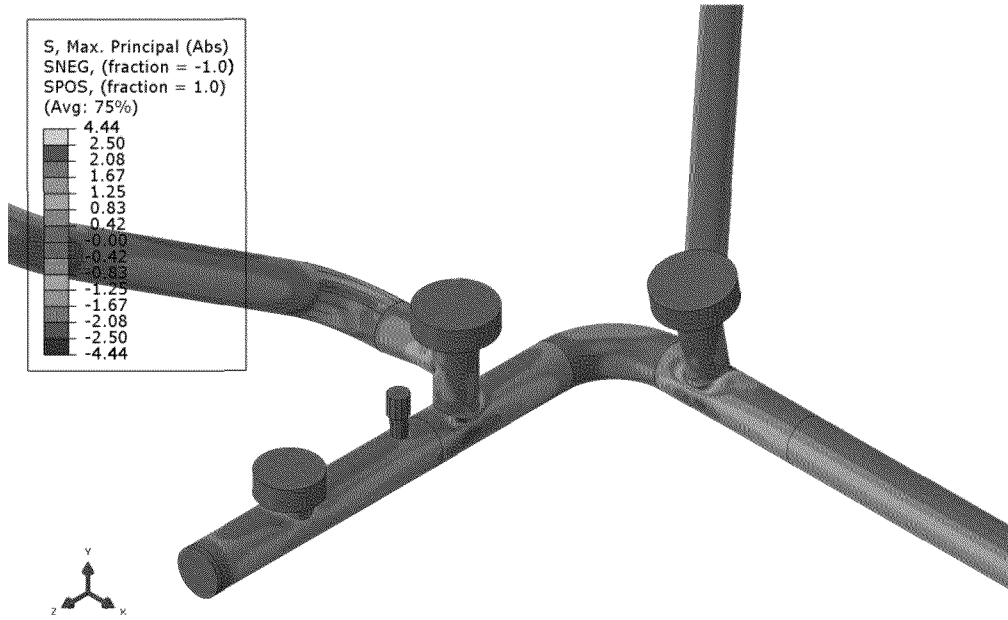
The first step of the model consists of applying gravity loading. The soil base was fixed in the vertical direction, and the four walls of the soil were fixed in the normal directions. The utility lines that intersect the model boundaries were constrained only by the surrounding soil and not by additional boundary conditions, so they may slide in or out of the soil walls. The top surface of the soil was coincident with the ground surface, so no loads or boundary conditions were applied to it. A uniform gravity load of 386 in/s<sup>2</sup> was applied to all elements, and the model was allowed to achieve geostatic equilibrium. The resulting tensile stresses in the pipe network and the incident elbow are shown in Figure 39 and Figure 40, respectively. Stresses were calculated to be less than 2 ksi for most of the network, with small localized regions as high as 4.4 ksi. The largest tensile stresses in the elbow were approximately 1.4 ksi; roughly one-fiftieth of the measured elbow tensile strength.

Figure 39. Tensile stresses in the pipe network subjected to gravitational loading. Units are ksi.

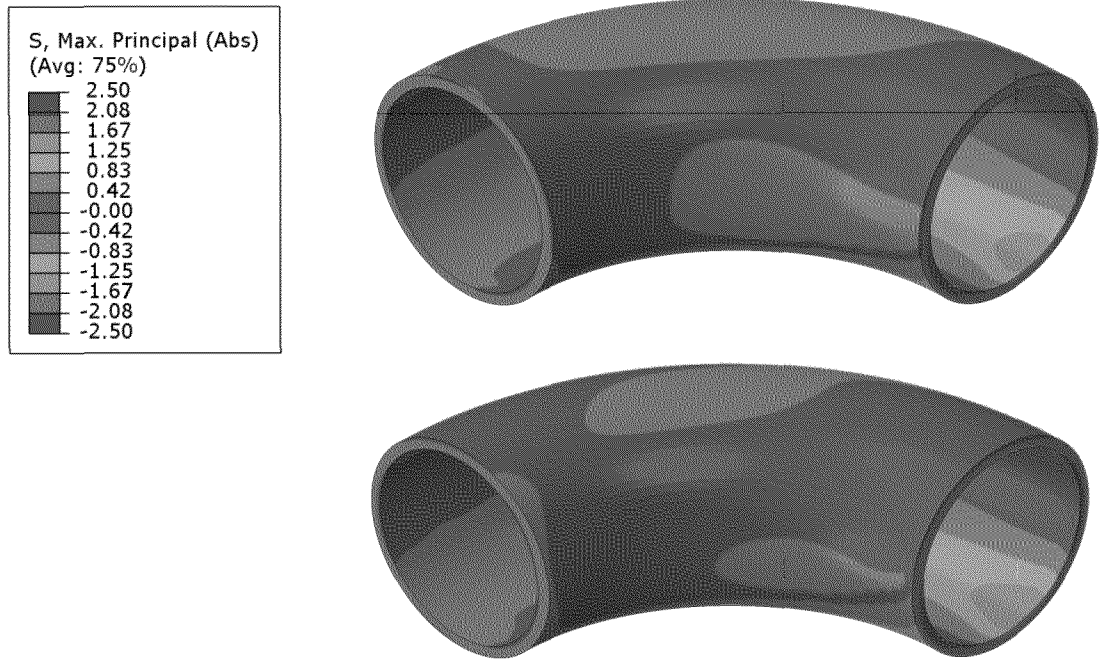
One uncertainty in the model geometry was the vertical distance between the water line and the gas line and the support condition beneath the water line near the gas line. It is possible that the water line was resting directly on the gas line and was not fully supported by soil in this vicinity. To determine the sensitivity of the stresses in the subject elbow to the water line support condition, a second model was built such that six feet of the water line in the vicinity of the gas line was unsupported by soil. For this condition, a larger load from the water line is transferred directly to the gas line. The tensile stresses calculated in the incident elbow are shown in the lower half of Figure 40; the largest tensile stresses were approximately 1.5 ksi, which was only slightly larger than the nominal condition and not large enough to cause failure. Thus, the support condition of the water line in the vicinity of the gas line was determined to have a negligible contribution to the failure.

Figure 40. Tensile stresses in the incident elbow subjected to gravitational loading with nominal water pipe support (top) and 6 ft unsupported water pipe (below). Units are ksi.

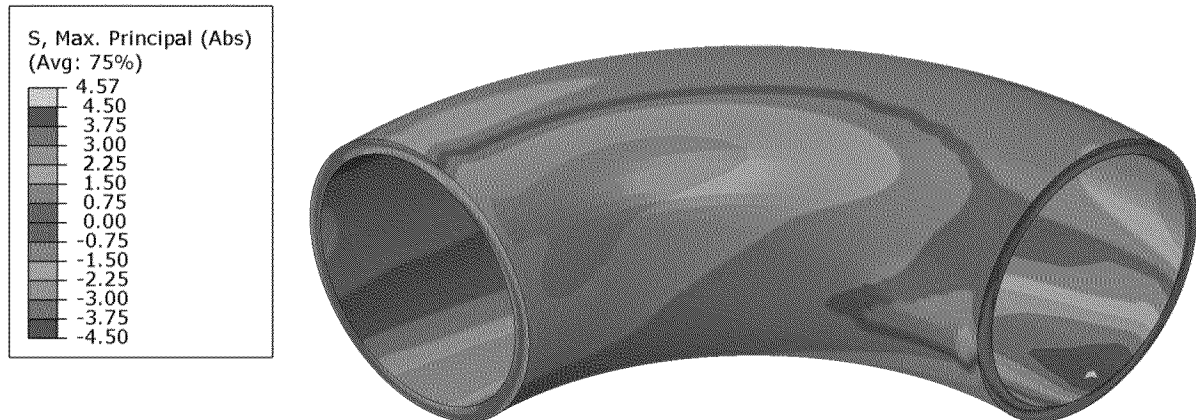
In order to determine the sensitivity of the elbow stresses to loading from heavy equipment on the road-surface, a load of 80,000 lbf was applied to the surface of the soil directly above the incident elbow in a patch of approximately 9” by 10”. This is approximately equivalent to a tractor trailer loaded to the legal limit, but carrying that load on just one tire instead of distributing the load over many tires.<sup>17,18</sup> The resulting tensile stresses in the elbow are shown in Figure 41. The peak tensile stress is approximately 4.5 ksi and is located on the lower surface of the inside of the elbow. Tensile stresses near the failure location are approximately 2 ksi; this is not a sufficient amount of stress to cause failure.

Figure 41. Tensile stresses in the elbow when subjected to an 80,000 lbf truck load on the surface of the soil above the elbow.

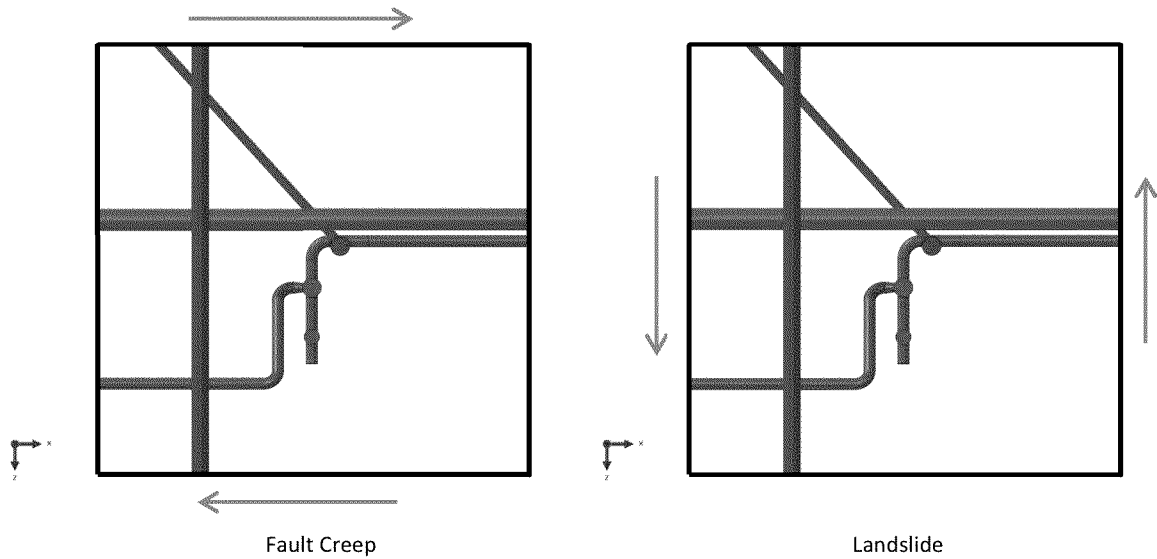
Because gravitational loading alone is not sufficient to achieve tensile stresses in the elbow that are consistent with the observed mode of failure, ground shearing movement was investigated as a possible source of stresses. After the model achieved equilibrium with gravitational loading, the soil was sheared in the horizontal plane to simulate ground movement associated with right-lateral strike-slip creep of the Hayward Fault or to simulate possible ground movement due to the ancient landslide. These two shearing directions are diagrammed in Figure 42. Two additional shearing directions were considered to investigate the sensitivity of the fault shearing direction; these directions were rotated  $\pm 10^\circ$  from the fault creep nominal condition shown in Figure 42.

Figure 42. The two primary ground movement shearing directions considered in the finite element model. The left image shows the shearing consistent with right-lateral strike-slip creep of the Hayward Fault, and the right image shows the shearing consistent with ground movement due to a nearby landslide.

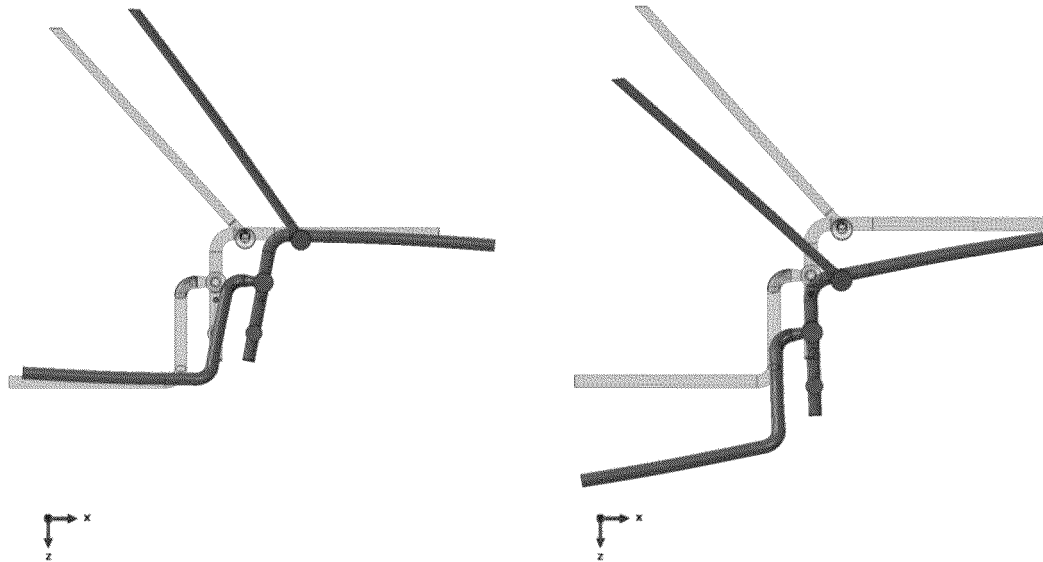
The resulting deflections of the gas pipe network when subjected to 0.2 in/ft of horizontal shear in the fault creep and landslide directions are shown in Figure 45. Tensile stresses in the gas lines in the vicinity of the incident elbow are shown in Figure 46. In both shearing conditions, tensile stresses were concentrated in the incident elbow near the failure location, i.e. on the outside surface of the elbow intrados, and have nearly the same tensile stresses for the same amount of ground shearing. The peak tensile stresses on the outside surface of the elbow intrados are 49.1 ksi for both the fault creep and landslide cases, and are shown on the left side of Figure 47. This stress approaches the magnitudes necessary to cause failure. However, note that the peak elbow stress occurred on the lower inside surface of the elbow, as indicated by the gray region in the left images of Figure 47, not on the outside wall of the elbow intrados. This point will be revisited later. Nonetheless, the magnitude, location and direction of peak tensile stress on the outside wall of the elbow intrados were consistent with the fractured incident elbow. Plots of the tensile stress direction on the outside surface of the elbow for the fault-creep and landslide-shear cases are shown on the right side of Figure 47.

Figure 45. Deformed shapes of the gas pipe network when subjected to fault-creep shear (left) and landslide shear (right). The total shearing applied is 0.2 in/ft, but the deformations are scaled by a factor of 10.

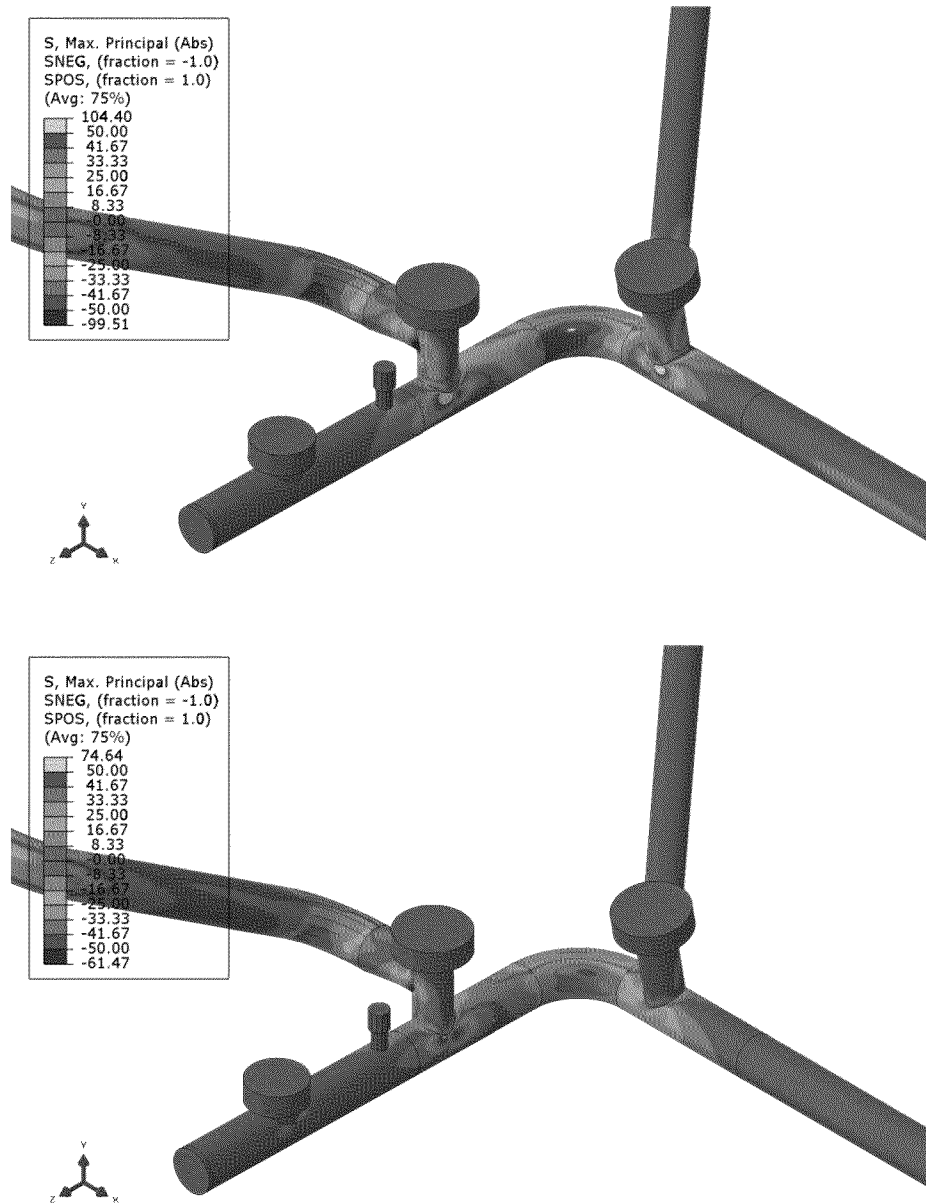
To further investigate the sensitivity to shearing direction on the peak tensile stress magnitude and location, the fault creep shearing direction was varied by  $\pm 10^\circ$ . Tensile stresses in the gas lines in the vicinity of the incident elbow are shown in Figure 48. The peak tensile stresses on the outside wall of the elbow intrados were slightly higher for the  $+10^\circ$  shearing direction and lower for the  $-10^\circ$  direction (50.2 ksi and 42.7 ksi respectively) as compared with the nominal fault creep condition in Figure 46. The location of the peak stress also shifted along the axial position of the elbow.

Figure 48. Tensile stresses in the gas pipes when subjected to 0.2 in/ft of shear in the fault creep +10° direction (top) and the fault creep -10° direction (bottom). Rotation angles are with respect to the model's y-axis. Units are ksi.

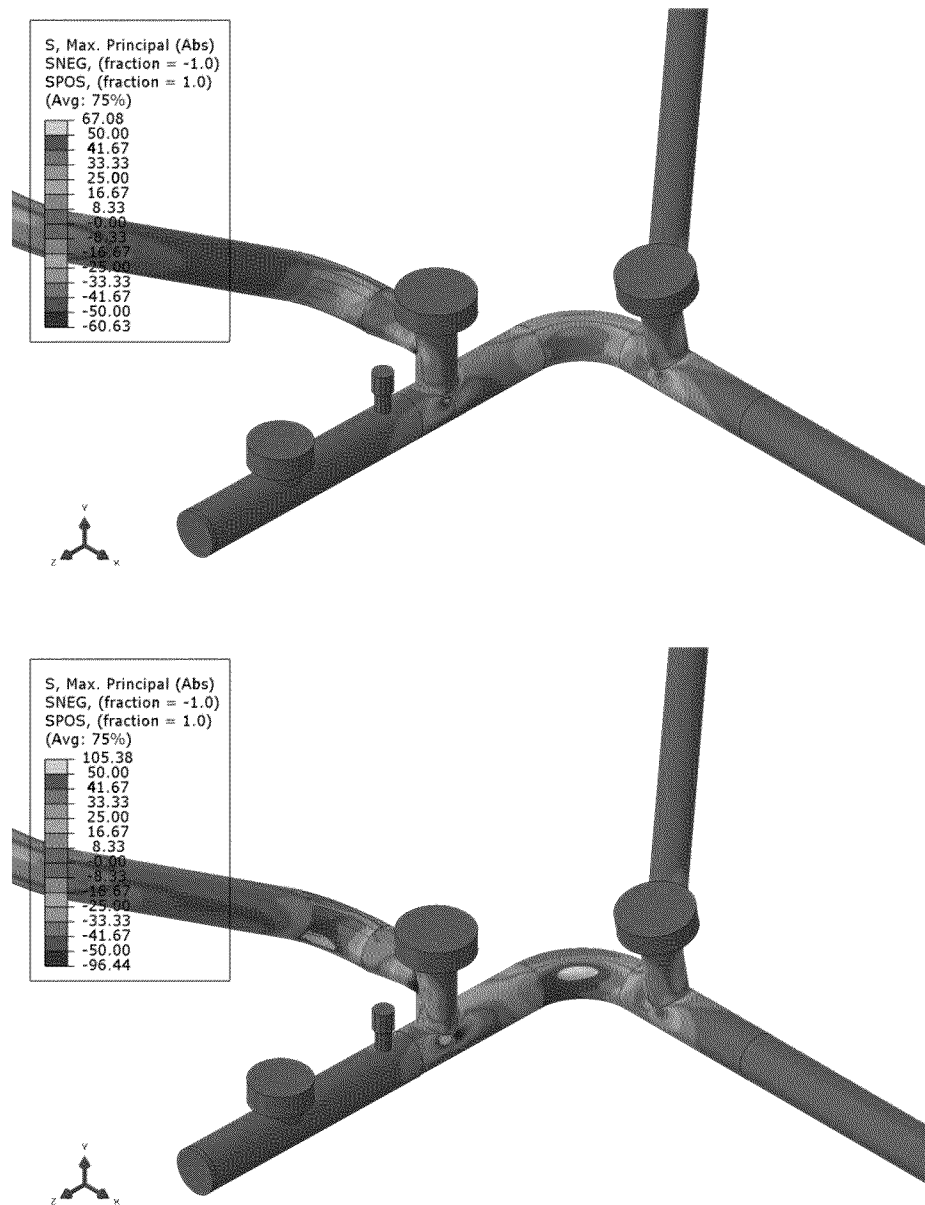
To investigate the sensitivity of soil modulus on the peak tensile stress magnitude, two other soil moduli were investigated, 200 atm and 1000 atm, as compared with the nominal value of 500 atm. Tensile stresses in the gas lines in the vicinity of the incident elbow are shown in Figure 49. The peak tensile stresses on the outside wall of the elbow intrados were 41.3 ksi and 55.2 ksi for the 200 atm and 1000 atm moduli soils, respectively. While the magnitude of stress varies for the different soil moduli, the location of the peak tensile stress on the outside wall of the elbow does not change. All of these stresses are summarized in Table 5, and all are approaching magnitudes that would be consistent with failure of the elbow.

Figure 49. Tensile stresses in the gas pipes when subjected to 0.2 in/ft of shear in the fault creep direction but with varying soil moduli, 200 atm (top) and 1000 atm (bottom). Units are ksi.

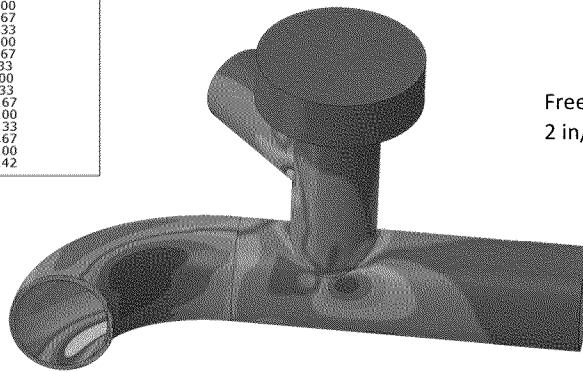
Free Boundary Condition  
2 in/ft fault creep shear

Fontaine pipe such that it cannot move axially and is forced into compression during the shearing, and a second model which provided a softer constraint that allowed the pipe to move only half the distance that it would if it were free to slide. The resulting tensile stresses in the region of the elbow and neighboring tee are shown in Figure 50. In all cases, the tensile stresses are near the magnitude to cause failure.

Figure 50. Tensile stresses in the incident elbow and neighboring tee for different boundary conditions on the Fontaine Street pipe. Note that the models have decreasing amount of shear despite increasing stresses. Units are ksi.

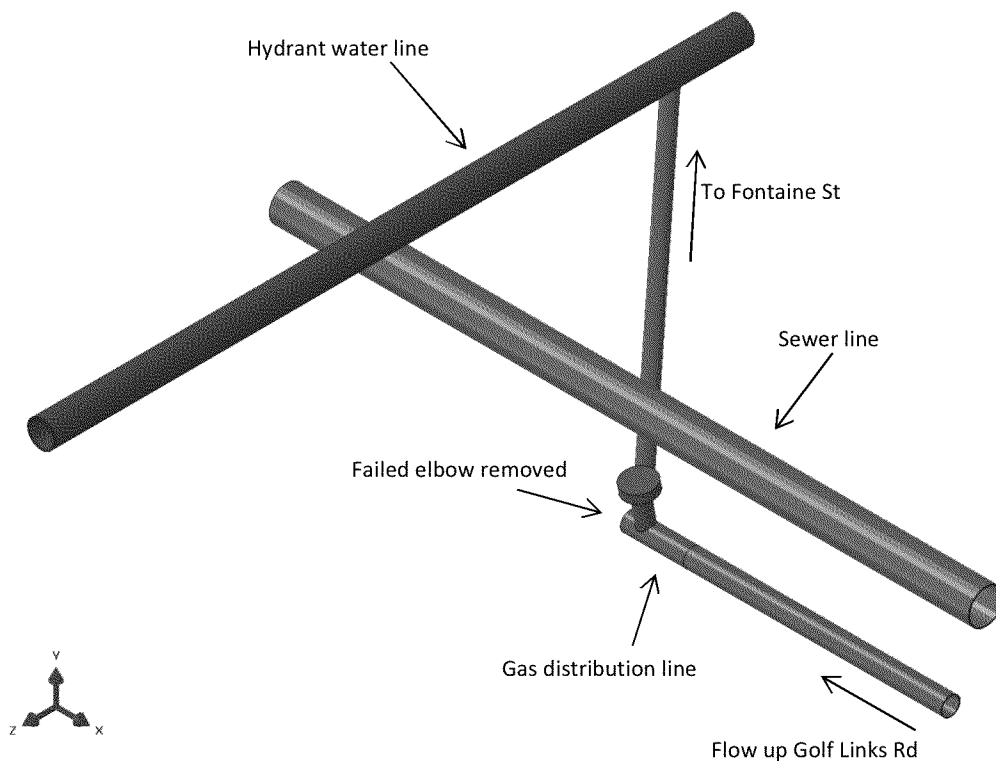
A finite element model was created to investigate the current stresses in the incident area following removal of the subject elbow and downstream piping. This new model is shown in Figure 51. The model was subjected to fault-creep shear of 0.2 in/ft consistent with the shear modeled in the subject elbow analysis. Tensile stresses in the repaired gas line near the location of the fractured elbow are shown in Figure 52; the stresses are reduced as compared with the stresses in the original configuration before the incident (upper image of Figure 50). Local stresses in the vicinity of the flange tee were predicted to be near 30 ksi. Thus, even after the removal of the subject elbow and associated downstream piping, stresses at the junction between the Golf Links Road and Fontaine Street piping could be as high as 30 ksi.

Figure 51. Post-repair model.

After the failure, the connection between the [Redacted] pipe and the [Redacted] Road pipe remains intact. Exponent's stress analysis indicates that local stresses at this connection may be approximately 30 ksi. As more fault creep occurs in the future, these stresses are expected to increase.

- After the failure, the connection between the [Redacted] pipe and the [Redacted] pipe remains intact. Exponent's stress analysis indicates that local stresses likely remain in the existing configuration. As more fault creep occurs in the future, these stresses are expected to increase. Exponent recommends the current connection be replaced to relieve the current stresses.

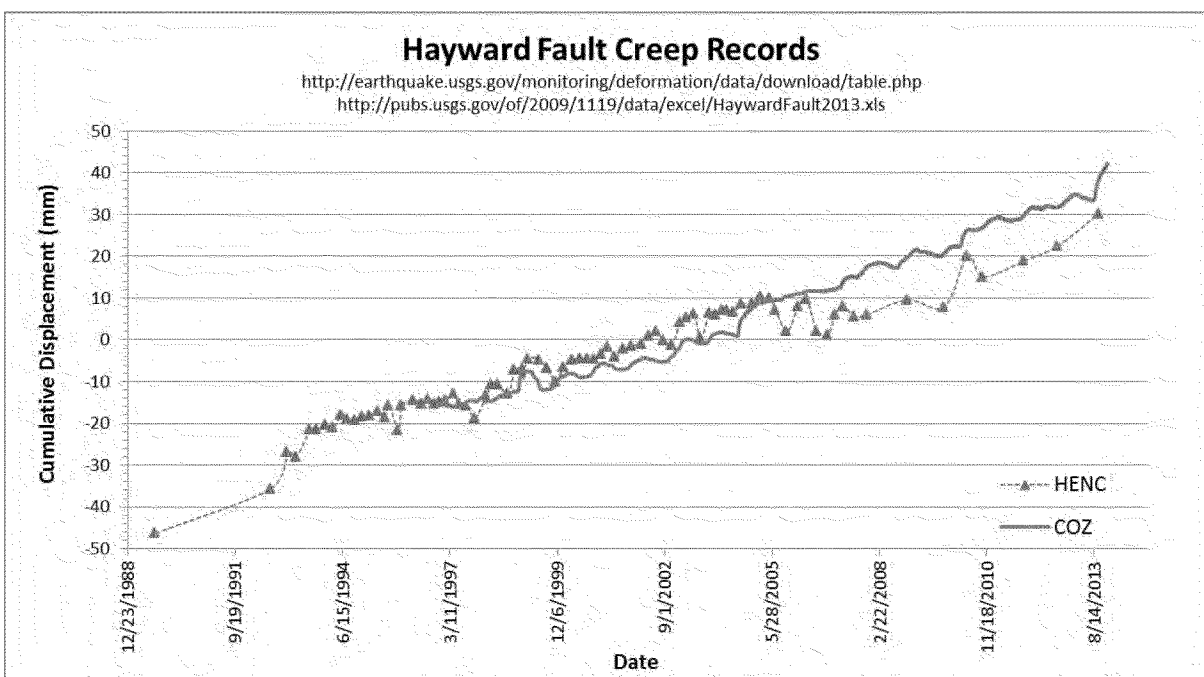
Figure D-3. [Redacted] creep records in the vicinity of [Redacted] (for available record interval). HENC = [Redacted] COZ = [Redacted]

As previously noted, at the En [Redacted] a total displacement of over 76 mm has been measured since 1989, for an average creep rate of 3.2 mm/yr. At the [Redacted] Station a total displacement of over 57 mm has been measured since 1996, for an average creep rate of 3.3 mm/yr.

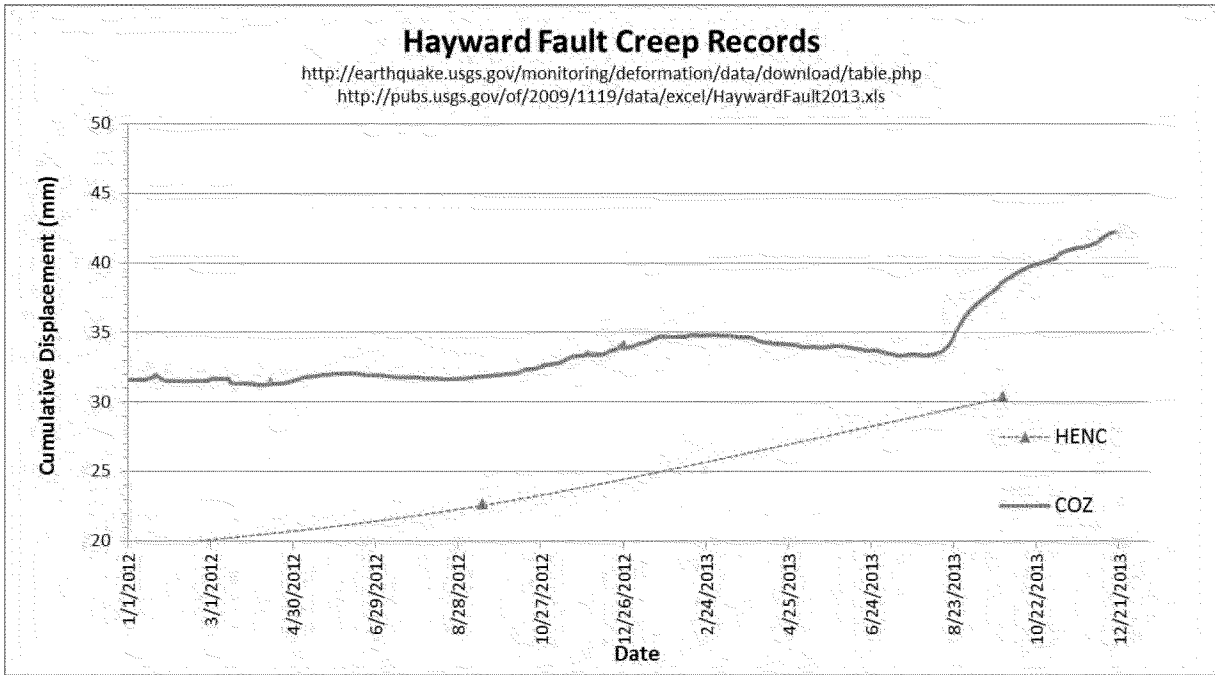
Figure D-4 shows the 2012 and 2013 portion of the data presented in Figure D-3. The figure shows an acceleration of creep movement measured at the [Redacted] starting in approximately August 2013. The timing of the gas release event may be related to this acceleration of creep movement.

Figure D-4. Hayward Fault creep records in the vicinity of [Redacted] (for 2012 and 2013). HENC = [Redacted] COZ = [Redacted]
