**Golf Links Road (Oakland)  
Incident Analysis**

January 2014  
Revised January 20, 2014

Doc. no. 1308766.000 - 3956

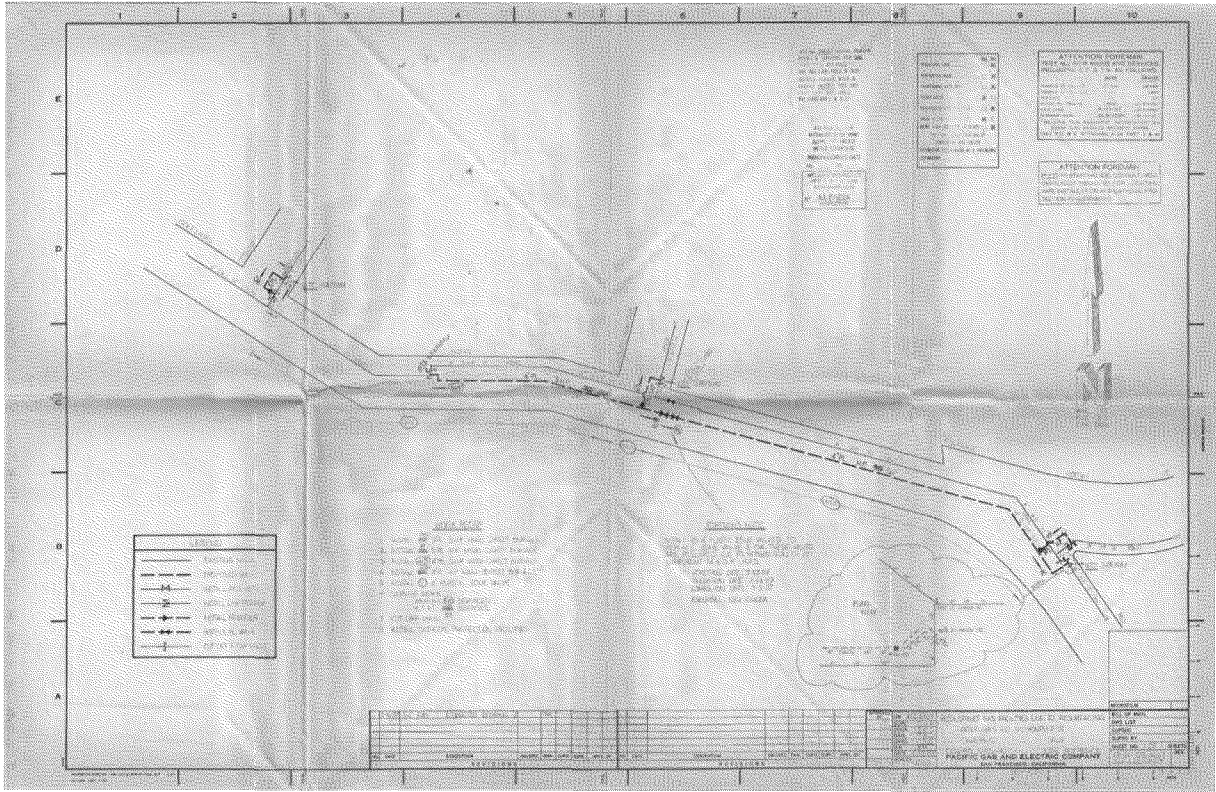
Figure 10. As-built construction drawing for G.M. 4564829 (1987).

- G.M. 4564829 (1987) - Installed a 4-inch diameter plastic distribution main along Golf Links Road starting near the leak site and extending northwest. This main was installed to replace an existing 4-inch steel main. During this job, a piece of 4-inch pipe that was installed in 1946 in the immediate vicinity of the gas release was cut and capped. The 4-inch plastic distribution main was installed with a steel-to-plastic transition, two elbows, and approximately four feet of steel pipe that connected to the existing 1946 4-inch steel main using a 3-inch flanged tee. An as-built construction drawing for G.M. 4564829 is shown in Figure 10 and Figure 11. The pipeline features and locations shown in this drawing were consistent with the features in the ground.

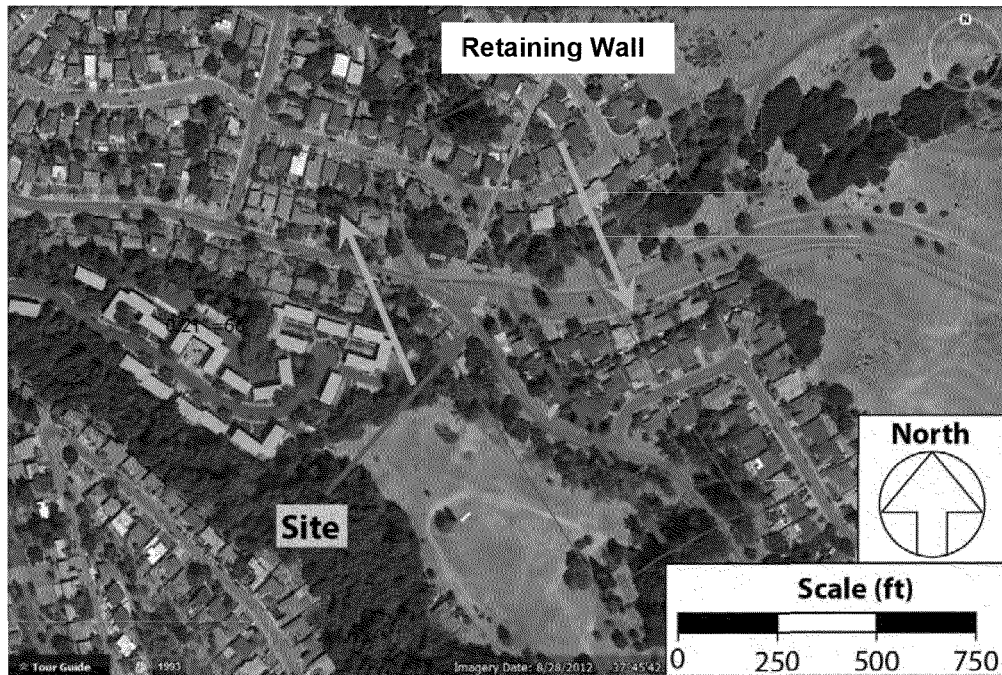
Lienkaemper (2006, revised 2008) stated that the accuracy of the mapped location of active fault traces varies throughout the mapped fault zone. In the vicinity of the Site, the actual active trace of the Hayward Fault is interpreted to be within 60 meters of the line shown on the map. Figure 29 shows the approximate area in which the active trace of the Hayward Fault is interpreted to be located, according to the Lienkaemper map. As shown on this figure, the Site is well within the mapped location of the active Hayward Fault trace. Figure 29 also shows the approximate direction of right-lateral displacement of the Hayward Fault in the vicinity of the Site. Figure 30 shows a plan view of the approximate configuration of the pipe system exposed during repairs and the pipe rupture location. The figure also shows the approximate direction of right-lateral movement of the Hayward Fault in the vicinity of the Site.

Figure 29. Aerial photograph showing approximate location of recently active trace of Hayward Fault in immediate vicinity of Site. Red box indicates width of zone of uncertainty within which the active fault trace is interpreted to be located. Sources: Google Earth; Lienkaemper (2006, revised 2008) <http://pubs.usgs.gov/ds/2006/177/>.

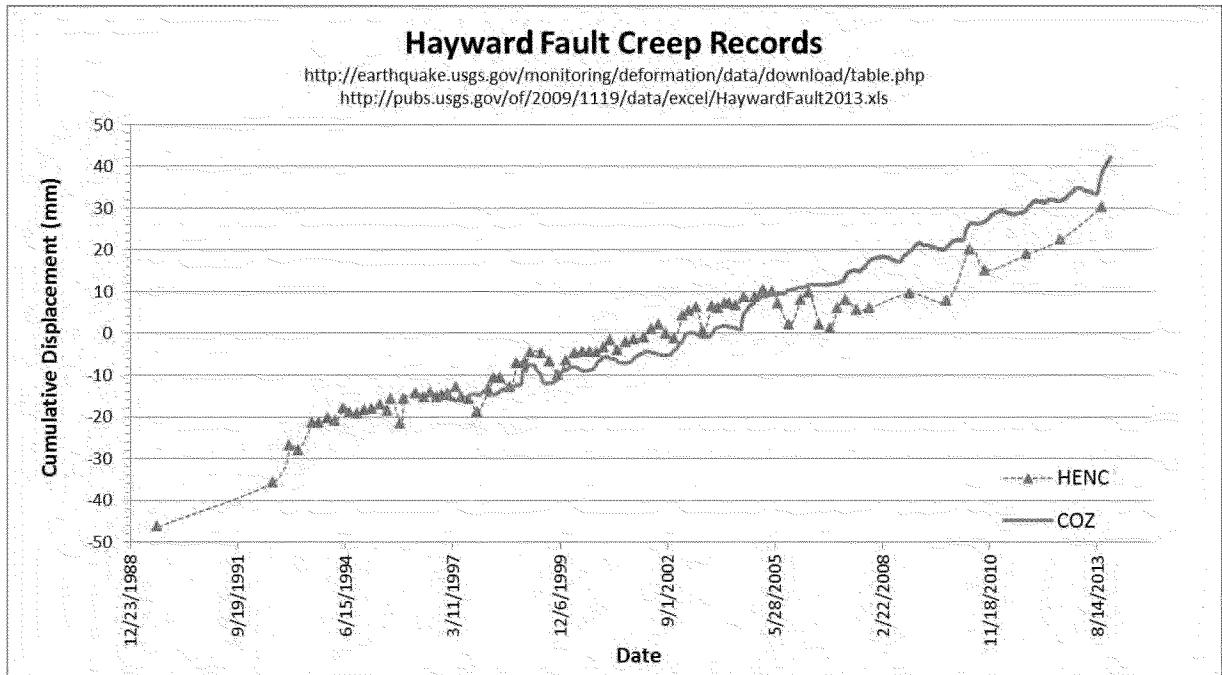
For the Encina Way Station (HENC), McFarland et al. (2009, revised 2013)<sup>12</sup> published creep data that have been recorded since 1989. For the Oakland Zoo Station (COZ), the USGS published creep data that have been recorded since 1996. Figure 34 shows the available data for these two stations. As shown in this figure, at the Encina Way Station a total displacement of

over 76 mm has been measured since 1989, for an average creep rate of 3.2 mm/yr. At the Oakland Zoo Station a total displacement of over 57 mm has been measured since 1996, for an average creep rate of 3.3 mm/yr. The figure shows an acceleration of creep movement measured at the Oakland Zoo Station starting in approximately August 2013. The timing of the gas release event may be related to this acceleration of creep movement. Additional creep data information is included in Appendix D.

Figure 34. Hayward Fault creep records in the vicinity of Golf Links Road (for available record interval). HENC = Encina Way Station. COZ = Oakland Zoo Station.

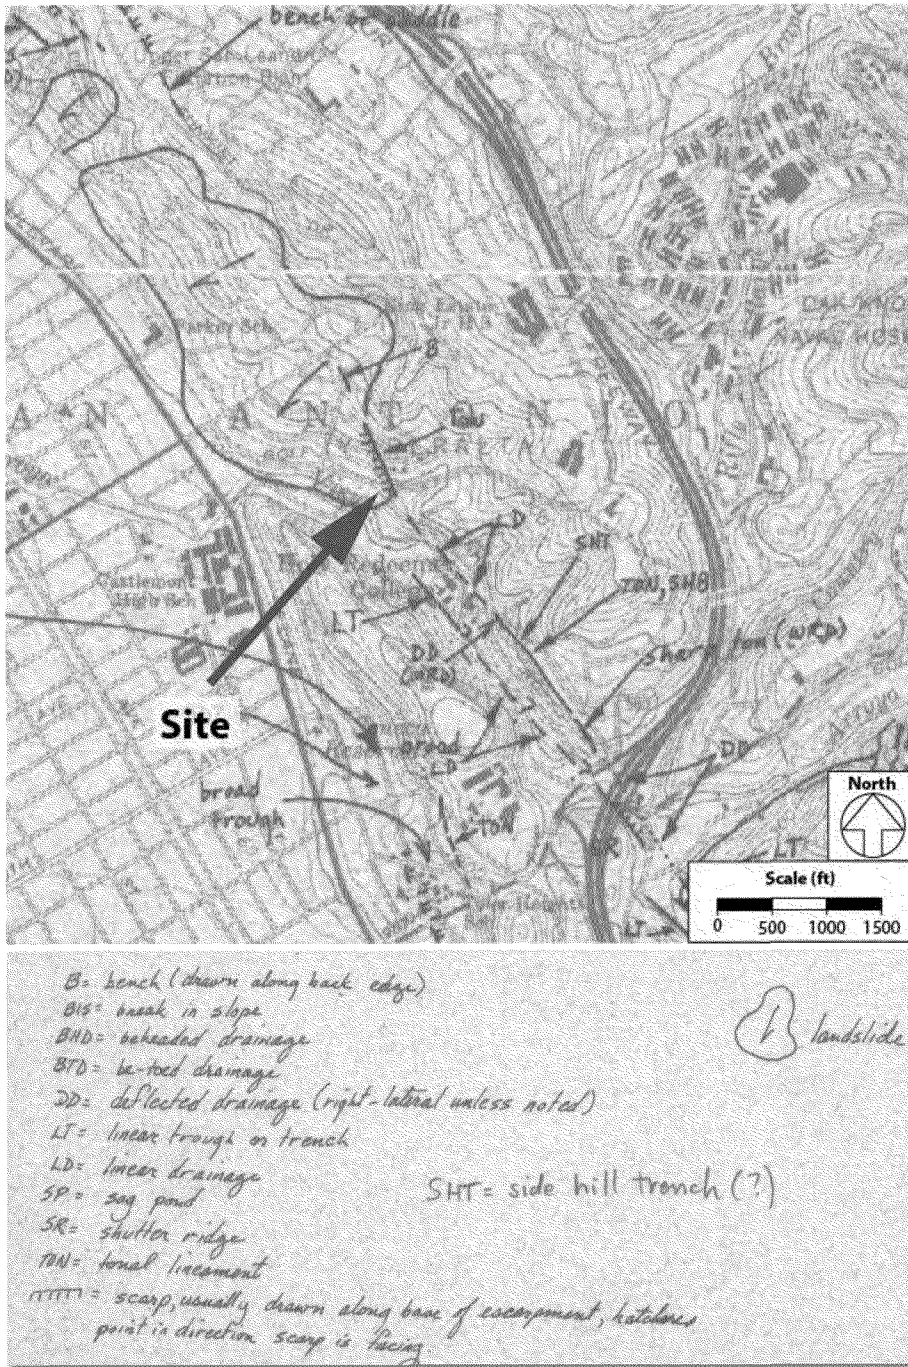
Exponent assessed the likelihood of landslide movement causing external forces on the pipe at the Site. As shown in Figure 36, the Site is located on the edge of a large ancient landslide. Exponent observed evidence of this landslide on topographic maps, aerial photographs, and in the field. In addition, a steep slope below Golf Links Road is potentially susceptible to landsliding.

The large landslide occurred long before development of the neighborhood. Its boundary in the immediate vicinity of the Site is based on maps made by interpretation of aerial photographs taken in 1939.<sup>14</sup> Subsequent grading for construction of Fontaine Street included excavation of a portion of the landslide mass northwest of the Site, changing the loads acting on the Site slope, likely reducing the potential for sliding at the Site.<sup>15</sup>

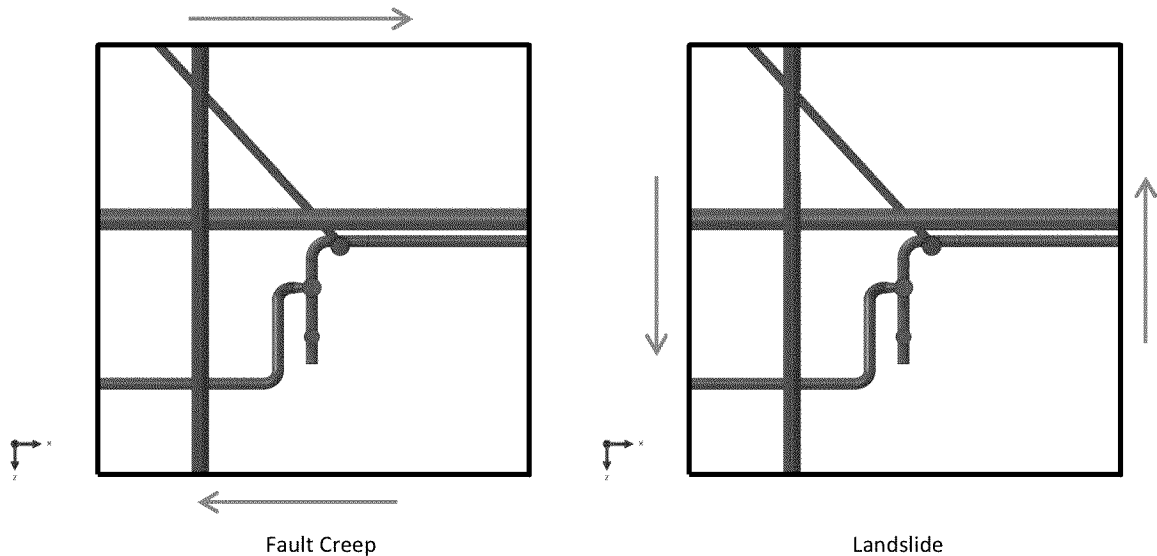
Because gravitational loading alone is not sufficient to achieve tensile stresses in the elbow that are consistent with the observed mode of failure, ground shearing movement was investigated as a possible source of stresses. After the model achieved equilibrium with gravitational loading, the soil was sheared in the horizontal plane to simulate ground movement associated with right-lateral strike-slip creep of the Hayward Fault or to simulate possible ground movement due to the ancient landslide. These two shearing directions are diagrammed in Figure 42. Two additional shearing directions were considered to investigate the sensitivity of the fault shearing direction; these directions were rotated  $\pm 10^\circ$  from the fault creep nominal condition shown in Figure 42.

Figure 42. The two primary ground movement shearing directions considered in the finite element model. The left image shows the shearing consistent with right-lateral strike-slip creep of the Hayward Fault, and the right image shows the shearing consistent with ground movement due to a nearby landslide.

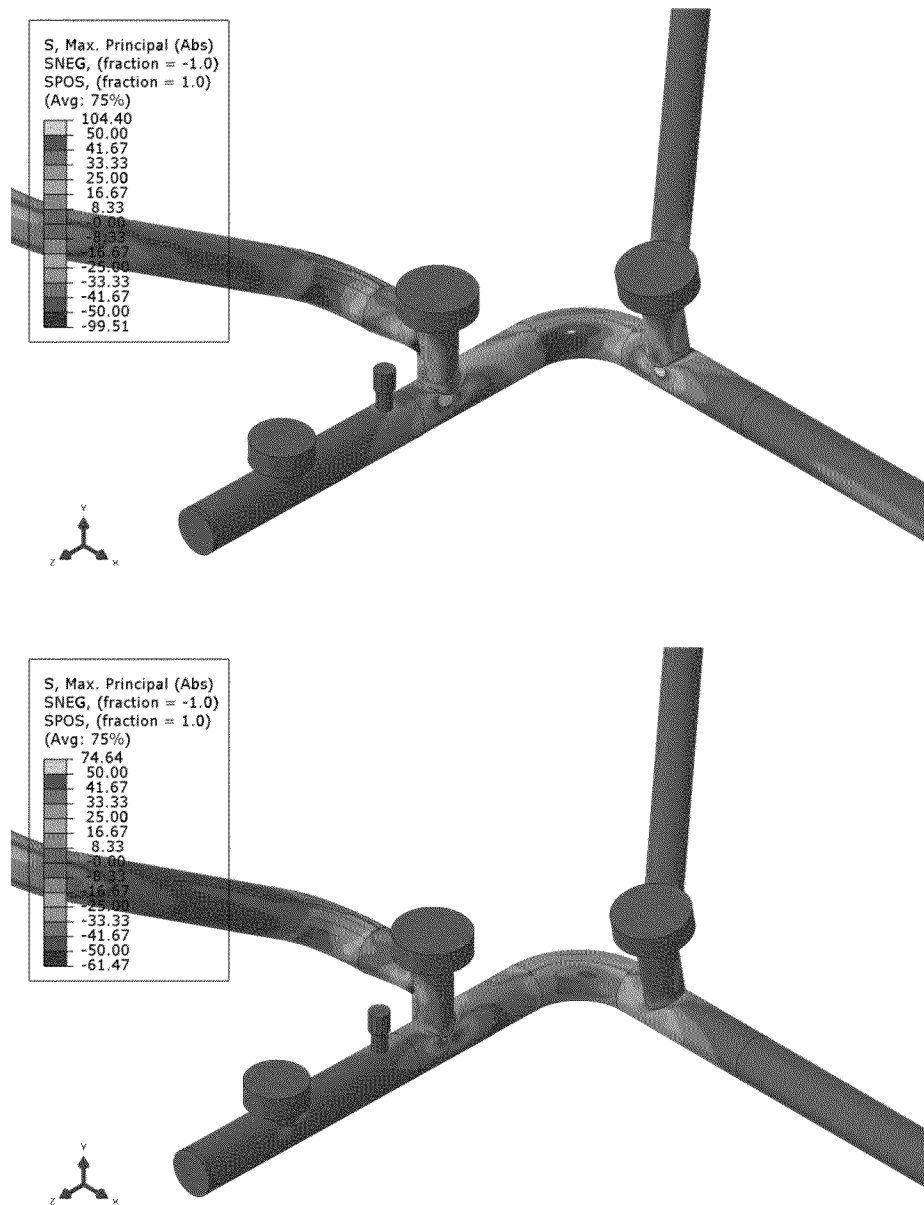
To further investigate the sensitivity to shearing direction on the peak tensile stress magnitude and location, the fault creep shearing direction was varied by  $\pm 10^\circ$ . Tensile stresses in the gas lines in the vicinity of the incident elbow are shown in Figure 48. The peak tensile stresses on the outside wall of the elbow intrados were slightly higher for the  $+10^\circ$  shearing direction and lower for the  $-10^\circ$  direction (50.2 ksi and 42.7 ksi respectively) as compared with the nominal fault creep condition in Figure 46. The location of the peak stress also shifted along the axial position of the elbow.

Figure 48. Tensile stresses in the gas pipes when subjected to 0.2 in/ft of shear in the fault creep +10° direction (top) and the fault creep -10° direction (bottom). Rotation angles are with respect to the model's y-axis. Units are ksi.

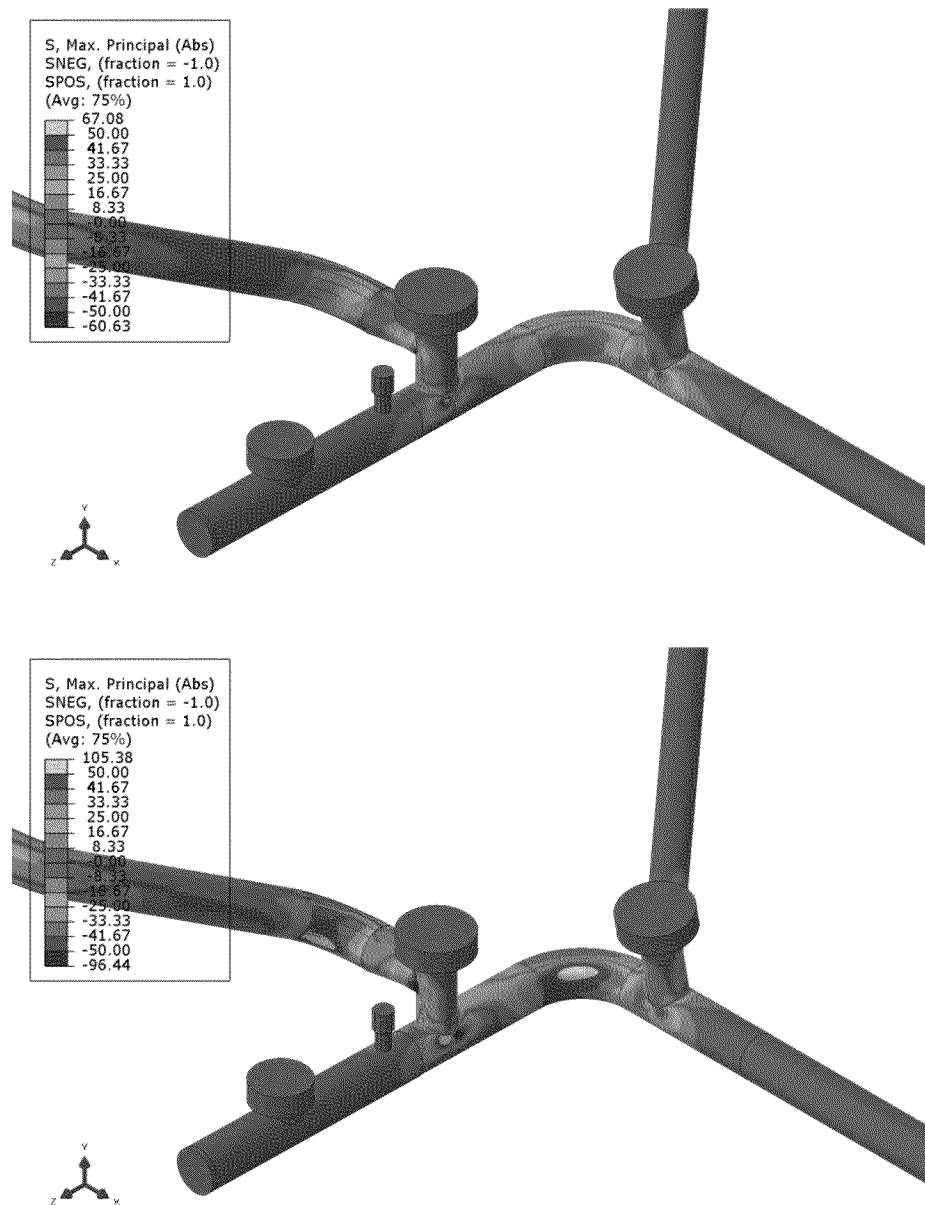
To investigate the sensitivity of soil modulus on the peak tensile stress magnitude, two other soil moduli were investigated, 200 atm and 1000 atm, as compared with the nominal value of 500 atm. Tensile stresses in the gas lines in the vicinity of the incident elbow are shown in Figure 49. The peak tensile stresses on the outside wall of the elbow intrados were 41.3 ksi and 55.2 ksi for the 200 atm and 1000 atm moduli soils, respectively. While the magnitude of stress varies for the different soil moduli, the location of the peak tensile stress on the outside wall of the elbow does not change. All of these stresses are summarized in Table 5, and all are approaching magnitudes that would be consistent with failure of the elbow.

Figure 49. Tensile stresses in the gas pipes when subjected to 0.2 in/ft of shear in the fault creep direction but with varying soil moduli, 200 atm (top) and 1000 atm (bottom). Units are ksi.

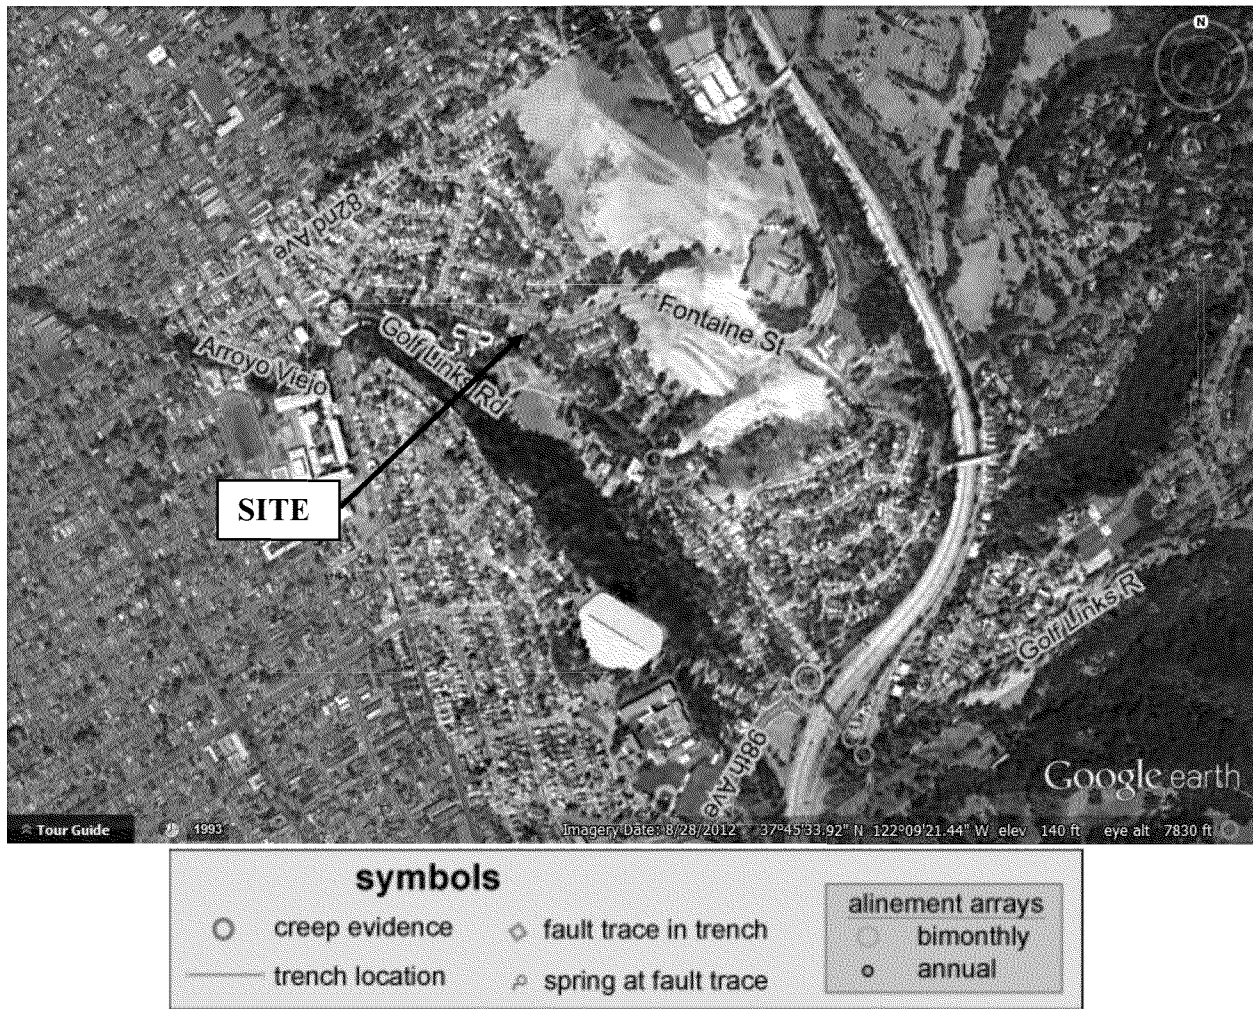
Figure D-1. Map showing recently active trace of Hayward Fault in vicinity of Site. Sources: Lienkaemper, J.J., 2006, revised 2008, Digital database of recently active traces of the Hayward Fault, California: USGS DS-177, <http://pubs.usgs.gov/ds/2006/177/> overlain on 2012 Google Earth air photo.
