Re: Update - Oakland Incident of December 10, 2013

Failure Analysis Associates

Pacific Gas and Electric (PG&E) has retained Exponent Failure Analysis Associates (Exponent) to conduct a failure analysis investigation of an elbow that fractured as part of a four-inch natural gas distribution line on December 10, 2013 near the intersection of [Redacted] [Redacted] in Oakland, California. Our investigation to-date has included inspection of the leak site, review of PG&E's historical construction documents, a fire cause and origin study, metallurgical analysis, geotechnical analysis, analysis of other leak locations within the immediate area, and finite element-based stress analyses of ground movement and stresses on the subject elbow and associated piping.

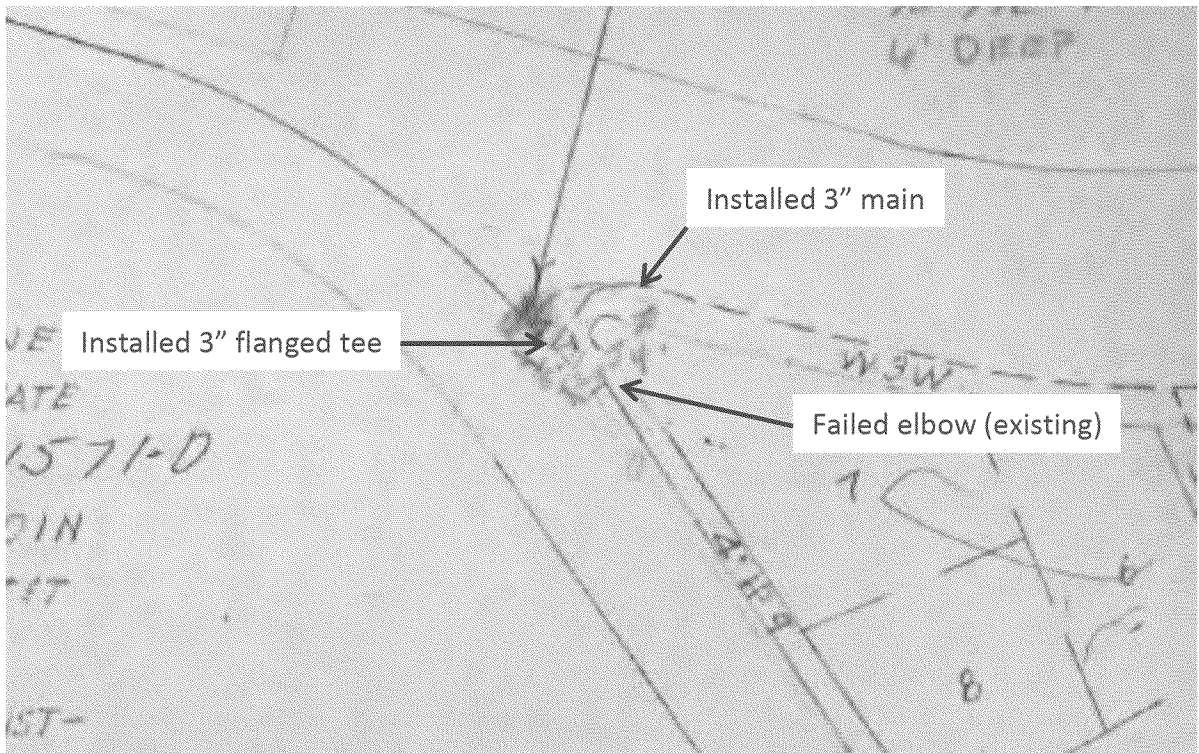
Figure 9. Cropped view of preliminary construction drawing for W.O. 4747 (1965) showing area of leak.

- W.O. 4747 (1965) - Installed a 3-inch diameter steel main extending along [Redacted] [Redacted]. The 3-inch steel main was connected to the existing 4-inch steel main using a 3-inch flanged tee. A preliminary construction drawing from W.O. 4747 is shown in Figure 8 and Figure 9. This construction drawing has a very low level of detail in the area of the leak. As-built construction drawings for W.O. 4747 were not available to Exponent at the time that this report was issued.

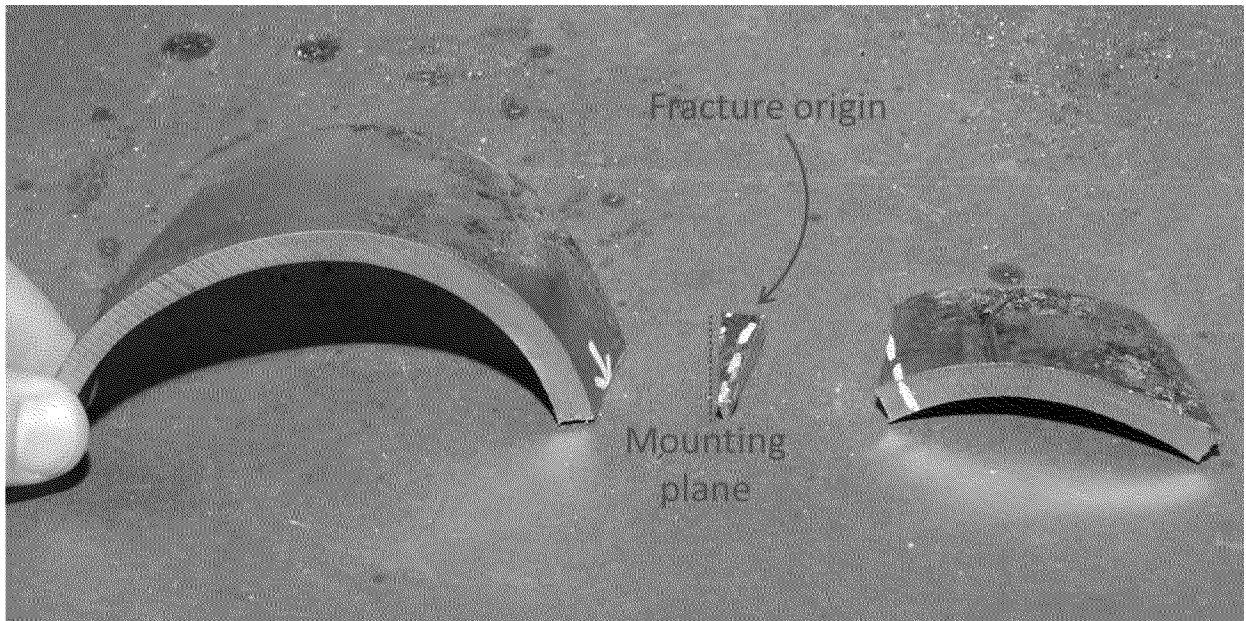
A portion of the fracture origin was sectioned to allow metallographic examination, shown in Figure 23. The sample was mounted perpendicular to the fracture plane (i.e., along the longitudinal direction along the elbow), and was ground, polished, and etched using typical metallographic procedures. The elbow exhibited a typical ferrite and pearlite microstructure, including at the fracture origin, as shown in Figure 24. Microhardness testing was conducted on the metallographic sample: the average hardness was measured to be 193 HV.

Figure 23. A photograph that shows the metallographic specimen from the origin area.

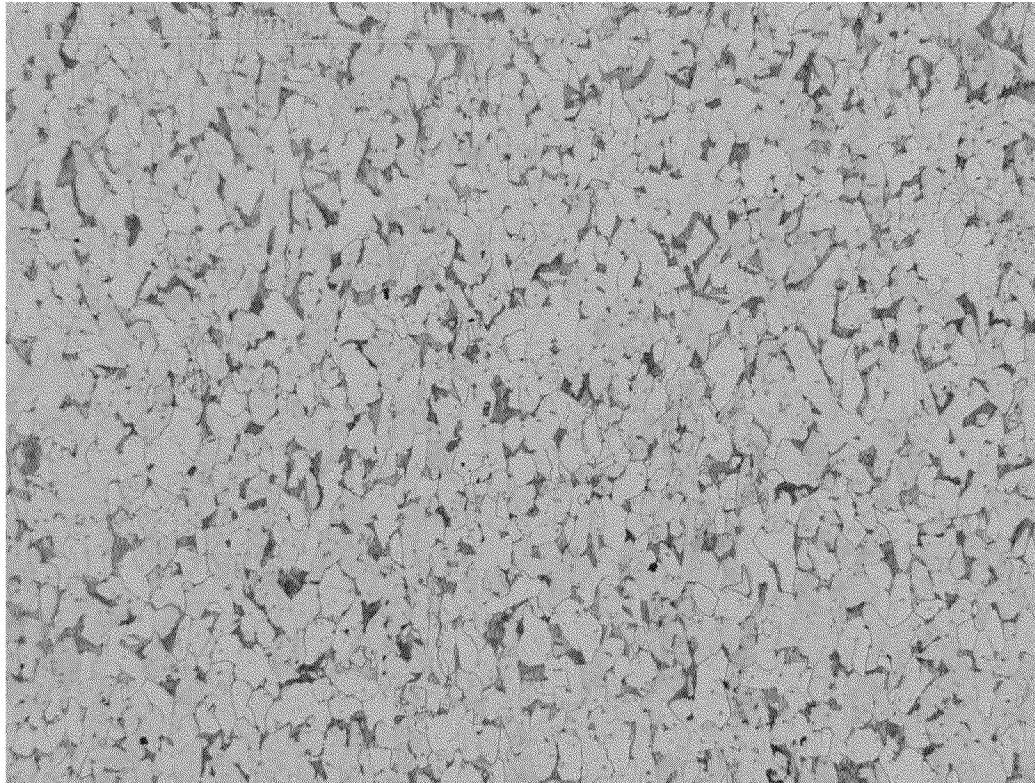
Figure 24. Metallographic image of the elbow ferrite-pearlite microstructure.

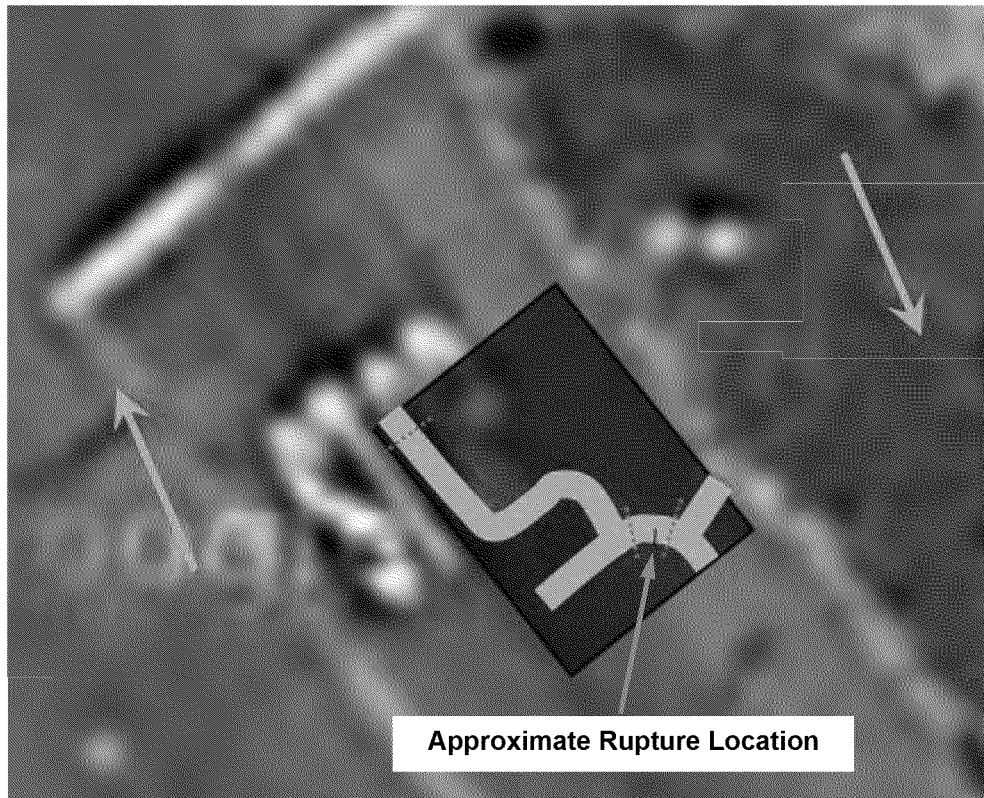
Figure 30. Plan view of pipe system exposed during repairs. Arrows indicate approximate direction of right-lateral movement of Hayward Fault in the vicinity of the Site. Photograph source: Google maps.

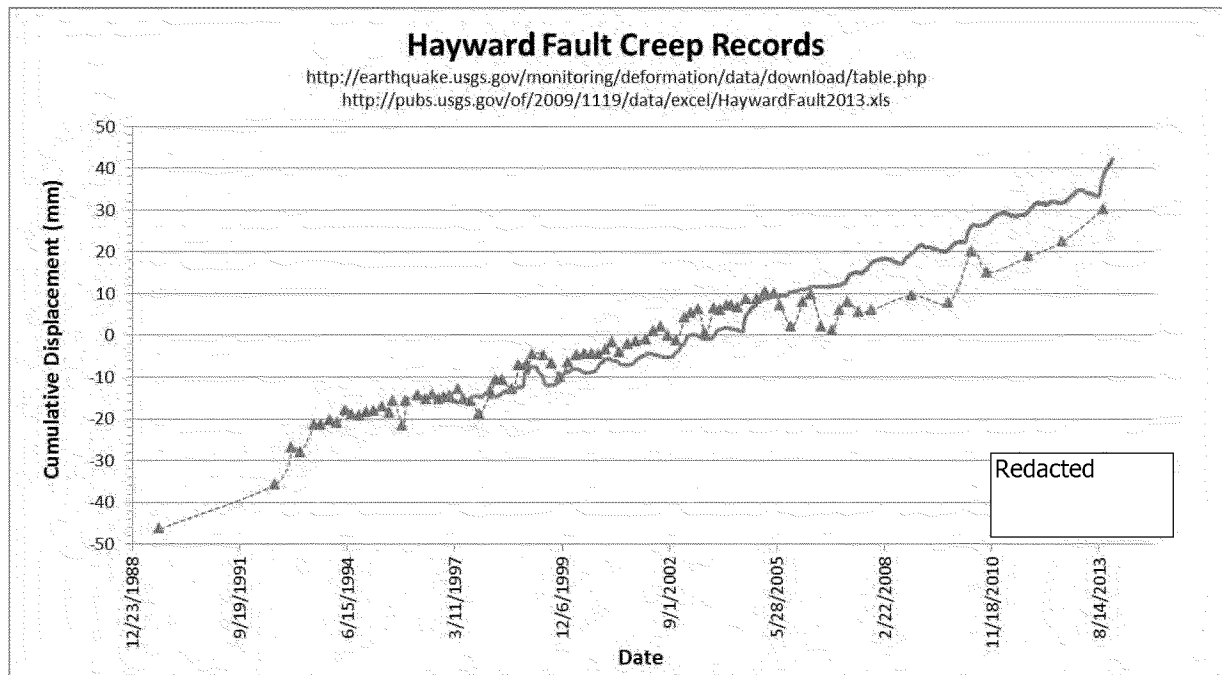
over 76 mm has been measured since 1989, for an average creep rate of 3.2 mm/yr. At the [Redacted] Station a total displacement of over 57 mm has been measured since 1996, for an average creep rate of 3.3 mm/yr. The figure shows an acceleration of creep movement measured at the [Redacted] Station starting in approximately August 2013. The timing of the gas release event may be related to this acceleration of creep movement. Additional creep data information is included in Appendix D.

Figure 34. Hayward Fault creep records in the vicinity of [Redacted] (for available record interval). [Redacted]

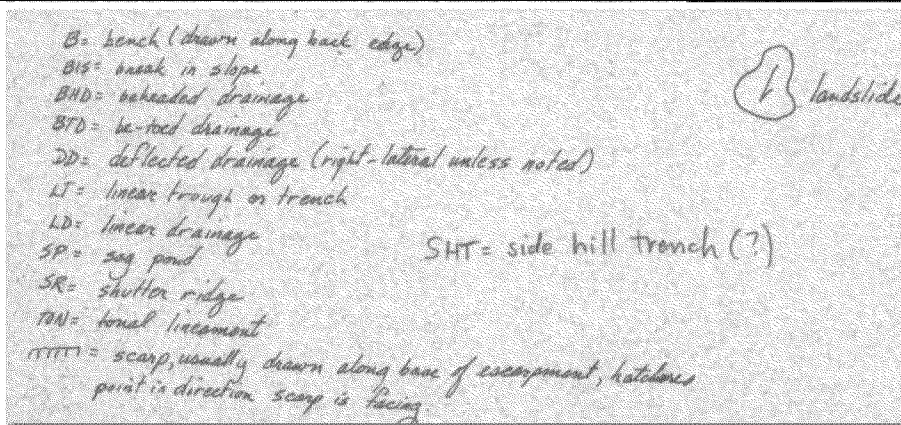
Exponent assessed the likelihood of landslide movement causing external forces on the pipe at the Site. As shown in Figure 36, the Site is located on the edge of a large ancient landslide. Exponent observed evidence of this landslide on topographic maps, aerial photographs, and in the field. In addition, a steep slope below [Redacted] is potentially susceptible to landsliding.

Figure 36. Map showing geomorphic and tonal features along recently active traces of the Hayward Fault. Based on 1939 (pre-development) aerial photographs. Source: California Division of Mines and Geology (now California Geological Survey), 1980, Fault Evaluation Report FER-102, Hayward fault (Oakland segment), Figure 4. Geomorphic and tonal features along recently-active traces of the Hayward fault, scale 1:24,000.

The large landslide occurred long before development of the neighborhood. Its boundary in the immediate vicinity of the Site is based on maps made by interpretation of aerial photographs taken in 1939.¹³ Subsequent grading for construction of [Redacted] included excavation of a portion of the landslide mass northwest of the Site, changing the loads acting on the Site slope, likely reducing the potential for sliding at the Site.¹⁴

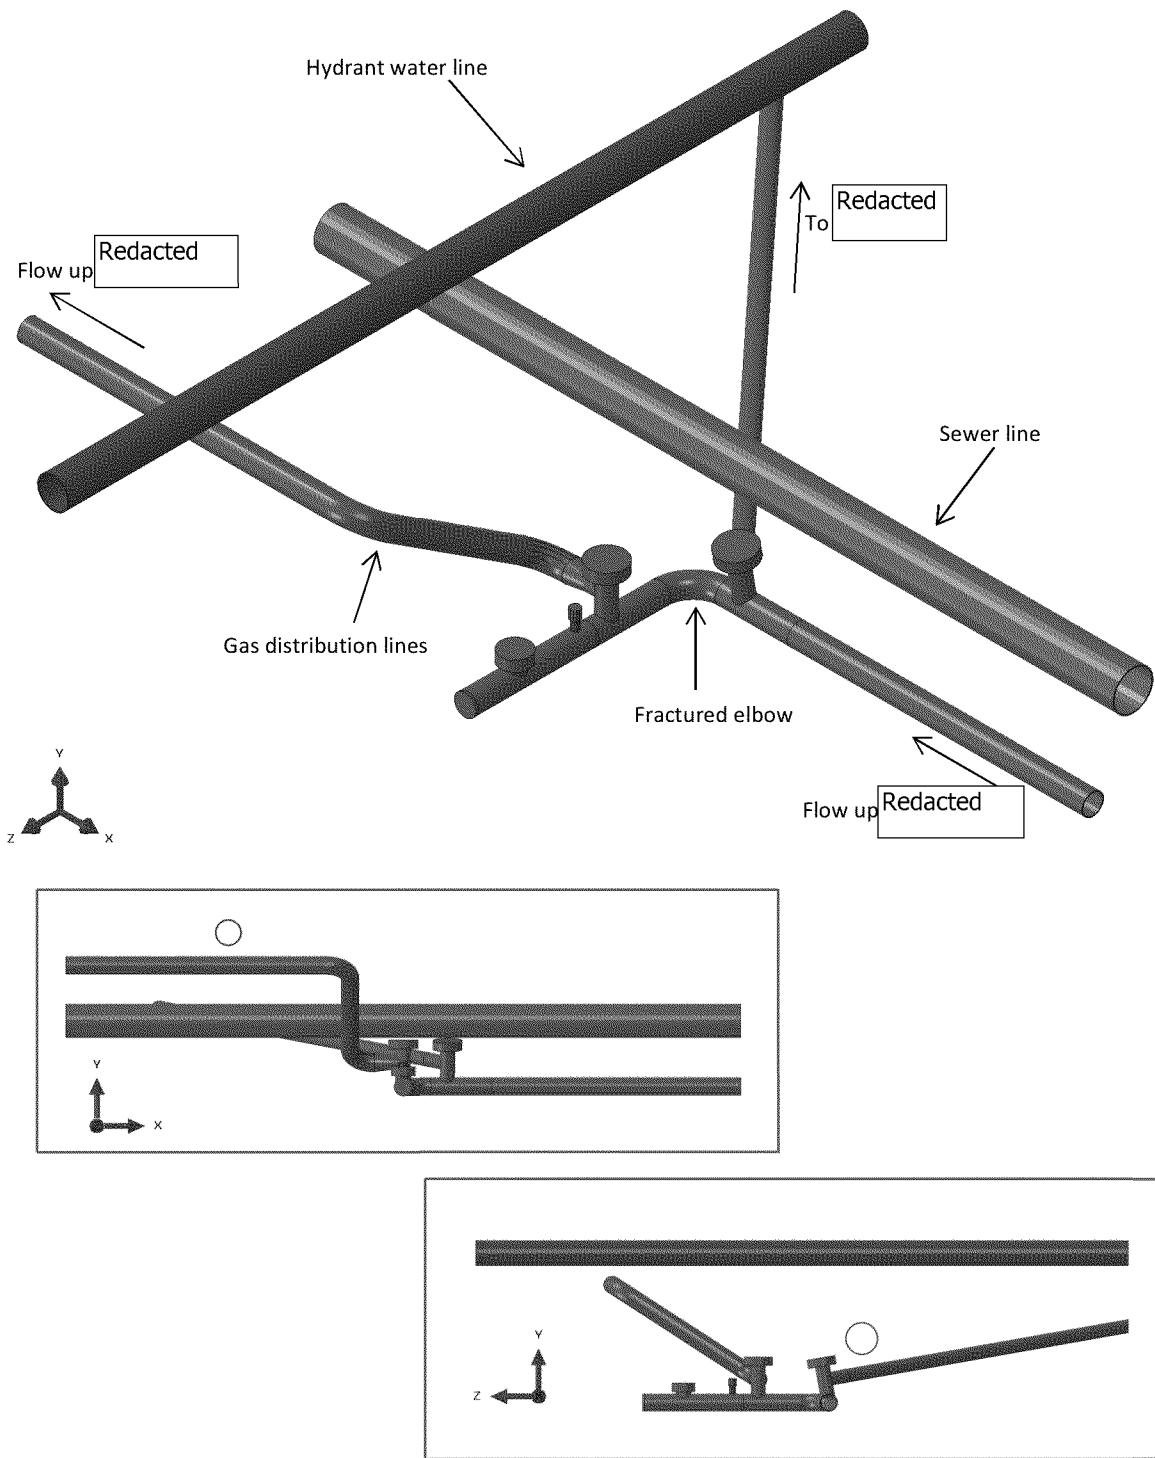
The Abaqus finite element software package was utilized to create a finite element model of the region near the incident to investigate loading scenarios that might have contributed to the subject elbow fracture. The region modeled is shown in Figure 37. Lines from three different utilities were included in the model: a network of gas distribution lines, a sewer line, and a hydrant water line. Surrounding soil was also included in the model, but is not shown in the figure.

The model encompasses a region that is 14 feet by 14 feet, 12 feet deep, and centered near the fractured elbow. The geometry of the gas piping shown to the left of the elbow in the figure was created from measurements of the pieces extracted after the repair. The tee to the right of the elbow was assumed to be identical to the one on the left (i.e. the one extracted after the repair). The gas lines traveling towards [Redacted] and up and down [Redacted] were assumed to have nominal dimensions (three and four-inches respectively). The hydrant water line was assumed to be a six-inch Schedule 40 steel pipe filled with water. The sewer line was assumed to be an empty eight-inch PVC pipe. The gas lines were assumed to be pressurized to 54 psig.

Figure 37. Network of pipes included in the finite element analysis. Surrounding soil was also included, but is not shown in the figure. The model encompasses a region that is 14 feet by 14 feet, 12 feet deep, and centered near the fractured elbow.

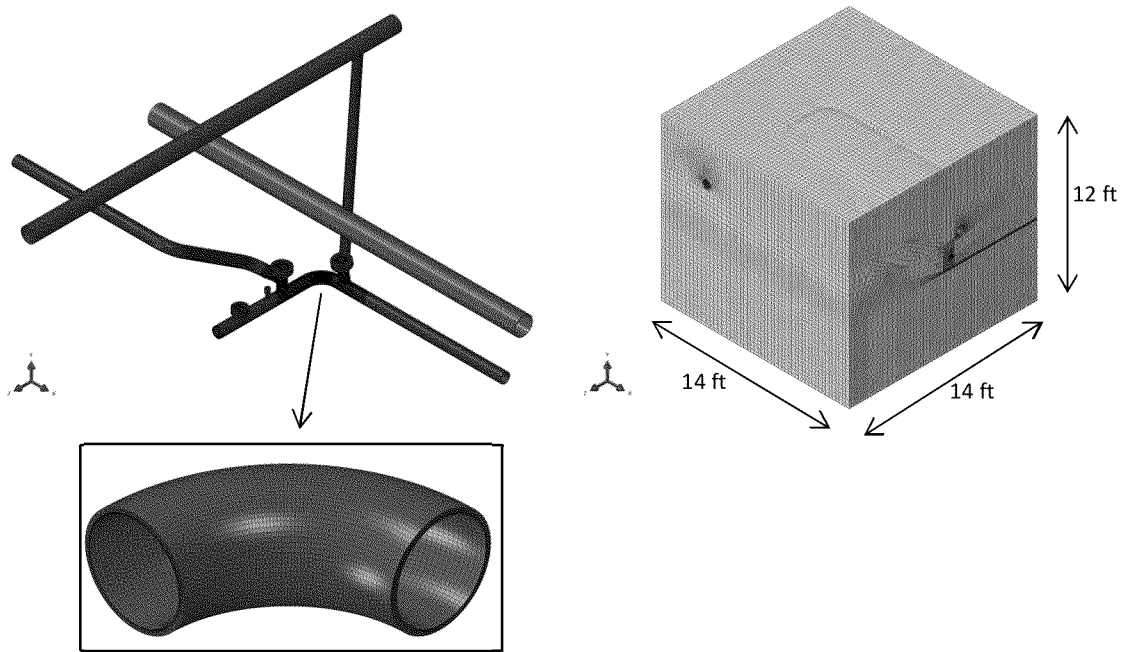
The finite element mesh used for the soil and pipes is shown in Figure 38. The subject elbow, the immediately adjacent pipes, the flange tees, and the soil were modeled with 3D hexahedral elements. The remaining gas pipes, the hydrant line, and the sewer line were all modeled with 3D continuum shell elements to reduce the numerical complexity. Approximately 560,000 elements were utilized in the model.

Figure 38. Mesh used in the finite element analysis. The failed elbow is shown in the lower left. The soil is shown in the upper right.

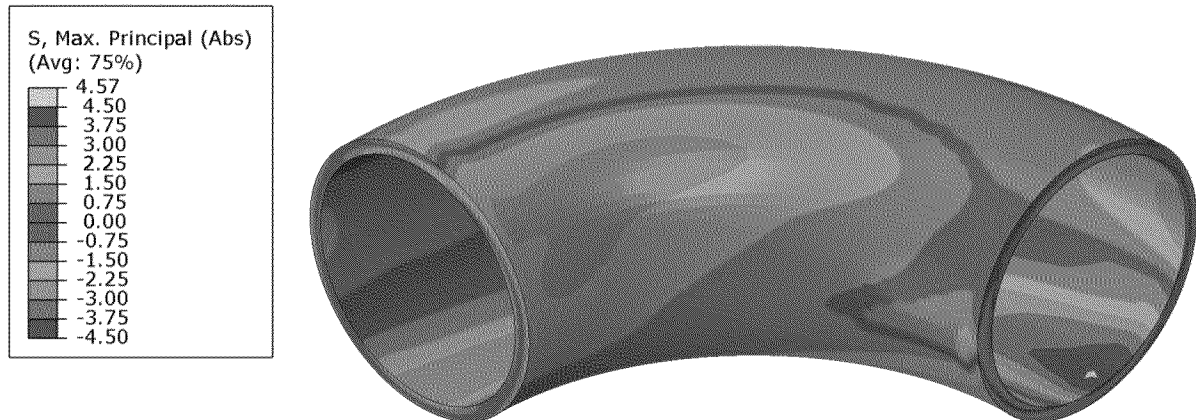
In order to determine the sensitivity of the elbow stresses to loading from heavy equipment on the road-surface, a load of 80,000 lbf was applied to the surface of the soil directly above the incident elbow in a patch of approximately 9” by 10”. This is approximately equivalent to a tractor trailer loaded to the legal limit, but carrying that load on just one tire instead of distributing the load over many tires.^{17,18} The resulting tensile stresses in the elbow are shown in Figure 41. The peak tensile stress is approximately 4.5 ksi and is located on the lower surface of the inside of the elbow. Tensile stresses near the failure location are approximately 2 ksi; this is not a sufficient amount of stress to cause failure.

Figure 41. Tensile stresses in the elbow when subjected to an 80,000 lbf truck load on the surface of the soil above the elbow.

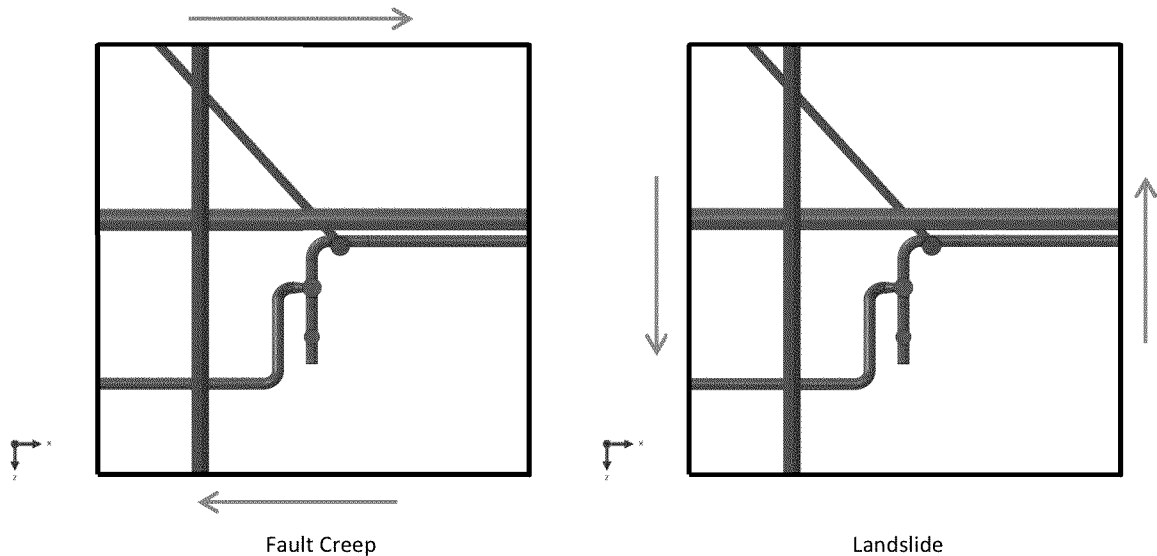
Because gravitational loading alone is not sufficient to achieve tensile stresses in the elbow that are consistent with the observed mode of failure, ground shearing movement was investigated as a possible source of stresses. After the model achieved equilibrium with gravitational loading, the soil was sheared in the horizontal plane to simulate ground movement associated with right-lateral strike-slip creep of the Hayward Fault or to simulate possible ground movement due to the ancient landslide. These two shearing directions are diagrammed in Figure 42. Two additional shearing directions were considered to investigate the sensitivity of the fault shearing direction; these directions were rotated $\pm 10^\circ$ from the fault creep nominal condition shown in Figure 42.

Figure 42. The two primary ground movement shearing directions considered in the finite element model. The left image shows the shearing consistent with right-lateral strike-slip creep of the Hayward Fault, and the right image shows the shearing consistent with ground movement due to a nearby landslide.

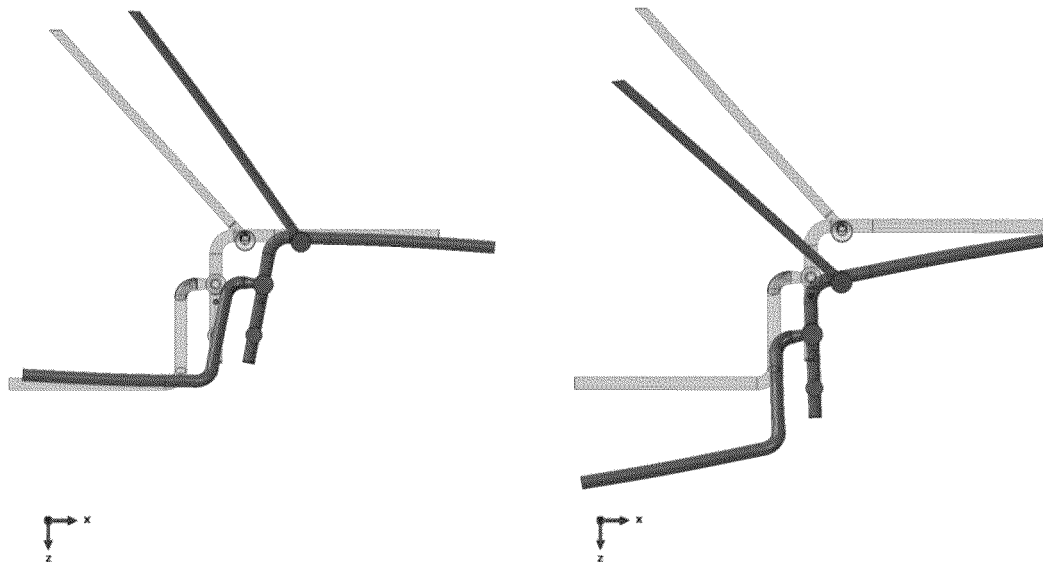
The resulting deflections of the gas pipe network when subjected to 0.2 in/ft of horizontal shear in the fault creep and landslide directions are shown in Figure 45. Tensile stresses in the gas lines in the vicinity of the incident elbow are shown in Figure 46. In both shearing conditions, tensile stresses were concentrated in the incident elbow near the failure location, i.e. on the outside surface of the elbow intrados, and have nearly the same tensile stresses for the same amount of ground shearing. The peak tensile stresses on the outside surface of the elbow intrados are 49.1 ksi for both the fault creep and landslide cases, and are shown on the left side of Figure 47. This stress approaches the magnitudes necessary to cause failure. However, note that the peak elbow stress occurred on the lower inside surface of the elbow, as indicated by the gray region in the left images of Figure 47, not on the outside wall of the elbow intrados. This point will be revisited later. Nonetheless, the magnitude, location and direction of peak tensile stress on the outside wall of the elbow intrados were consistent with the fractured incident elbow. Plots of the tensile stress direction on the outside surface of the elbow for the fault-creep and landslide-shear cases are shown on the right side of Figure 47.

Figure 45. Deformed shapes of the gas pipe network when subjected to fault-creep shear (left) and landslide shear (right). The total shearing applied is 0.2 in/ft, but the deformations are scaled by a factor of 10.

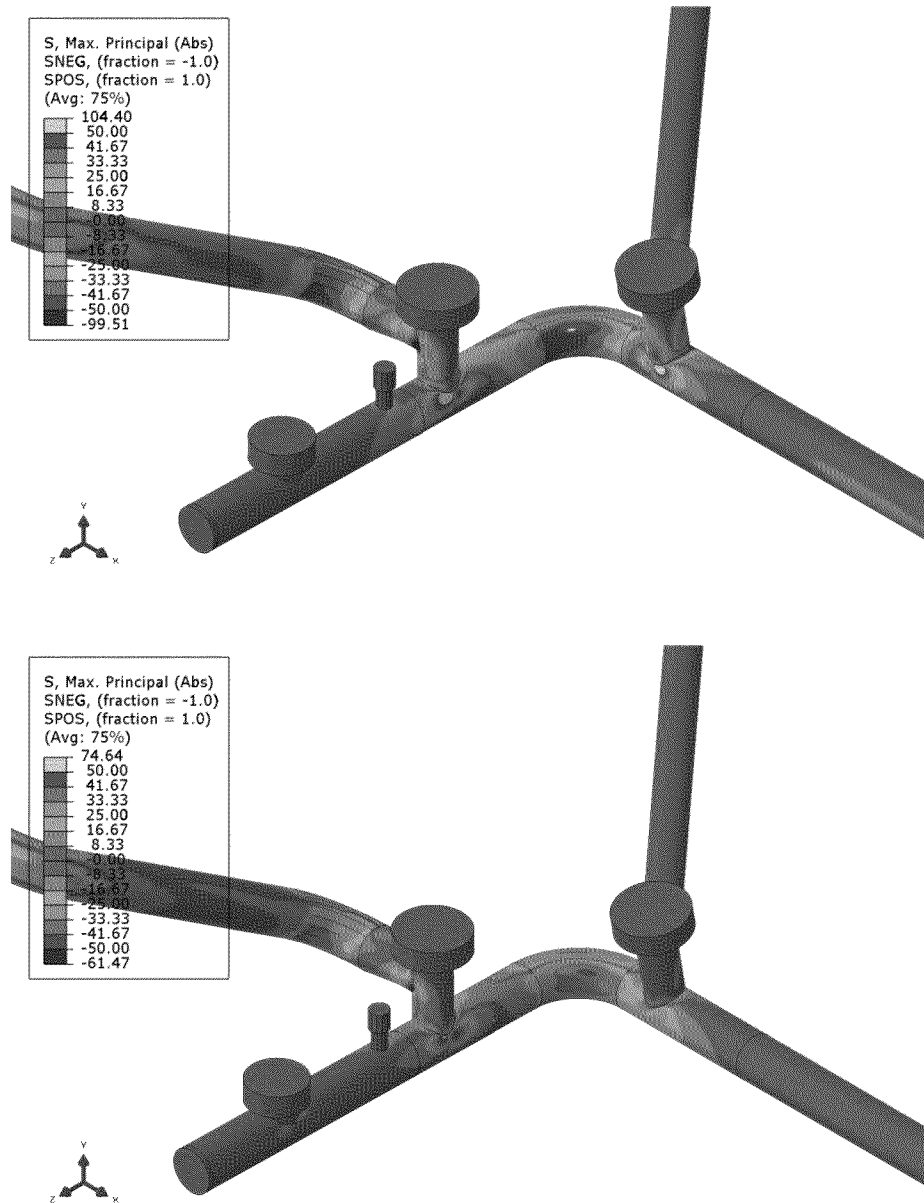
To further investigate the sensitivity to shearing direction on the peak tensile stress magnitude and location, the fault creep shearing direction was varied by $\pm 10^\circ$. Tensile stresses in the gas lines in the vicinity of the incident elbow are shown in Figure 48. The peak tensile stresses on the outside wall of the elbow intrados were slightly higher for the $+10^\circ$ shearing direction and lower for the -10° direction (50.2 ksi and 42.7 ksi respectively) as compared with the nominal fault creep condition in Figure 46. The location of the peak stress also shifted along the axial position of the elbow.

Figure 48. Tensile stresses in the gas pipes when subjected to 0.2 in/ft of shear in the fault creep +10° direction (top) and the fault creep -10° direction (bottom). Rotation angles are with respect to the model's y-axis. Units are ksi.

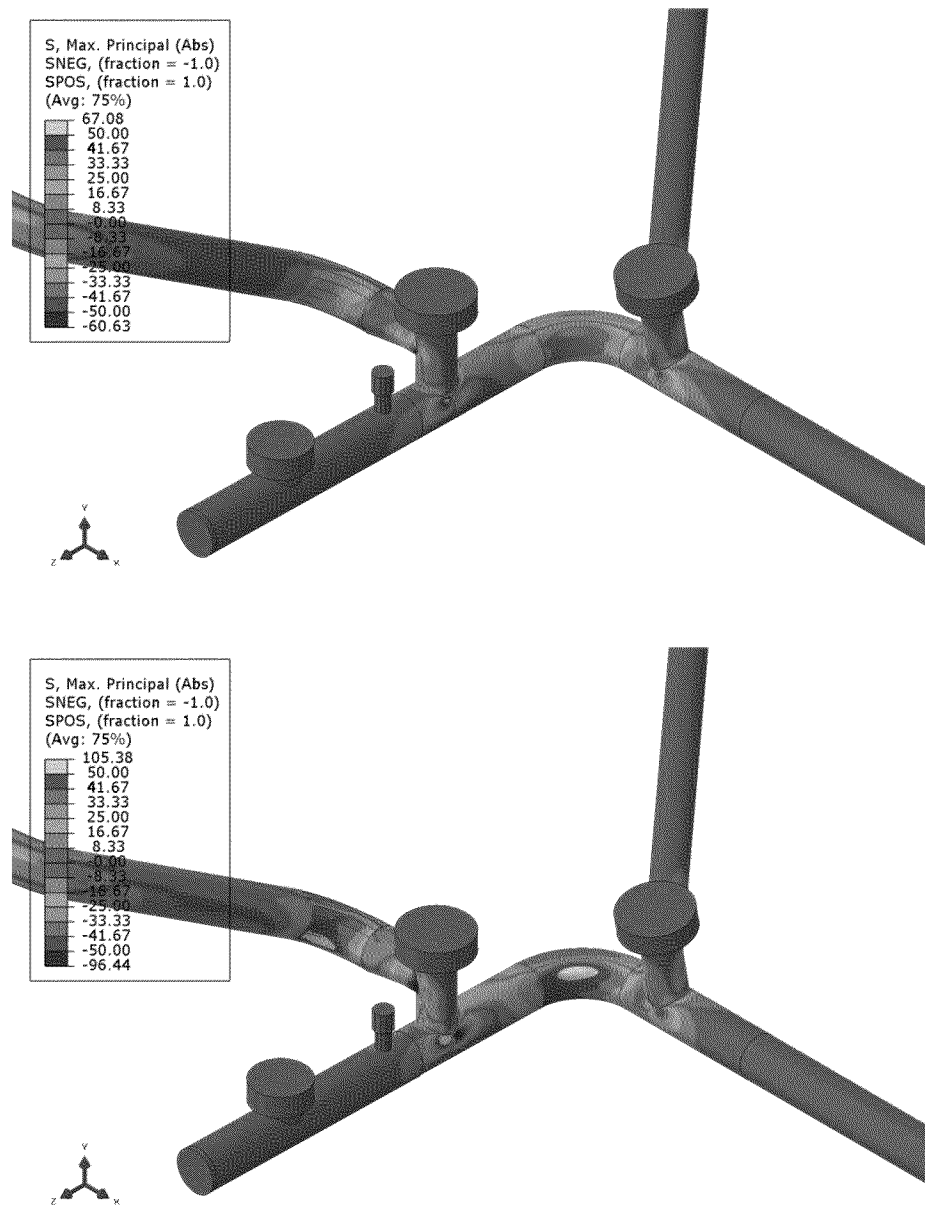
To investigate the sensitivity of soil modulus on the peak tensile stress magnitude, two other soil moduli were investigated, 200 atm and 1000 atm, as compared with the nominal value of 500 atm. Tensile stresses in the gas lines in the vicinity of the incident elbow are shown in Figure 49. The peak tensile stresses on the outside wall of the elbow intrados were 41.3 ksi and 55.2 ksi for the 200 atm and 1000 atm moduli soils, respectively. While the magnitude of stress varies for the different soil moduli, the location of the peak tensile stress on the outside wall of the elbow does not change. All of these stresses are summarized in Table 5, and all are approaching magnitudes that would be consistent with failure of the elbow.

Figure 49. Tensile stresses in the gas pipes when subjected to 0.2 in/ft of shear in the fault creep direction but with varying soil moduli, 200 atm (top) and 1000 atm (bottom). Units are ksi.

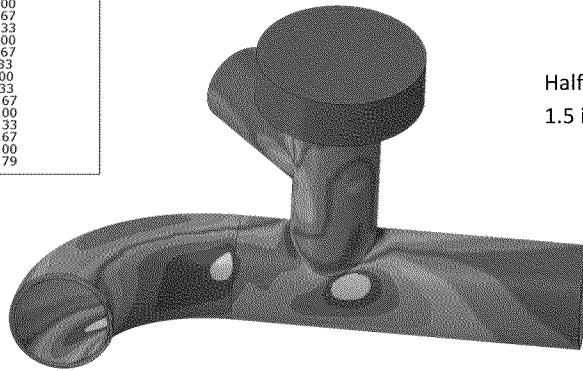
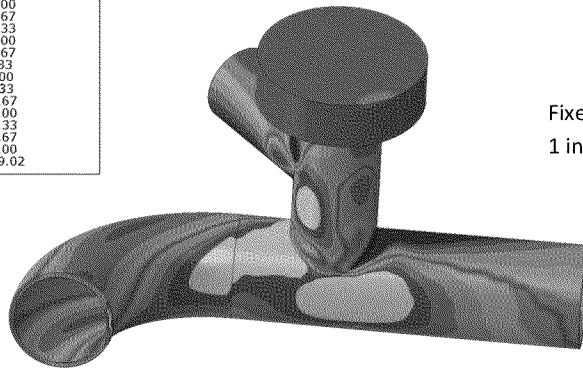
Redacted pipe such that it cannot move axially and is forced into compression during the shearing, and a second model which provided a softer constraint that allowed the pipe to move only half the distance that it would if it were free to slide. The resulting tensile stresses in the region of the elbow and neighboring tee are shown in Figure 50. In all cases, the tensile stresses are near the magnitude to cause failure.

A summary of the peak tensile stress on the outside and inside walls of the elbow for the three boundary condition cases is presented in Table 6. It is important to note that decreasing levels of shear were applied to the models as the constraint was increased. The reduction in ground movement shearing reduces the stresses on the inside wall of the elbow. If the constraint on the end of the Redacted pipe were unchanged, then we would also expect the stress on the outside wall to be reduced in a constant ratio. However, the constraint on the end of the Redacted pipe causes the stress on the outside of the elbow (as well as the neighboring tee) to increase, and therefore causes the peak tensile stress location to switch from the lower inside surface to the outside surface of the elbow intrados. The fully constrained condition is unrealistic and causes very high stresses in the tee; the true constraint condition is likely somewhere between the two extremes of free and fixed.

Figure 50. Tensile stresses in the incident elbow and neighboring tee for different boundary conditions on the Redacted pipe. Note that the models have decreasing amount of shear despite increasing stresses. Units are ksi.

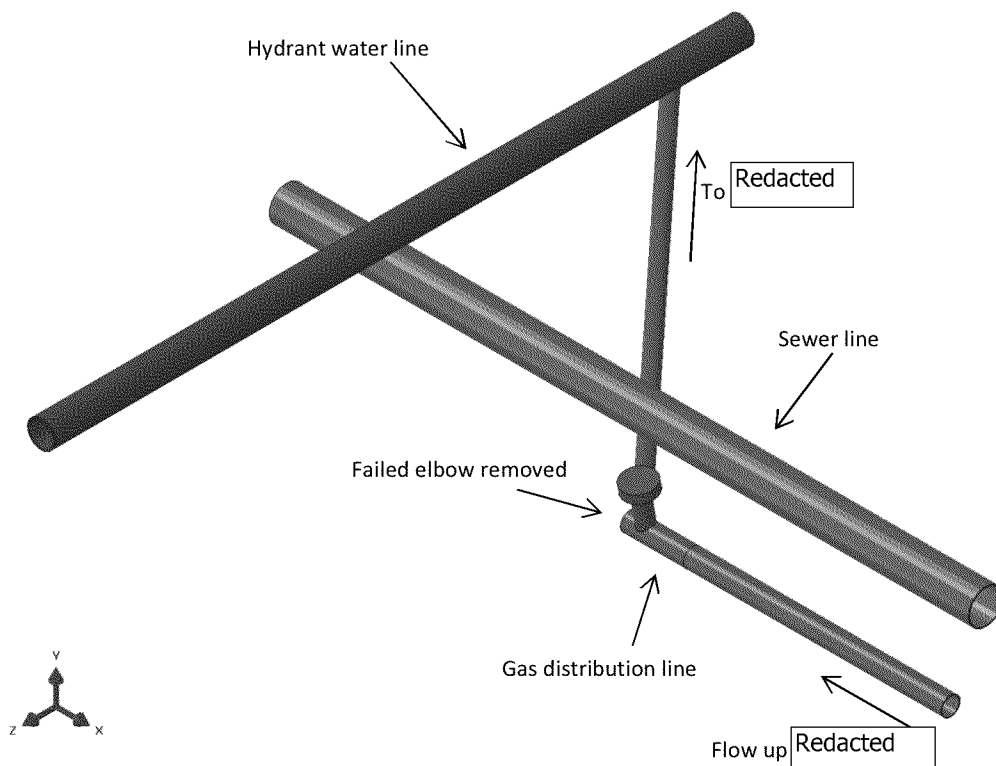
A finite element model was created to investigate the current stresses in the incident area following removal of the subject elbow and downstream piping. This new model is shown in Figure 51. The model was subjected to fault-creep shear of 0.2 in/ft consistent with the shear modeled in the subject elbow analysis. Tensile stresses in the repaired gas line near the location of the fractured elbow are shown in Figure 52; the stresses are reduced as compared with the stresses in the original configuration before the incident (upper image of Figure 50). Local stresses in the vicinity of the flange tee were predicted to be near 30 ksi. Thus, even after the removal of the subject elbow and associated downstream piping, stresses at the junction between the [Redacted] piping could be as high as 30 ksi.

Figure 51. Post-repair model.

After the failure, the connection between the [Redacted] pipe and the [Redacted] pipe remains intact. Exponent's stress analysis indicates that local stresses at this connection may be approximately 30 ksi. As more fault creep occurs in the future, these stresses are expected to increase.

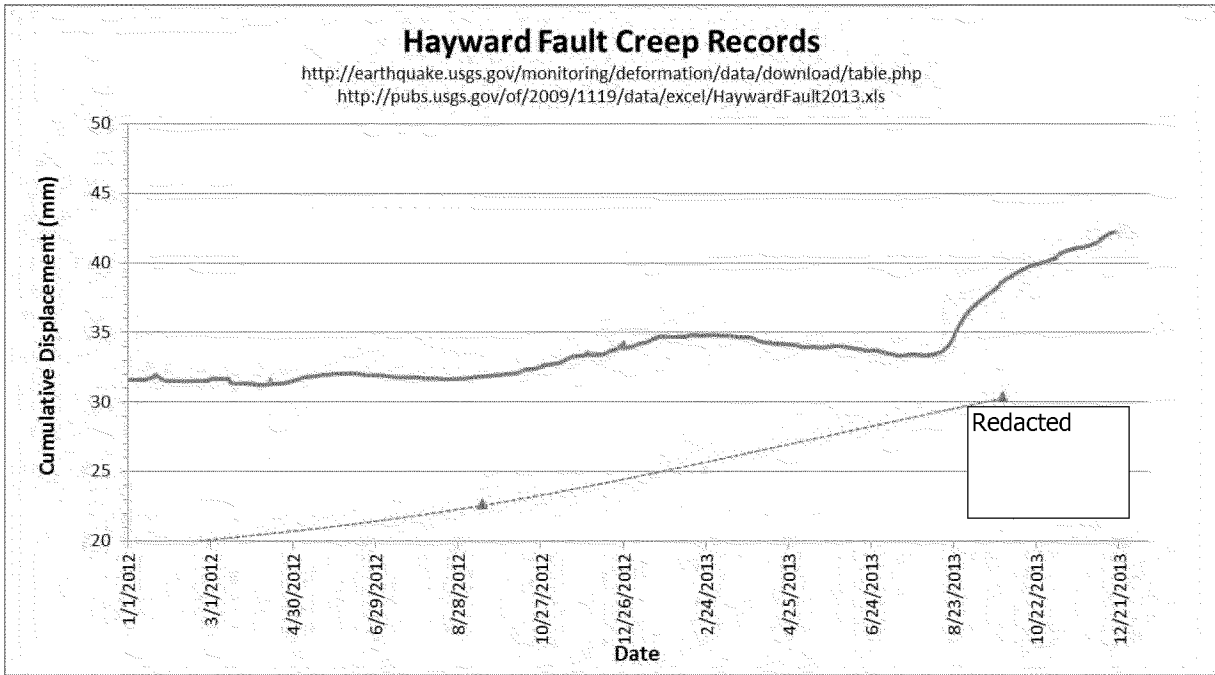
Figure D-4 shows the 2012 and 2013 portion of the data presented in Figure D-3. The figure shows an acceleration of creep movement measured at the [Redacted] Station starting in approximately August 2013. The timing of the gas release event may be related to this acceleration of creep movement.

Figure D-4. Hayward Fault creep records in the vicinity of [Redacted] for 2012 and 2013). [Redacted]
