FINAL REPORT
VOLUME I
R-PG&E-20140117

Pacific Gas and Electric Company

Tree Root Interference Assessment

January 17, 2014

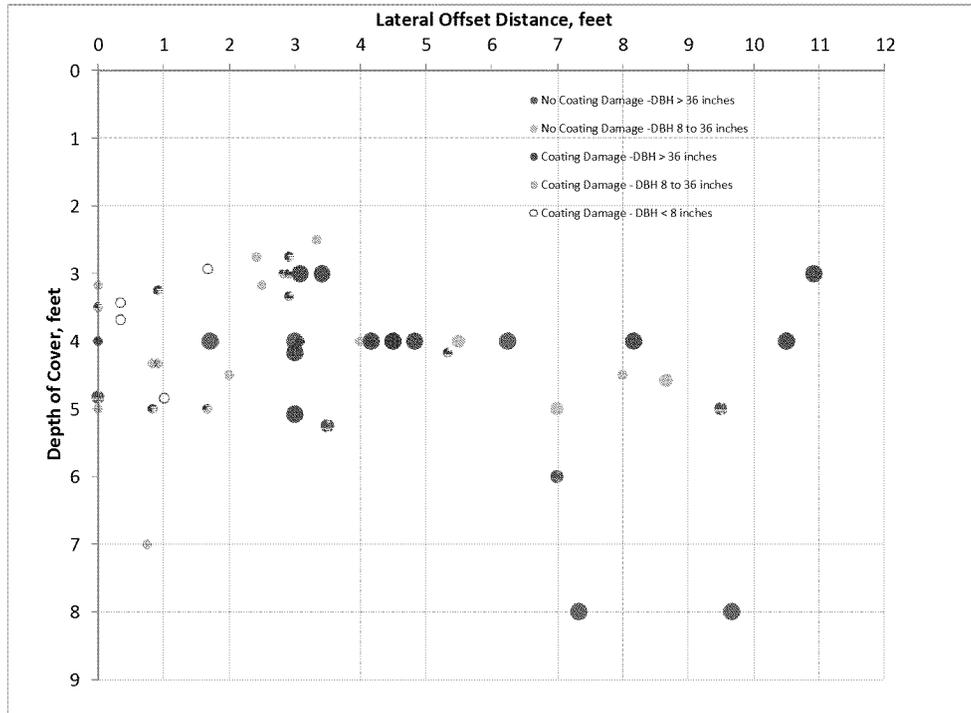
Figure 5. Depth of Cover versus Lateral Offset Distance⁵.

In evaluating the results from the 53 sites, a comparison between the lateral offset distance and depth of cover was produced and is presented in Figure 5. The legend provided in this figure discriminates the data based upon the tree diameter (DBH) and whether or not coating damage was evident.

As is evident from Figure 5, there is no obvious trend from these results. This is likely due to the number of attributes that influence the results. However, it is evident that tree size (DBH), offset distance, and depth of cover may be indicators as to whether or not coating damage has occurred.
