Carmel Gas Incident

Sumeet Singh
Pacific Gas and Electric Company
6111 Bollinger Canyon Road
San Ramon, CA 94583

Doc. no. 1401752.000 - 6877

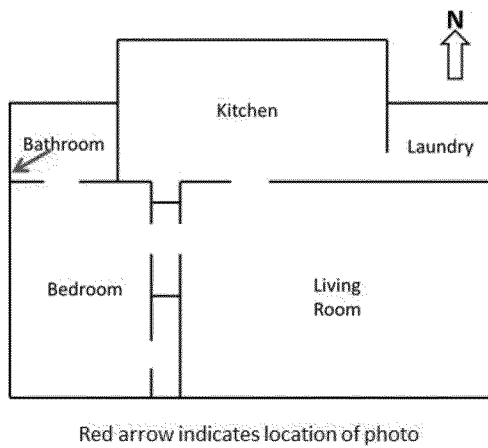
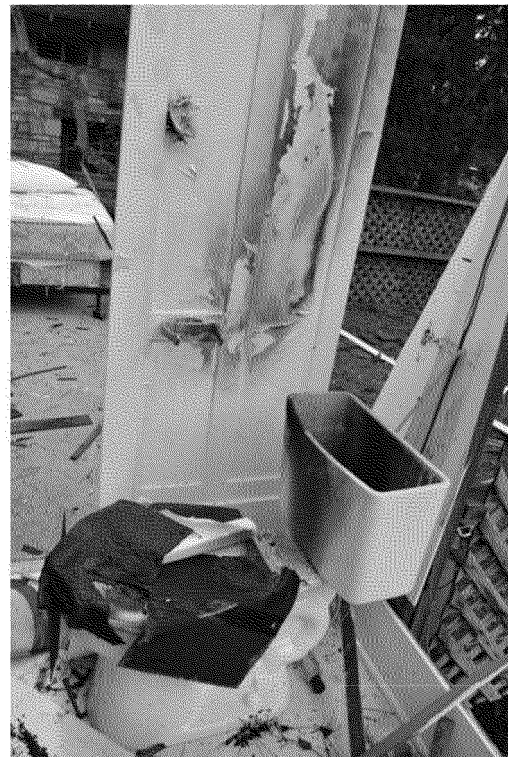
Figure 14. Bathroom toilet. Photograph by Exponent on March 6, 2014.

Figure 15. Damage to bathroom toilet. Burn marks below toilet seat and melted components inside toilet tank. Photographs by Exponent on March 6, 2014.

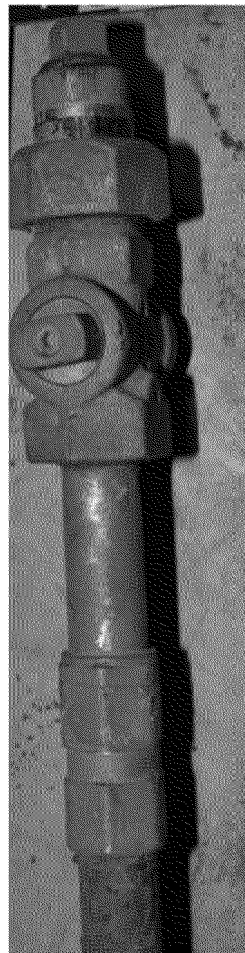
The service head adapter seals the annular space between the 3/4-inch steel pipe and the 1/2-inch plastic pipe. The service head adapter was lacking identifying markings, but appears to be similar to a Perfection 3/4" x (1/2" PE) x 3/4" Extended Service-Head Adapter. The two service head adapters are shown in Figure 25.

Figure 25. Service head adapter. Sources: Photograph by Exponent on March 10, 2014, service head adapter image from PG&E Gas Methods and Procedures document Service-Head Adapter Photo Identification.

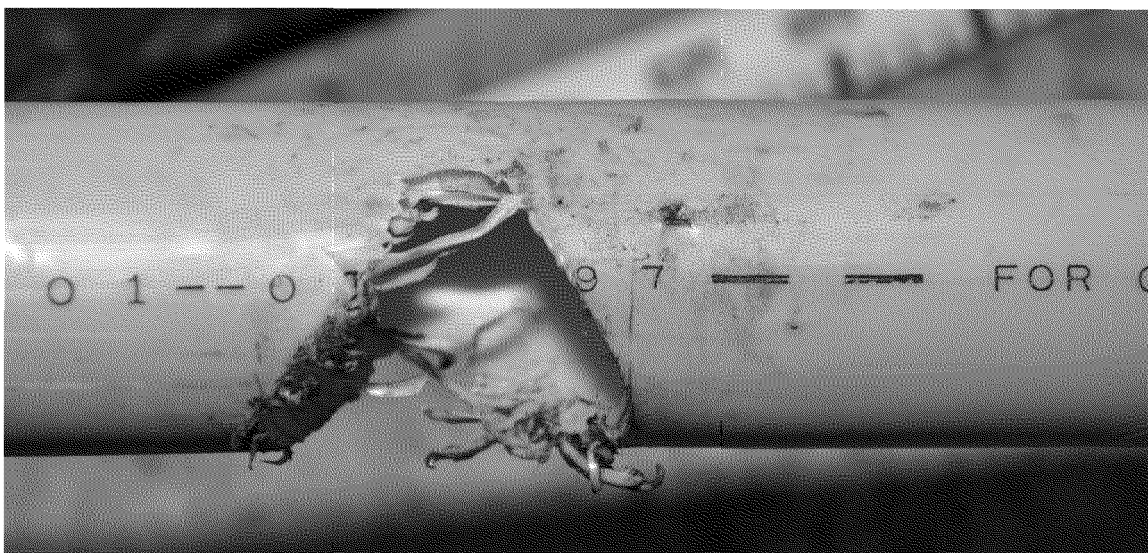
pipes (Figure 28). The plastic line segment has two perforations that correspond to the Save-a-Valve and M/2 fittings (Figure 29). There are some markings printed along the exterior of the pipe. A portion of the writing is associated with the fabrication date; in this particular piece only the year is visible, 1997 (Figure 30).

Figure 30. Close-up of the visible portion of the date code on the plastic pipe. Photograph by Exponent on March 10, 2014.

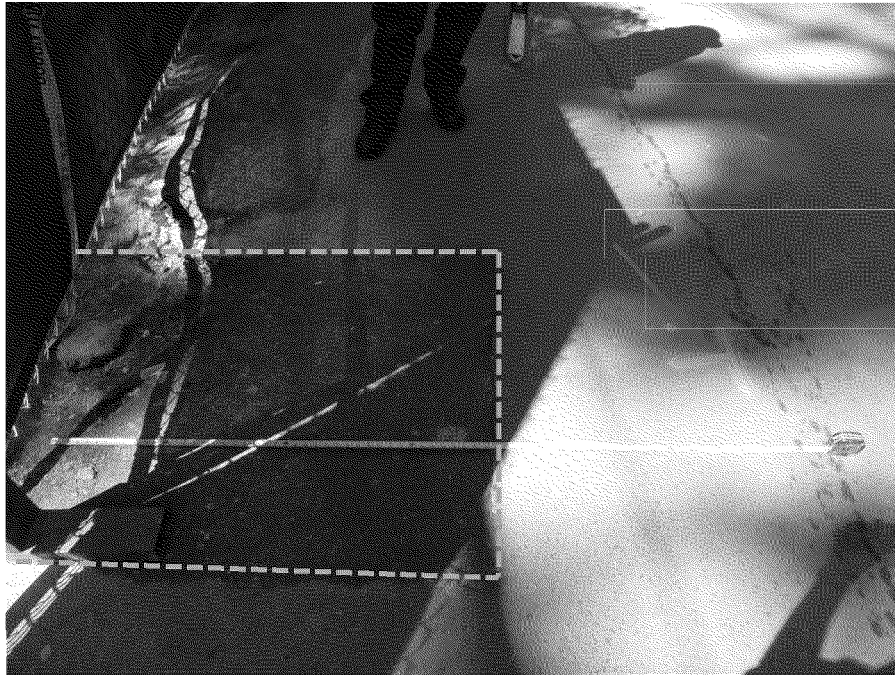
Along [Redacted] approximately 50 feet west of the manhole at [Redacted] a break tap was observed. This was the first lateral entry point from the aforementioned manhole. Figure 35 shows the street marking for the location of the sewer lateral and the asphalt patch performed

by PG&E for the gas service line. As shown in this figure, the sewer line is in close proximity to the gas service tee.

Figure 35. Relative location of cold asphalt patch for gas service tee (dashed yellow lines) and sewer lateral tap connection to sewer main (green arrow) for subject residence. Residence is to the left in photograph. Photograph by Exponent on March 11, 2014.

As shown in Figure 36, approximately 8 feet from the tap at the sewer main, the sewer lateral had a joint offset and opening. The green painted dot marked inside the left side of the cold asphalt patch shown in Figure 35 indicates the approximate location of this joint offset. More than 50 percent of the cross-sectional area of the pipe was offset, exposing the backfill around the pipe. The lateral-launch camera was unable to continue beyond this joint offset.

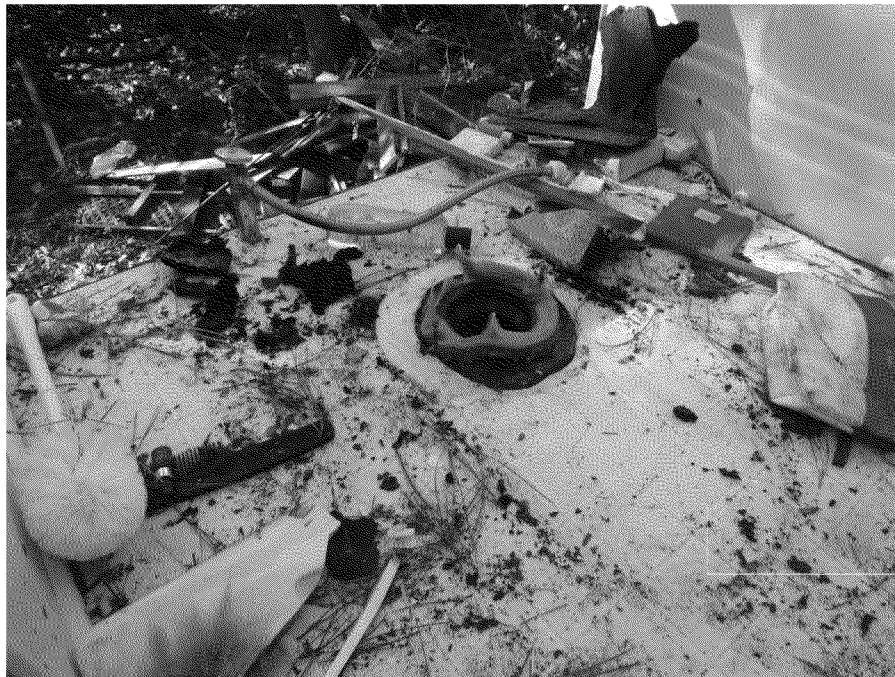
At the subject residence, because of the sewer lateral joint offset near the sewer main, video of the sewer lateral was attempted from the interior of the residence. The selected entry point for the video was a toilet, which was removed to allow the push camera to enter the sewer pipe (Figure 39).

Figure 39. Toilet removed to allow for insertion of sewer push camera. Photograph by Exponent on March 11, 2014.

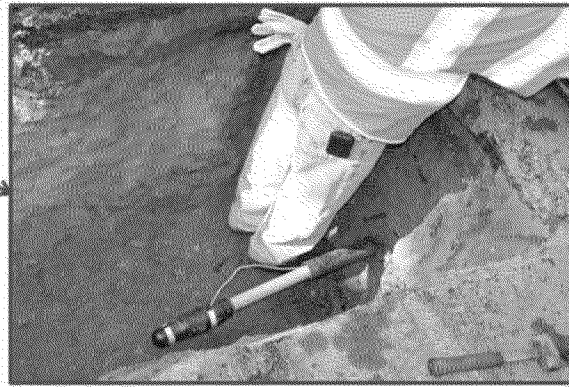
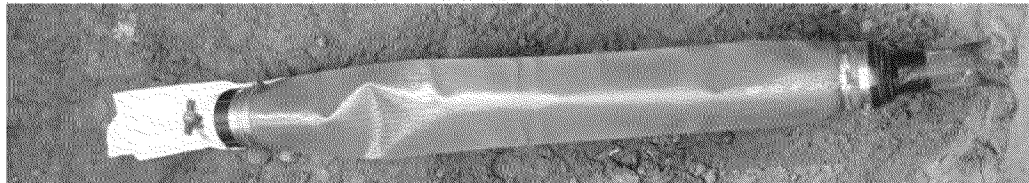
The gas migration test consisted of injecting helium gas through the annular space between the plastic gas main and the 2-inch steel pipe partially encasing it on Redacted. Helium injected through the annular space was allowed to travel through the area while helium concentrations were monitored at selected site locations during the test. The helium injection point near the location of the plastic pipe was punctured on the day of the explosion (Figure 51). The nineteen helium monitoring points are listed in Table 1 and shown graphically in Figure 52 for the area outside the subject residence, in Figure 53 at the residence's basement and in Figure 54 for the residence's first floor. Figure 55 through Figure 57 show example monitoring points for the tests.

Figure 51. Annotated D-Plat 3956-C08 showing helium injection point and test fitting. Photographs by Exponent on March 21, 2014.

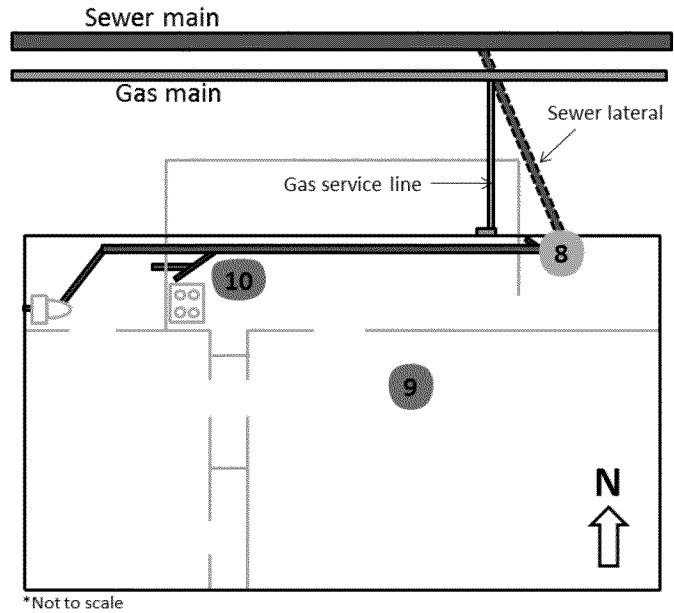
Figure 53. Helium test monitoring points and results at the residence's basement.

As summarized in Table 1 and Figure 52 through Figure 54, the results of the helium gas migration test conclusively show that, when helium gas is released near the location where the puncturing of the plastic pipe occurred on March 3, 2014, the gas can enter the sewer system in the vicinity of the subject residence. Once inside the sewer system, helium gas can travel through the sewer system and be released into the living space of the subject residence.

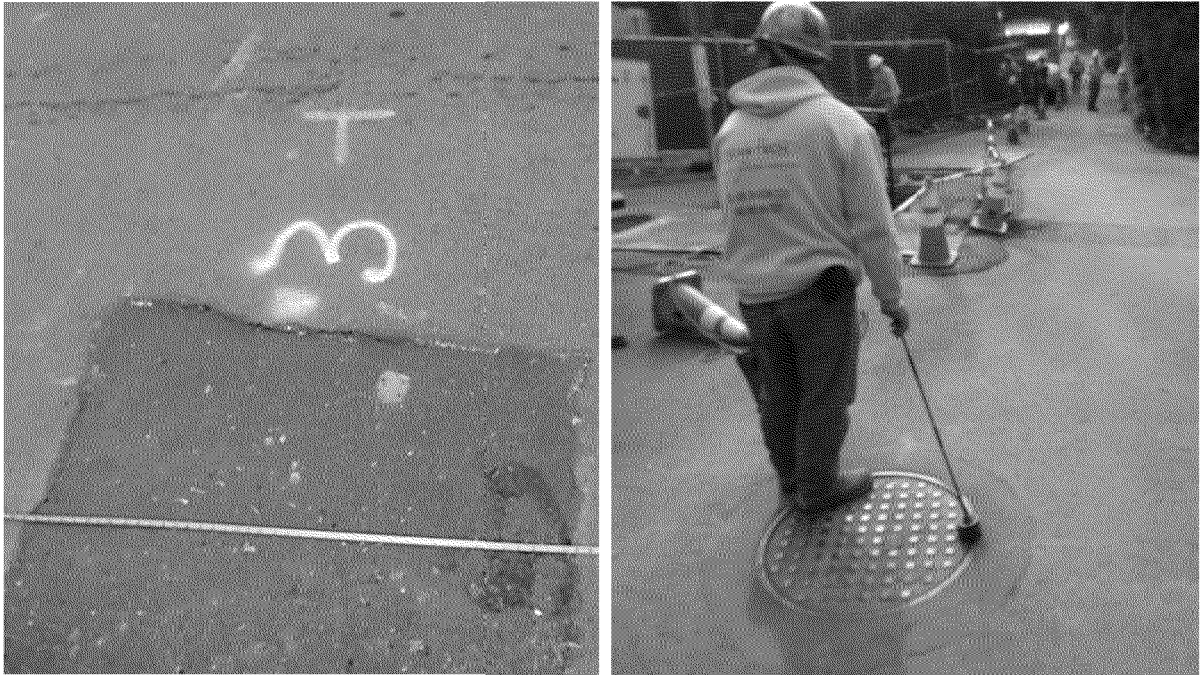
Figure 55. Example monitoring points outside of residence. Monitoring point #3 (left) near excavation performed by PG&E at gas service tee for residence. Monitoring point #19 (right) at sewer manhole near the intersection of [Redacted] Photographs by Exponent on March 21, 2014.
