Carmel Gas Incident

Doc. no. 1401752.000 - 6877

Pacific Gas and Electric (PG&E) has retained Exponent Failure Analysis Associates (Exponent) to conduct a failure analysis investigation of a gas leak and subsequent explosion on March 3, 2014 in Carmel-by-the-Sea (Carmel), California.

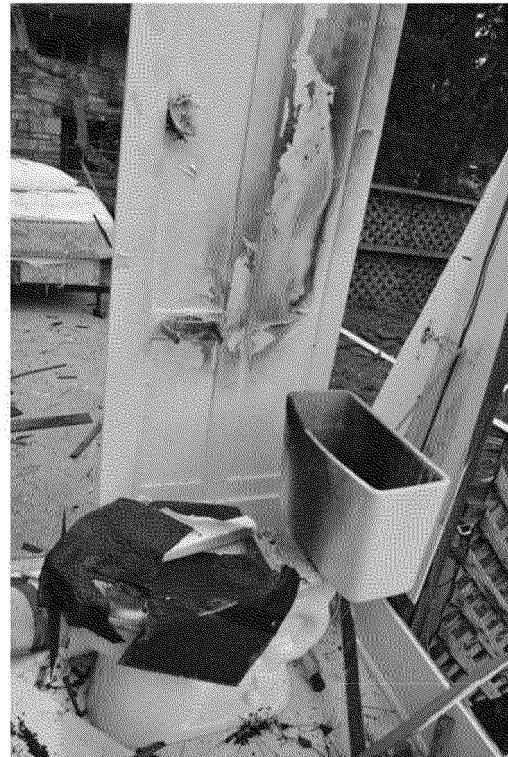
Figure 14. Bathroom toilet. Photograph by Exponent on March 6, 2014.

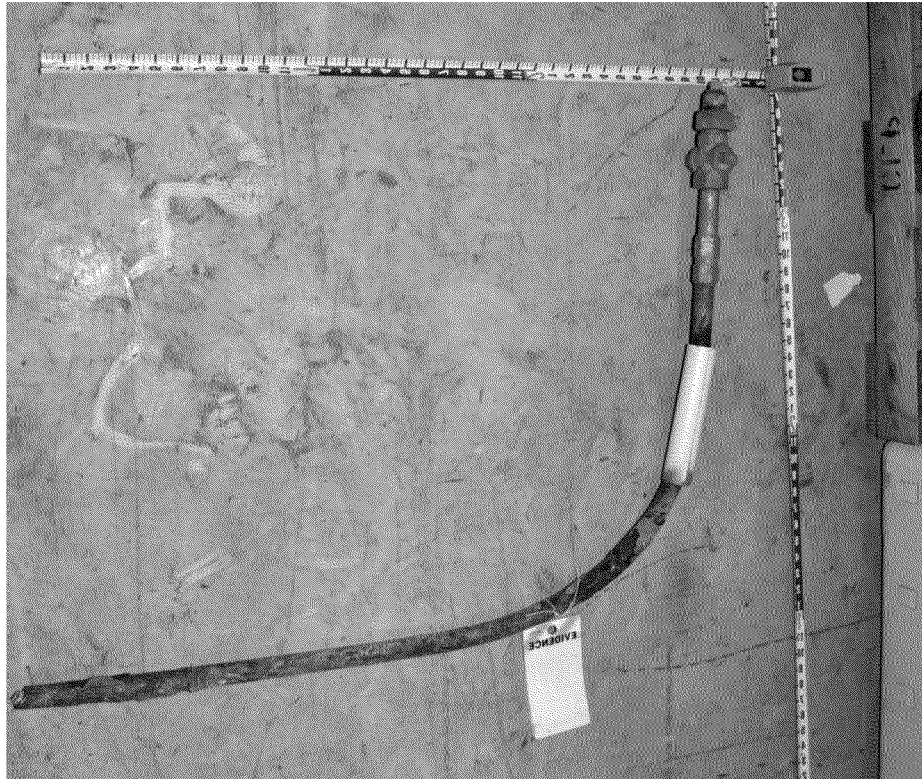
The steel $\frac{3}{4}$ -inch gas service line and riser are shown in Figure 23. The steel line is approximately five feet in length and inserted with a $\frac{1}{2}$ -inch plastic line (Figure 24). The line segment terminates in a service head adapter kit and service riser shut-off valve. According to the PG&E leak repair report, the service riser shut-off valve was turned to the closed position during the incident response operations.

Figure 23. Portion of the gas service line to incident house. Photograph by Exponent on March 10, 2014.

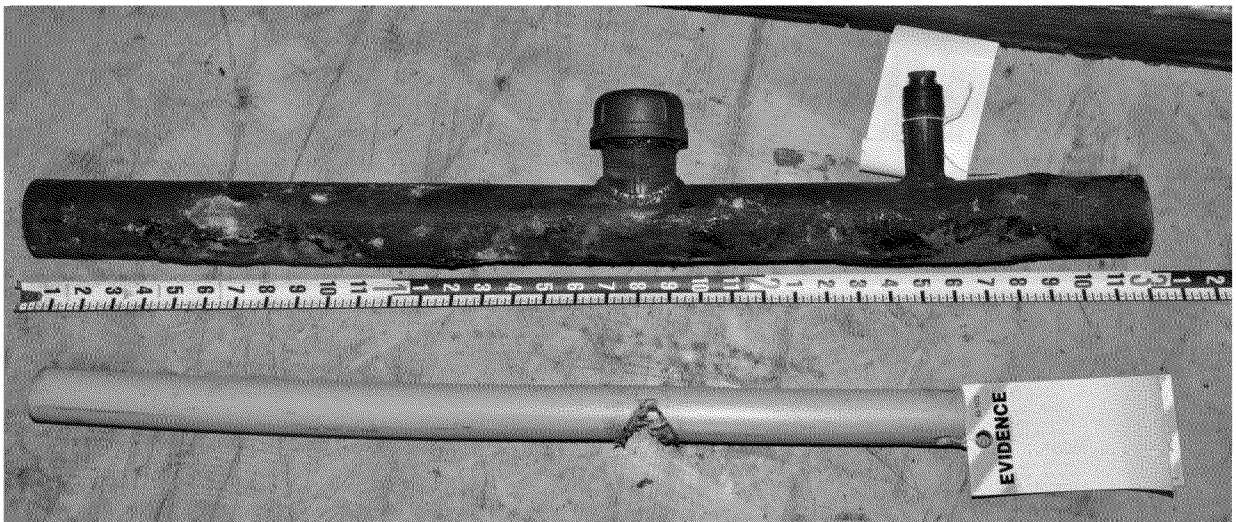
A three-foot long section of the 2-inch steel main running along [Redacted] was removed from the bell hole at the intersection of [Redacted] (Figure 27). The steel pipe segment has two welded fittings that were installed on March 3, 2014; one is a 1-inch Save-a-valve fitting and the other is a 2-inch M/2 line stopper fitting. There were no obstructions either in the main pipe or the two fittings.

Figure 27. Portion of the gas main along [Redacted] Steel pipe (top) with welded fittings and plastic pipe insert. Photograph by Exponent on March 10, 2014.

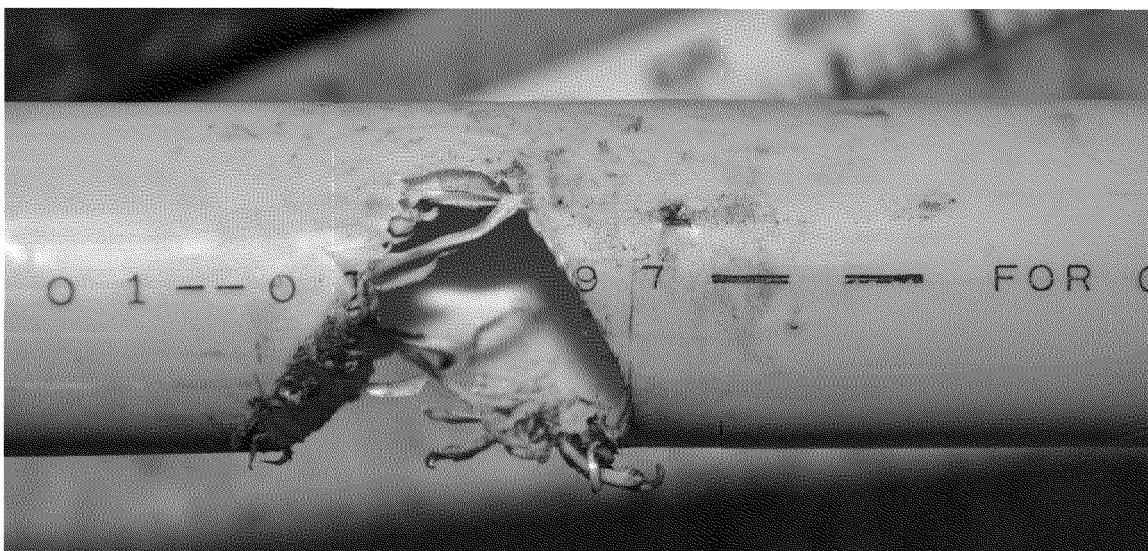
pipes (Figure 28). The plastic line segment has two perforations that correspond to the Save-a-Valve and M/2 fittings (Figure 29). There are some markings printed along the exterior of the pipe. A portion of the writing is associated with the fabrication date; in this particular piece only the year is visible, 1997 (Figure 30).

Figure 30. Close-up of the visible portion of the date code on the plastic pipe. Photograph by Exponent on March 10, 2014.

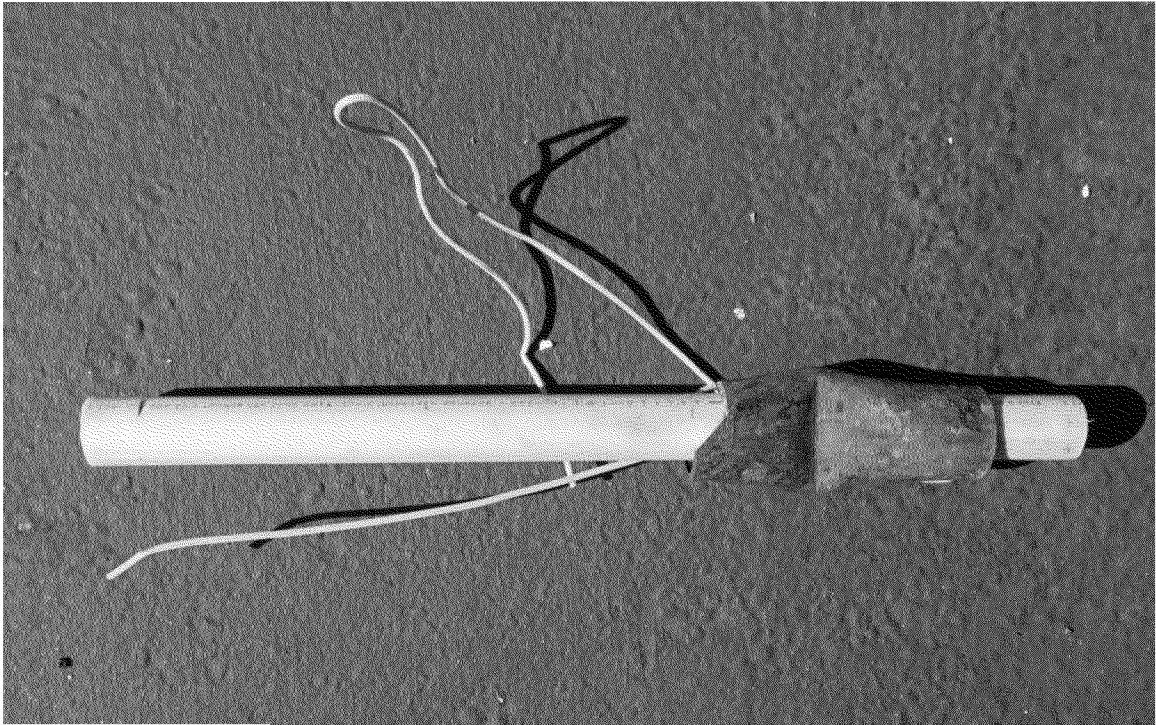
An additional portion of the gas main along Redacted was taken into evidence by PG&E. Exponent did not inspect this item, but PG&E provided multiple pictures to Exponent. The additional item corresponds to the west side gas main portion where the line had been squeezed after the incident (Figure 31). The writing on the photographs shown to Exponent indicates that the plastic pipe had a complete manufacturing date code of July 17, 1997 (Figure 32).

Figure 31. West-side squeeze point of the gas main along Redacted Yellow tracer wire is visible. Photograph provided by PG&E.

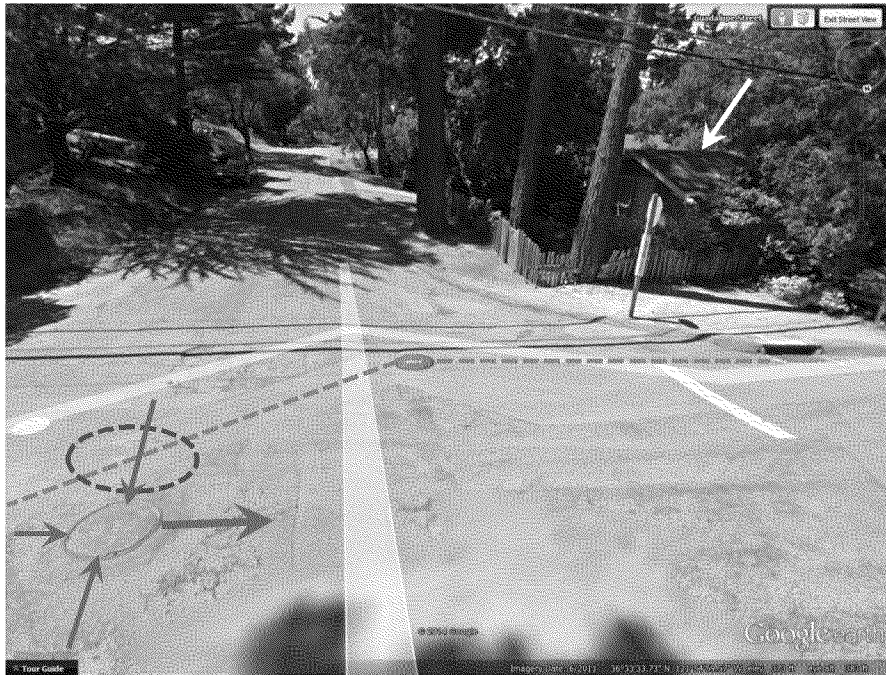
Figure 38. Underground utilities in the vicinity of subject residence (indicated by white arrow). Green arrows indicate sewer line flow directions into manhole (only one line discharging towards [Redacted] the western direction). Blue dashed lines indicate likely alignment of storm drain pipes inside pavement trench marks. Red oval indicates approximate location of collapsed sewer pipe.

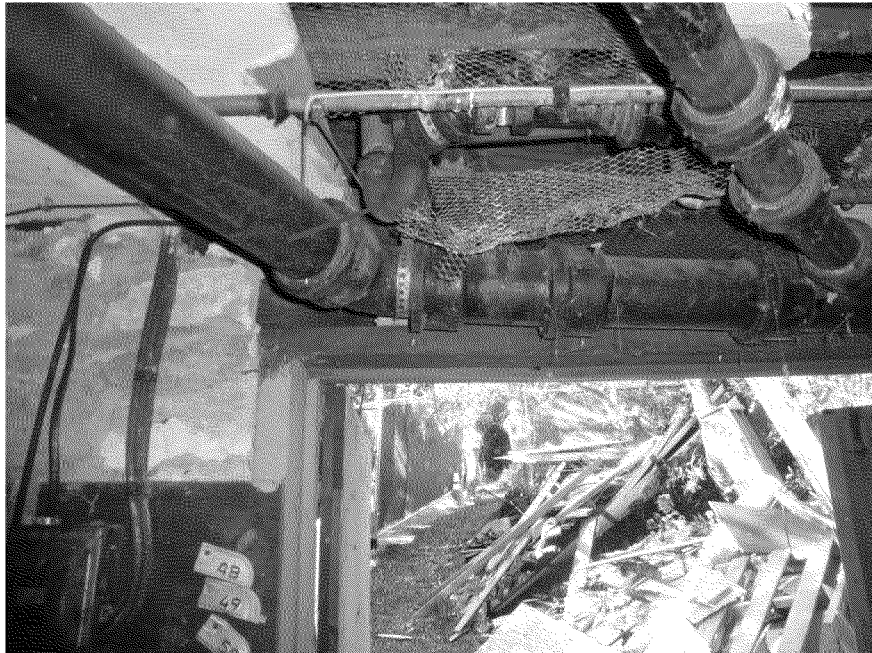
Figure 41. Multiple connections to building sewer system inside residence. Arrow indicates tub plumbing trap. Photograph from inside residence's basement. Photograph by Exponent on March 11, 2014.

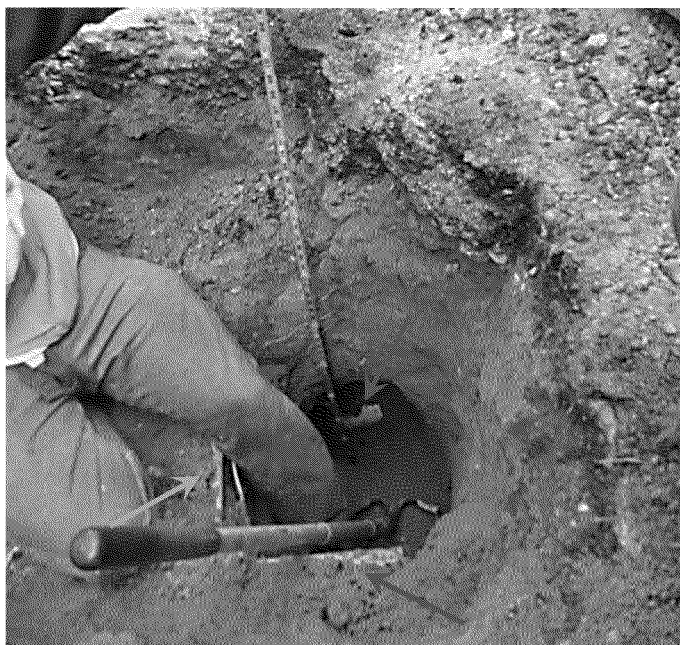
The approximate area previously excavated by PG&E on the day of the explosion (Figure 35) was re-excavated. The depth of excavation continued until a portion of the sewer lateral was exposed (Figure 45). As shown in Figure 46, the presence of a white plastic segment of sewer lateral, and an offset of the pipe, was confirmed by the excavation. The date of installation of the plastic segment in the sewer lateral is unknown. According to statements by [Redacted] of Fire Cause Analysis, the homeowners stated that they have not performed sewer replacement/repair work since they purchased the property in 1999.

Figure 45. Excavation to expose sewer lateral at subject residence in the vicinity of gas service tee. Yellow arrow indicates gas main along Redacted Redacted Redacted. Red arrow indicates gas service line. Green arrow indicates sewer lateral. Photograph by Exponent on March 21, 2014.

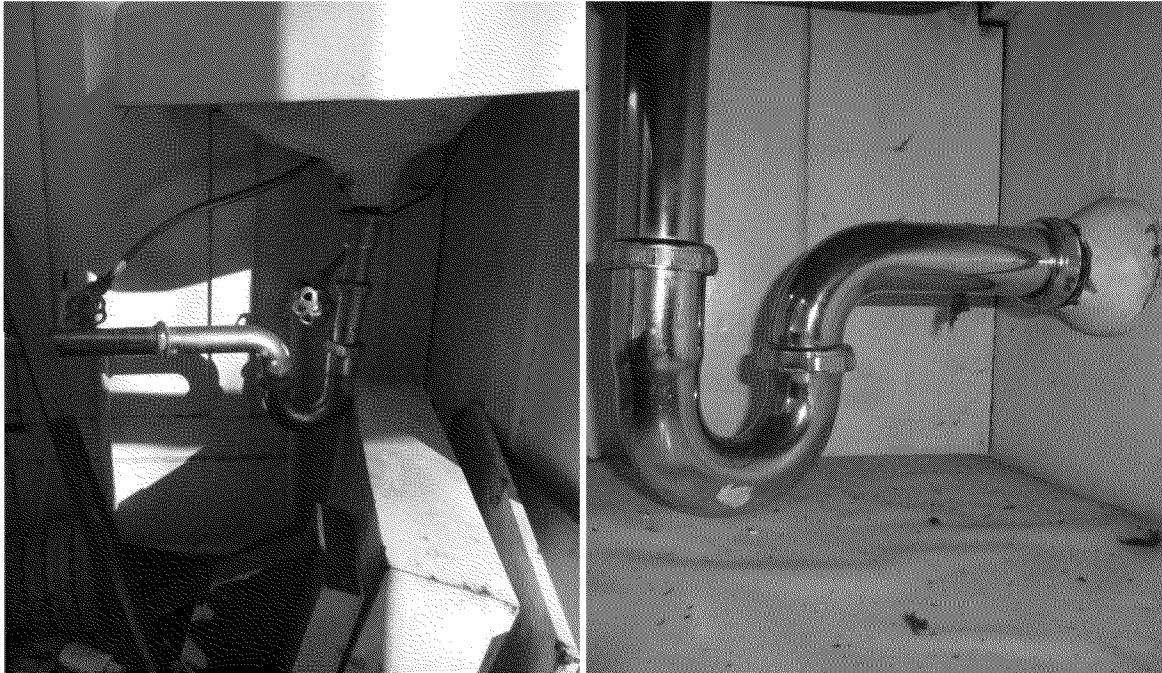
Plumbing traps are curved sections of pipe installed to contain water and provide a barrier to sewer gases entering living space. The water seal trap on any plumbing fixture or plumbing drain line must be filled with water to be effective. At the subject residence, traps were observed in all lines leading to, or in, all plumbing fixtures present.²⁴ Some of these plumbing fixture traps are shown in Figure 48 and some of the plumbing line traps are shown in Figure 41.

Figure 48. Plumbing traps at bathroom sink (left) and kitchen sink (right). Photographs by Exponent on March 11, 2014.

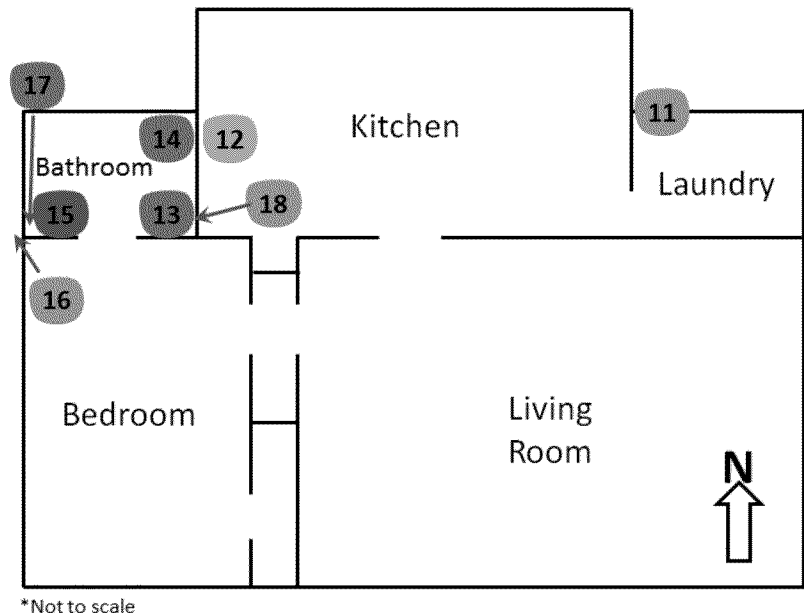
Figure 54. Helium test monitoring points and results at the residence's first floor.

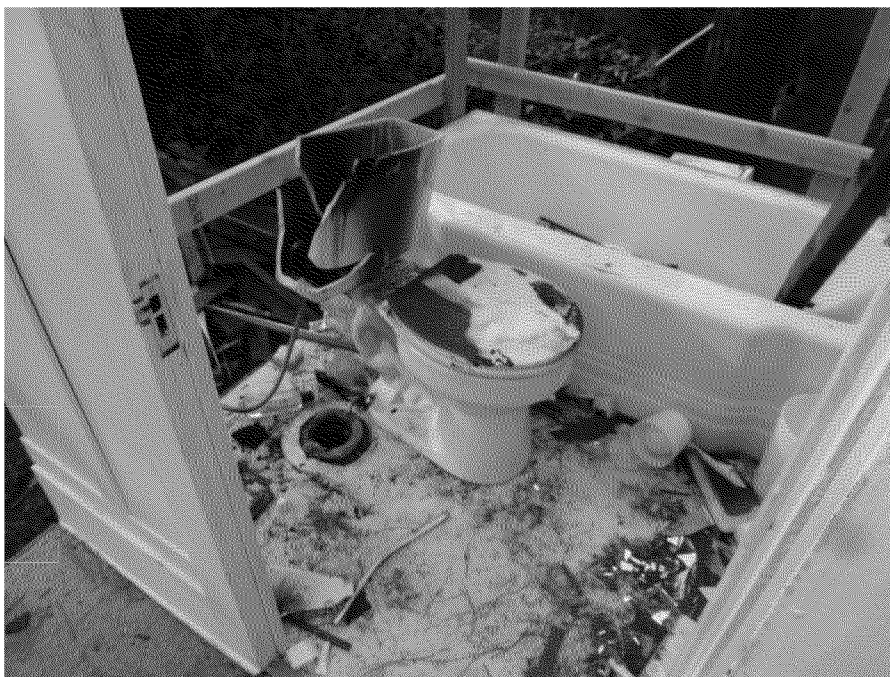
- Test 5: To test the condition of dry toilet bowl on the day of the explosion, the toilet was removed, and helium measurements were taken directly at the toilet sewer riser (Figure 59). Other field conditions were as described for Test 4.

Figure 59. Monitoring point #15 after removal of the toilet.
Photograph by Exponent on March 21, 2014.
