**Carmel Gas Incident**

Prepared for

Sumeet Singh  
Pacific Gas and Electric Company  
6111 Bollinger Canyon Road  
San Ramon, CA 94583

Doc. no. 1401752.000 - 6877

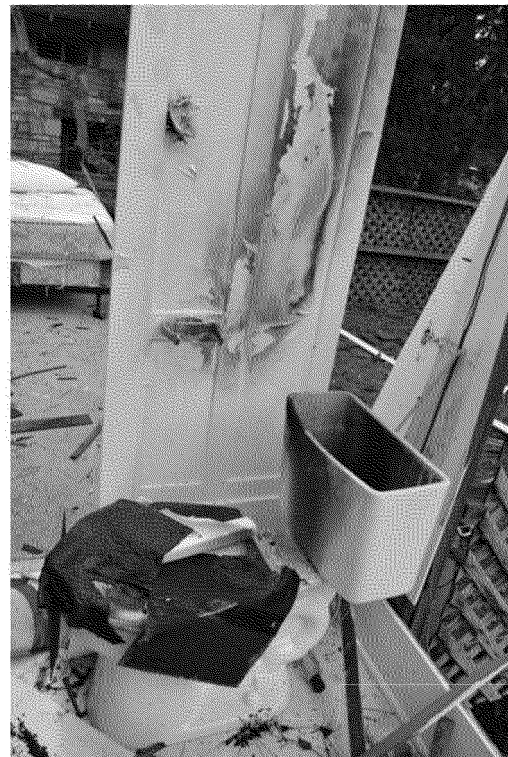
Exponent's interior inspections of the subject house<sup>12</sup> discovered limited evidence of fire inside the house. Some of the paint on the walls of the living and bedrooms had signs of high temperature (blistering), but very few signs of sustained flame impingement (Figure 11 and Figure 12). Some of the debris showed a small amount of charring. The bathroom was the only place where clear signs of sustained fire were observable. There was a distinct fire pattern on the South wall next to the toilet and on the toilet bowl, toilet seat, and tank (Figure 13 through Figure 15). PG&E provided Exponent with a photograph taken shortly after the explosion (Figure 16). The photograph shows flames in the bathroom, matching the location of the observed fire patterns.

Figure 14. Bathroom toilet. Photograph by Exponent on March 6, 2014.

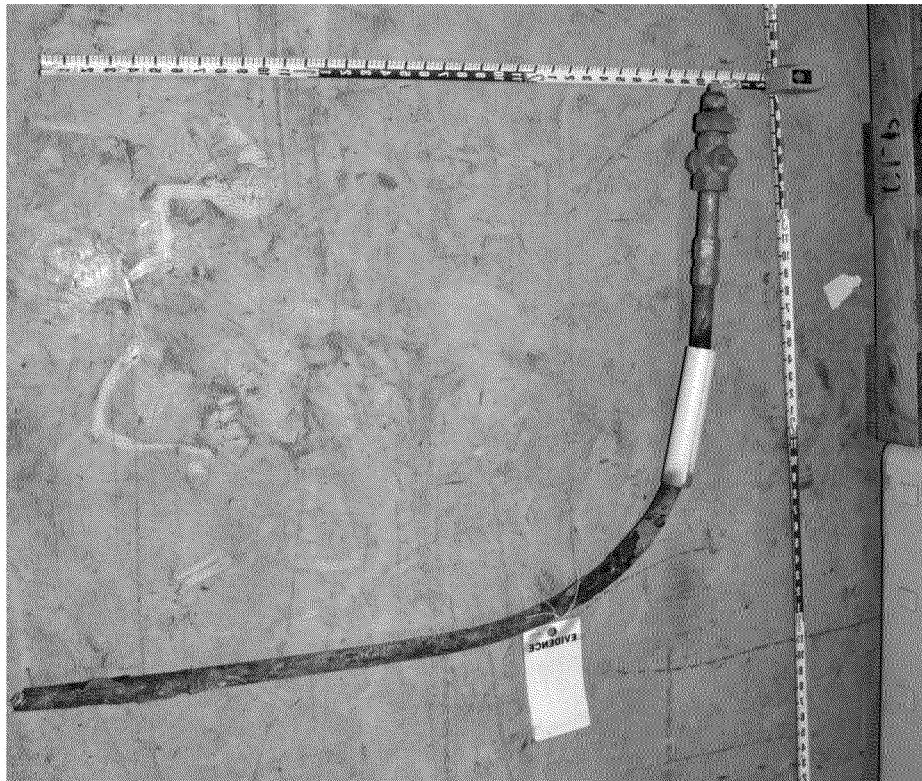
The steel  $\frac{3}{4}$ -inch gas service line and riser are shown in Figure 23. The steel line is approximately five feet in length and inserted with a  $\frac{1}{2}$ -inch plastic line (Figure 24). The line segment terminates in a service head adapter kit and service riser shut-off valve. According to the PG&E leak repair report, the service riser shut-off valve was turned to the closed position during the incident response operations.

Figure 23. Portion of the gas service line to incident house. Photograph by Exponent on March 10, 2014.

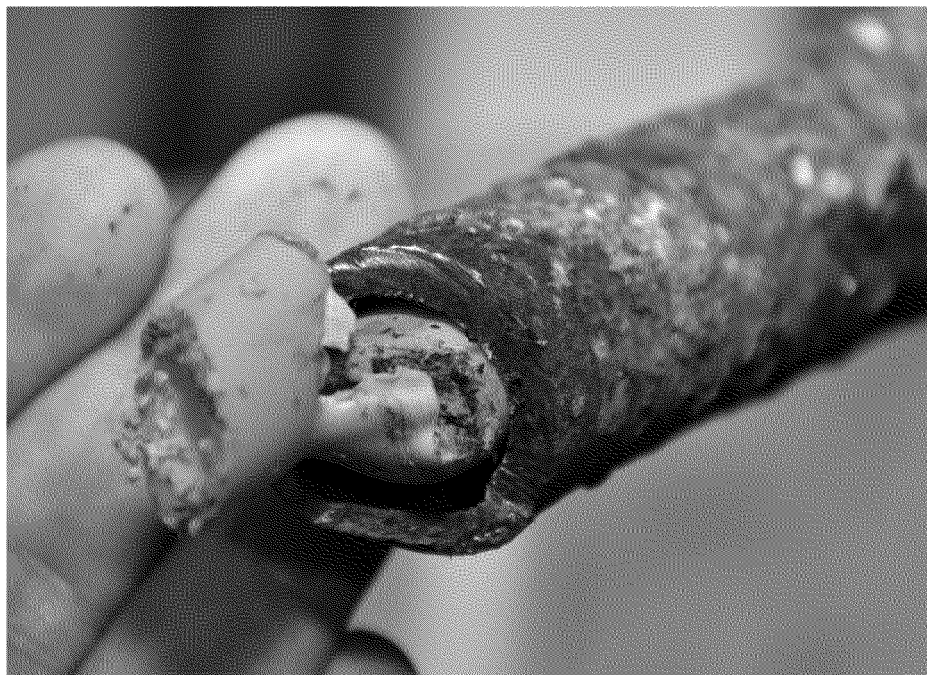
Figure 24. Close-up of the cut end of the gas service line. Photograph by Exponent on March 10, 2014.

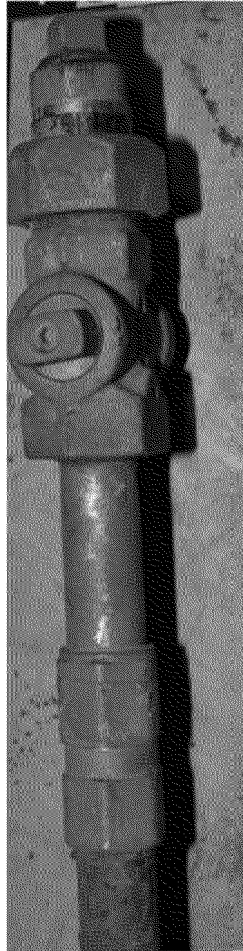
The service head adapter seals the annular space between the 3/4-inch steel pipe and the 1/2-inch plastic pipe. The service head adapter was lacking identifying markings, but appears to be similar to a Perfection 3/4" x (1/2" PE) x 3/4" Extended Service-Head Adapter. The two service head adapters are shown in Figure 25.

Figure 25. Service head adapter. Sources: Photograph by Exponent on March 10, 2014, service head adapter image from PG&E Gas Methods and Procedures document Service-Head Adapter Photo Identification.

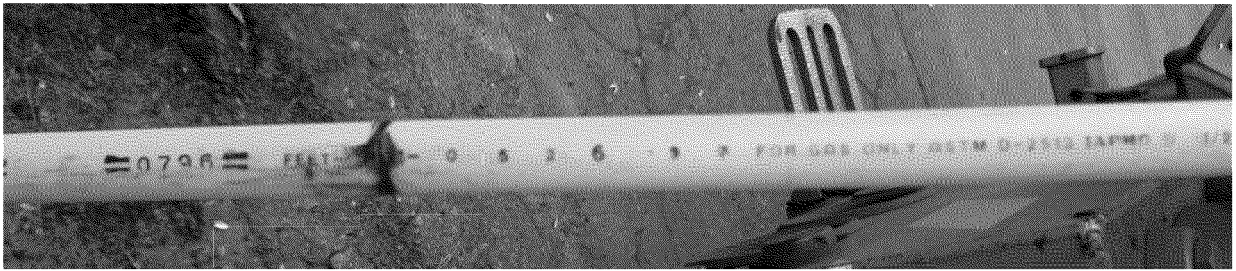
The inserted plastic pipe from the service line had a date code that read "052697," indicating a date of manufacture of May 26, 1997. The inserted plastic service line is shown in Figure 26.

Figure 26. Inserted plastic service line. Photograph source: PG&E.

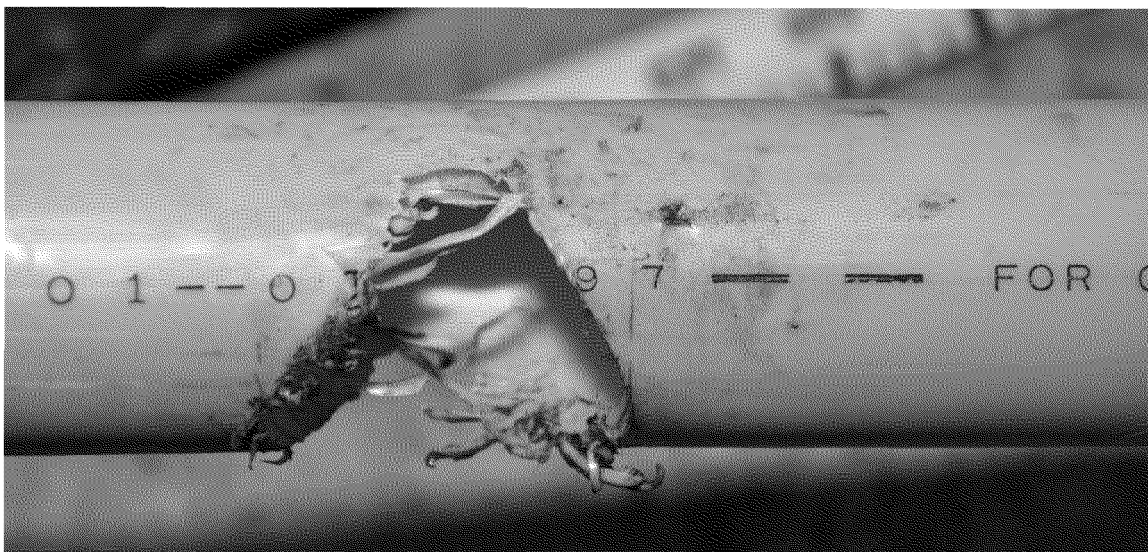
pipes (Figure 28). The plastic line segment has two perforations that correspond to the Save-a-Valve and M/2 fittings (Figure 29). There are some markings printed along the exterior of the pipe. A portion of the writing is associated with the fabrication date; in this particular piece only the year is visible, 1997 (Figure 30).

Figure 30. Close-up of the visible portion of the date code on the plastic pipe. Photograph by Exponent on March 10, 2014.

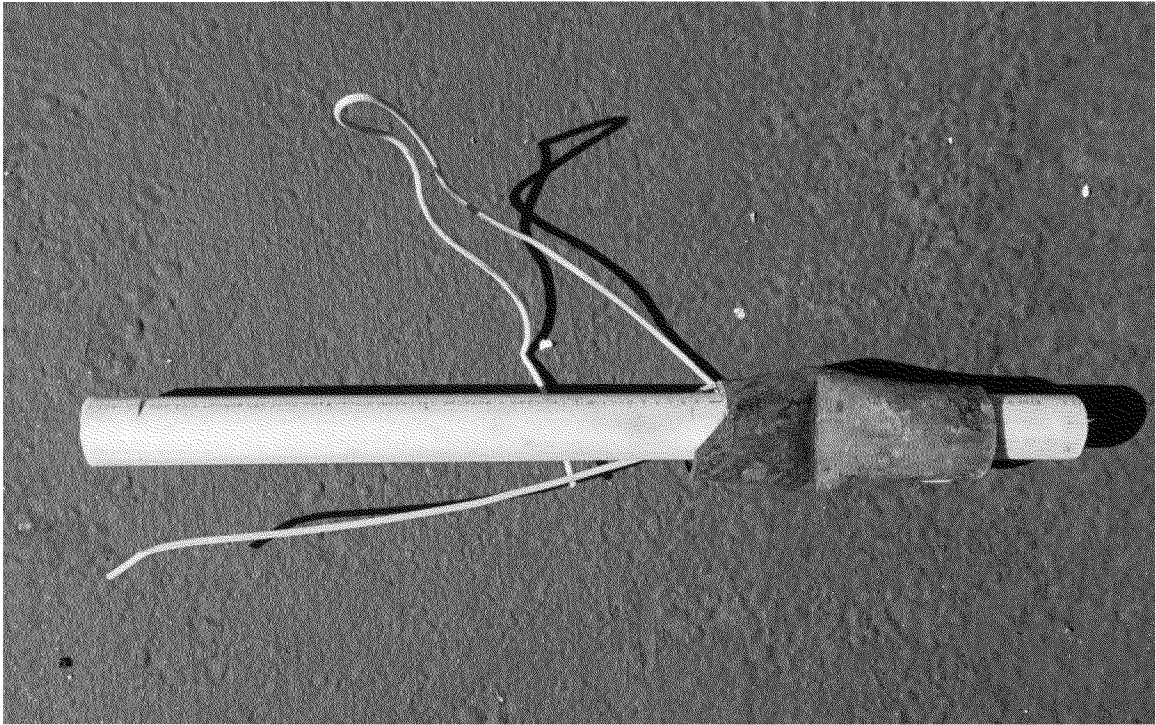
An additional portion of the gas main along Redacted was taken into evidence by PG&E. Exponent did not inspect this item, but PG&E provided multiple pictures to Exponent. The additional item corresponds to the west side gas main portion where the line had been squeezed after the incident (Figure 31). The writing on the photographs shown to Exponent indicates that the plastic pipe had a complete manufacturing date code of July 17, 1997 (Figure 32).

Figure 31. West-side squeeze point of the gas main along Redacted Yellow tracer wire is visible. Photograph provided by PG&E.

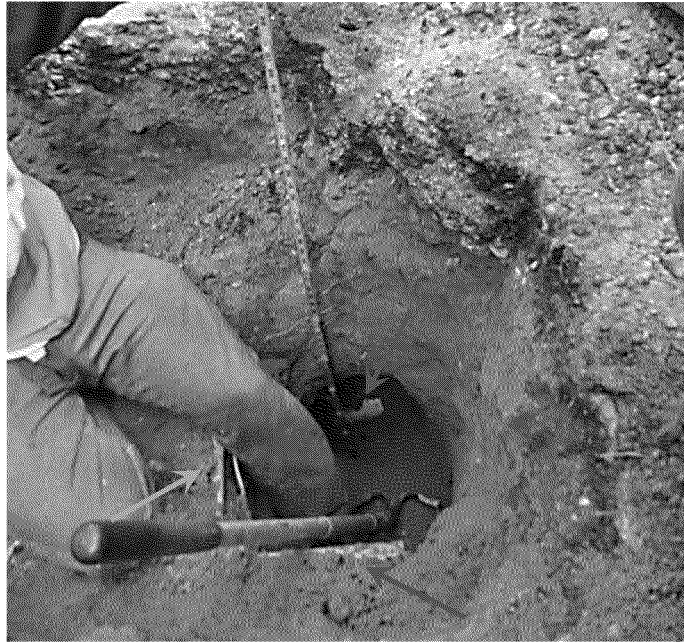
The approximate area previously excavated by PG&E on the day of the explosion (Figure 35) was re-excavated. The depth of excavation continued until a portion of the sewer lateral was exposed (Figure 45). As shown in Figure 46, the presence of a white plastic segment of sewer lateral, and an offset of the pipe, was confirmed by the excavation. The date of installation of the plastic segment in the sewer lateral is unknown. According to statements by [Redacted] of Fire Cause Analysis, the homeowners stated that they have not performed sewer replacement/repair work since they purchased the property in 1999.

Figure 45. Excavation to expose sewer lateral at subject residence in the vicinity of gas service tee. Yellow arrow indicates gas main along 3<sup>rd</sup> Avenue. Red arrow indicates gas service line. Green arrow indicates sewer lateral. Photograph by Exponent on March 21, 2014.

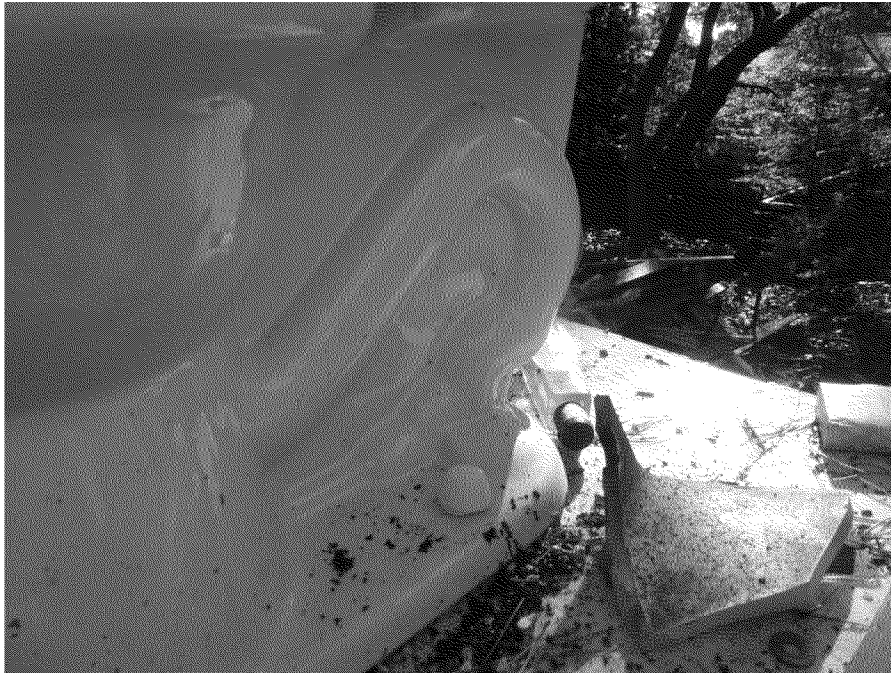
As previously noted, there was no plumbing trap in the sewer drain line section video recorded from the toilet towards the sewer main on Redacted. The only trap along this sewer line path was the integral trap in the toilet fixture. Figure 49 documents this trap.

Figure 49. Toilet drain trap. Photograph by Exponent on March 11, 2014.

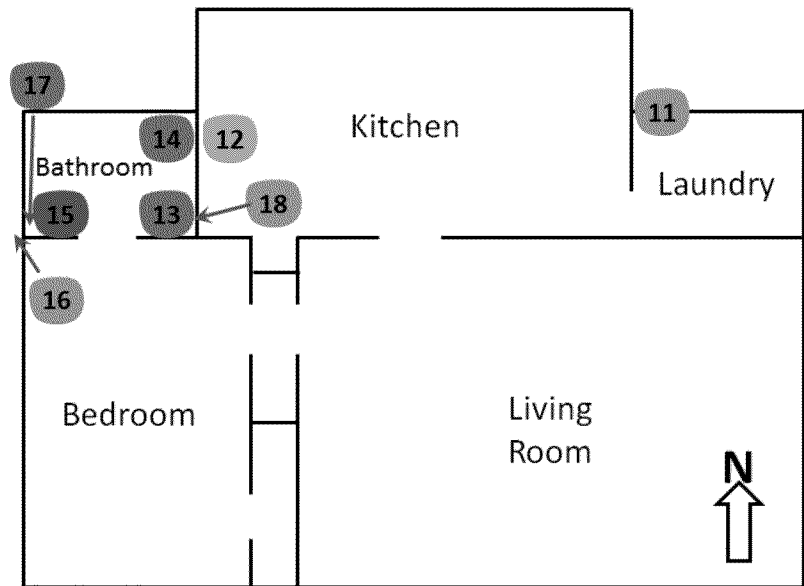
Figure 54. Helium test monitoring points and results at the residence's first floor.

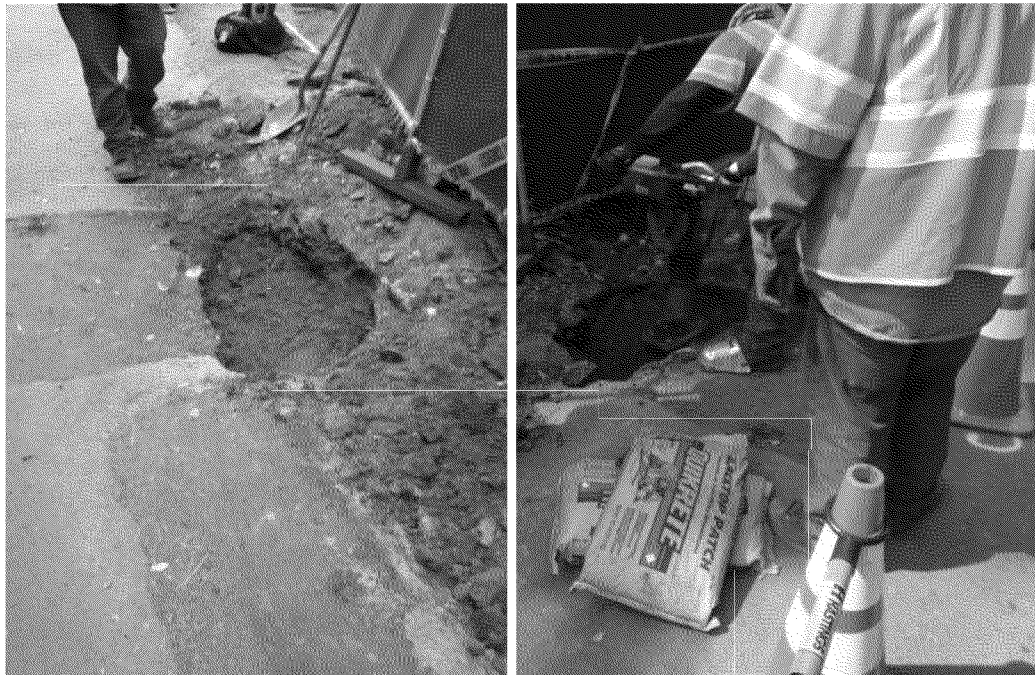
- Test 4: In an attempt to bring soil conditions closer to those present before the gas service tee excavation was performed by PG&E on the day of the explosion, the shallowest eight inches (approximately) of soil above the gas service tee were excavated, re-compacted in place and paved with an asphalt cold patch (Figure 58). Other field conditions were as described for Test 1.

Figure 58. Excavation (left) and re-compaction (right) near gas service tee. Photographs by Exponent on March 21, 2014.
