**FINAL REPORT
VOLUME I
R-PG&E-20140117**

Pacific Gas and Electric Company

Tree Root Interference Assessment

January 17, 2014

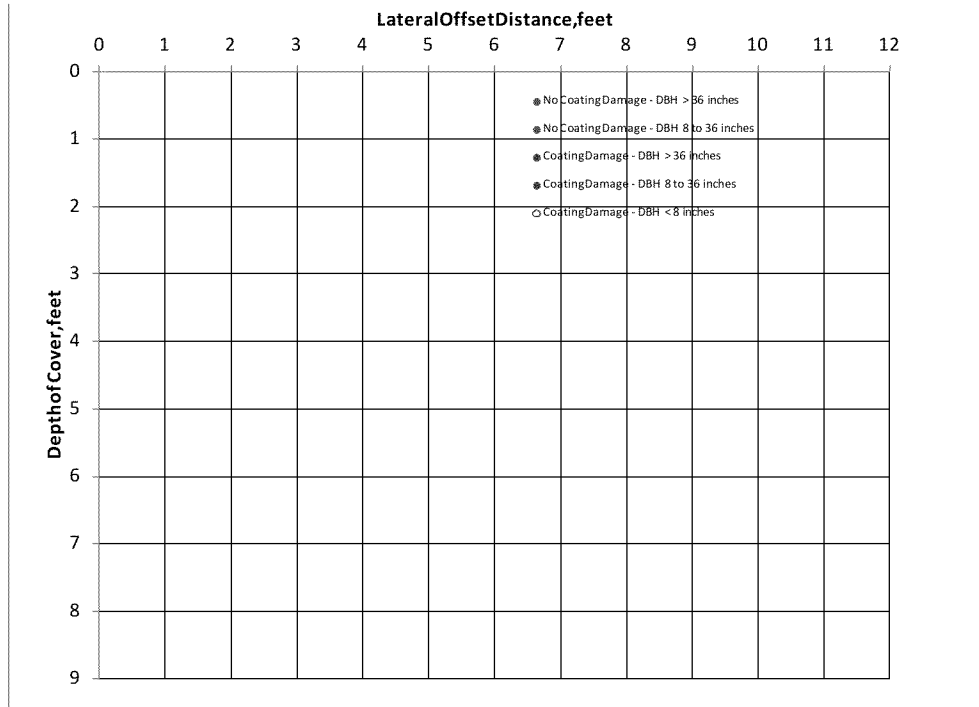
Figure 5. Depth of Cover versus Lateral Offset Distance⁵.

In evaluating the results from the 53 sites, a comparison between the lateral offset distance and depth of cover was produced and is presented in Figure 5. The legend provided in this figure discriminates the data based upon the tree diameter (DBH) and whether or not coating damage was evident.

As is evident from Figure 5, there is no obvious trend from these results. This is likely due to the number of attributes that influence the results. However, it is evident that tree size (DBH), offset distance, and depth of cover may be indicators as to whether or not coating damage has occurred.
