Threats Posed by Trees on ROW

For CPUC
By Transmission Asset Integrity Management

April 23, 2014

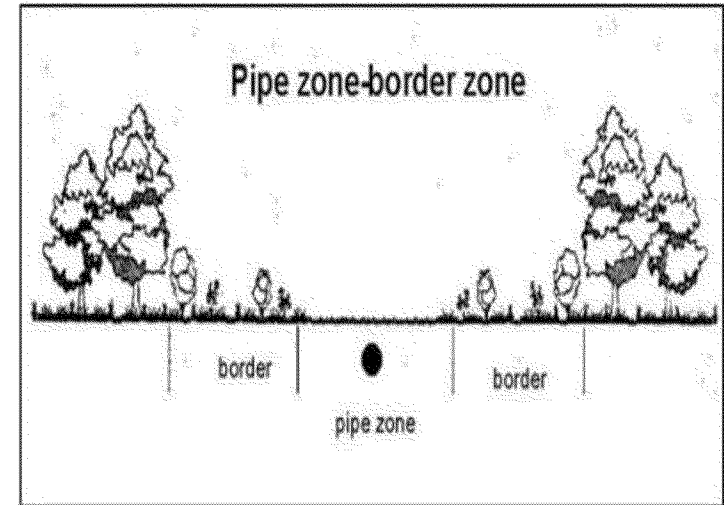
Pipe zone: an area around the pipeline extending from the edge of the pipe to the border zone. In a ROW with widths equal to or less than 10 feet: the width of the pipe zone must be equal to the width of the ROW. In ROW with widths greater than 10 feet, the width of the pipe zone must be equal to the width in the ROW that is up to 5 feet on either side of the edge of the pipeline. Any area within the ROW that is outside of the pipe zone will be considered "border zone."
