**Carmel Gas Incident**

April 2014

Doc. no. 1401752.000 - 6877

Pacific Gas and Electric (PG&E) has retained Exponent Failure Analysis Associates (Exponent) to conduct a failure analysis investigation of a gas leak and subsequent explosion on March 3, 2014 in Carmel-by-the-Sea (Carmel), California.

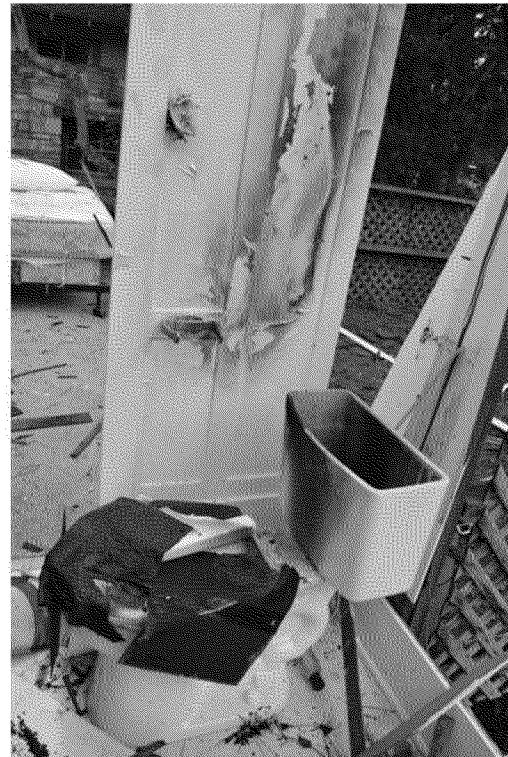
Figure 15. Damage to bathroom toilet. Burn marks below toilet seat and melted components inside toilet tank. Photographs by Exponent on March 6, 2014.

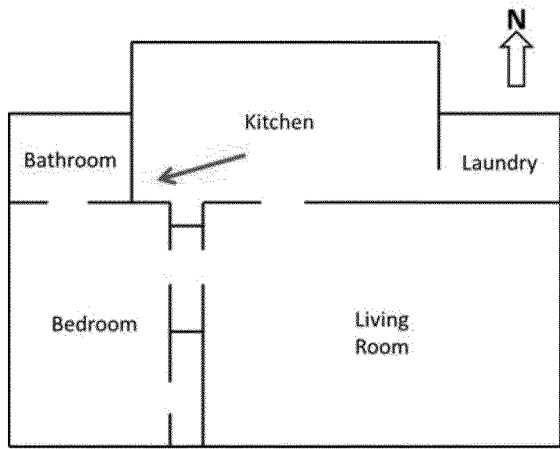
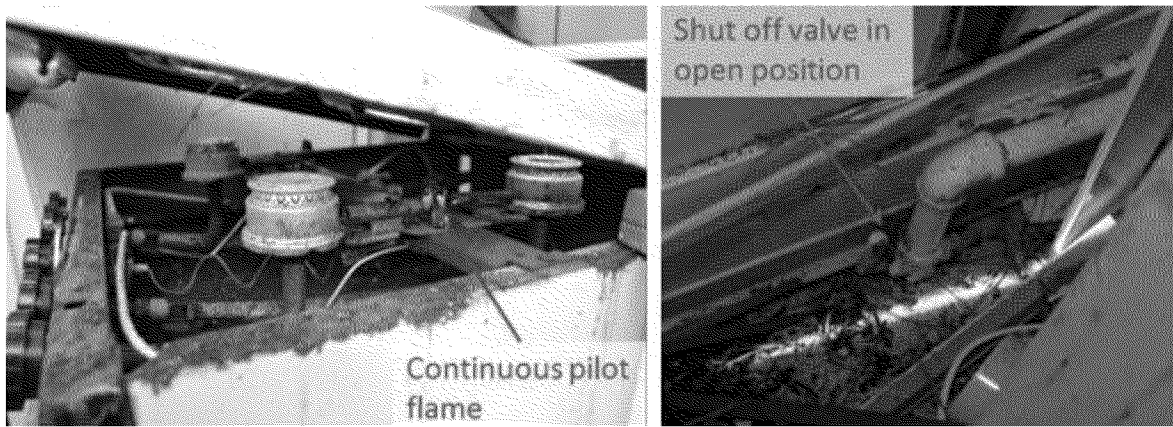
*Stove:* A kitchen stove was present in the subject house. The location of the stove is shown in Figure 20. The appliance shut-off valve for the stove was found in the open position and the stove was equipped with a continuous pilot flame (Figure 21). Based on these facts, the stove cannot be ruled out as a likely ignition source for the incident explosion.

Figure 21. Kitchen stove components. Photographs by Exponent on March 6, 2014.

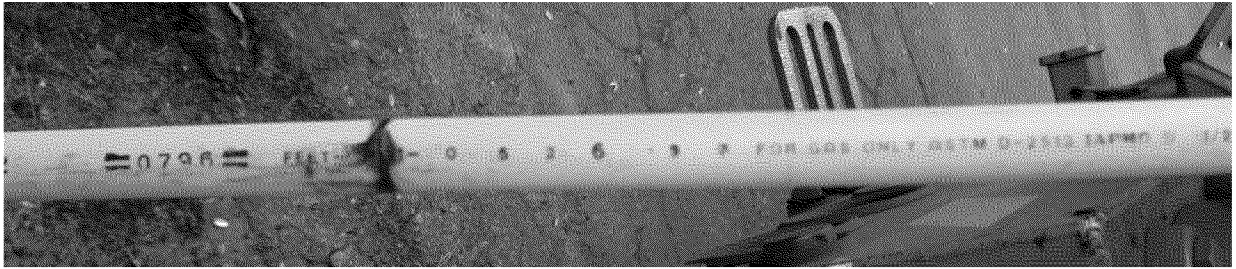
The inserted plastic pipe from the service line had a date code that read "052697," indicating a date of manufacture of May 26, 1997. The inserted plastic service line is shown in Figure 26.

Figure 26. Inserted plastic service line. Photograph source: PG&E.

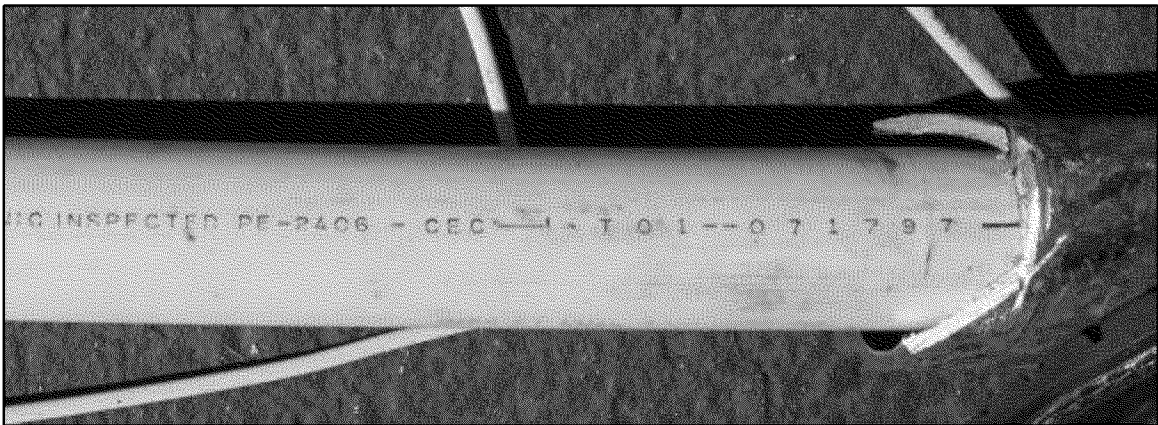
Figure 32. Close-up of the complete manufacturing date code of the plastic gas main. Photograph provided by PG&E.

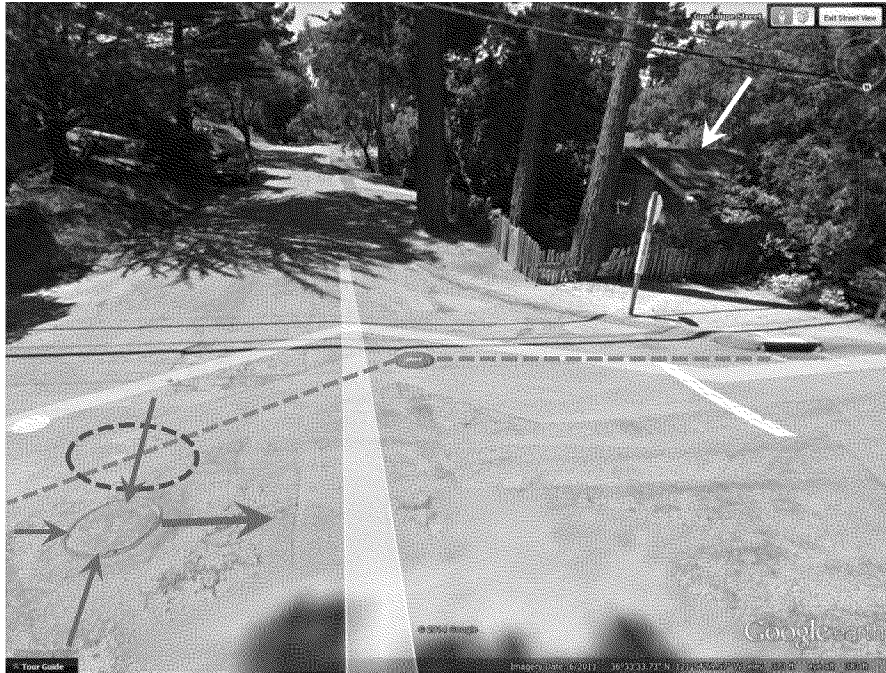
Figure 38. Underground utilities in the vicinity of subject residence (indicated by white arrow). Green arrows indicate sewer line flow directions into manhole (only one line discharging towards [Redacted] in the western direction). Blue dashed lines indicate likely alignment of storm drain pipes inside pavement trench marks. Red oval indicates approximate location of collapsed sewer pipe.

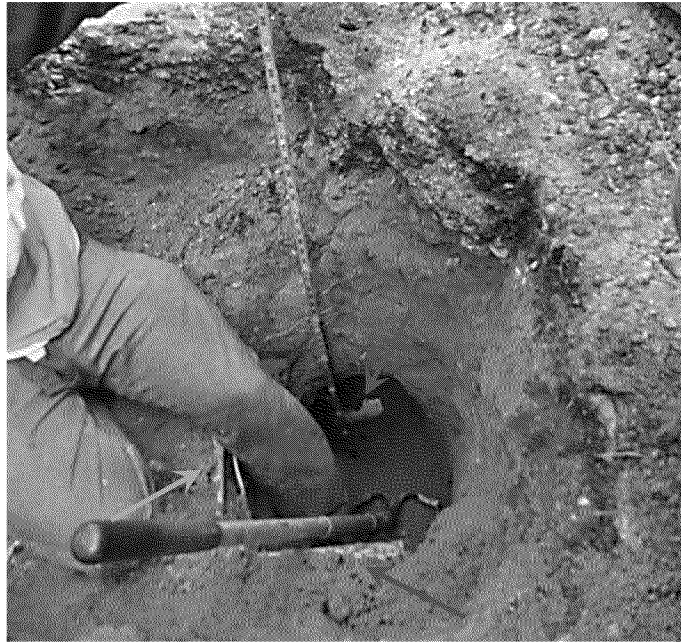
The approximate area previously excavated by PG&E on the day of the explosion (Figure 35) was re-excavated. The depth of excavation continued until a portion of the sewer lateral was exposed (Figure 45). As shown in Figure 46, the presence of a white plastic segment of sewer lateral, and an offset of the pipe, was confirmed by the excavation. The date of installation of the plastic segment in the sewer lateral is unknown. According to statements by Redacted of Fire Cause Analysis, the homeowners stated that they have not performed sewer replacement/repair work since they purchased the property in 1999.

Figure 45. Excavation to expose sewer lateral at subject residence in the vicinity of gas service tee. Yellow arrow indicates gas main along [Redacted] [Redacted] Red arrow indicates gas service line. Green arrow indicates sewer lateral. Photograph by Exponent on March 21, 2014.

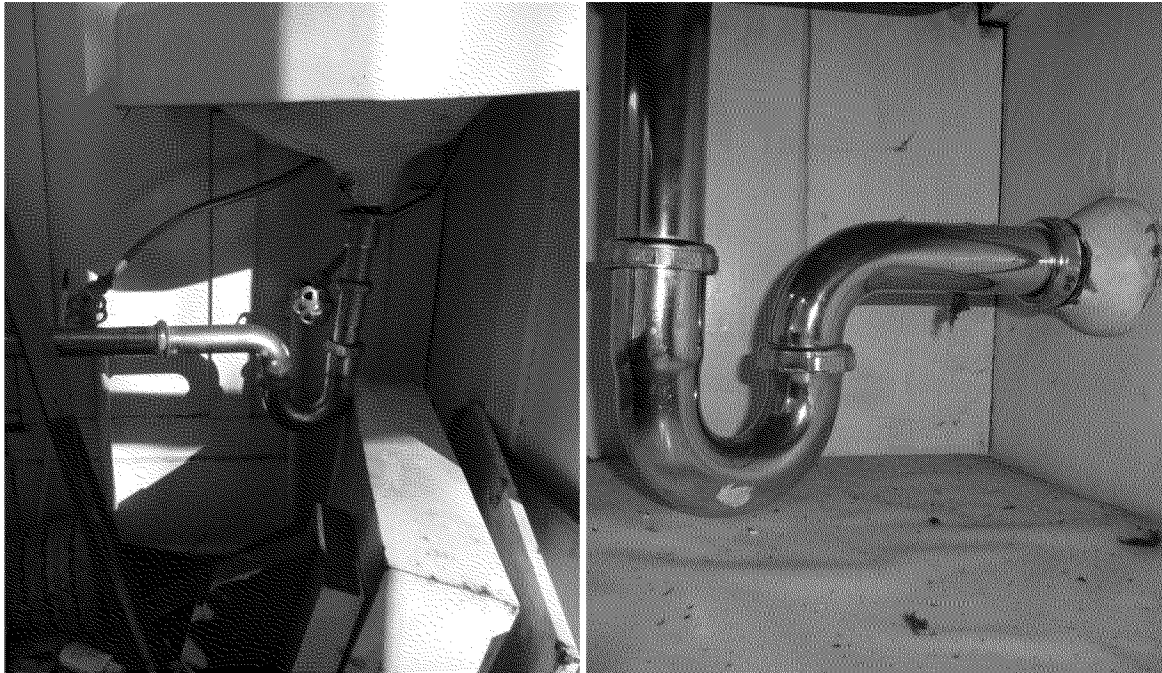
Plumbing traps are curved sections of pipe installed to contain water and provide a barrier to sewer gases entering living space. The water seal trap on any plumbing fixture or plumbing drain line must be filled with water to be effective. At the subject residence, traps were observed in all lines leading to, or in, all plumbing fixtures present.<sup>24</sup> Some of these plumbing fixture traps are shown in Figure 48 and some of the plumbing line traps are shown in Figure 41.

Figure 48. Plumbing traps at bathroom sink (left) and kitchen sink (right). Photographs by Exponent on March 11, 2014.

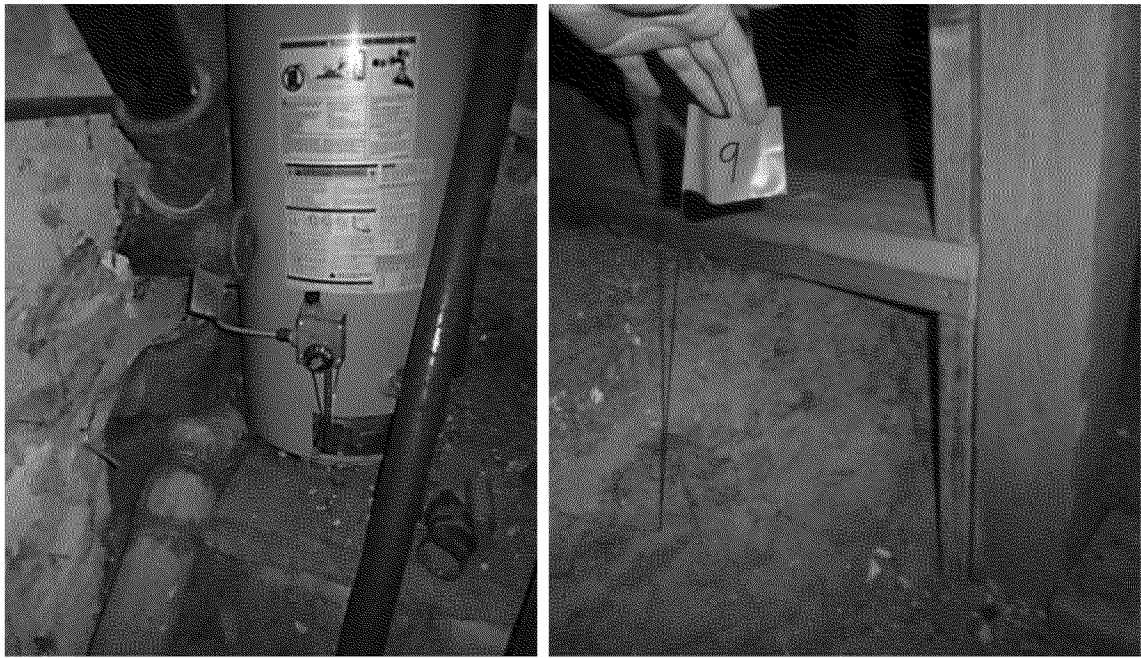
Figure 56. Example monitoring points at the residence's basement. Monitoring point #8 (left) by the cleanout next to water heater. Monitoring point #9 (right) near center of basement, over soil. Photographs by Exponent on March 21, 2014.

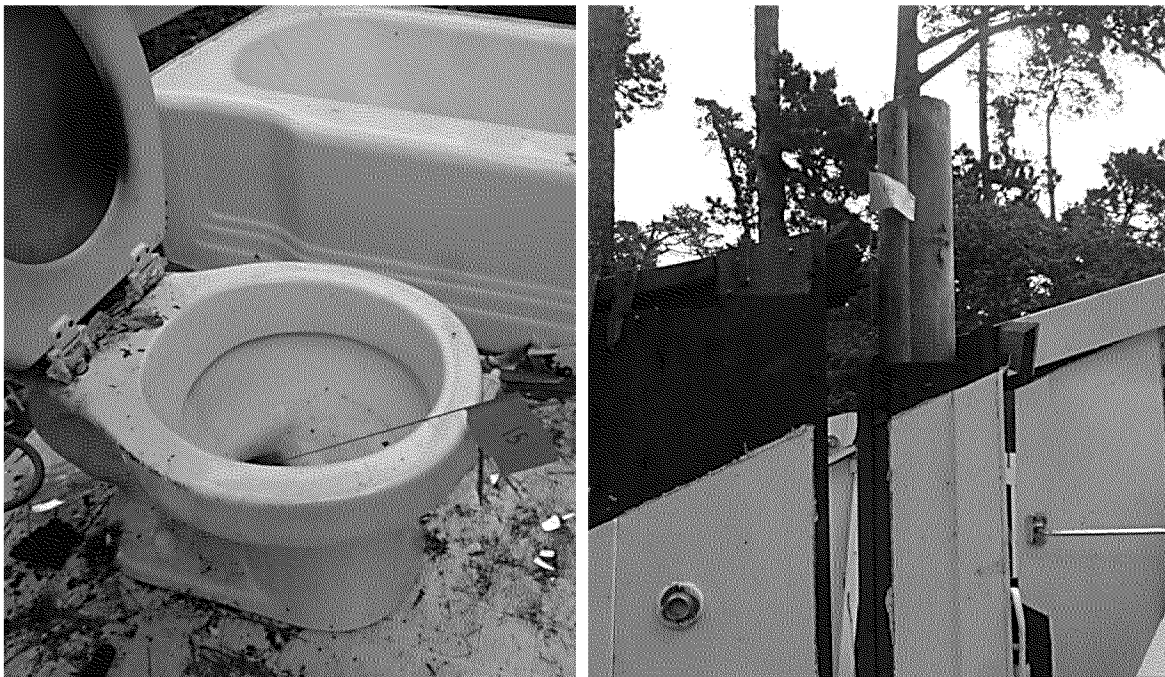
Figure 57. Example monitoring points at the residence's first floor. Monitoring point #15 (left) at the toilet. Monitoring point #18 (right) at bathroom vents. Photographs by Exponent on March 21, 2014.

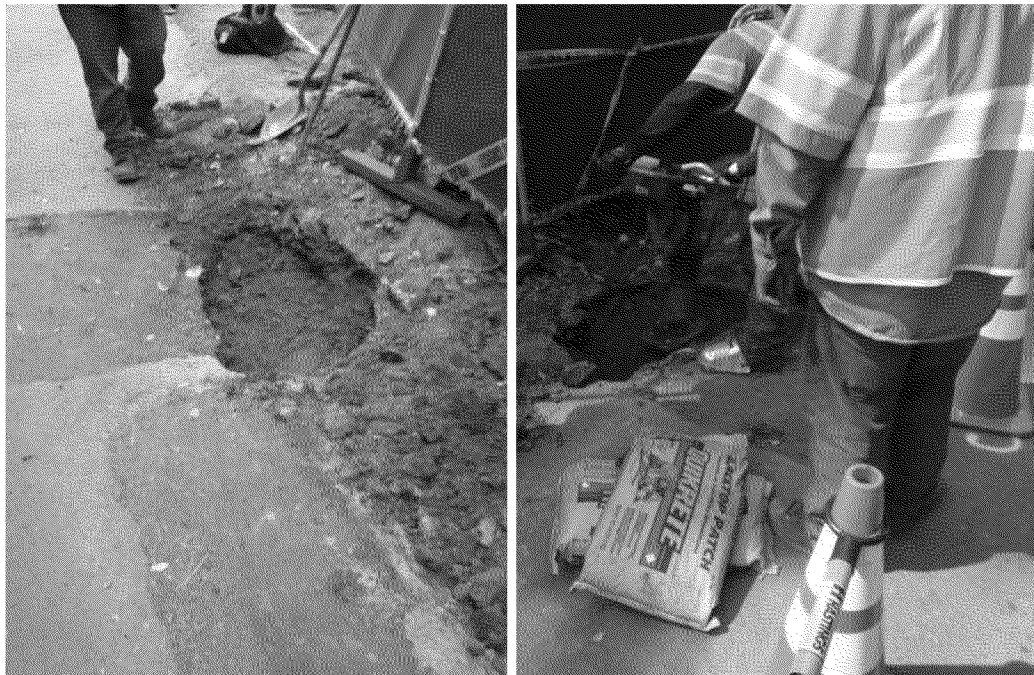
- Test 4: In an attempt to bring soil conditions closer to those present before the gas service tee excavation was performed by PG&E on the day of the explosion, the shallowest eight inches (approximately) of soil above the gas service tee were excavated, re-compacted in place and paved with an asphalt cold patch (Figure 58). Other field conditions were as described for Test 1.

Figure 58. Excavation (left) and re-compaction (right) near gas service tee. Photographs by Exponent on March 21, 2014.

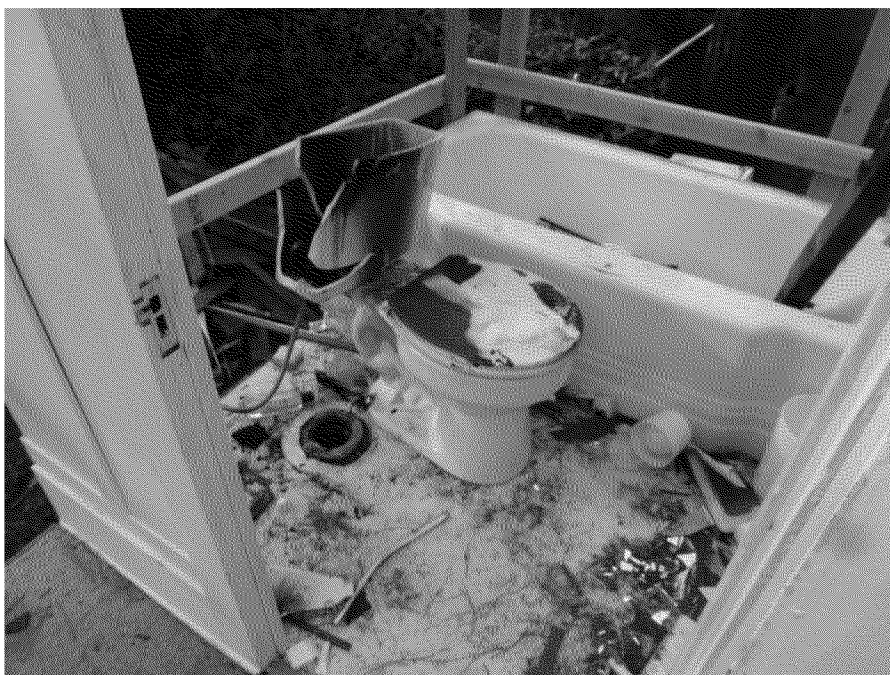
- Test 5: To test the condition of dry toilet bowl on the day of the explosion, the toilet was removed, and helium measurements were taken directly at the toilet sewer riser (Figure 59). Other field conditions were as described for Test 4.

Figure 59. Monitoring point #15 after removal of the toilet.  
Photograph by Exponent on March 21, 2014.
