Failure Analysis Associates

Carmel Gas Incident

April 2014

Doc. no. 1401752.000 - 6877

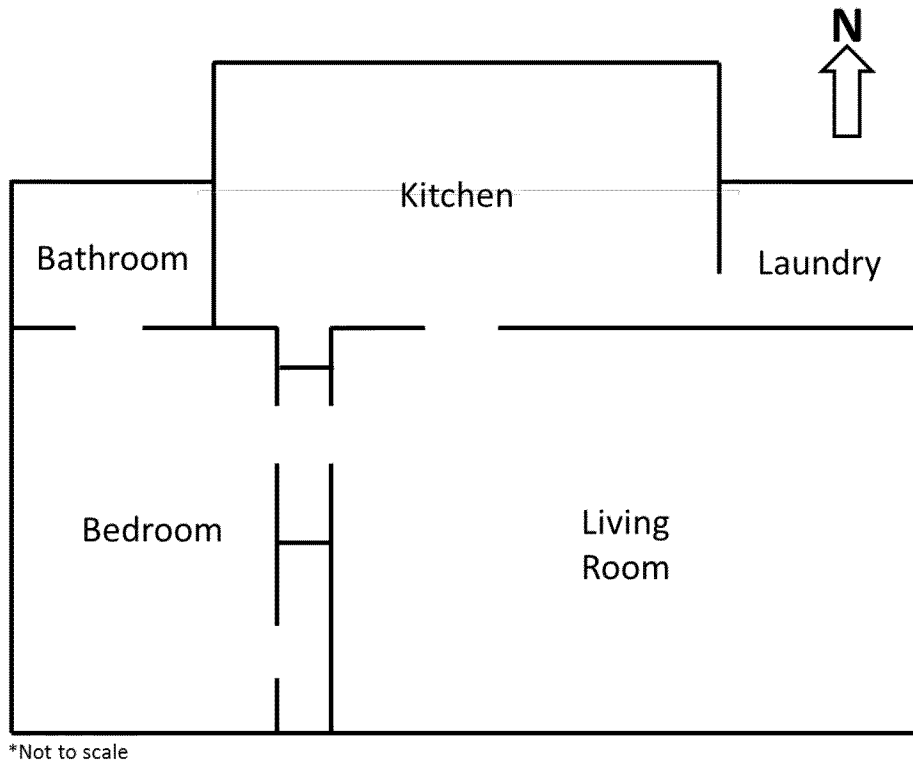
Figure 5. Sketch of incident house approximate main floor plan.

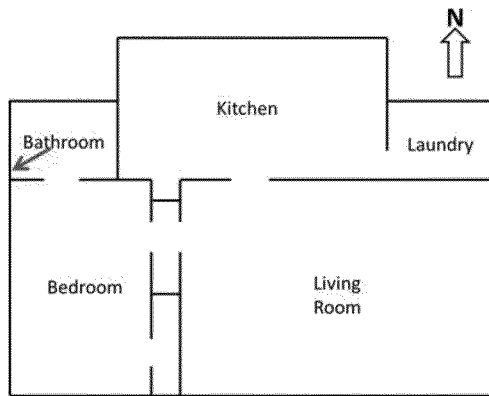
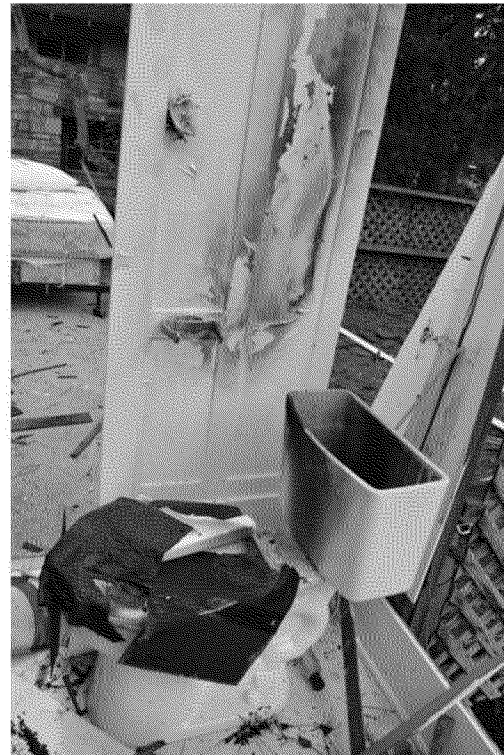
Figure 14. Bathroom toilet. Photograph by Exponent on March 6, 2014.

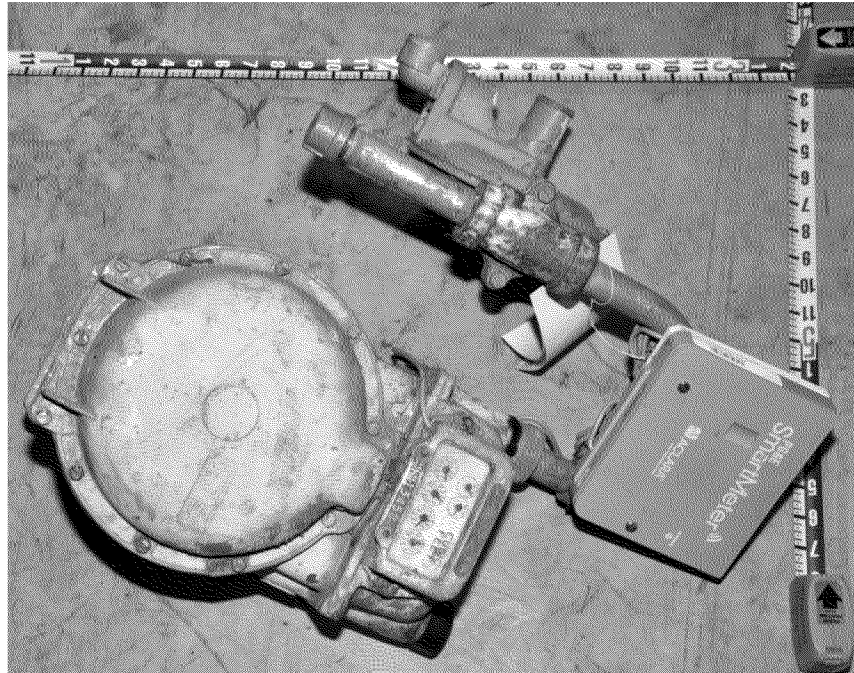
The regulator and meter set (Figure 22) had been removed just downstream of the service riser shut-off valve. The meter was equipped with a SmartMeter module. No functional tests were performed during the inspection.

Figure 22. Regulator meter set removed from incident house. Photograph by Exponent on March 10, 2014.

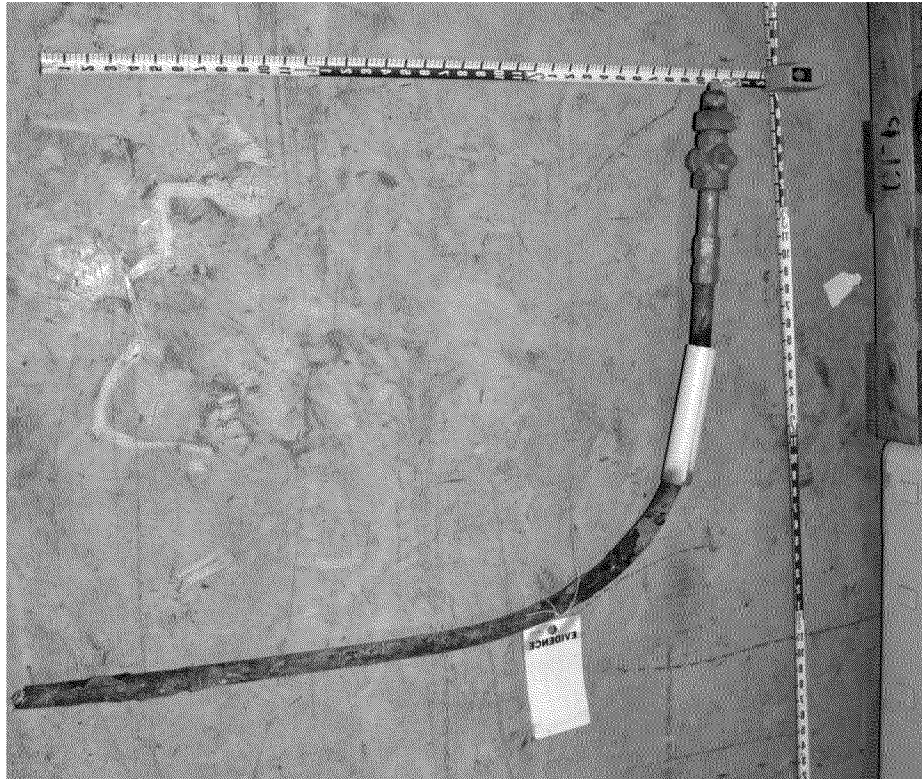
The steel $\frac{3}{4}$ -inch gas service line and riser are shown in Figure 23. The steel line is approximately five feet in length and inserted with a $\frac{1}{2}$ -inch plastic line (Figure 24). The line segment terminates in a service head adapter kit and service riser shut-off valve. According to the PG&E leak repair report, the service riser shut-off valve was turned to the closed position during the incident response operations.

Figure 23. Portion of the gas service line to incident house. Photograph by Exponent on March 10, 2014.

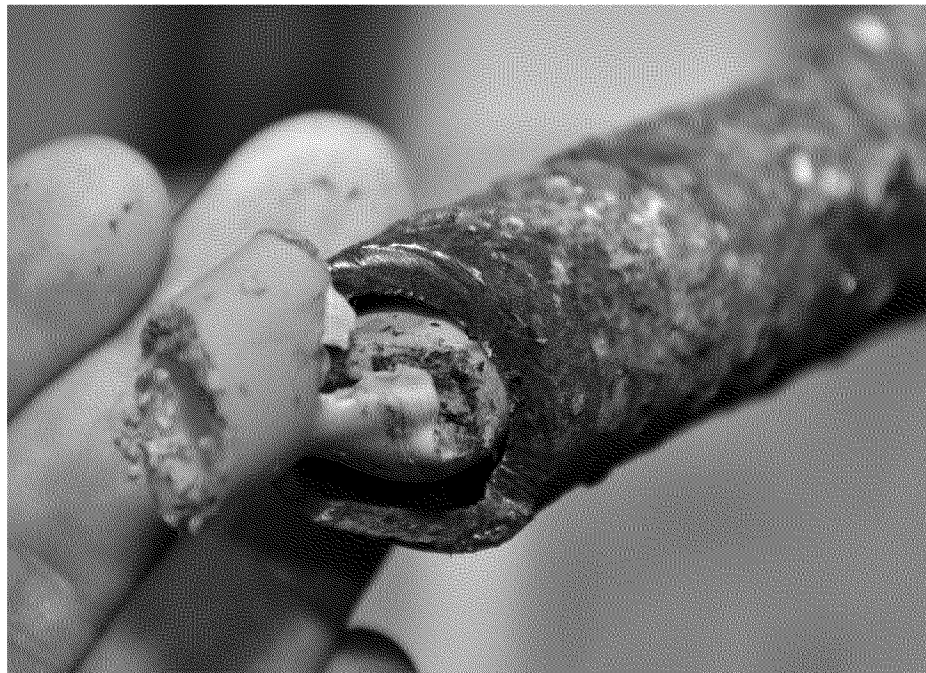
Figure 24. Close-up of the cut end of the gas service line. Photograph by Exponent on March 10, 2014.

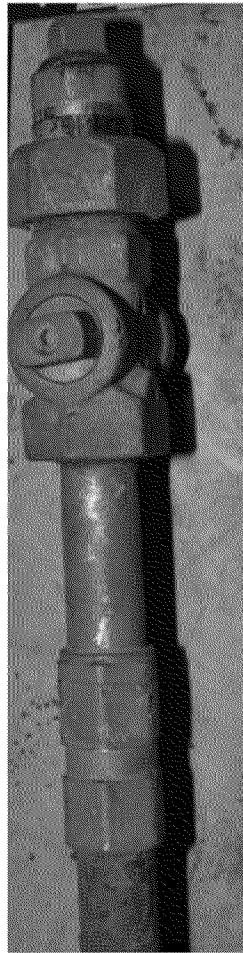
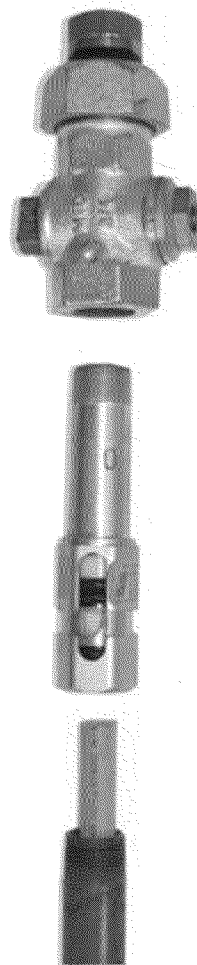
The service head adapter seals the annular space between the 3/4-inch steel pipe and the 1/2-inch plastic pipe. The service head adapter was lacking identifying markings, but appears to be similar to a Perfection 3/4" x (1/2" PE) x 3/4" Extended Service-Head Adapter. The two service head adapters are shown in Figure 25.

Figure 25. Service head adapter. Sources: Photograph by Exponent on March 10, 2014, service head adapter image from PG&E Gas Methods and Procedures document Service-Head Adapter Photo Identification.

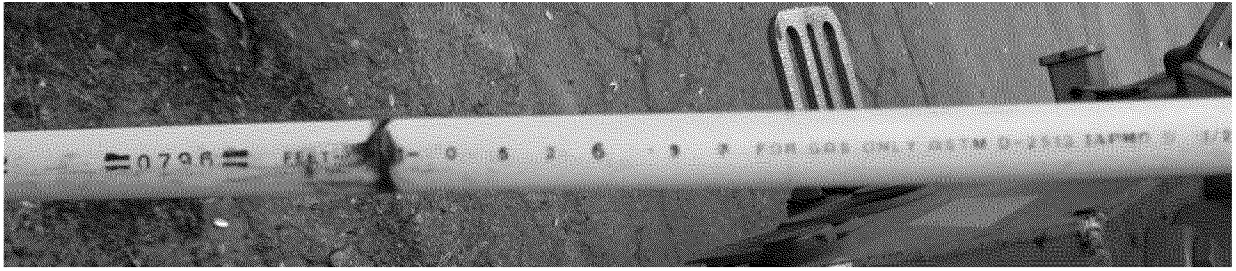
The inserted plastic pipe from the service line had a date code that read "052697," indicating a date of manufacture of May 26, 1997. The inserted plastic service line is shown in Figure 26.

Figure 26. Inserted plastic service line. Photograph source: PG&E.

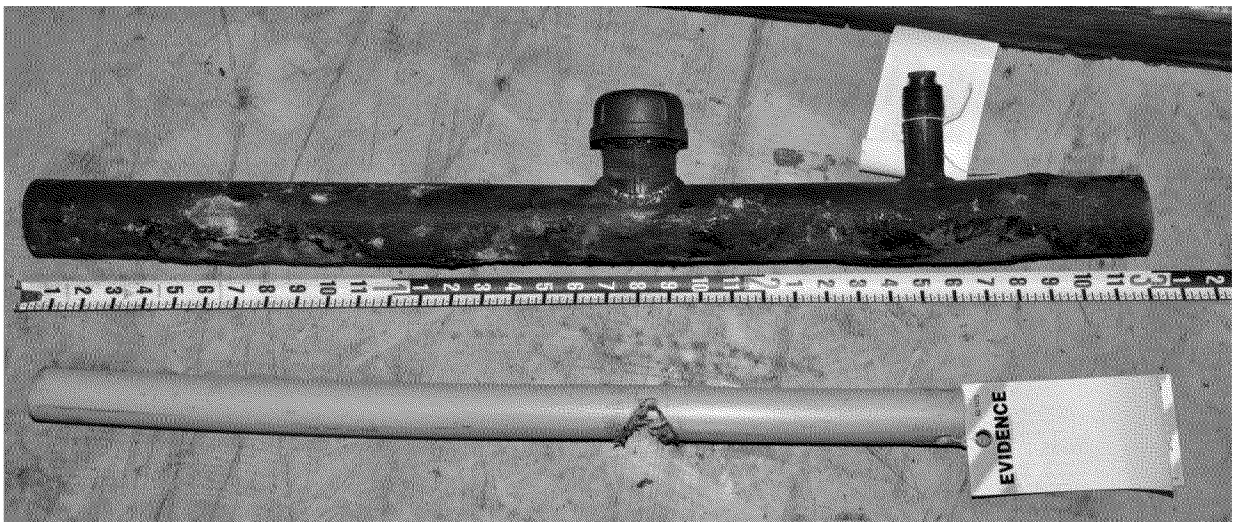
A three-foot long section of the 2-inch steel main running along 3rd Avenue was removed from the bell hole at the intersection of [Redacted] (Figure 27). The steel pipe segment has two welded fittings that were installed on March 3, 2014; one is a 1-inch Save-a-valve fitting and the other is a 2-inch M/2 line stopper fitting. There were no obstructions either in the main pipe or the two fittings.

Figure 27. Portion of the gas main along [Redacted] Steel pipe (top) with welded fittings and plastic pipe insert. Photograph by Exponent on March 10, 2014.

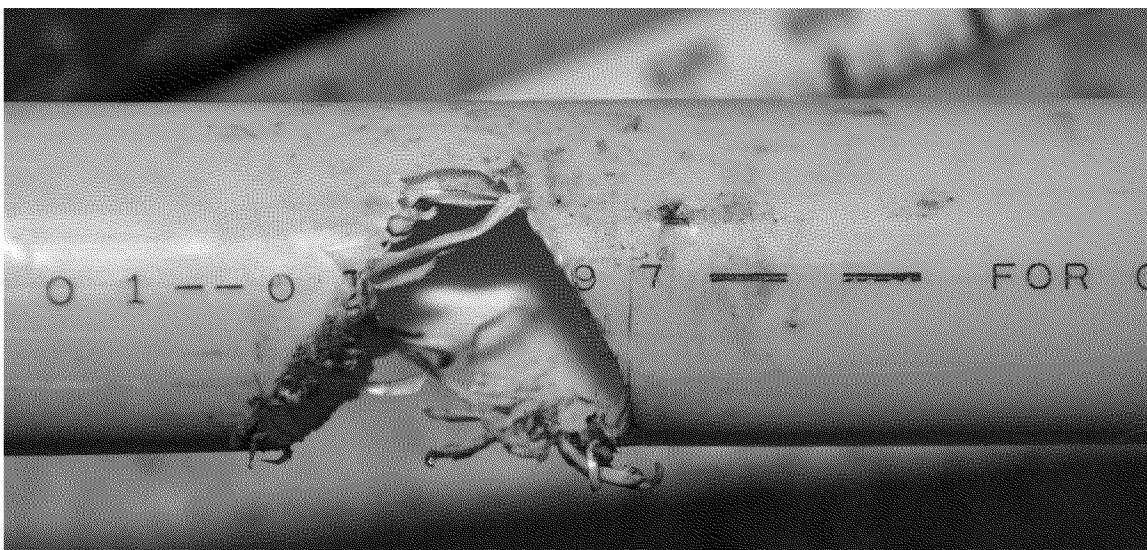
pipes (Figure 28). The plastic line segment has two perforations that correspond to the Save-a-Valve and M/2 fittings (Figure 29). There are some markings printed along the exterior of the pipe. A portion of the writing is associated with the fabrication date; in this particular piece only the year is visible, 1997 (Figure 30).

Figure 30. Close-up of the visible portion of the date code on the plastic pipe. Photograph by Exponent on March 10, 2014.

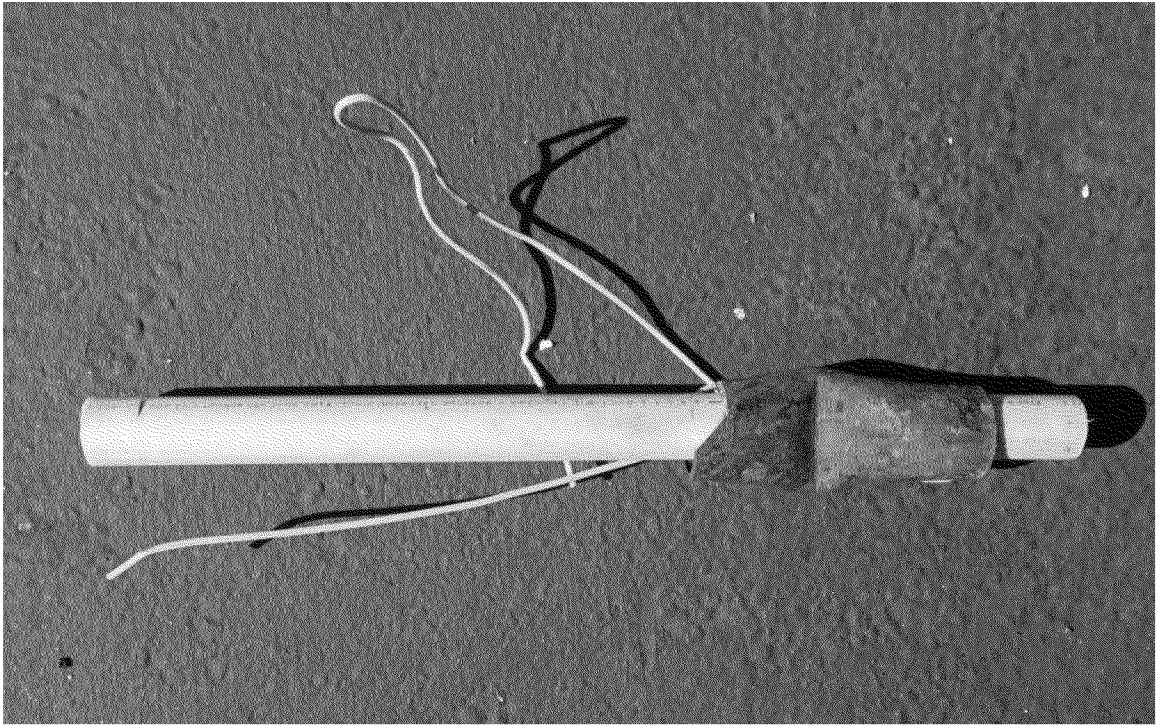
An additional portion of the gas main along Redacted was taken into evidence by PG&E. Exponent did not inspect this item, but PG&E provided multiple pictures to Exponent. The additional item corresponds to the west side gas main portion where the line had been squeezed after the incident (Figure 31). The writing on the photographs shown to Exponent indicates that the plastic pipe had a complete manufacturing date code of July 17, 1997 (Figure 32).

Figure 31. West-side squeeze point of the gas main along [Redacted] Yellow tracer wire is visible. Photograph provided by PG&E.

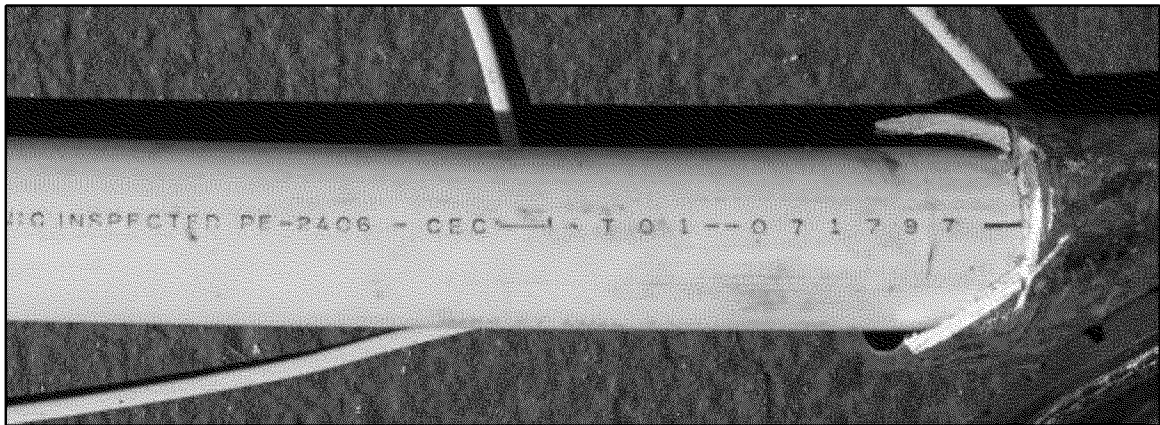
Figure 32. Close-up of the complete manufacturing date code of the plastic gas main. Photograph provided by PG&E.

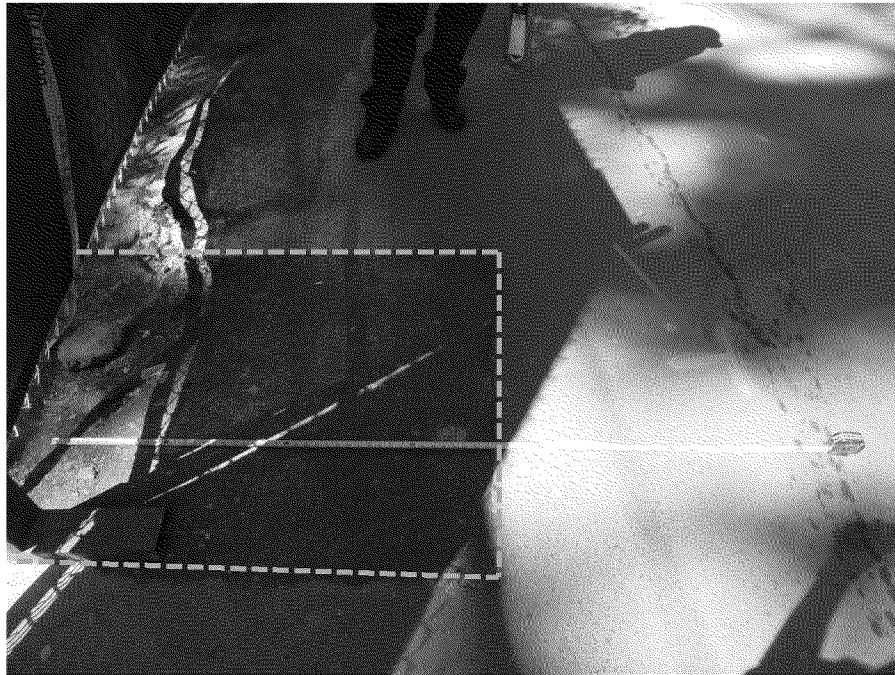
by PG&E for the gas service line. As shown in this figure, the sewer line is in close proximity to the gas service tee.

Figure 35. Relative location of cold asphalt patch for gas service tee (dashed yellow lines) and sewer lateral tap connection to sewer main (green arrow) for subject residence. Residence is to the left in photograph. Photograph by Exponent on March 11, 2014.

As shown in Figure 36, approximately 8 feet from the tap at the sewer main, the sewer lateral had a joint offset and opening. The green painted dot marked inside the left side of the cold asphalt patch shown in Figure 35 indicates the approximate location of this joint offset. More than 50 percent of the cross-sectional area of the pipe was offset, exposing the backfill around the pipe. The lateral-launch camera was unable to continue beyond this joint offset.

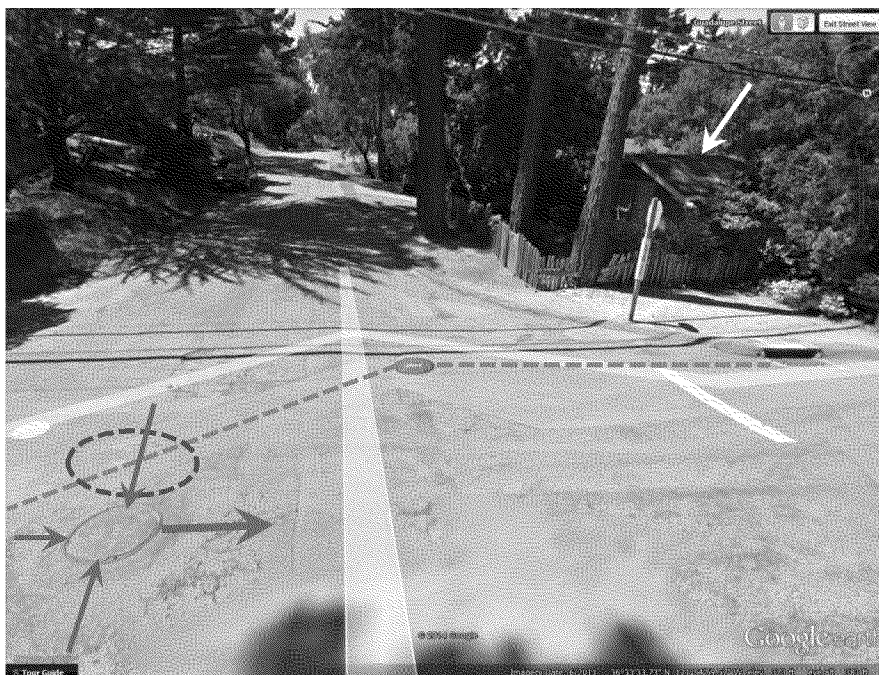
south of the manhole (Figure 37). Standing water was observed in the collapsed area. The area of the observed collapse appears to be aligned with the storm pipe system.

Figure 38. Underground utilities in the vicinity of subject residence (indicated by white arrow). Green arrows indicate sewer line flow directions into manhole (only one line discharging towards [Redacted] in the western direction). Blue dashed lines indicate likely alignment of storm drain pipes inside pavement trench marks. Red oval indicates approximate location of collapsed sewer pipe.

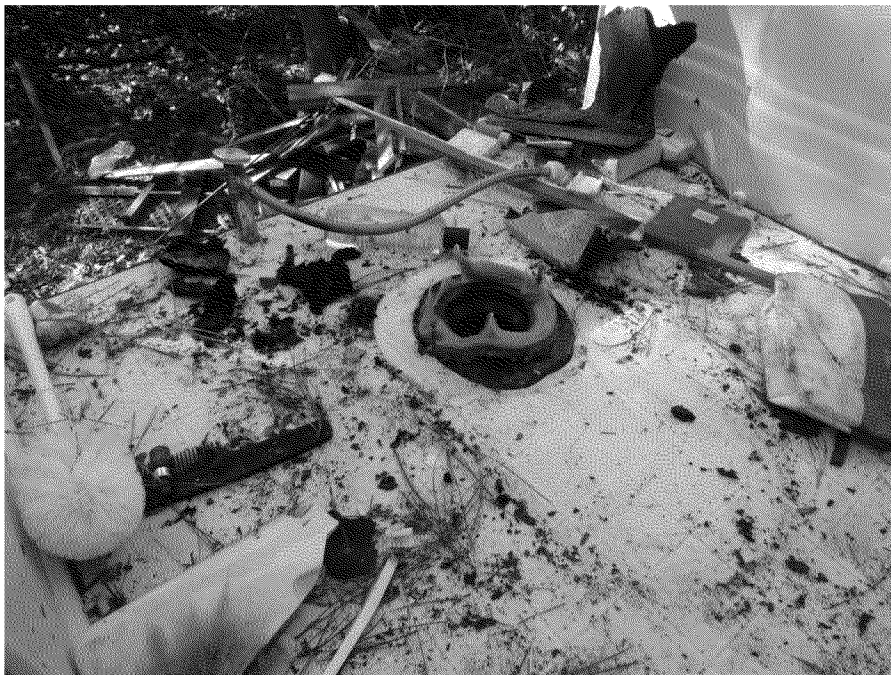
At the subject residence, because of the sewer lateral joint offset near the sewer main, video of the sewer lateral was attempted from the interior of the residence. The selected entry point for the video was a toilet, which was removed to allow the push camera to enter the sewer pipe (Figure 39).

Figure 39. Toilet removed to allow for insertion of sewer push camera. Photograph by Exponent on March 11, 2014.

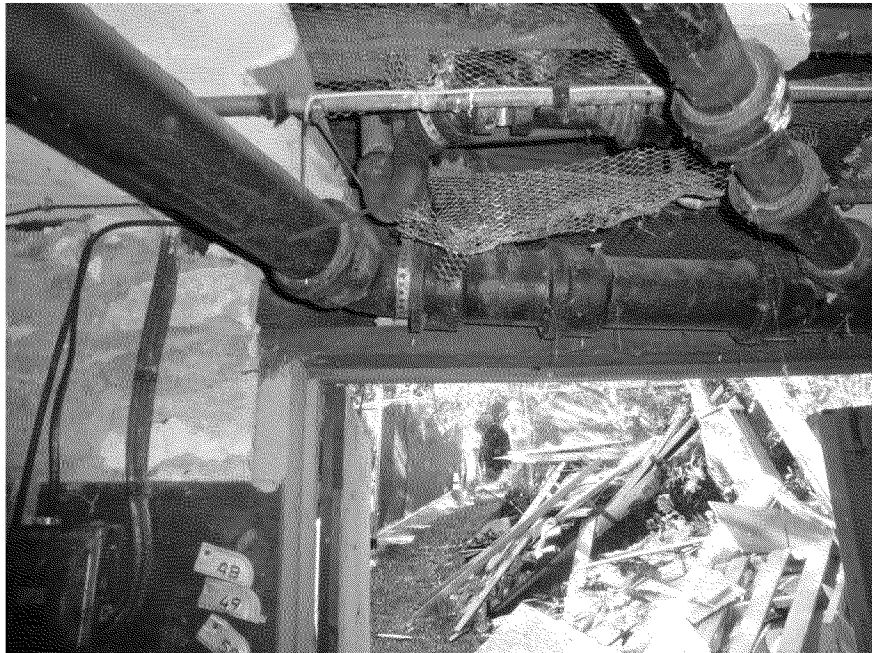
- Sewer line below toilet was an approximately 4-inch cast iron pipe (Figure 40).
- Various pipe connections occurred inside the house. The connections were for other sewer pipes and vents (Figure 41).
- Sewer pipe exited the residence approximately 23 feet from the toilet (distance measured along the sewer pipe). The sewer pipe at the wall’s residence exterior was approximately 1¼ feet below ground.

Figure 41. Multiple connections to building sewer system inside residence. Arrow indicates tub plumbing trap. Photograph from inside residence's basement. Photograph by Exponent on March 11, 2014.

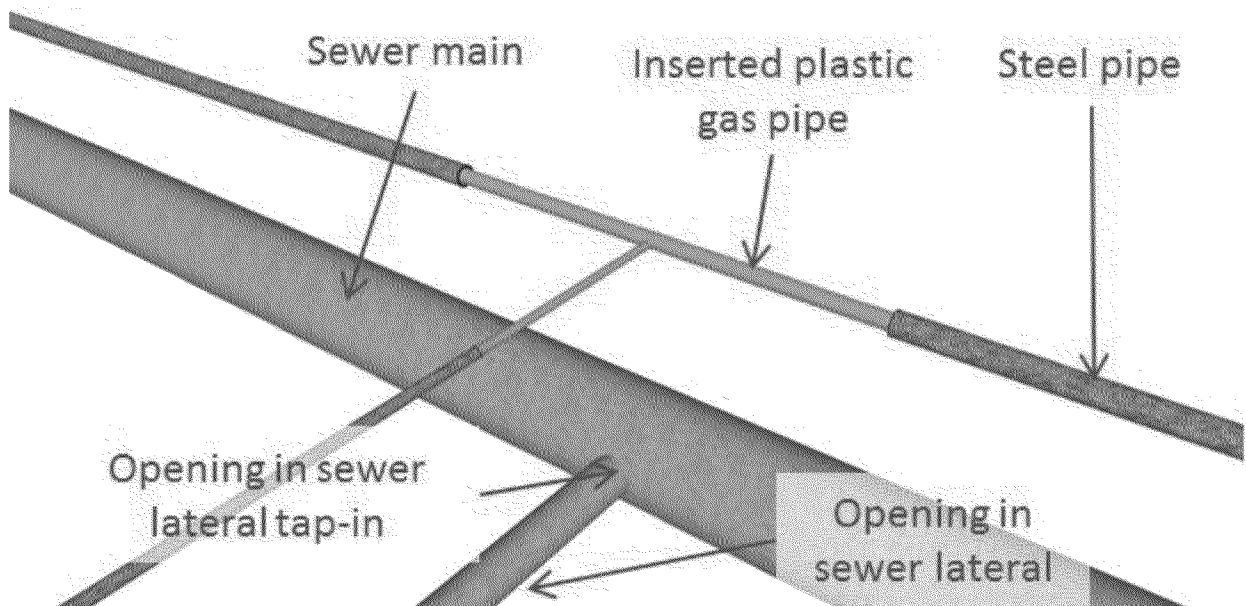
Figure 44. Schematic configuration of the sewer and gas systems in the vicinity of the excavation. Figure not to scale.

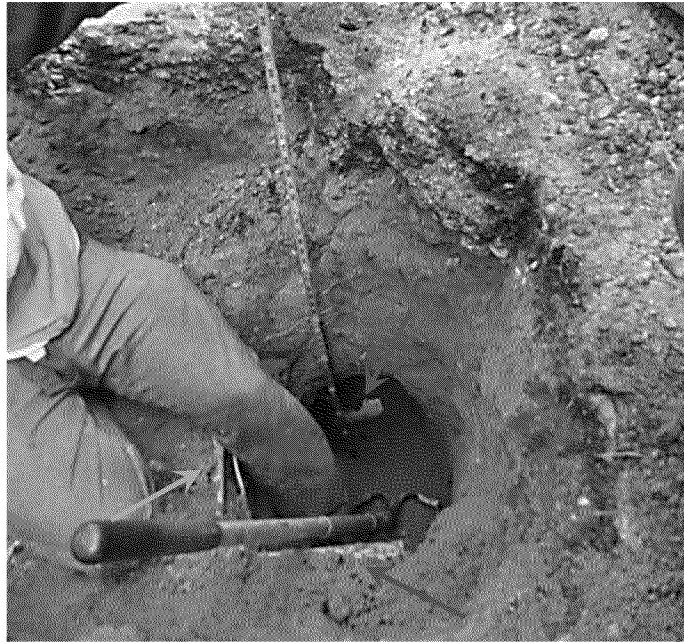
The approximate area previously excavated by PG&E on the day of the explosion (Figure 35) was re-excavated. The depth of excavation continued until a portion of the sewer lateral was exposed (Figure 45). As shown in Figure 46, the presence of a white plastic segment of sewer lateral, and an offset of the pipe, was confirmed by the excavation. The date of installation of the plastic segment in the sewer lateral is unknown. According to statements by [Redacted] of Fire Cause Analysis, the homeowners stated that they have not performed sewer replacement/repair work since they purchased the property in 1999.

Figure 45. Excavation to expose sewer lateral at subject residence in the vicinity of gas service tee. Yellow arrow indicates [Redacted] [Redacted] Red arrow indicates gas service line. Green arrow indicates sewer lateral. Photograph by Exponent on March 21, 2014.

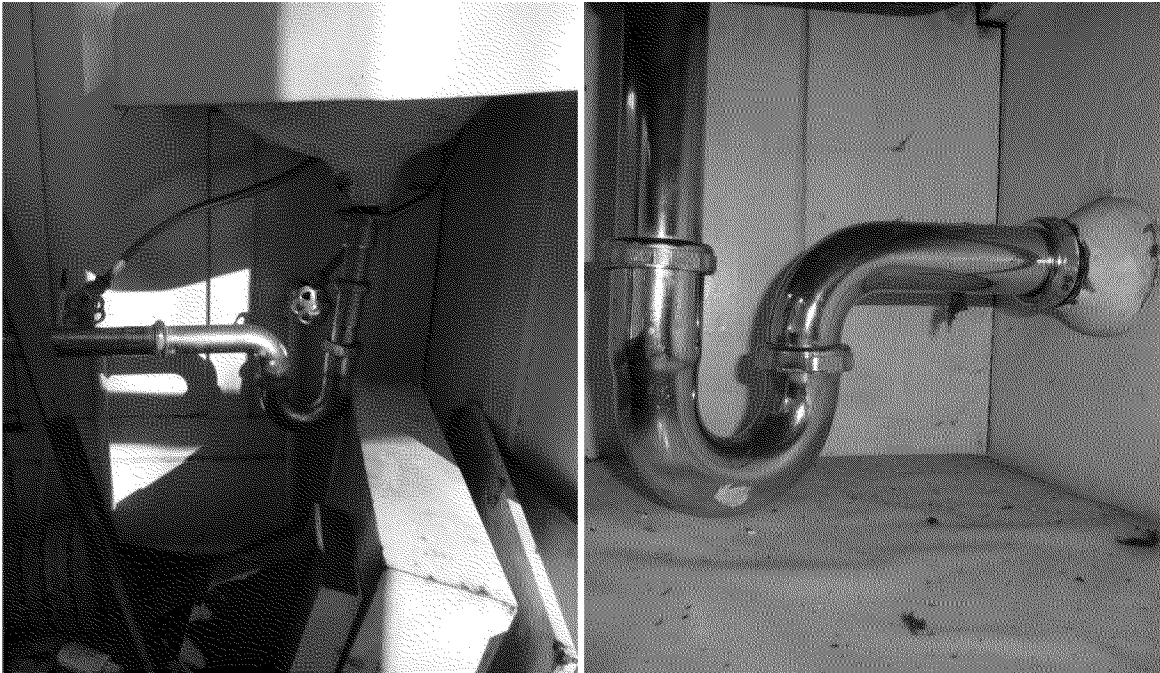
Plumbing traps are curved sections of pipe installed to contain water and provide a barrier to sewer gases entering living space. The water seal trap on any plumbing fixture or plumbing drain line must be filled with water to be effective. At the subject residence, traps were observed in all lines leading to, or in, all plumbing fixtures present.²⁴ Some of these plumbing fixture traps are shown in Figure 48 and some of the plumbing line traps are shown in Figure 41.

Figure 48. Plumbing traps at bathroom sink (left) and kitchen sink (right). Photographs by Exponent on March 11, 2014.

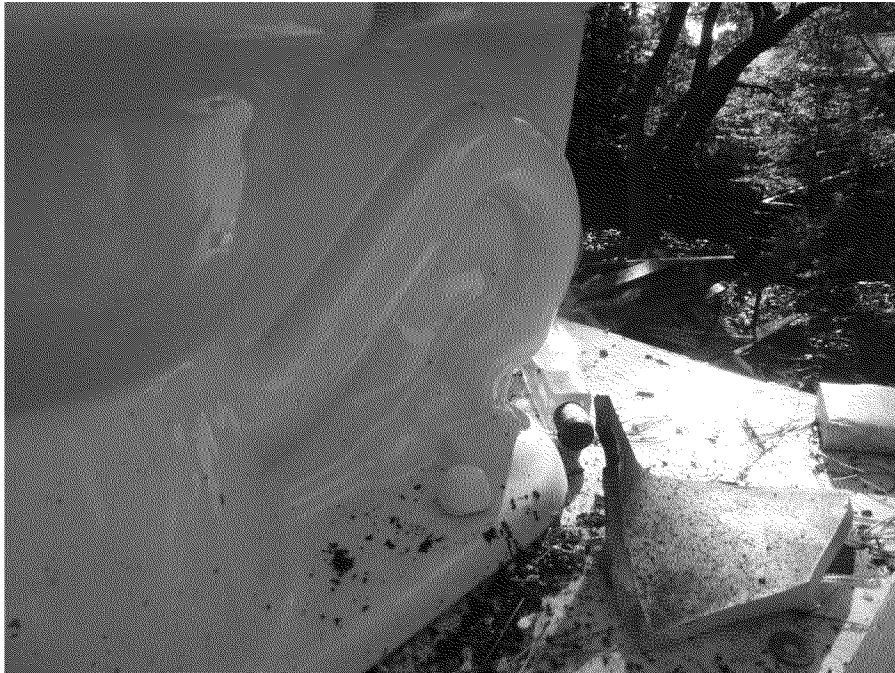
As previously noted, there was no plumbing trap in the sewer drain line section video recorded from the toilet towards the sewer main on Redacted. The only trap along this sewer line path was the integral trap in the toilet fixture. Figure 49 documents this trap.

It is Exponent's understanding that the residence had been unoccupied for over one year. When plumbing fixtures are not used for extended periods of time the plumbing traps can lose their water seal through evaporation. On March 6, 2014, Exponent observed a low water level in the bathroom toilet bowl (Figure 50). The exact water level conditions of the toilet at the time of the explosion are unknown. As noted earlier, the fire department deployed a hose line to extinguish a small fire in the demolished structure,²⁵ and it is likely that the water observed in the toilet bowl was introduced at the time the small fire was being extinguished.

Figure 49. Toilet drain trap. Photograph by Exponent on March 11, 2014.

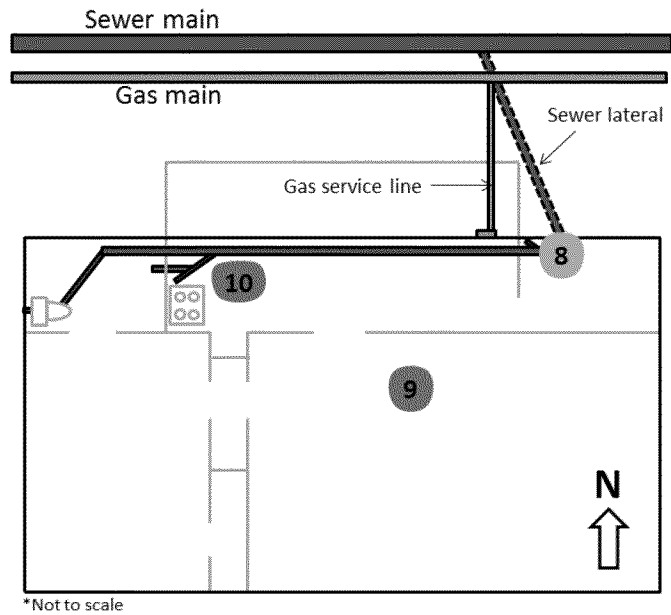
Figure 53. Helium test monitoring points and results at the residence's basement.

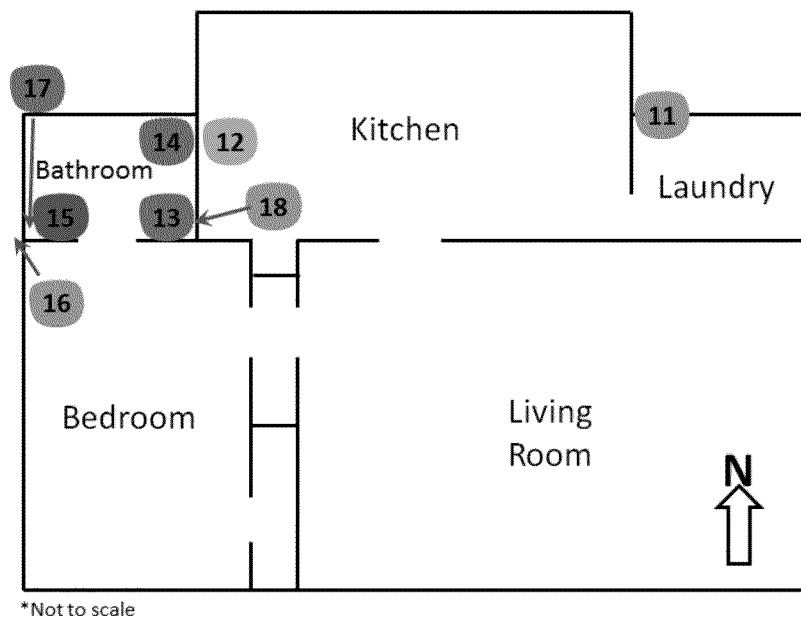
Figure 54. Helium test monitoring points and results at the residence's first floor.

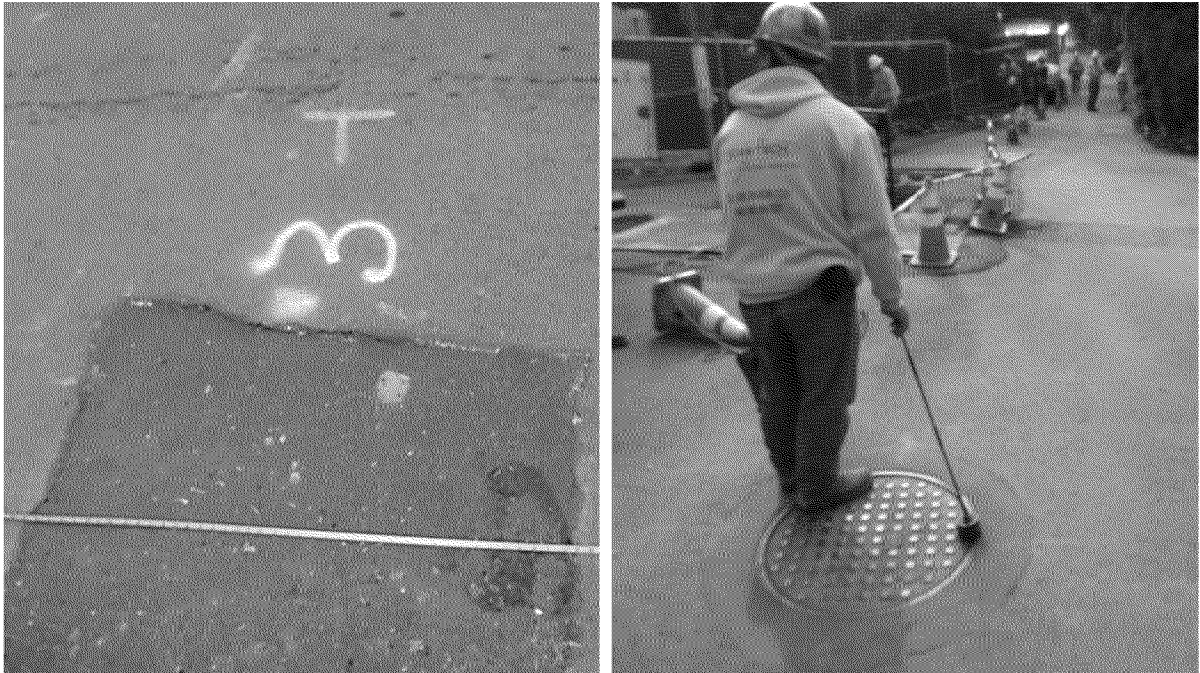
Figure 55. Example monitoring points outside of residence. Monitoring point #3 (left) near excavation performed by PG&E at gas service tee for residence. Monitoring point #19 (right) at sewer manhole [Redacted] [Redacted] Photographs by Exponent on March 21, 2014.

Tests 3: a hole created by escaping helium was found close to point 3b.

- Tests 1 through 3 were with “As-is” conditions (i.e., no field modifications taking place on the day of the test). Test injection pressures varied. During Test 3, a pinhole formed through the soil near the gas service tee, causing release of helium gas into the air.

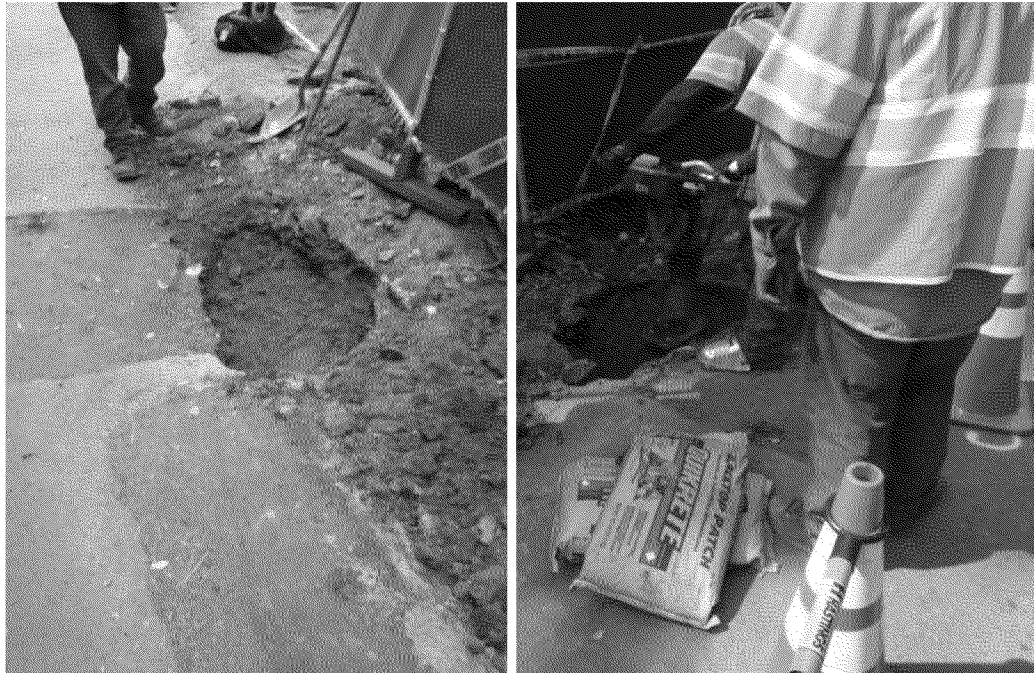
- Test 4: In an attempt to bring soil conditions closer to those present before the gas service tee excavation was performed by PG&E on the day of the explosion, the shallowest eight inches (approximately) of soil above the gas service tee were excavated, re-compacted in place and paved with an asphalt cold patch (Figure 58). Other field conditions were as described for Test 1.

Figure 58. Excavation (left) and re-compaction (right) near gas service tee. Photographs by Exponent on March 21, 2014.
