Carmel Gas Incident

April 2014

Doc. no. 1401752.000 - 4253

Pacific Gas and Electric (PG&E) has retained Exponent Failure Analysis Associates (Exponent) to conduct a failure analysis investigation of a gas leak and subsequent explosion on March 3, 2014 in Carmel-by-the-Sea (Carmel), California.

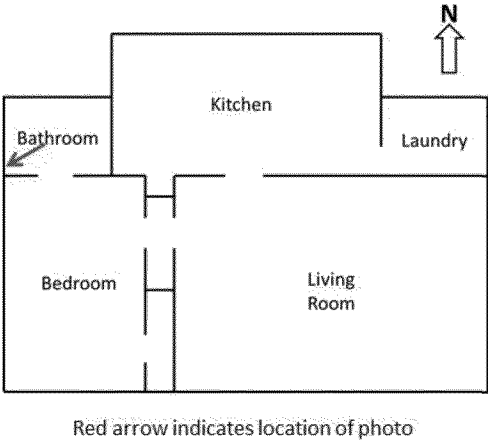
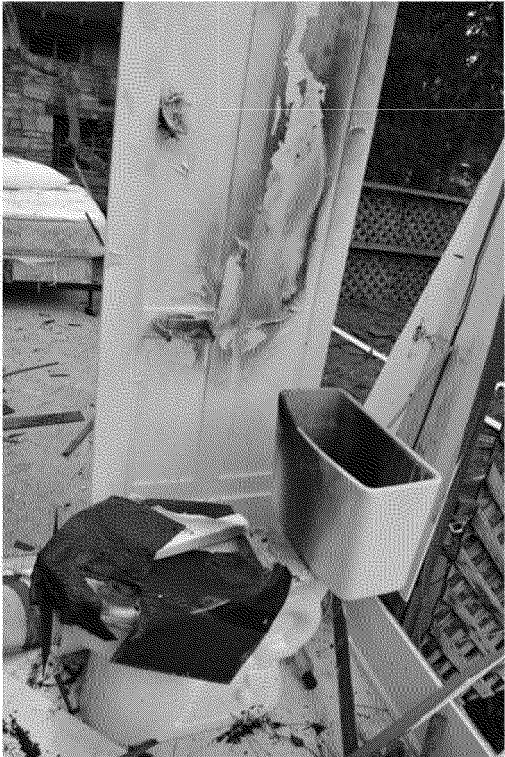
Figure 14. Bathroom toilet. Photograph by Exponent on March 6, 2014.

Figure 15. Damage to bathroom toilet. Burn marks below toilet seat and melted components inside toilet tank. Photographs by Exponent on March 6, 2014.

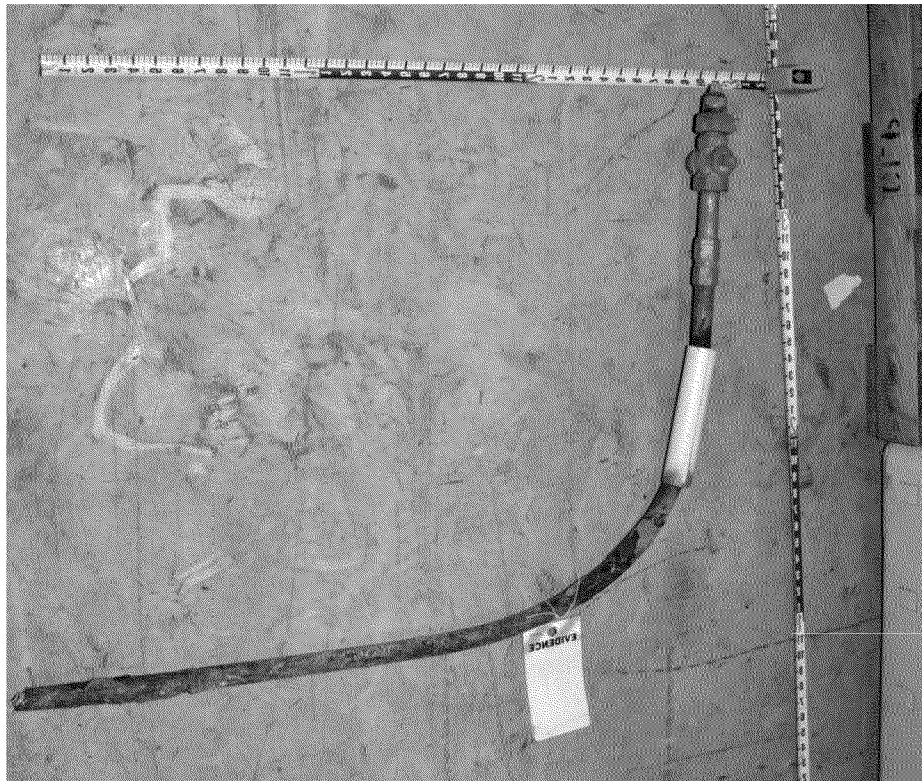
The steel $\frac{3}{4}$ -inch gas service line and riser are shown in Figure 23. The steel line is approximately five feet in length and inserted with a $\frac{1}{2}$ -inch plastic line (Figure 24). The line segment terminates in a service head adapter kit and service riser shut-off valve. According to the PG&E leak repair report, the service riser shut-off valve was turned to the closed position during the incident response operations.

Figure 23. Portion of the gas service line to incident house. Photograph by Exponent on March 10, 2014.

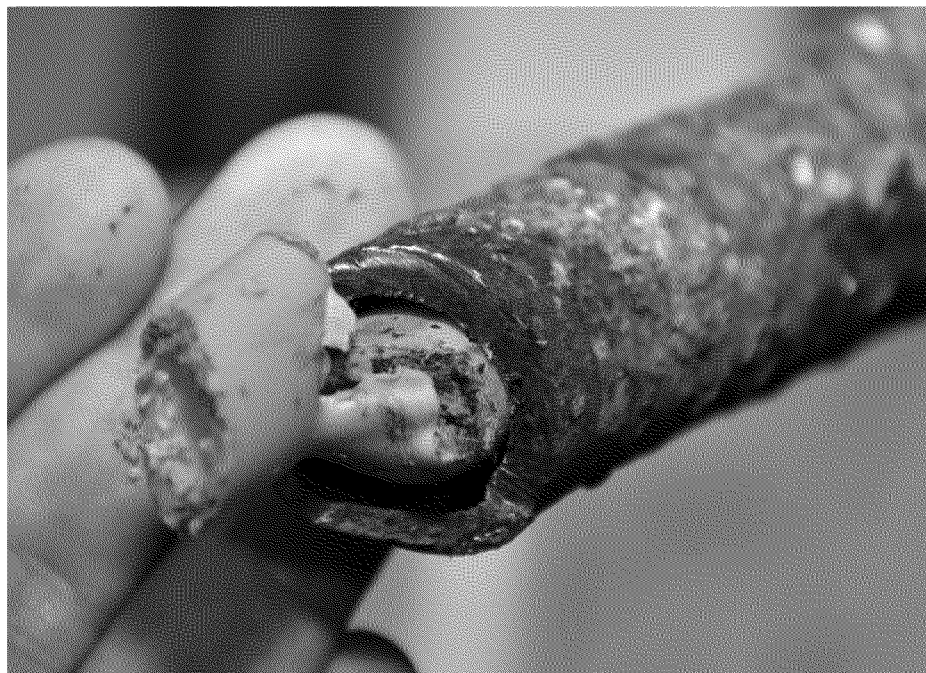
Figure 24. Close-up of the cut end of the gas service line. Photograph by Exponent on March 10, 2014.

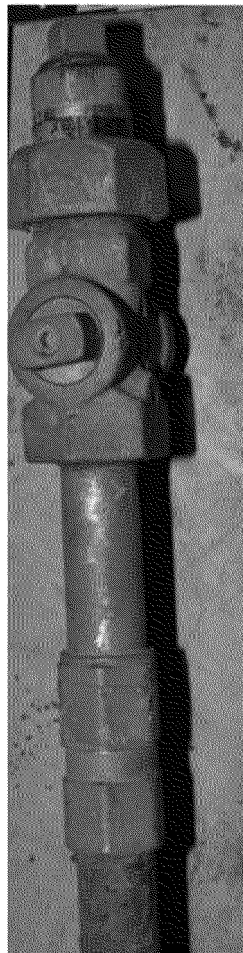
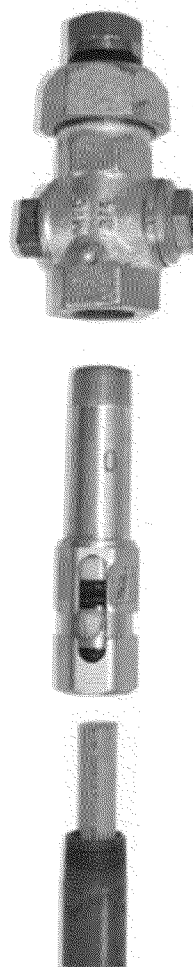
The service head adapter seals the annular space between the 3/4-inch steel pipe and the 1/2-inch plastic pipe. The service head adapter was lacking identifying markings, but appears to be similar to a Perfection 3/4" x (1/2" PE) x 3/4" Extended Service-Head Adapter. The two service head adapters are shown in Figure 25.

Figure 25. Service head adapter. Sources: Photograph by Exponent on March 10, 2014, service head adapter image from PG&E Gas Methods and Procedures document Service-Head Adapter Photo Identification.

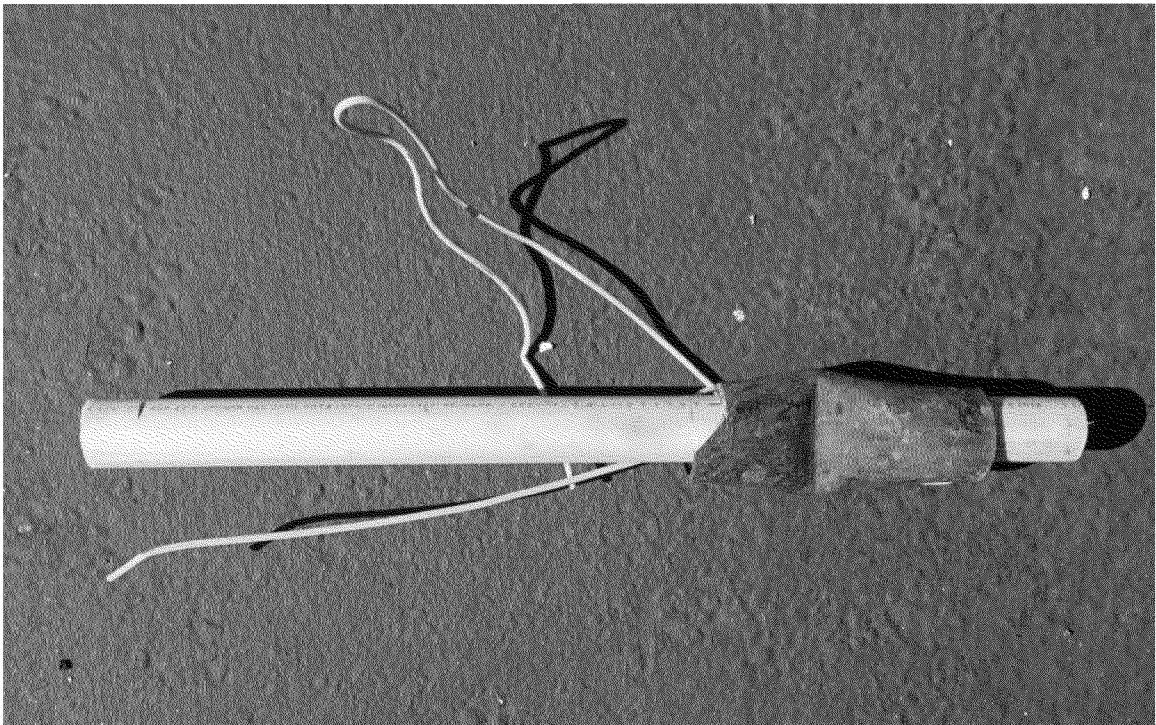
An additional portion of the gas main along Redacted was taken into evidence by PG&E. Exponent did not inspect this item but PG&E provided multiple pictures to Exponent. The additional item corresponds to the west side gas main portion where the line had been squeezed after the incident (Figure 31). The writing on the photographs shown to Exponent indicates that the plastic pipe had a complete manufacturing date code of July 17, 1997 (Figure 32).

Figure 31. West-side squeeze point of the gas main along [Redacted] Photograph provided by PG&E.

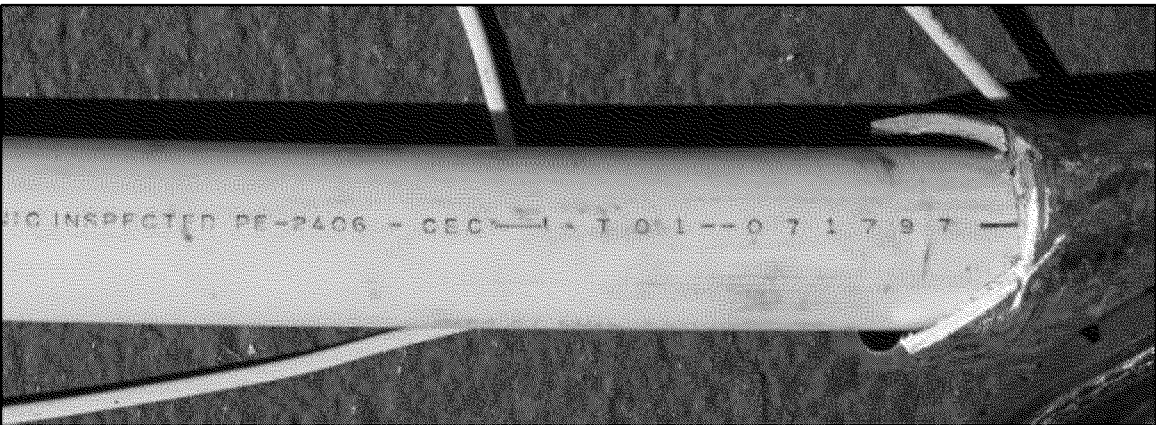
Figure 32. Close-up of the complete manufacturing date code of the plastic gas main. Photograph provided by PG&E.

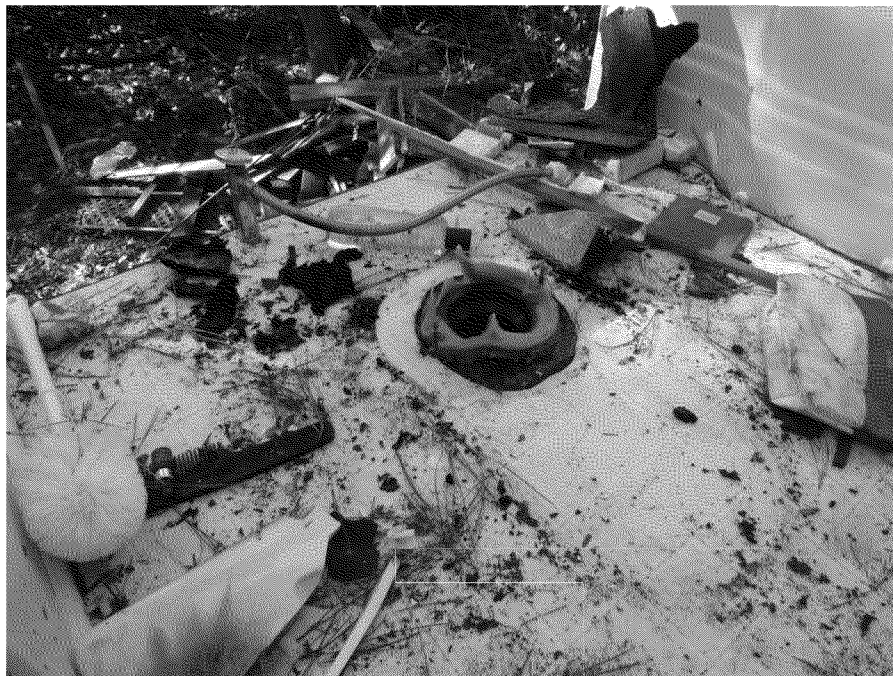
At the subject residence, because of the sewer lateral joint offset near the sewer main, video of the sewer lateral was attempted from the interior of the residence. The selected entry point for the video was a toilet, which was removed to allow for the push camera to enter the sewer pipe (Figure 39).

Figure 39. Toilet removed to allow for insertion of sewer push camera. Photograph by Exponent on March 11, 2014.

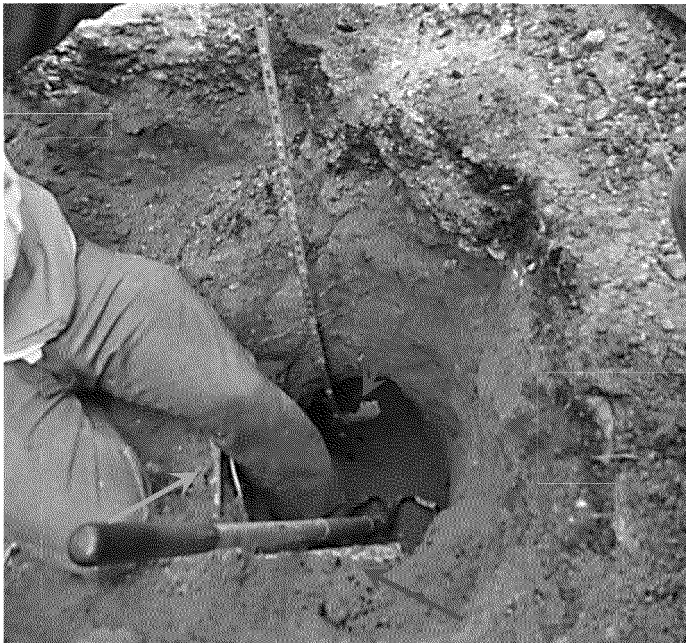
The approximate area previously excavated by PG&E on the day of the explosion (Figure 35) was re-excavated. The depth of excavation continued until a portion of the sewer lateral was exposed (Figure 45). As shown in Figure 46, the presence of a white plastic segment of sewer lateral, and an offset of the pipe, was confirmed by the excavation. The date of installation of the plastic segment in the sewer lateral is unknown. According to statements by John White of Fire Cause Analysis, the homeowners stated that they have not performed sewer replacement/repair work since they purchased the property in 1999.

Figure 45. Excavation to expose sewer lateral at subject residence in the vicinity of gas service tee. Yellow arrow indicates gas main along [Redacted] [Redacted] Red arrow indicates gas service line. Green arrow indicates sewer lateral. Photograph by Exponent on March 21, 2014.

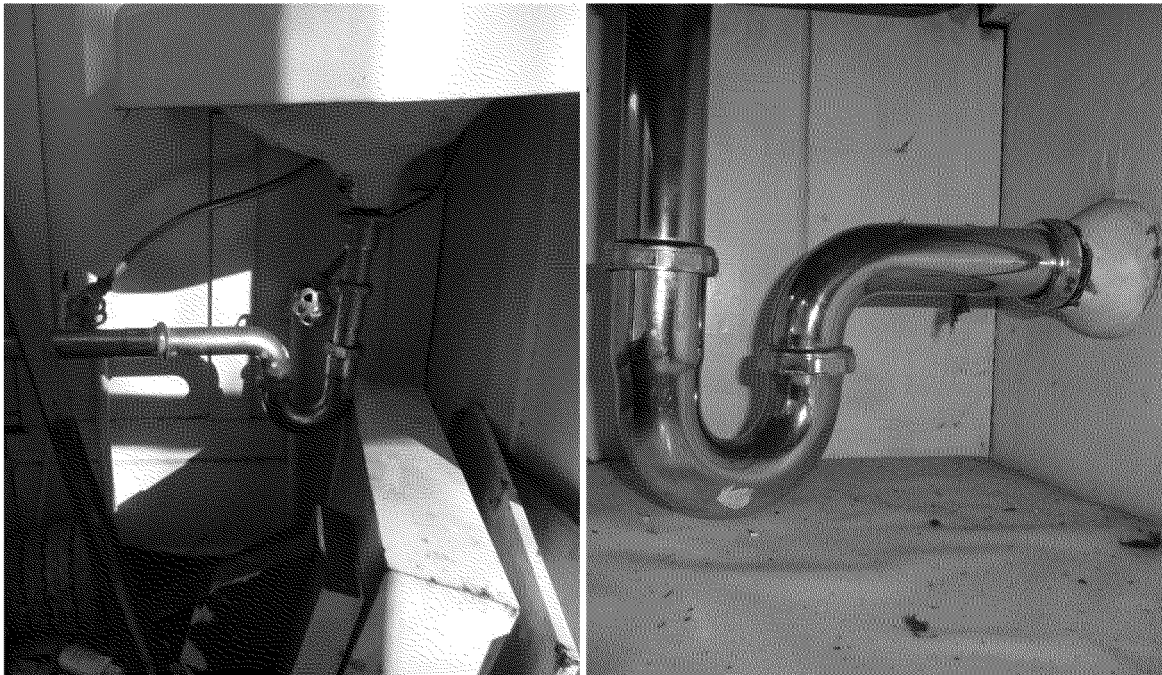
Plumbing traps are curved sections of pipe installed to contain water and provide a barrier to sewer gases entering living space. The water seal trap on any plumbing fixture or plumbing drain line must be filled with water to be effective. At the subject residence, traps were observed in all lines leading to, or in, all plumbing fixtures present.²⁰ Some of these plumbing fixture traps are shown in Figure 48 and some of the plumbing line traps are shown in Figure 41.

Figure 48. Plumbing traps at bathroom sink (left) and kitchen sink (right). Photographs by Exponent on March 11, 2014.

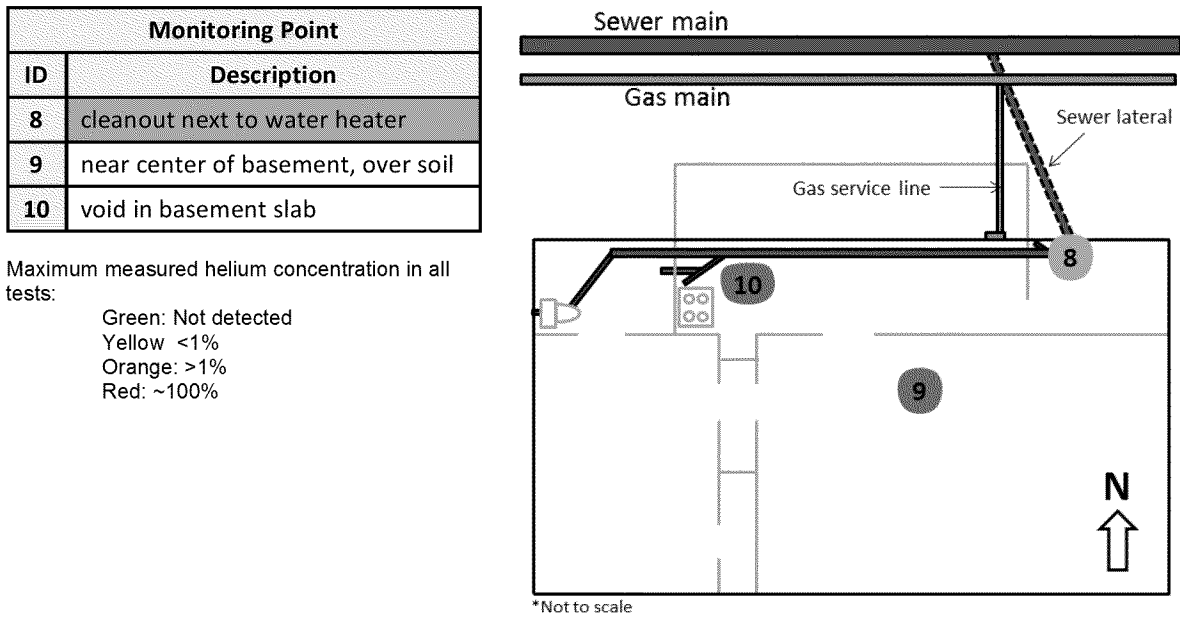
Figure 53. Helium test monitoring points and results at the residence's basement.

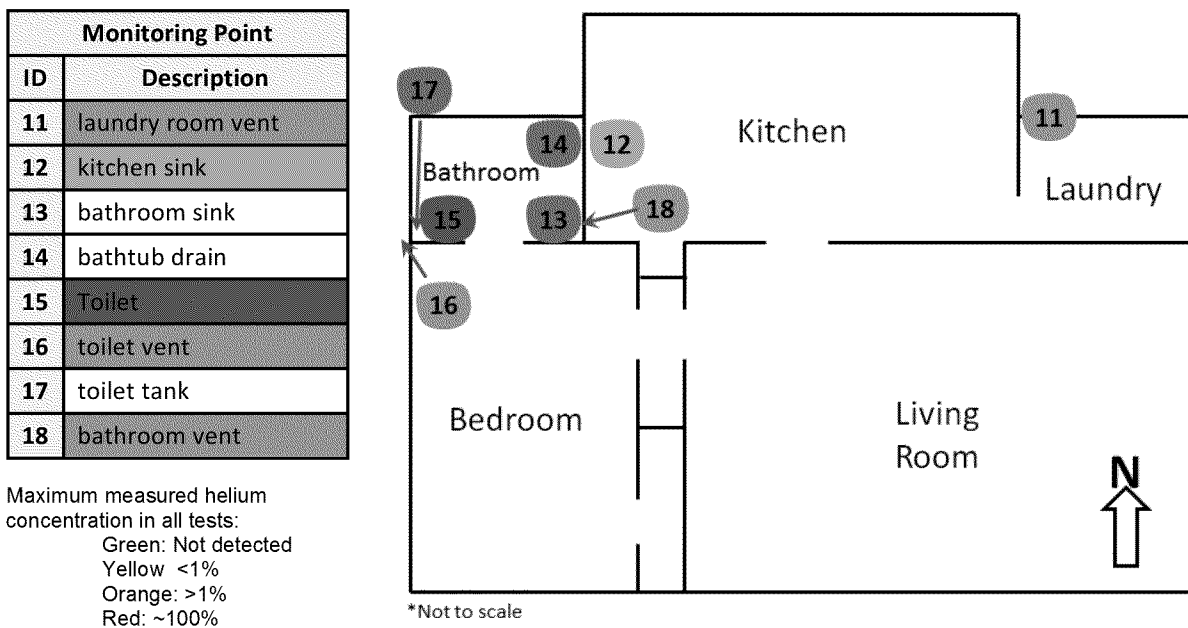
Figure 54. Helium test monitoring points and results at the residence's first floor.

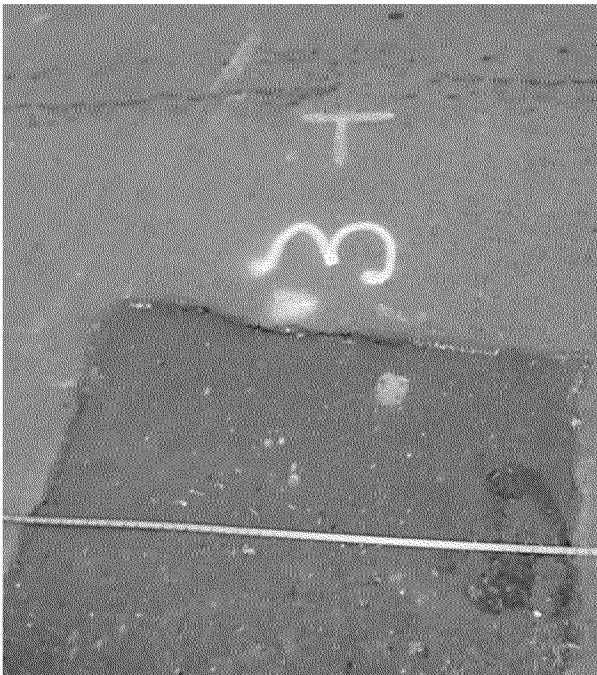
Figure 55. Example monitoring points outside of residence. Monitoring point #3 (left) near excavation performed by PG&E at gas service tee for residence. Monitoring point #19 (right) at sewer manhole near the intersection of Red
Redacted Photographs by Exponent on March 21, 2014.

Tests 3: a hole created by escaping helium was found close to point 3b.

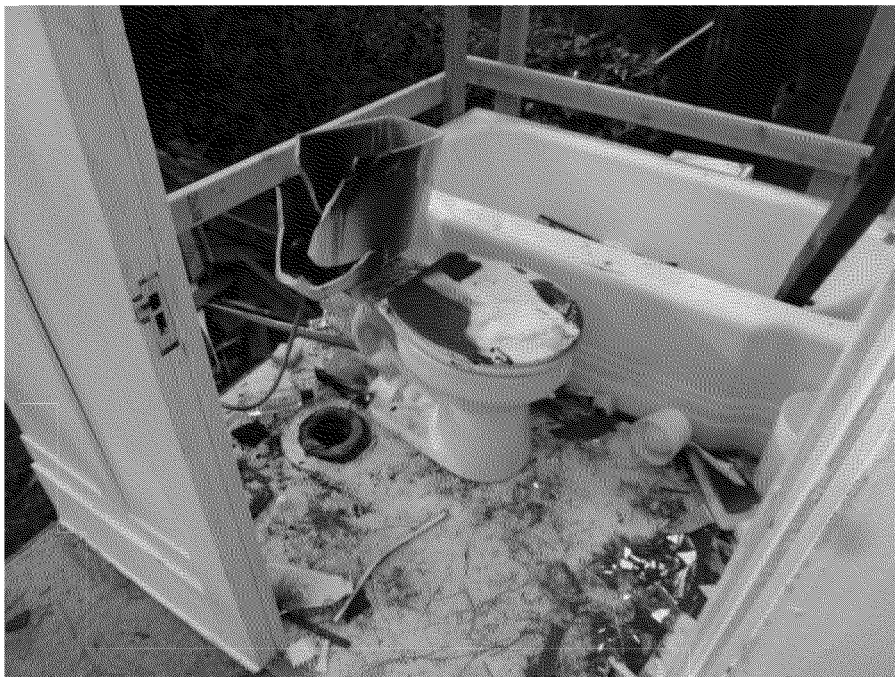
- Test 5: To test the condition of dry toilet bowl on the day of the explosion, the toilet was removed, and helium measurements were taken directly at the toilet sewer raiser (Figure 59). Other field conditions were as described for Test 4.

Figure 59. Monitoring point #15 after removal of the toilet. Photograph by Exponent on March 21, 2014.
