Threats Posed by Trees on ROW

For CPUC
By Transmission Asset Integrity Management

April 23, 2014

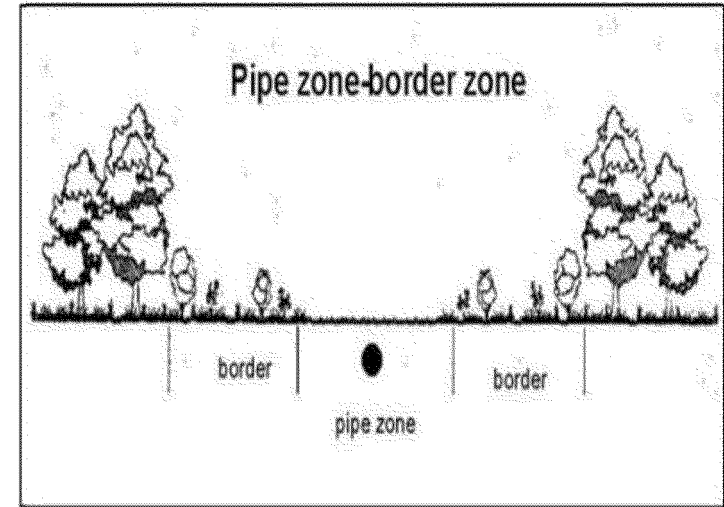
Pipe zone: an area around the pipeline extending from the edge of the pipe to the border zone. In a ROW with widths equal to or less than 10 feet: the width of the pipe zone must be equal to the width of the ROW. In ROW with widths greater than 10 feet, the width of the pipe zone must be equal to the width in the ROW that is up to 5 feet on either side of the edge of the pipeline. Any area within the ROW that is outside of the pipe zone will be considered “border zone.”
