Carmel Gas Incident

Prepared for

Sumeet Singh
Pacific Gas and Electric Company
6111 Bollinger Canyon Road
San Ramon, CA 94583

Doc. no. 1401752.000 - 6877

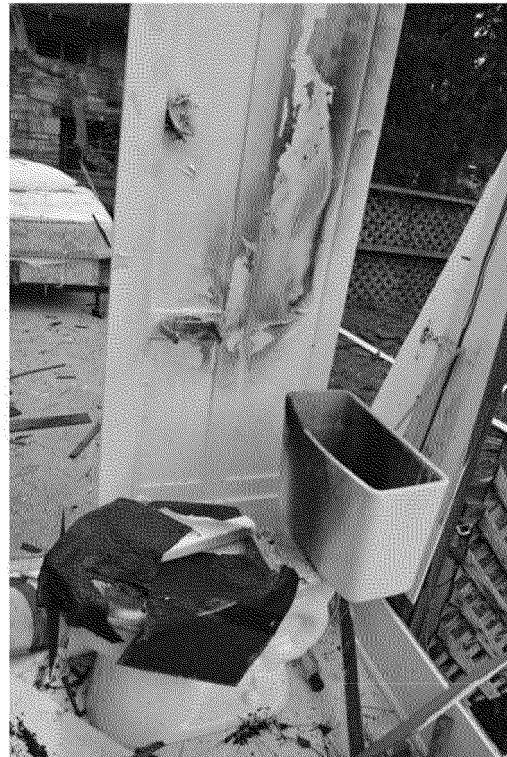
Red arrow indicates location of photo

Exponent's interior inspections of the subject house¹² discovered limited evidence of fire inside the house. Some of the paint on the walls of the living and bedrooms had signs of high temperature (blistering), but very few signs of sustained flame impingement (Figure 11 and Figure 12). Some of the debris showed a small amount of charring. The bathroom was the only place where clear signs of sustained fire were observable. There was a distinct fire pattern on the South wall next to the toilet and on the toilet bowl, toilet seat, and tank (Figure 13 through Figure 15). PG&E provided Exponent with a photograph taken shortly after the explosion (Figure 16). The photograph shows flames in the bathroom, matching the location of the observed fire patterns.

Figure 14. Bathroom toilet. Photograph by Exponent on March 6, 2014.

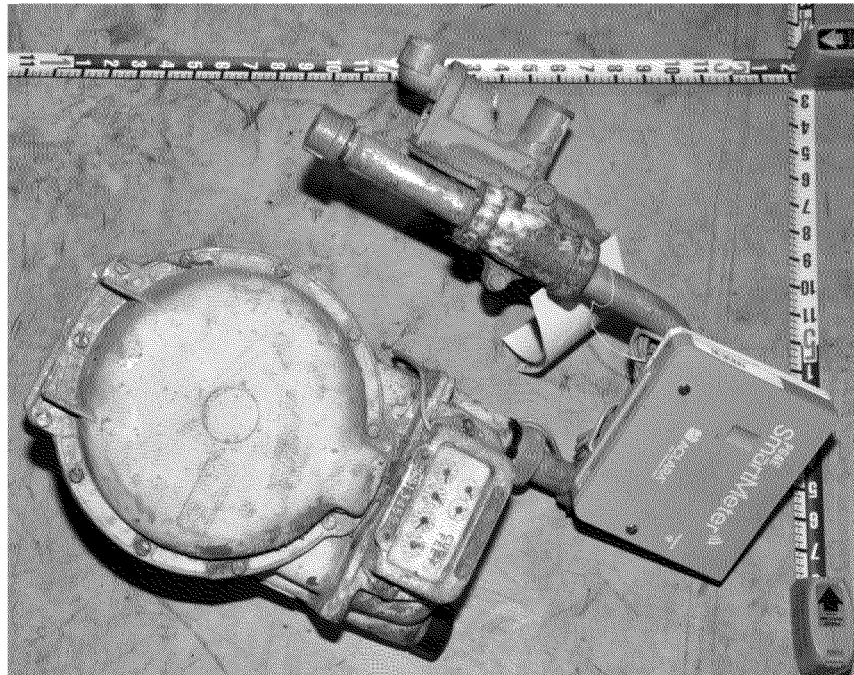
The regulator and meter set (Figure 22) had been removed just downstream of the service riser shut-off valve. The meter was equipped with a SmartMeter module. No functional tests were performed during the inspection.

Figure 22. Regulator meter set removed from incident house. Photograph by Exponent on March 10, 2014.

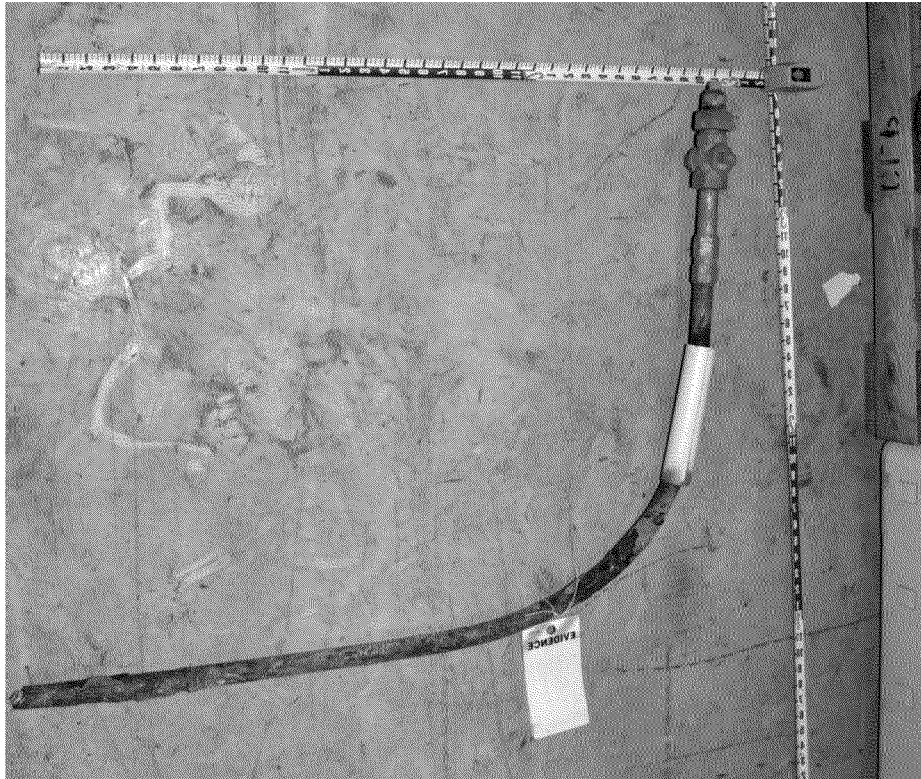
The steel $\frac{3}{4}$ -inch gas service line and riser are shown in Figure 23. The steel line is approximately five feet in length and inserted with a $\frac{1}{2}$ -inch plastic line (Figure 24). The line segment terminates in a service head adapter kit and service riser shut-off valve. According to the PG&E leak repair report, the service riser shut-off valve was turned to the closed position during the incident response operations.

Figure 23. Portion of the gas service line to incident house. Photograph by Exponent on March 10, 2014.

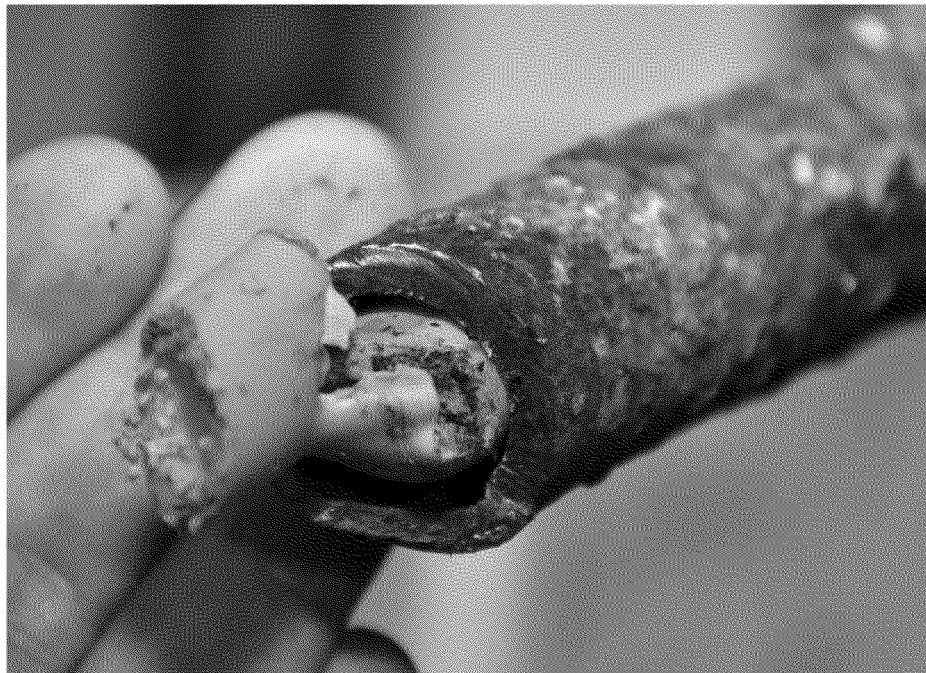
Figure 24. Close-up of the cut end of the gas service line. Photograph by Exponent on March 10, 2014.

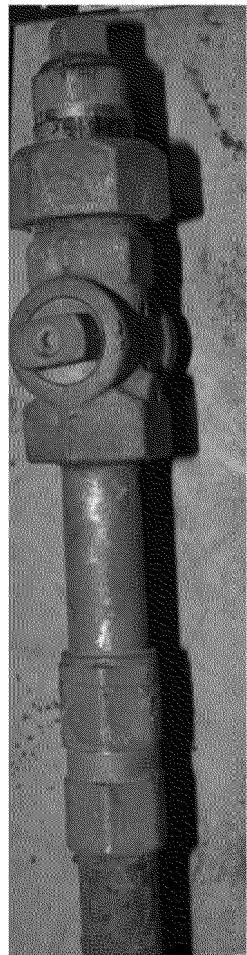
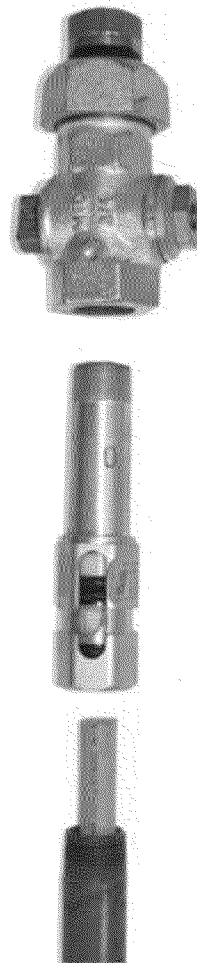
The service head adapter seals the annular space between the 3/4-inch steel pipe and the 1/2-inch plastic pipe. The service head adapter was lacking identifying markings, but appears to be similar to a Perfection 3/4" x (1/2" PE) x 3/4" Extended Service-Head Adapter. The two service head adapters are shown in Figure 25.

Figure 25. Service head adapter. Sources: Photograph by Exponent on March 10, 2014, service head adapter image from PG&E Gas Methods and Procedures document Service-Head Adapter Photo Identification.

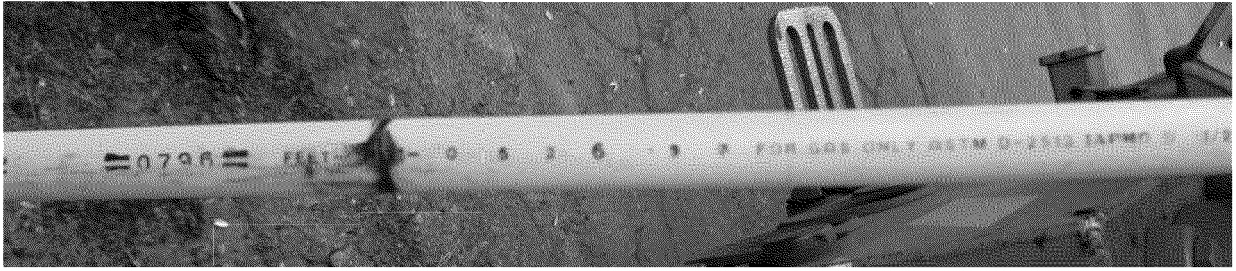
The inserted plastic pipe from the service line had a date code that read "052697," indicating a date of manufacture of May 26, 1997. The inserted plastic service line is shown in Figure 26.

Figure 26. Inserted plastic service line. Photograph source: PG&E.

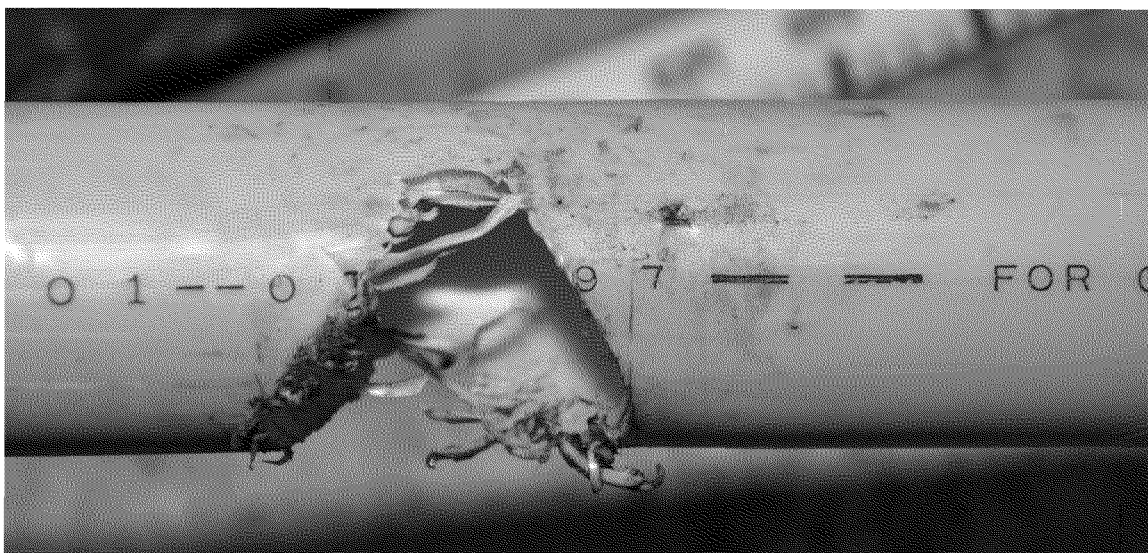
pipes (Figure 28). The plastic line segment has two perforations that correspond to the Save-a-Valve and M/2 fittings (Figure 29). There are some markings printed along the exterior of the pipe. A portion of the writing is associated with the fabrication date; in this particular piece only the year is visible, 1997 (Figure 30).

Figure 30. Close-up of the visible portion of the date code on the plastic pipe. Photograph by Exponent on March 10, 2014.

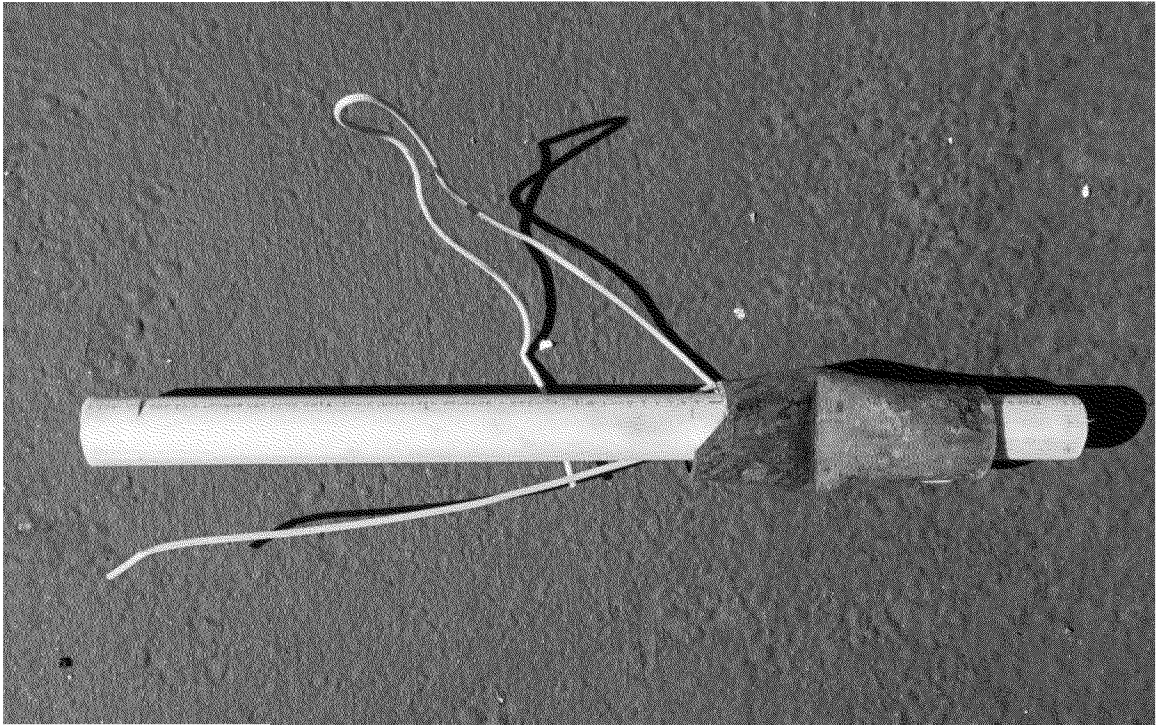
An additional portion of the gas main along Redacted was taken into evidence by PG&E. Exponent did not inspect this item, but PG&E provided multiple pictures to Exponent. The additional item corresponds to the west side gas main portion where the line had been squeezed after the incident (Figure 31). The writing on the photographs shown to Exponent indicates that the plastic pipe had a complete manufacturing date code of July 17, 1997 (Figure 32).

Figure 31. West-side squeeze point of the gas main along Redacted Yellow tracer wire is visible. Photograph provided by PG&E.

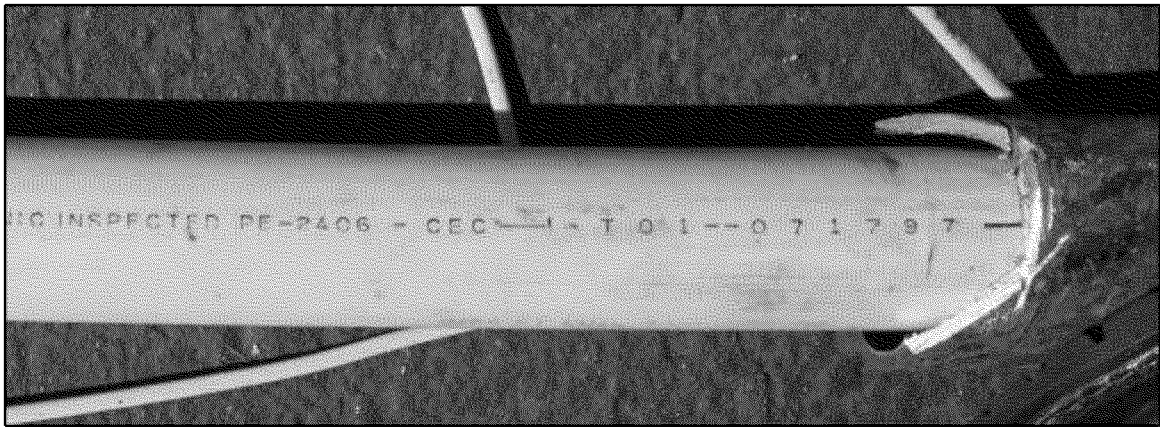
Figure 32. Close-up of the complete manufacturing date code of the plastic gas main. Photograph provided by PG&E.

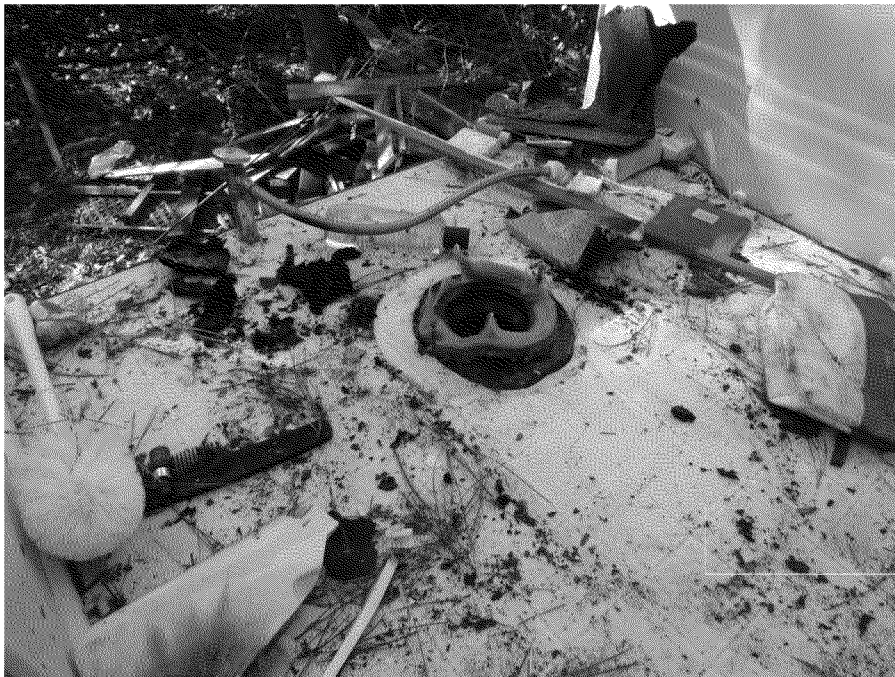
Figure 39. Toilet removed to allow for insertion of sewer push camera. Photograph by Exponent on March 11, 2014.

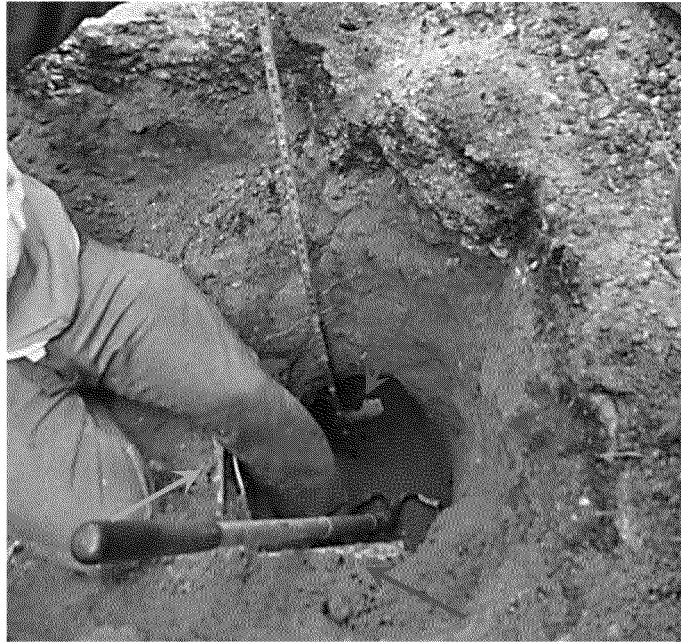
The approximate area previously excavated by PG&E on the day of the explosion (Figure 35) was re-excavated. The depth of excavation continued until a portion of the sewer lateral was exposed (Figure 45). As shown in Figure 46, the presence of a white plastic segment of sewer lateral, and an offset of the pipe, was confirmed by the excavation. The date of installation of the plastic segment in the sewer lateral is unknown. According to statements by Redacted of Fire Cause Analysis, the homeowners stated that they have not performed sewer replacement/repair work since they purchased the property in 1999.

Figure 45. Excavation to expose sewer lateral at subject residence in the vicinity of gas service tee. Yellow arrow indicates gas main along [Redacted] Redacted Red arrow indicates gas service line. Green arrow indicates sewer lateral. Photograph by Exponent on March 21, 2014.

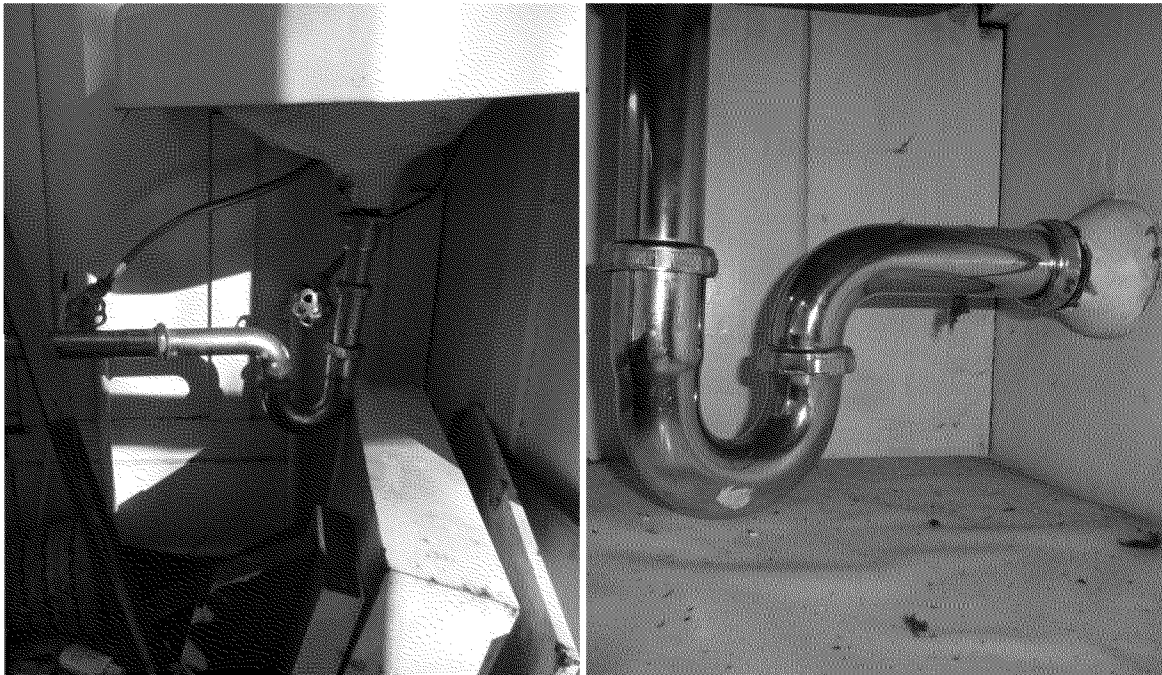
Plumbing traps are curved sections of pipe installed to contain water and provide a barrier to sewer gases entering living space. The water seal trap on any plumbing fixture or plumbing drain line must be filled with water to be effective. At the subject residence, traps were observed in all lines leading to, or in, all plumbing fixtures present.²⁴ Some of these plumbing fixture traps are shown in Figure 48 and some of the plumbing line traps are shown in Figure 41.

Figure 48. Plumbing traps at bathroom sink (left) and kitchen sink (right). Photographs by Exponent on March 11, 2014.

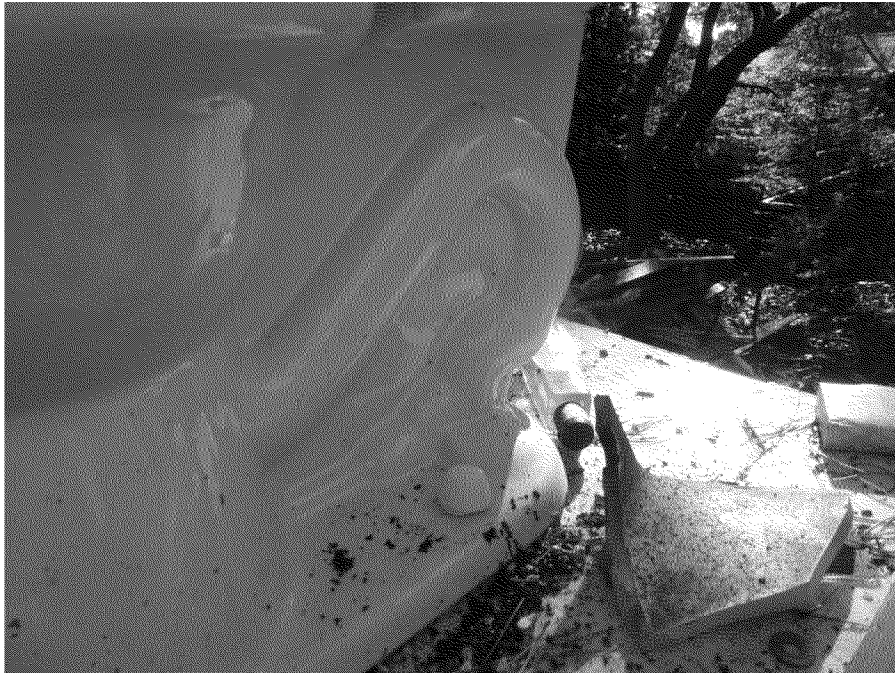
As previously noted, there was no plumbing trap in the sewer drain line section video recorded from the toilet towards the sewer main of [Redacted]. The only trap along this sewer line path was the integral trap in the toilet fixture. Figure 49 documents this trap.

Figure 49. Toilet drain trap. Photograph by Exponent on March 11, 2014.

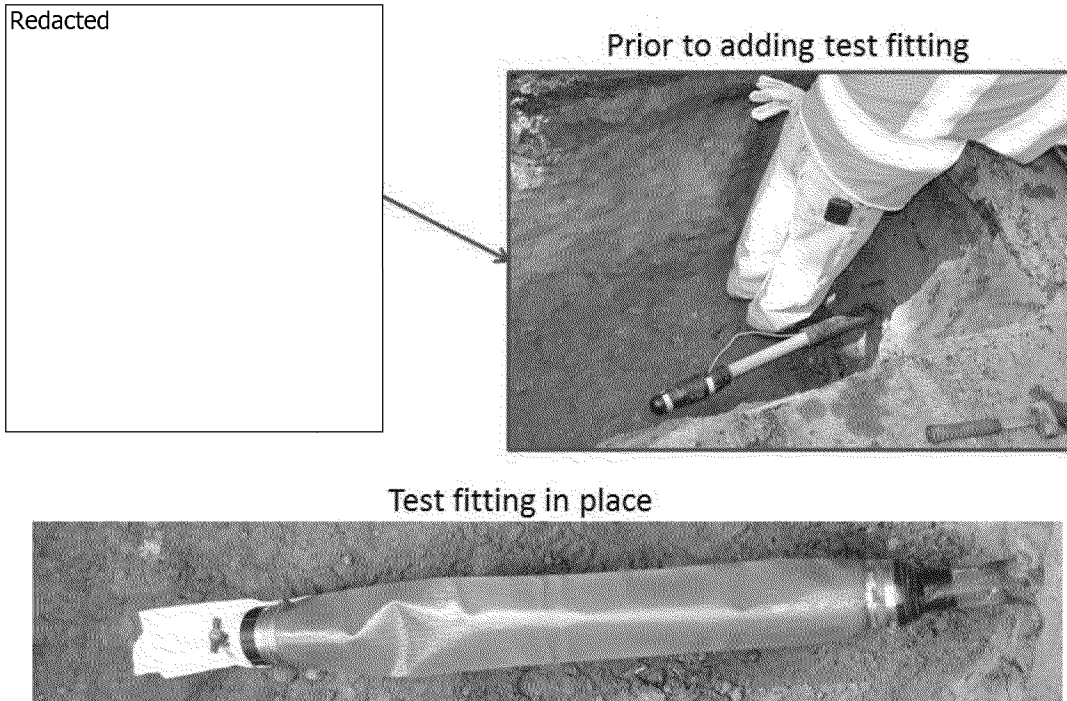
Figure 51. Annotated D-Plat 3956-C08 showing helium injection point and test fitting. Photographs by Exponent on March 21, 2014.

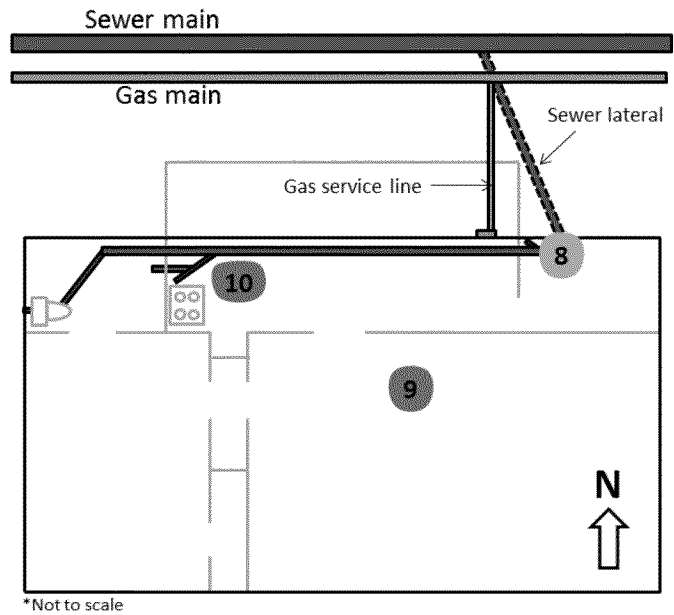
Green: Not detected
 Yellow: <1%
 Orange: >1%
 Red: ~100%

Figure 53. Helium test monitoring points and results at the residence's basement.

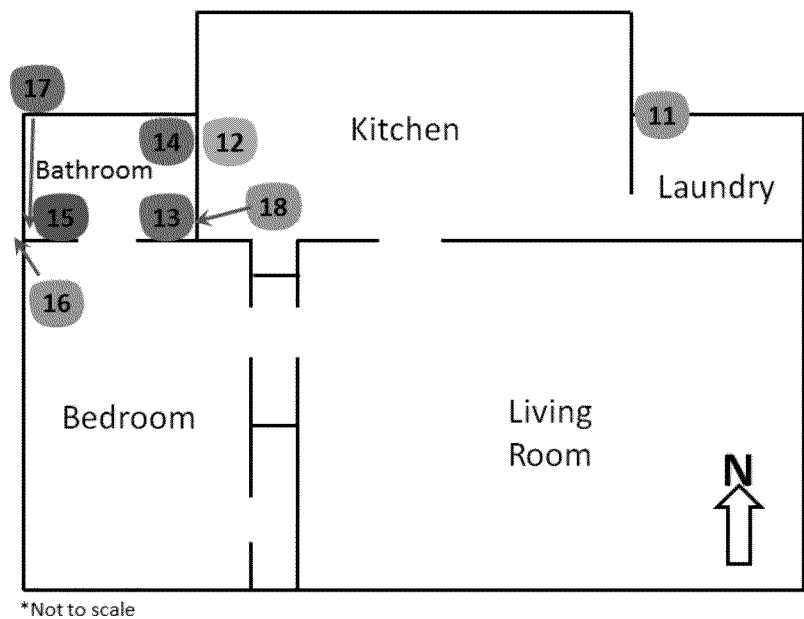
Maximum measured helium concentration in all tests:
 Green: Not detected
 Yellow: <1%
 Orange: >1%
 Red: ~100%

Figure 54. Helium test monitoring points and results at the residence's first floor.

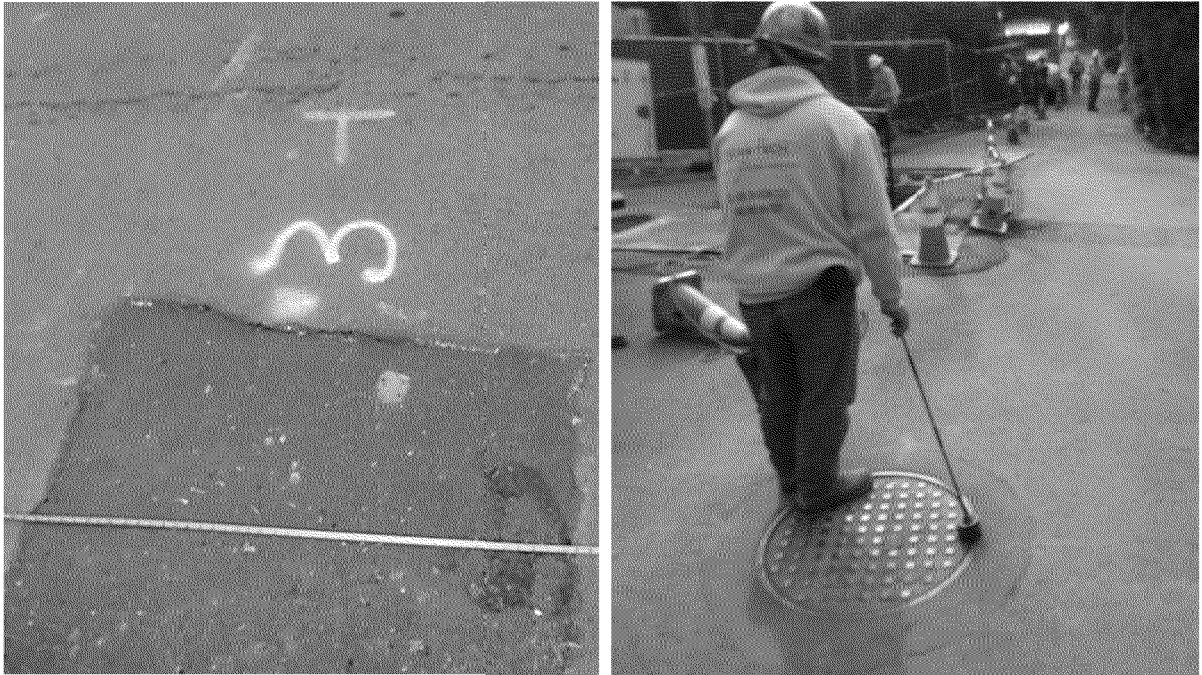
Figure 55. Example monitoring points outside of residence. Monitoring point #3 (left) near excavation performed by PG&E at gas service tee for residence. Monitoring point #19 (right) at sewer manhole near the intersection of [Redacted] Photographs by Exponent on March 21, 2014.

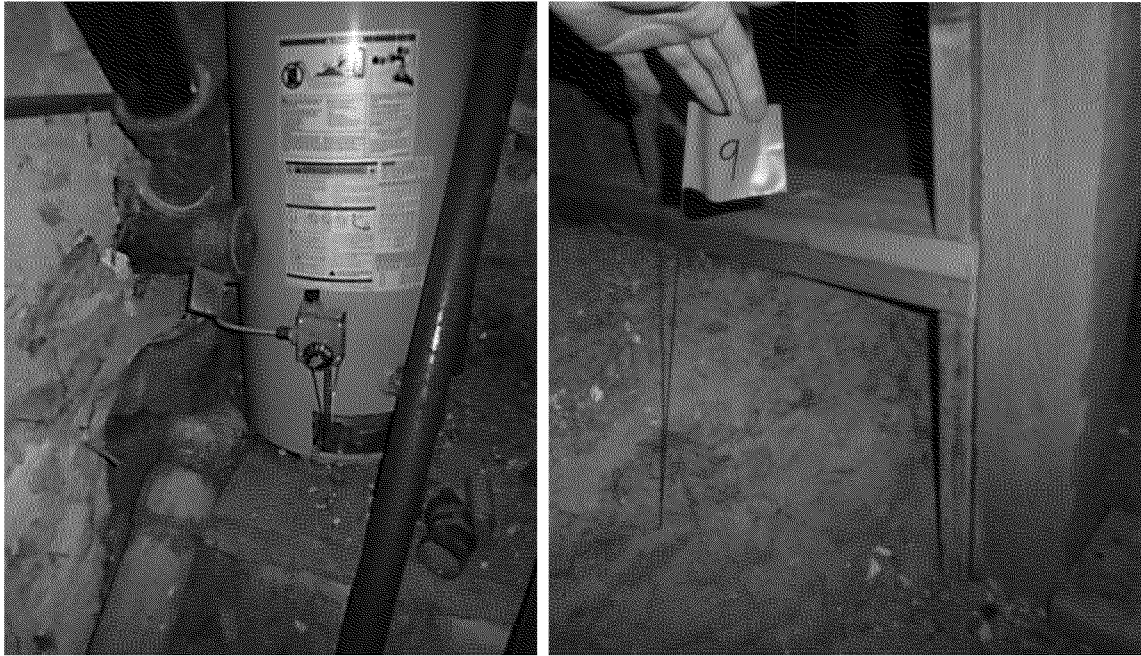
Figure 56. Example monitoring points at the residence's basement. Monitoring point #8 (left) by the cleanout next to water heater. Monitoring point #9 (right) near center of basement, over soil. Photographs by Exponent on March 21, 2014.

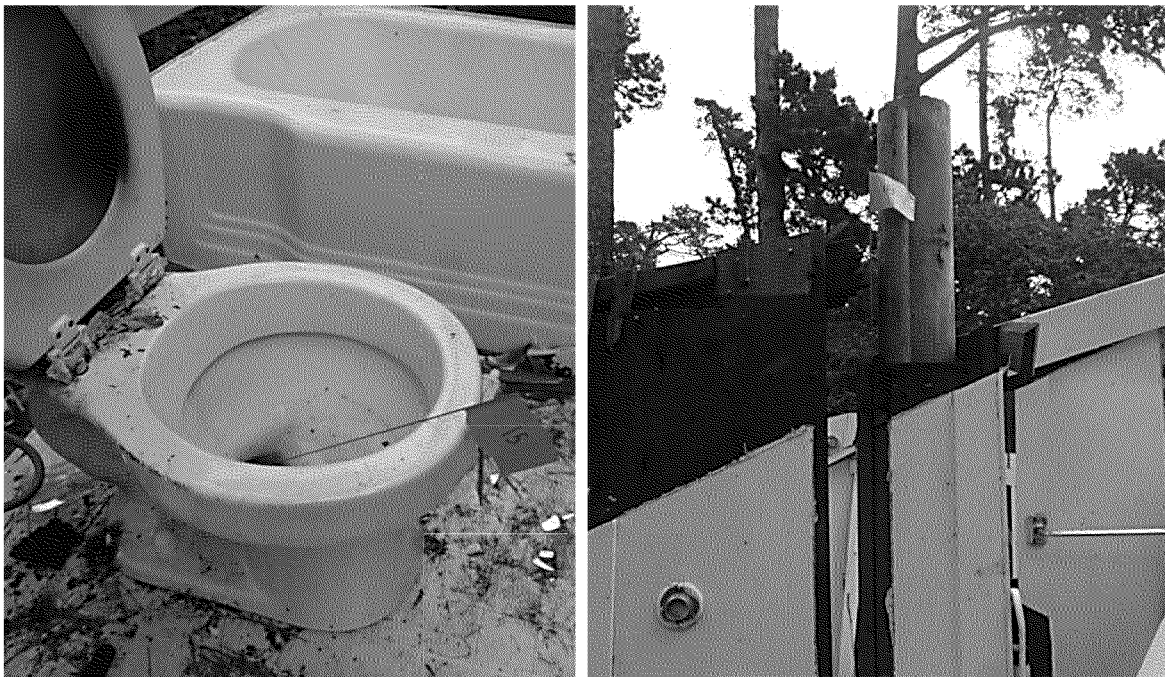
Figure 57. Example monitoring points at the residence's first floor. Monitoring point #15 (left) at the toilet. Monitoring point #18 (right) at bathroom vents. Photographs by Exponent on March 21, 2014.

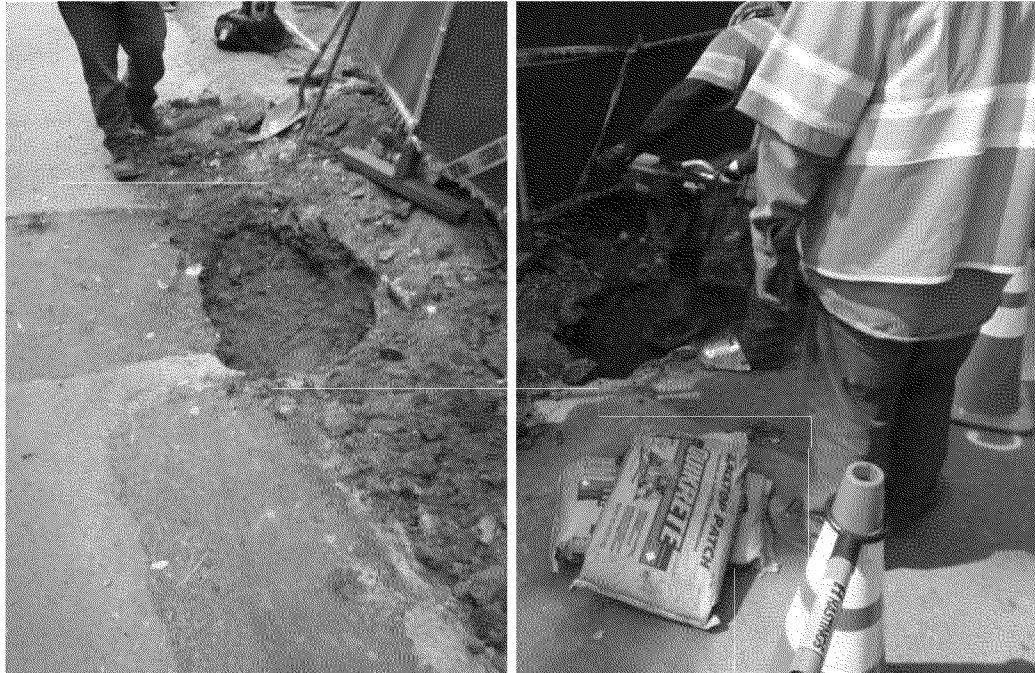
- Test 4: In an attempt to bring soil conditions closer to those present before the gas service tee excavation was performed by PG&E on the day of the explosion, the shallowest eight inches (approximately) of soil above the gas service tee were excavated, re-compacted in place and paved with an asphalt cold patch (Figure 58). Other field conditions were as described for Test 1.

Figure 58. Excavation (left) and re-compaction (right) near gas service tee. Photographs by Exponent on March 21, 2014.

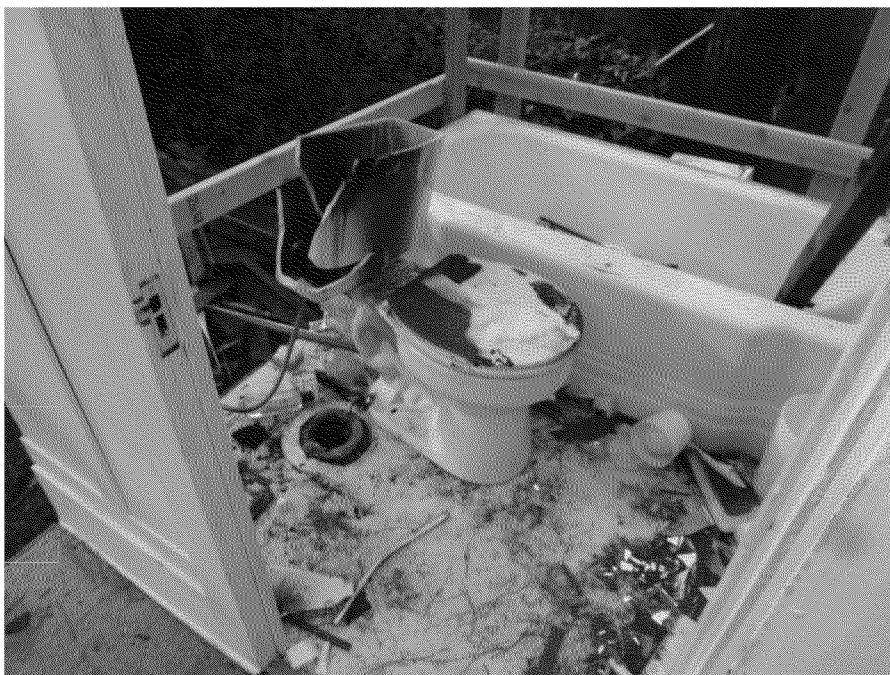
- Test 5: To test the condition of dry toilet bowl on the day of the explosion, the toilet was removed, and helium measurements were taken directly at the toilet sewer riser (Figure 59). Other field conditions were as described for Test 4.

Figure 59. Monitoring point #15 after removal of the toilet.
Photograph by Exponent on March 21, 2014.
