**FINAL REPORT
VOLUME I
R-PG&E-20140117**

Pacific Gas and Electric Company

Tree Root Interference Assessment

January 17, 2014

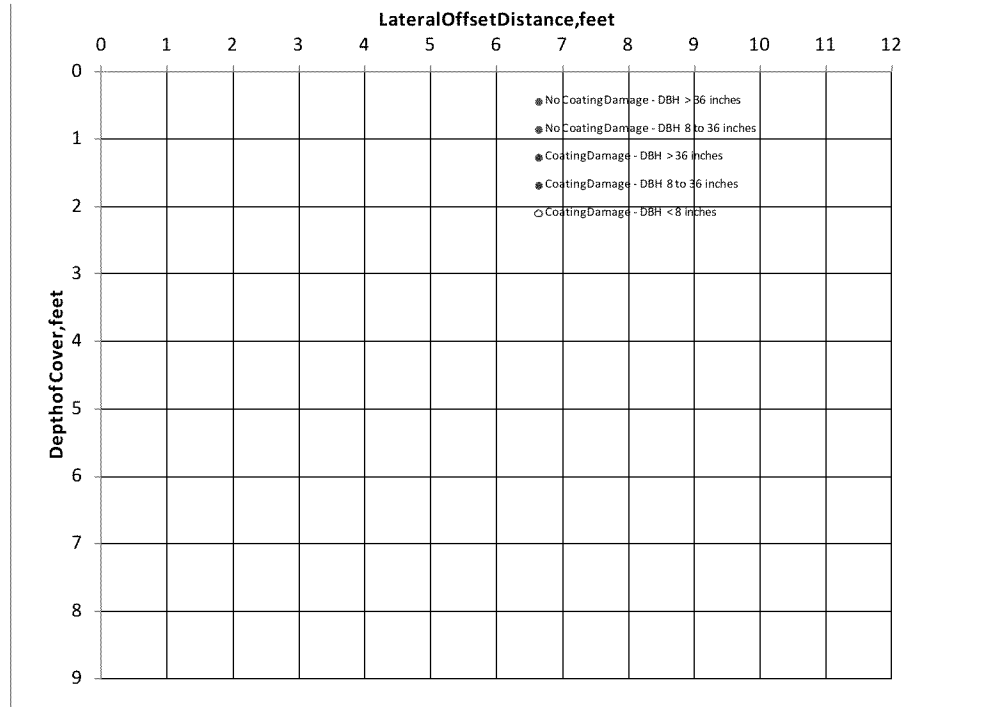
Figure 5. Depth of Cover versus Lateral Offset Distance⁵.

In evaluating the results from the 53 sites, a comparison between the lateral offset distance and depth of cover was produced and is presented in Figure 5. The legend provided in this figure discriminates the data based upon the tree diameter (DBH) and whether or not coating damage was evident.

As is evident from Figure 5, there is no obvious trend from these results. This is likely due to the number of attributes that influence the results. However, it is evident that tree size (DBH), offset distance, and depth of cover may be indicators as to whether or not coating damage has occurred.

One of the attributes that warrants further investigation is whether incorporating depth of cover into the offset distances referenced within the ROW Standard is warranted. In order to consider both lateral offset distance and depth of cover, the ‘z-factor’ was developed to assess the shortest distance between the tree and the top of the buried pipeline. The ‘z-factor’ is a function of the horizontal offset distance between the pipe and the tree (x) and the depth of cover (y). A schematic of this is provided in Figure 2 and is calculated using the equation shown below:
