**Carmel Gas Incident**

April 2014

Doc. no. 1401752.000 - 4253

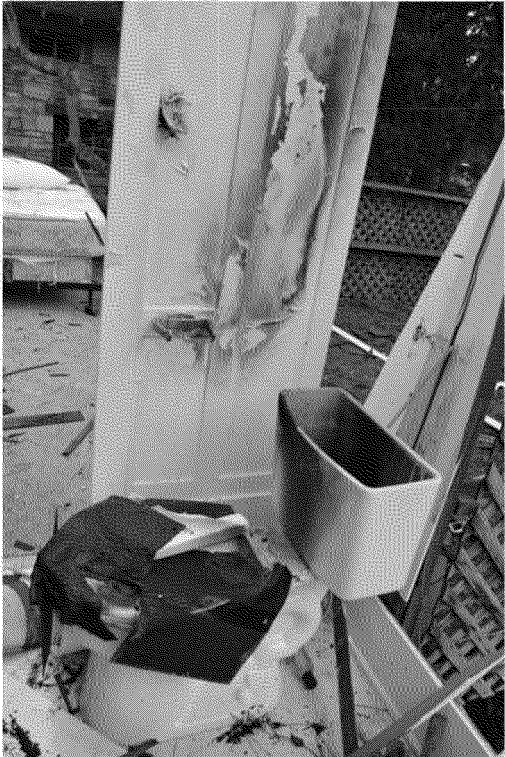
Figure 14. Bathroom toilet. Photograph by Exponent on March 6, 2014.

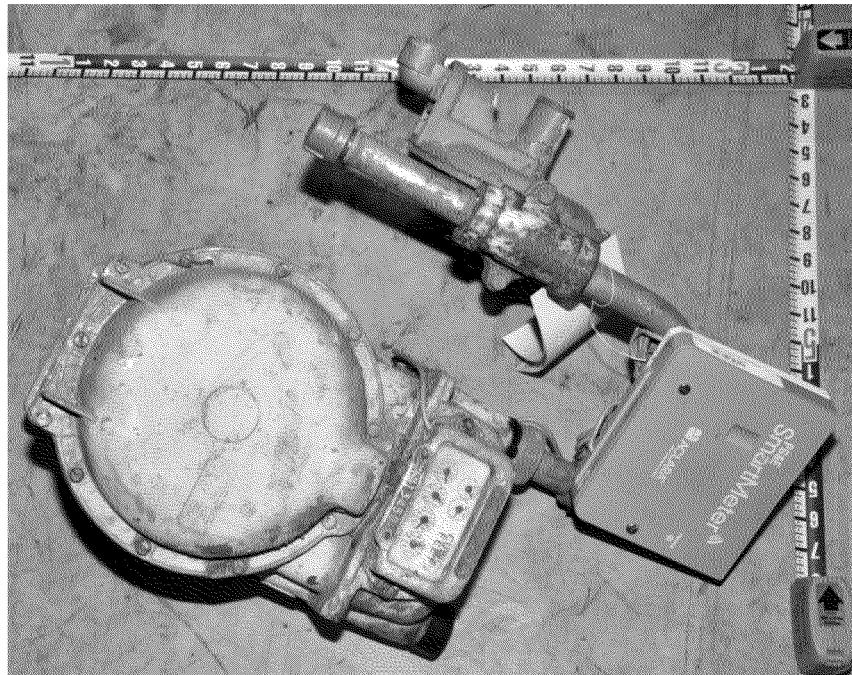
The regulator and meter set (Figure 22) had been removed just downstream of the service riser shut-off valve. The meter was equipped with a SmartMeter module. No functional tests were performed during the inspection.

Figure 22. Regulator meter set removed from incident house.  
Photograph by Exponent on March 10, 2014.

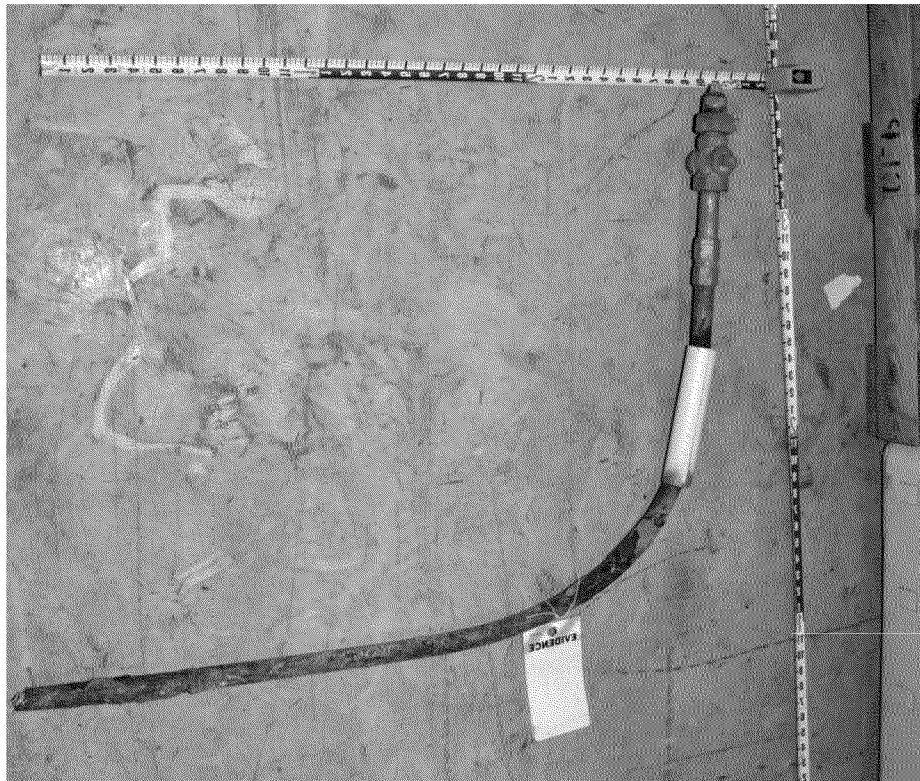
The steel  $\frac{3}{4}$ -inch gas service line and riser are shown in Figure 23. The steel line is approximately five feet in length and inserted with a  $\frac{1}{2}$ -inch plastic line (Figure 24). The line segment terminates in a service head adapter kit and service riser shut-off valve. According to the PG&E leak repair report, the service riser shut-off valve was turned to the closed position during the incident response operations.

Figure 23. Portion of the gas service line to incident house. Photograph by Exponent on March 10, 2014.

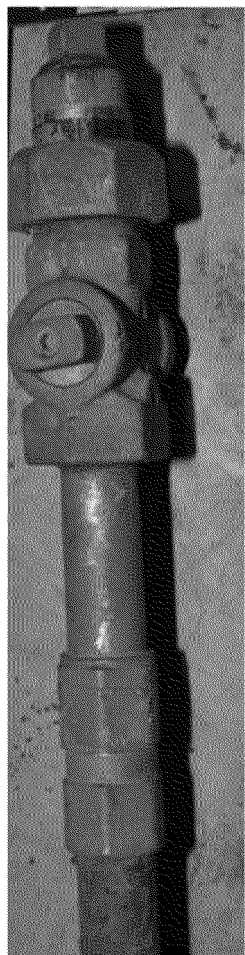
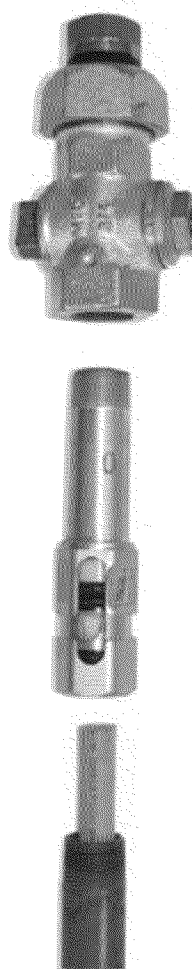
The service head adapter seals the annular space between the 3/4-inch steel pipe and the 1/2-inch plastic pipe. The service head adapter was lacking identifying markings, but appears to be similar to a Perfection 3/4" x (1/2" PE) x 3/4" Extended Service-Head Adapter. The two service head adapters are shown in Figure 25.

Figure 25. Service head adapter. Sources: Photograph by Exponent on March 10, 2014, service head adapter image from PG&E Gas Methods and Procedures document Service-Head Adapter Photo Identification.

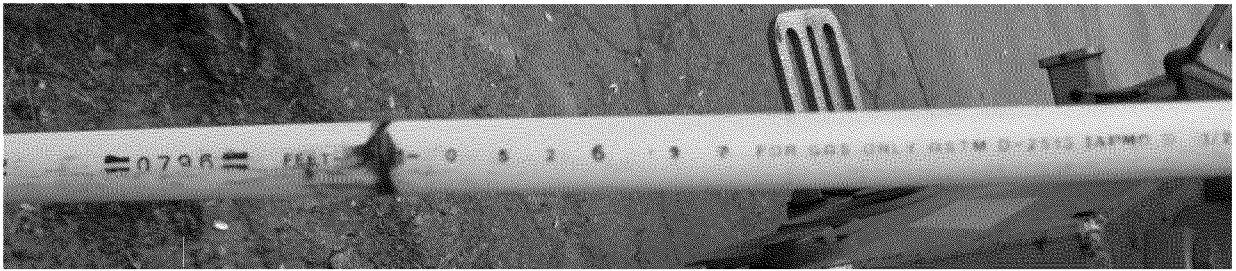
The inserted plastic pipe from the service line had a date code that read "052697", indicating a date of manufacture of May 26, 1997. The inserted plastic service line is shown in Figure 26.

Figure 26. Inserted plastic service line. Photograph source: PG&E.

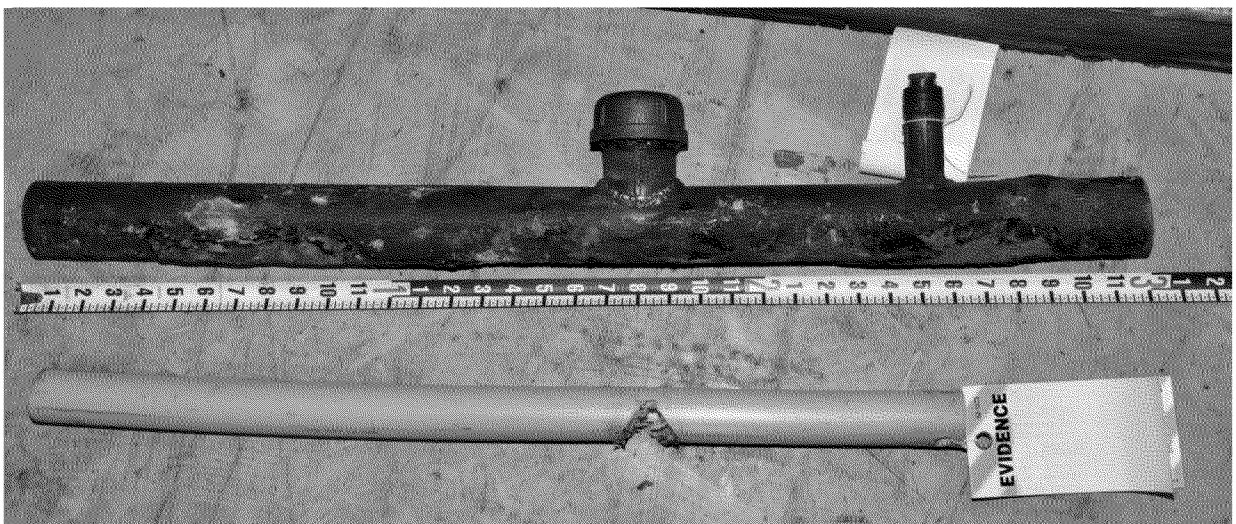
A three foot long section of the 2-inch steel main running along 3<sup>rd</sup> Avenue was removed from the bell hole at the intersection of Guadalupe Street and 3<sup>rd</sup> Avenue (Figure 27). The steel pipe segment has two welded fittings that were installed on March 3, 2014; one is a one-inch Save-a-valve fitting and the other is a two-inch M/2 line stopper fitting. There were no obstructions either in the main pipe or the two ports.

Figure 27. Portion of the gas main along 3<sup>rd</sup> Avenue. Steel pipe (top) with welded fittings and plastic pipe insert. Photograph by Exponent on March 10, 2014.

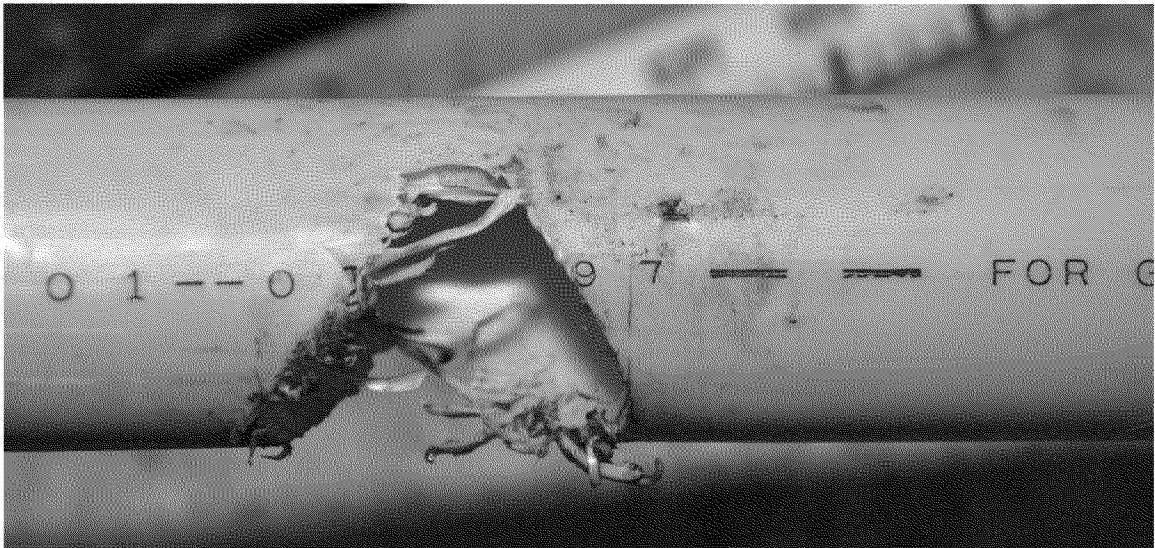
Figure 30. Close-up of the visible portion of the date code on the plastic pipe.  
Photograph by Exponent on March 10, 2014.

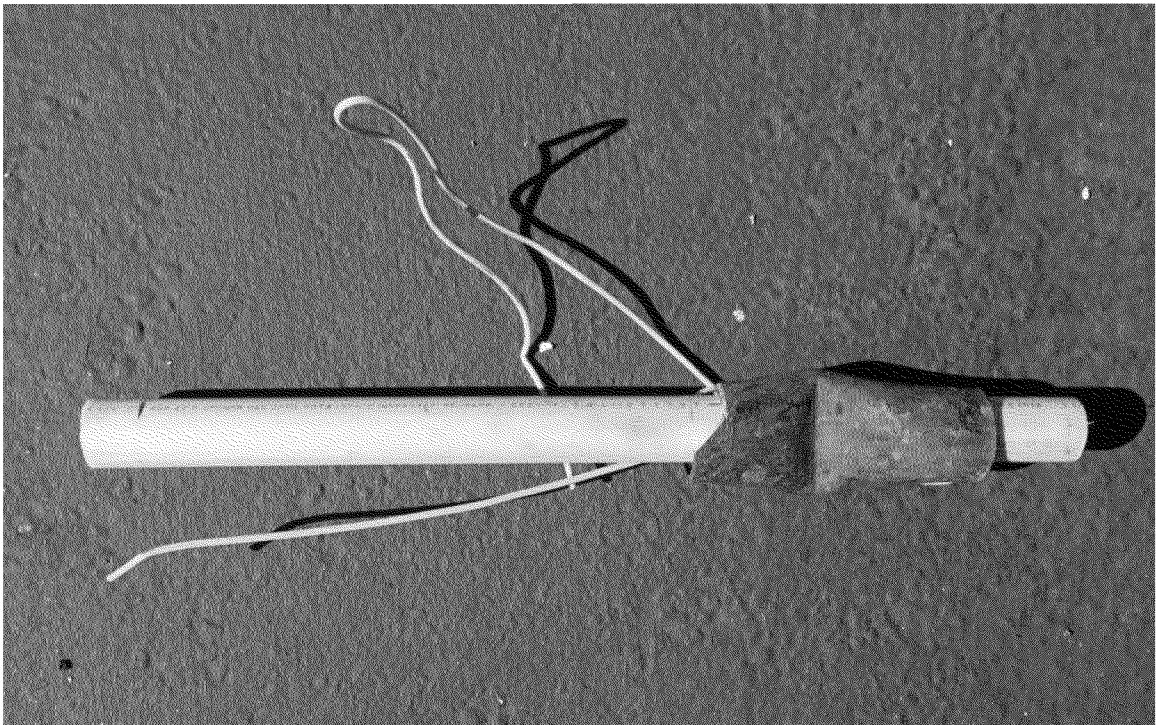
An additional portion of the gas main along 3<sup>rd</sup> Avenue was taken into evidence by PG&E. Exponent did not inspect this item but PG&E provided multiple pictures to Exponent. The additional item corresponds to the west side gas main portion where the line had been squeezed after the incident (Figure 31). The writing on the photographs shown to Exponent indicates that the plastic pipe had a complete manufacturing date code of July 17, 1997 (Figure 32).

Figure 31. West-side squeeze point of the gas main along 3<sup>rd</sup> Avenue. Photograph provided by PG&E.

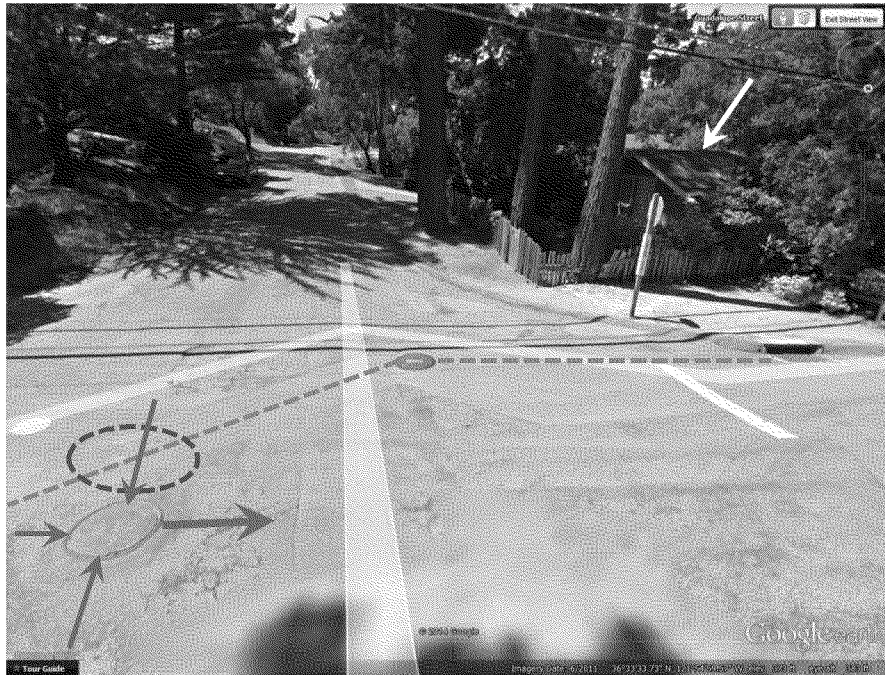
Figure 38. Underground utilities in the vicinity of subject residence (indicated by white arrow). Green arrows indicate sewer line flow directions into manhole (only one line discharging towards 3<sup>rd</sup> Avenue in the western direction). Blue dashed lines indicate likely alignment of storm drain pipes inside pavement trench marks. Red oval indicates approximate location of collapsed sewer pipe.

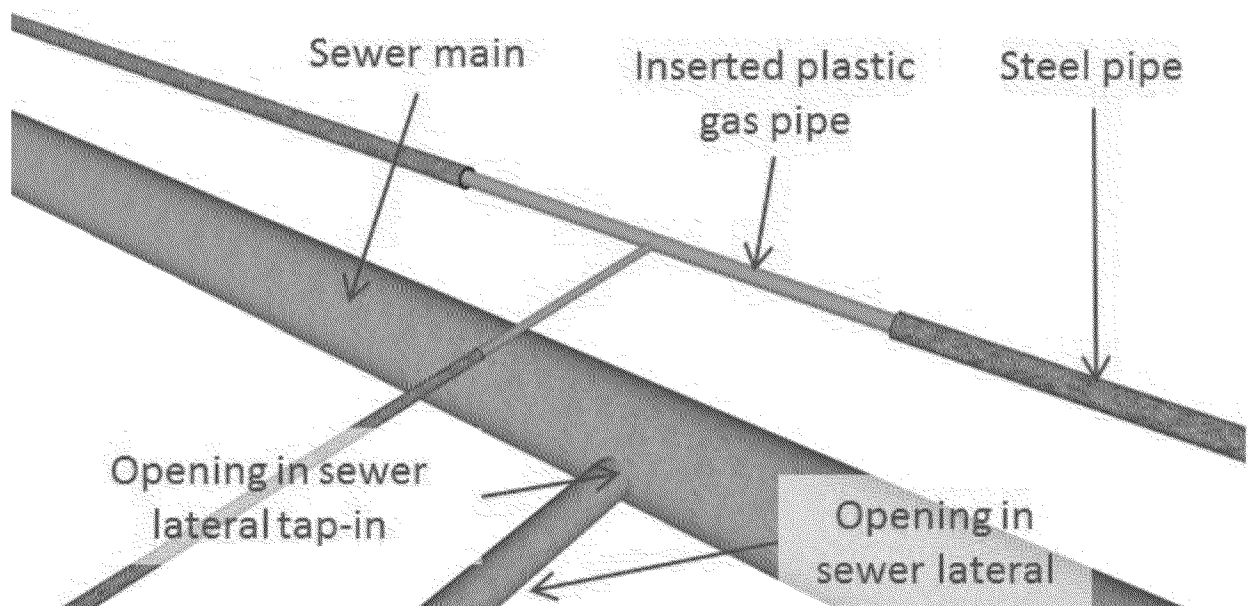
Figure 44. Schematic configuration of the sewer and gas systems in the vicinity of the excavation. Figure not to scale.

<sup>19</sup> The horizontal distance along 3rd Avenue between the sewer lateral and the end of the annular space of the gas main was approximately 12 inches. The horizontal distance along the sewer lateral between the end of the annular space of the gas main and the sewer lateral offset closest to the sewer main was between 6 and 12 inches.

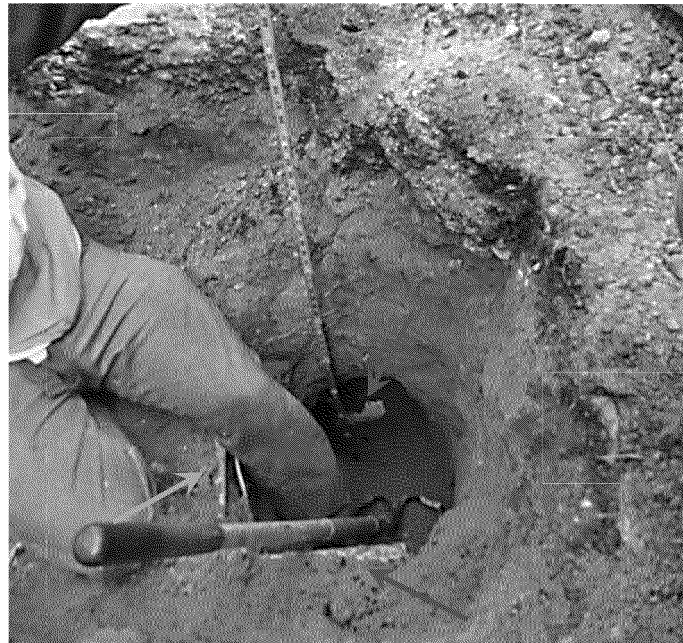
The approximate area previously excavated by PG&E on the day of the explosion (Figure 35) was re-excavated. The depth of excavation continued until a portion of the sewer lateral was exposed (Figure 45). As shown in Figure 46, the presence of a white plastic segment of sewer lateral, and an offset of the pipe, was confirmed by the excavation. The date of installation of the plastic segment in the sewer lateral is unknown. According to statements by John White of Fire Cause Analysis, the homeowners stated that they have not performed sewer replacement/repair work since they purchased the property in 1999.

Figure 45. Excavation to expose sewer lateral at subject residence in the vicinity of gas service tee. Yellow arrow indicates gas main along 3<sup>rd</sup> Avenue. Red arrow indicates gas service line. Green arrow indicates sewer lateral. Photograph by Exponent on March 21, 2014.

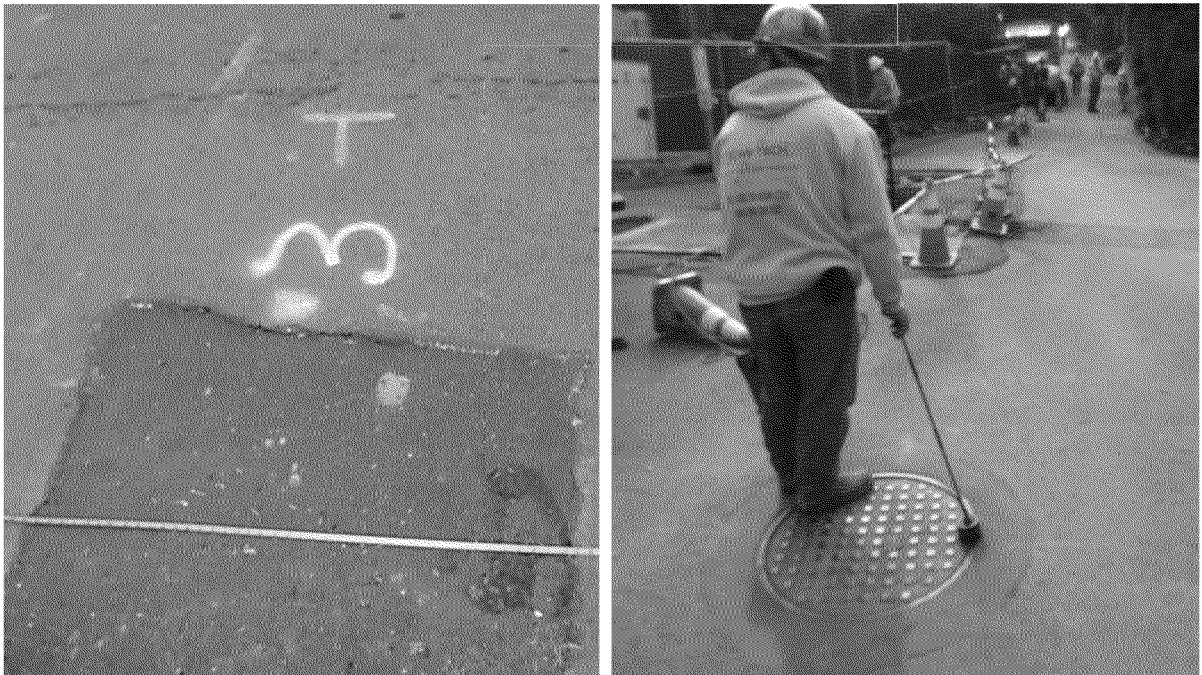
Figure 55. Example monitoring points outside of residence. Monitoring point #3 (left) near excavation performed by PG&E at gas service tee for residence. Monitoring point #19 (right) at sewer manhole near the intersection of 3<sup>rd</sup> Avenue and Guadalupe Street. Photographs by Exponent on March 21, 2014.

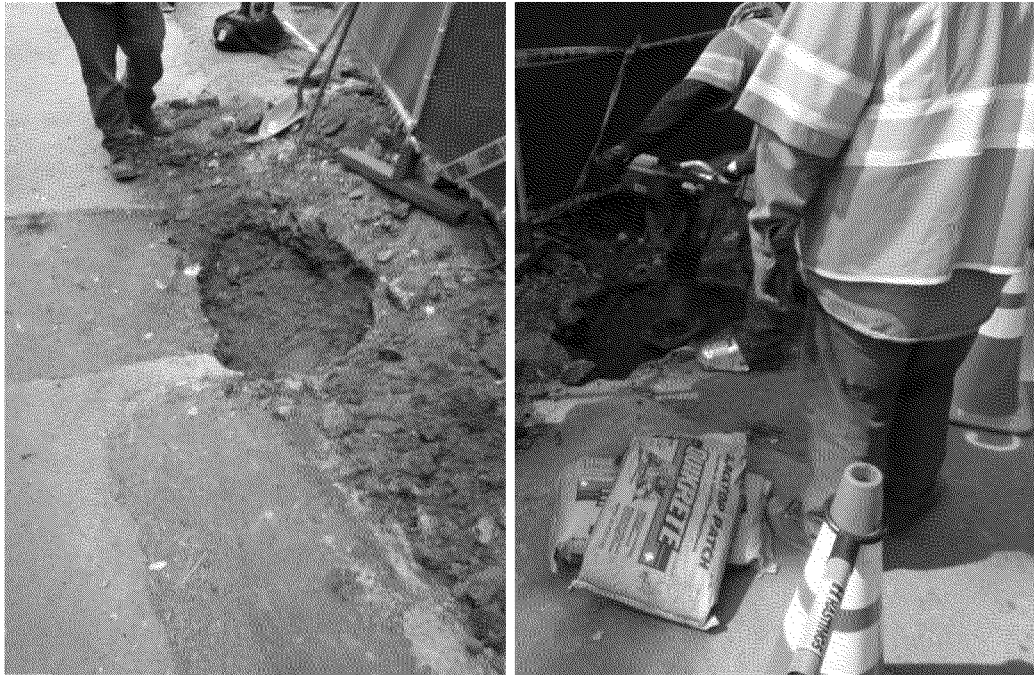
- Test 4: In an attempt to bring soil conditions closer to those present before the gas service tee excavation was performed by PG&E on the day of the explosion, the shallowest eight inches (approximately) of soil above the gas service tee were excavated, re-compacted in place and paved with an asphalt cold patch (Figure 58). Other field conditions were as described for Test 1.

Figure 58. Excavation (left) and re-compaction (right) near gas service tee. Photographs by Exponent on March 21, 2014.
