**FINAL REPORT  
VOLUME I  
R-PG&E-20140117**

**Pacific Gas and Electric Company**

**Tree Root Interference Assessment**

**January 17, 2014**

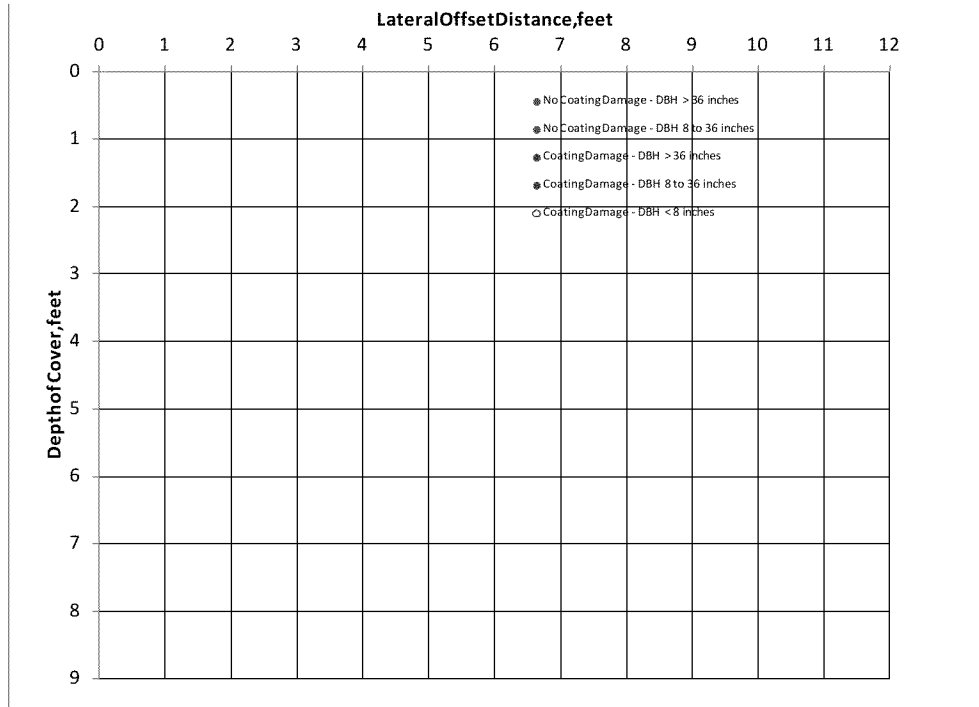
Figure 5. Depth of Cover versus Lateral Offset Distance<sup>5</sup>.

In evaluating the results from the 53 sites, a comparison between the lateral offset distance and depth of cover was produced and is presented in Figure 5. The legend provided in this figure discriminates the data based upon the tree diameter (DBH) and whether or not coating damage was evident.

As is evident from Figure 5, there is no obvious trend from these results. This is likely due to the number of attributes that influence the results. However, it is evident that tree size (DBH), offset distance, and depth of cover may be indicators as to whether or not coating damage has occurred.
