Carmel Gas Incident

Prepared for

Sumeet Singh
Pacific Gas and Electric Company
6111 Bollinger Canyon Road
San Ramon, CA 94583

Doc. no. 1401752.000 - 4253

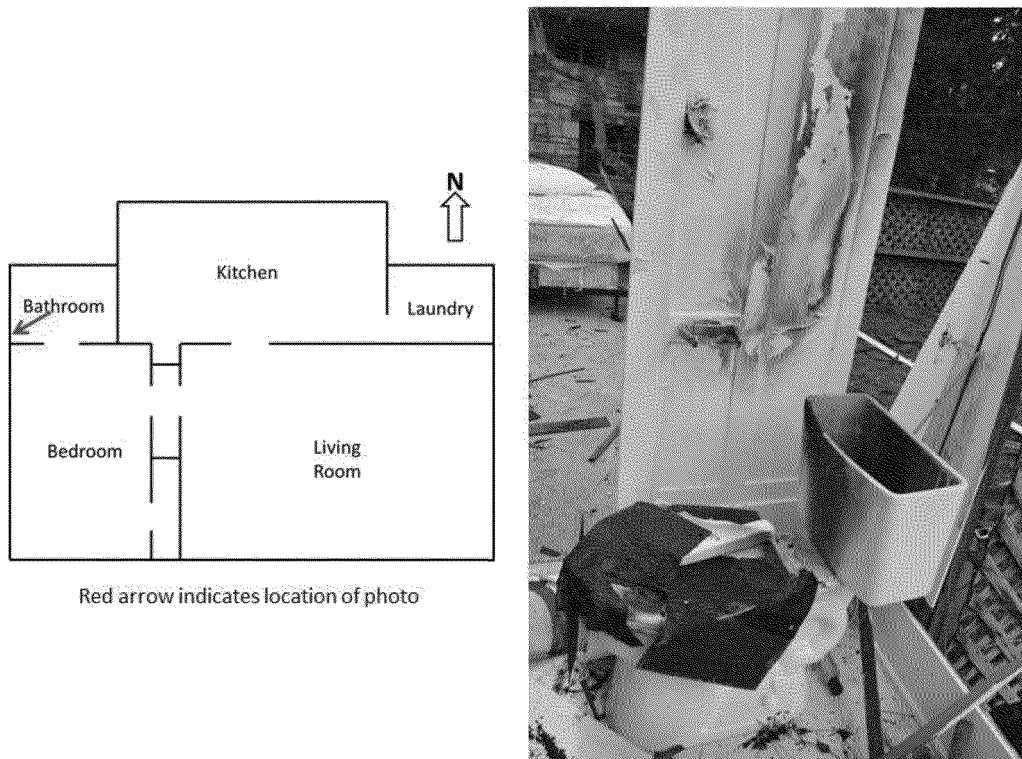
Figure 14. Bathroom toilet. Photograph by Exponent on March 6, 2014.

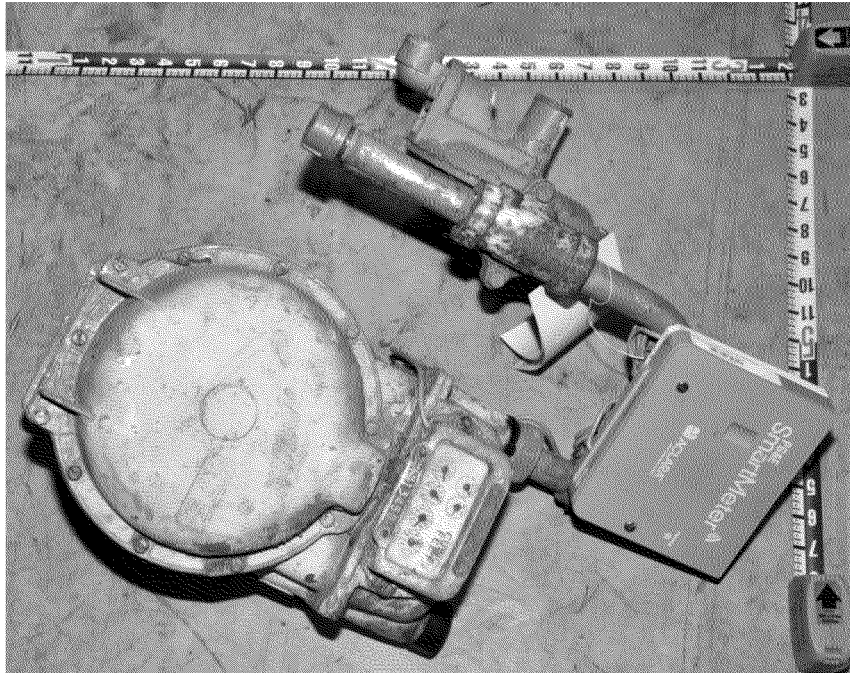
The regulator and meter set (Figure 22) had been removed just downstream of the service riser shut-off valve. The meter was equipped with a SmartMeter module. No functional tests were performed during the inspection.

Figure 22. Regulator meter set removed from incident house.
Photograph by Exponent on March 10, 2014.

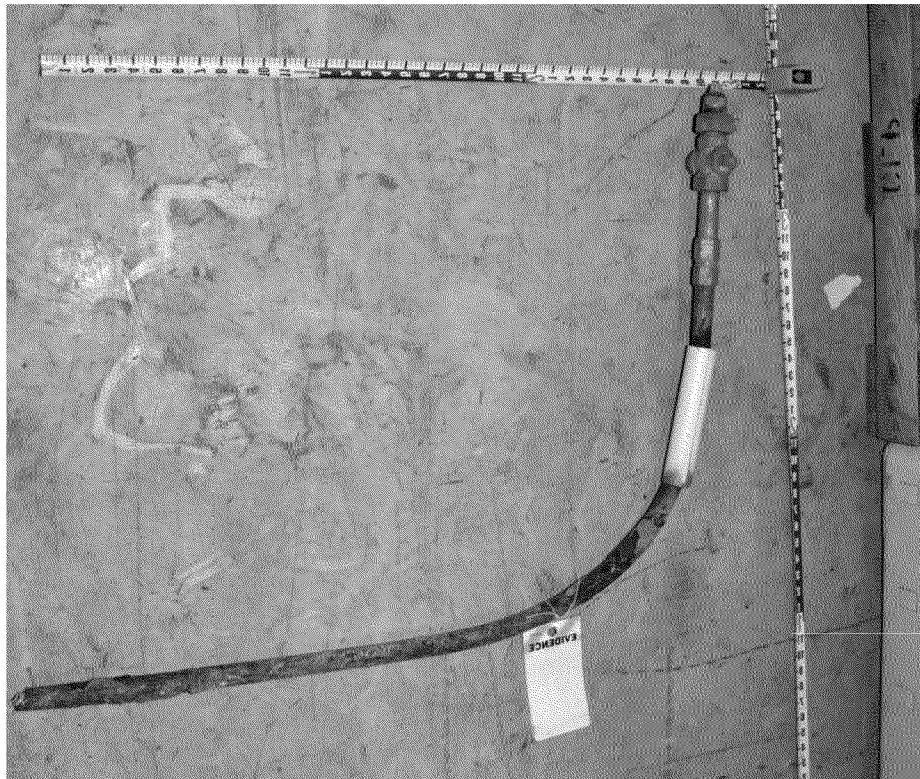
The steel $\frac{3}{4}$ -inch gas service line and riser are shown in Figure 23. The steel line is approximately five feet in length and inserted with a $\frac{1}{2}$ -inch plastic line (Figure 24). The line segment terminates in a service head adapter kit and service riser shut-off valve. According to the PG&E leak repair report, the service riser shut-off valve was turned to the closed position during the incident response operations.

Figure 23. Portion of the gas service line to incident house. Photograph by Exponent on March 10, 2014.

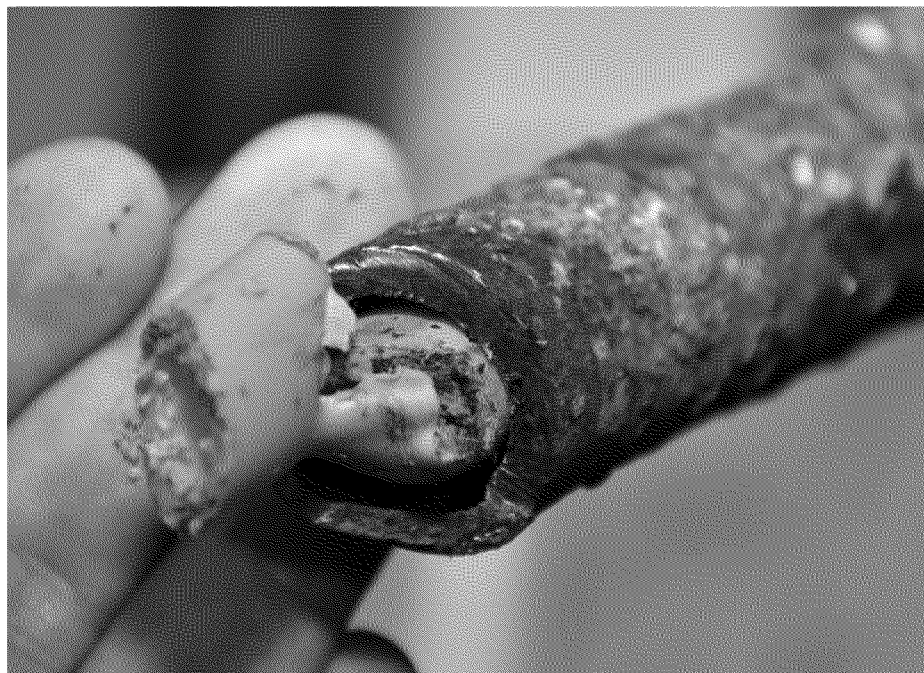
Figure 24. Close-up of the cut end of the gas service line. Photograph by Exponent on March 10, 2014.

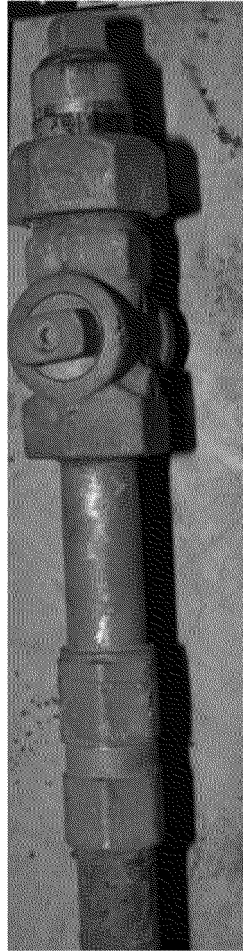
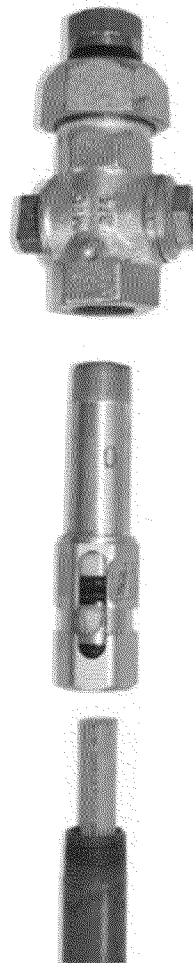
The service head adapter seals the annular space between the 3/4-inch steel pipe and the 1/2-inch plastic pipe. The service head adapter was lacking identifying markings, but appears to be similar to a Perfection 3/4" x (1/2" PE) x 3/4" Extended Service-Head Adapter. The two service head adapters are shown in Figure 25.

Figure 25. Service head adapter. Sources: Photograph by Exponent on March 10, 2014, service head adapter image from PG&E Gas Methods and Procedures document Service-Head Adapter Photo Identification.

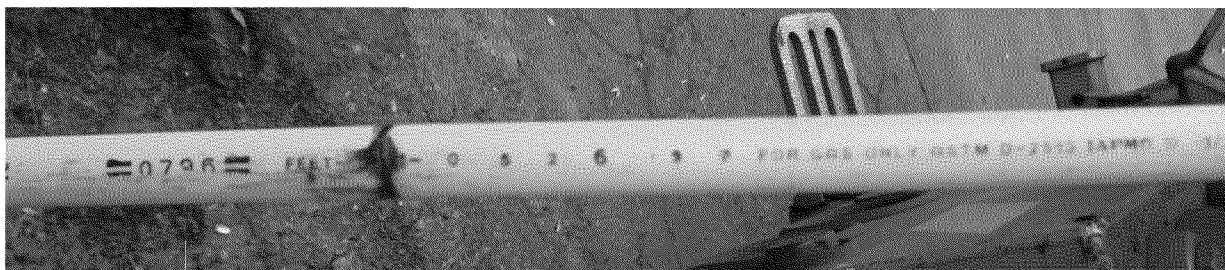
The inserted plastic pipe from the service line had a date code that read “052697”, indicating a date of manufacture of May 26, 1997. The inserted plastic service line is shown in Figure 26.

Figure 26. Inserted plastic service line. Photograph source: PG&E.

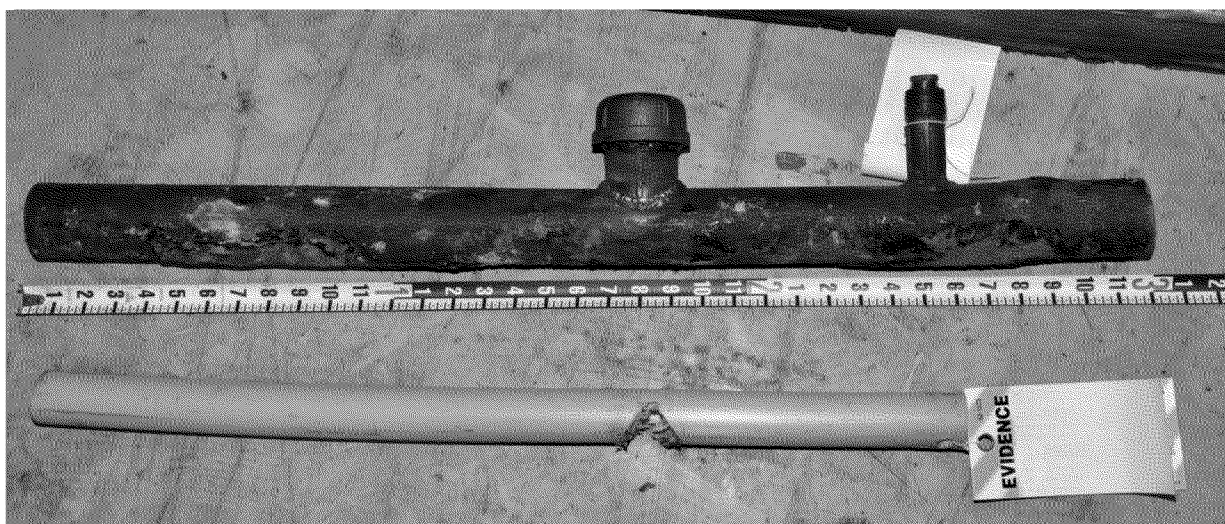
A three foot long section of the 2-inch steel main running along 3rd Avenue was removed from the bell hole at the intersection of [Redacted] Avenue (Figure 27). The steel pipe segment has two welded fittings that were installed on March 3, 2014; one is a one-inch Save-a-valve fitting and the other is a two-inch M/2 line stopper fitting. There were no obstructions either in the main pipe or the two ports.

Figure 27. Portion of the gas main along [Redacted] Steel pipe (top) with welded fittings and plastic pipe insert. Photograph by Exponent on March 10, 2014.

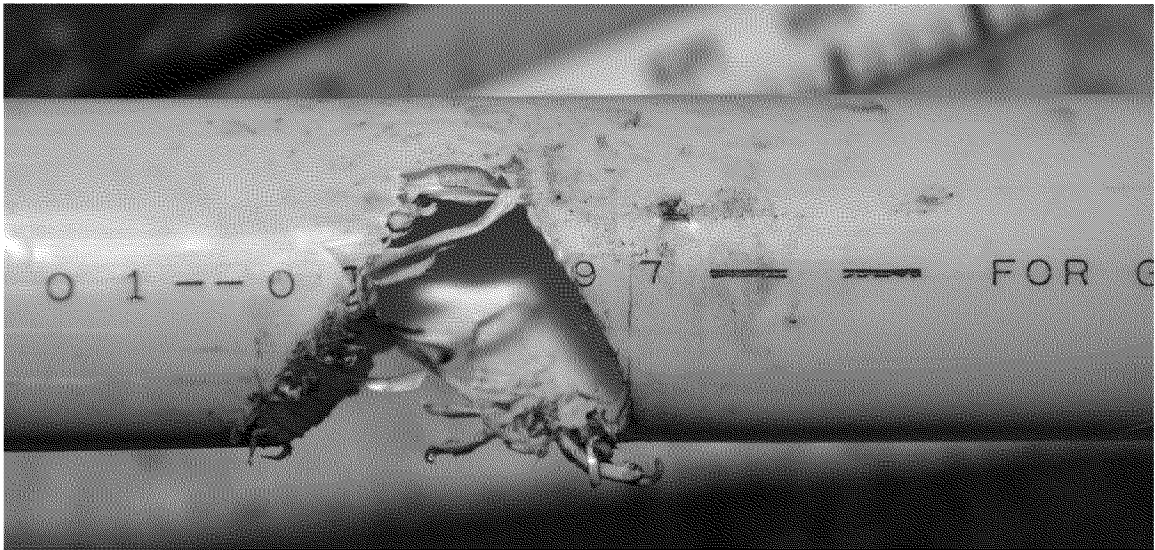
pipes (Figure 28). The plastic line segment has two perforations that correspond to the Save-a-Valve and M/2 fittings (Figure 29). There are some markings printed along the exterior of the pipe. A portion of the writing is associated with the fabrication date; in this particular piece only the year is visible, 1997 (Figure 30).

Figure 30. Close-up of the visible portion of the date code on the plastic pipe. Photograph by Exponent on March 10, 2014.

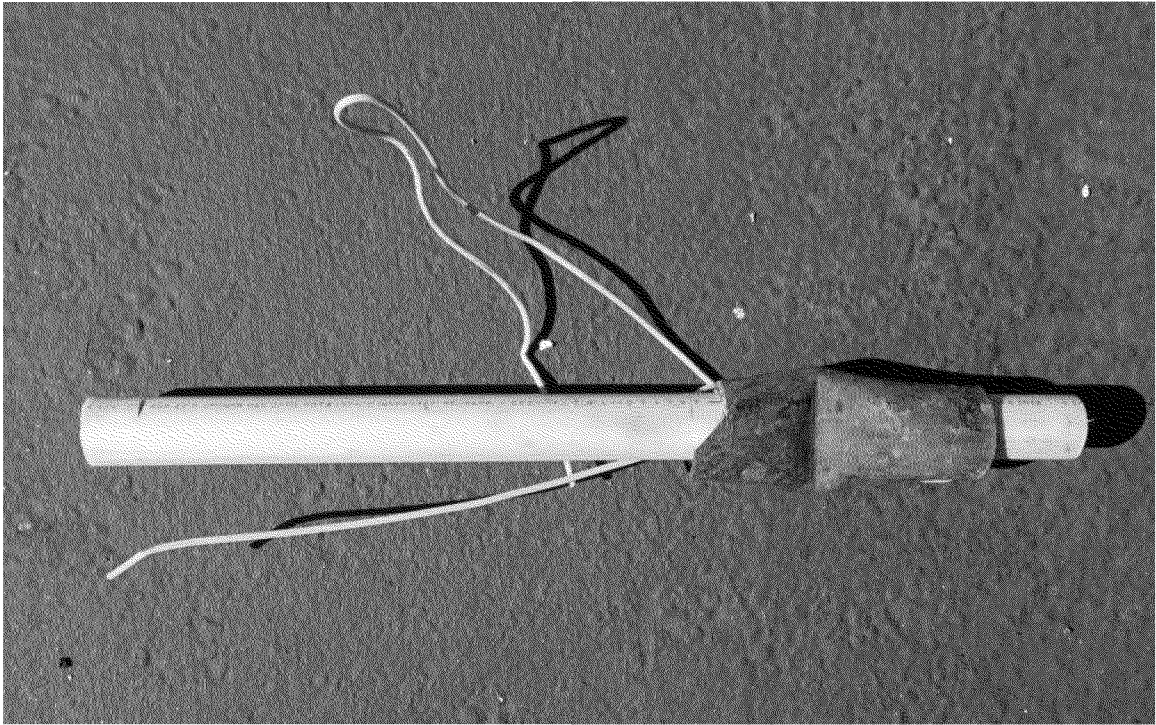
An additional portion of the gas main along 3rd Avenue was taken into evidence by PG&E. Exponent did not inspect this item but PG&E provided multiple pictures to Exponent. The additional item corresponds to the west side gas main portion where the line had been squeezed after the incident (Figure 31). The writing on the photographs shown to Exponent indicates that the plastic pipe had a complete manufacturing date code of July 17, 1997 (Figure 32).

Figure 31. West-side squeeze point of the gas main along [Redacted]. Photograph provided by PG&E.

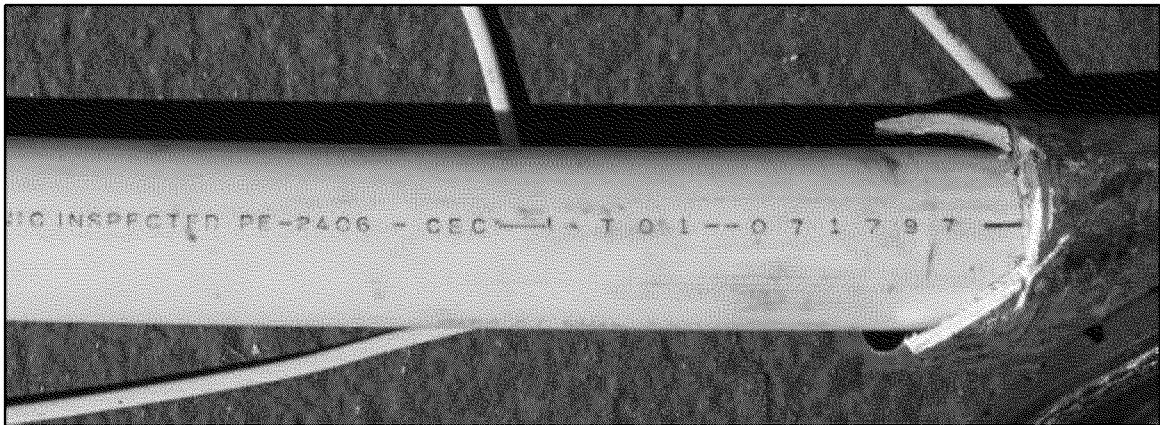
Figure 32. Close-up of the complete manufacturing date code of the plastic gas main. Photograph provided by PG&E.

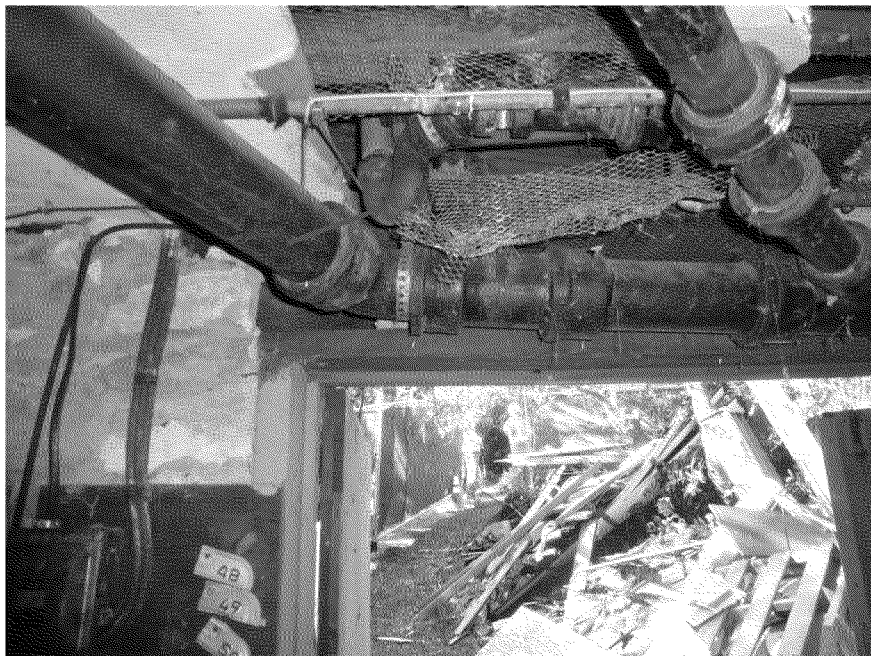
Figure 41. Multiple connections to building sewer system inside residence. Arrow indicates plumbing trap. Photograph from inside residence's basement. Photograph by Exponent on March 11, 2014.

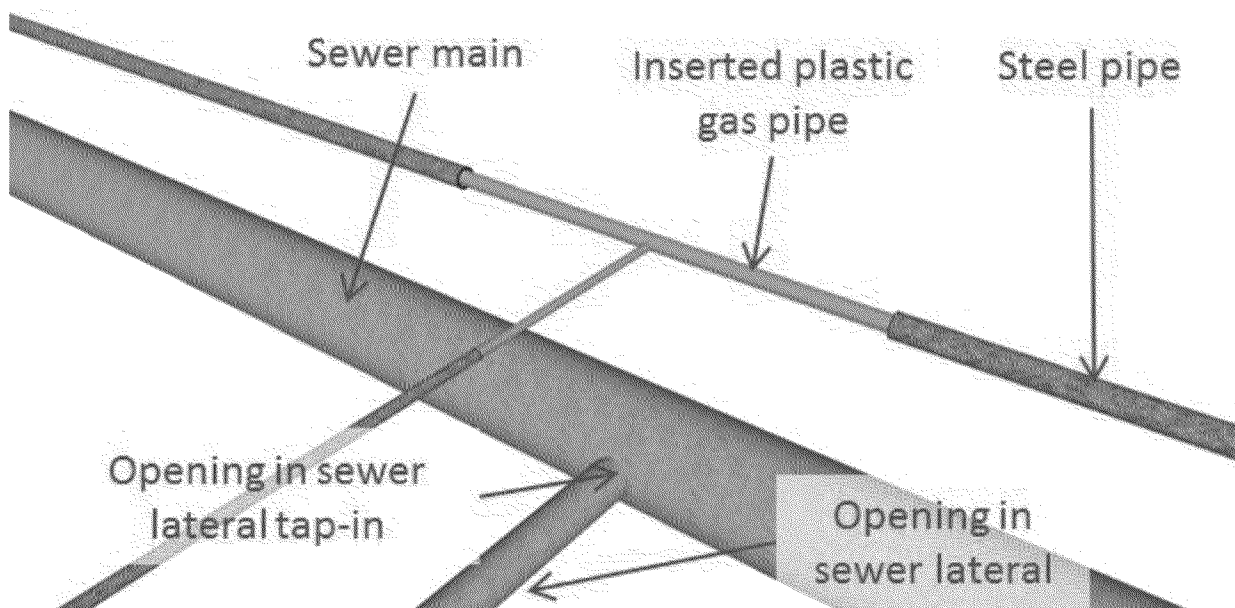
Figure 44. Schematic configuration of the sewer and gas systems in the vicinity of the excavation. Figure not to scale.

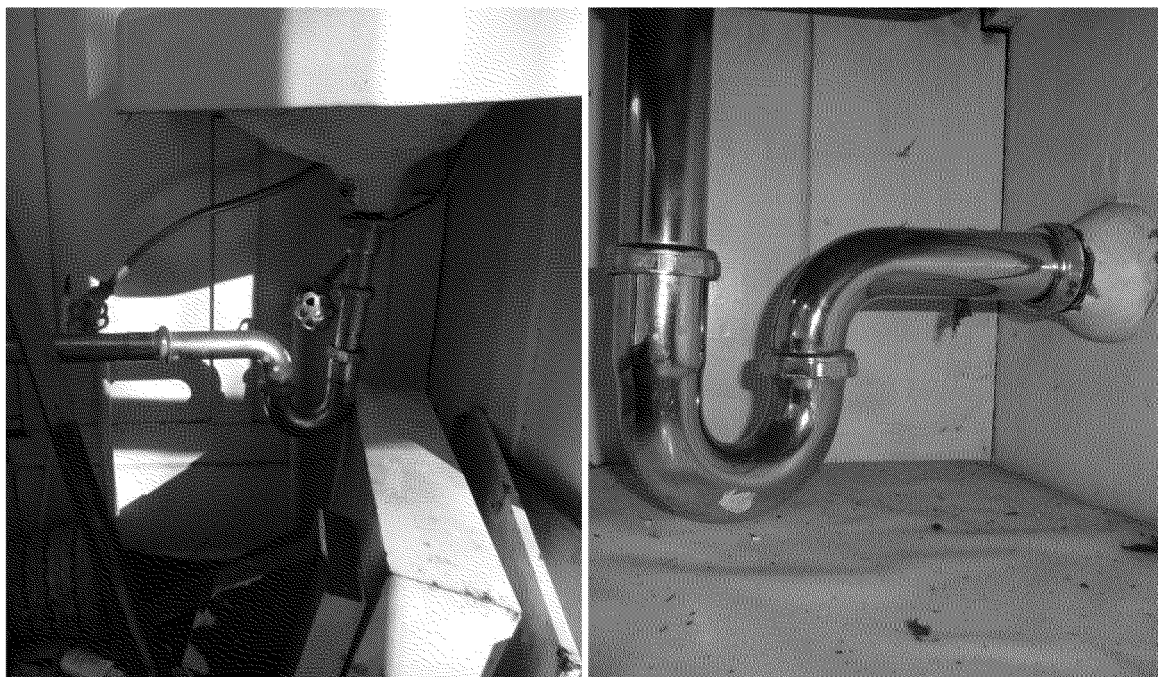
Plumbing traps are curved sections of pipe installed to contain water and provide a barrier to sewer gases entering living space. The water seal trap on any plumbing fixture or plumbing drain line must be filled with water to be effective. At the subject residence, traps were observed in all lines leading to, or in, all plumbing fixtures present.²⁰ Some of these plumbing fixture traps are shown in Figure 48 and some of the plumbing line traps are shown in Figure 41.

Figure 48. Plumbing traps at bathroom sink (left) and kitchen sink (right). Photographs by Exponent on March 11, 2014.

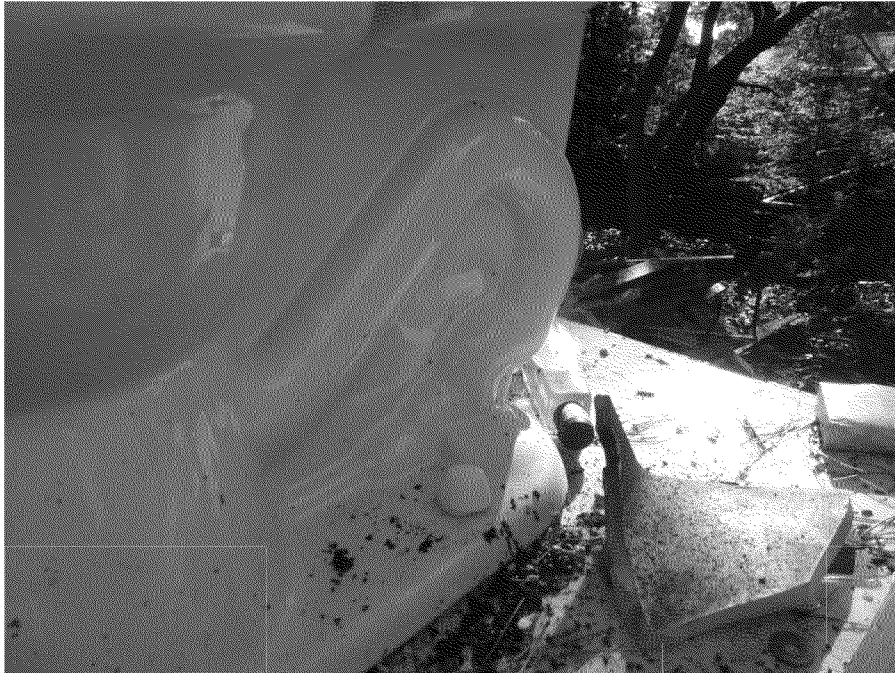
As previously noted, there was no plumbing trap in the sewer drain line section video recorded from the toilet towards the sewer main on Redacted. The only trap along this sewer line path was the integral trap in the toilet fixture. Figure 49 documents this trap.

Figure 49. Toilet drain trap. Photograph by Exponent on March 11, 2014.

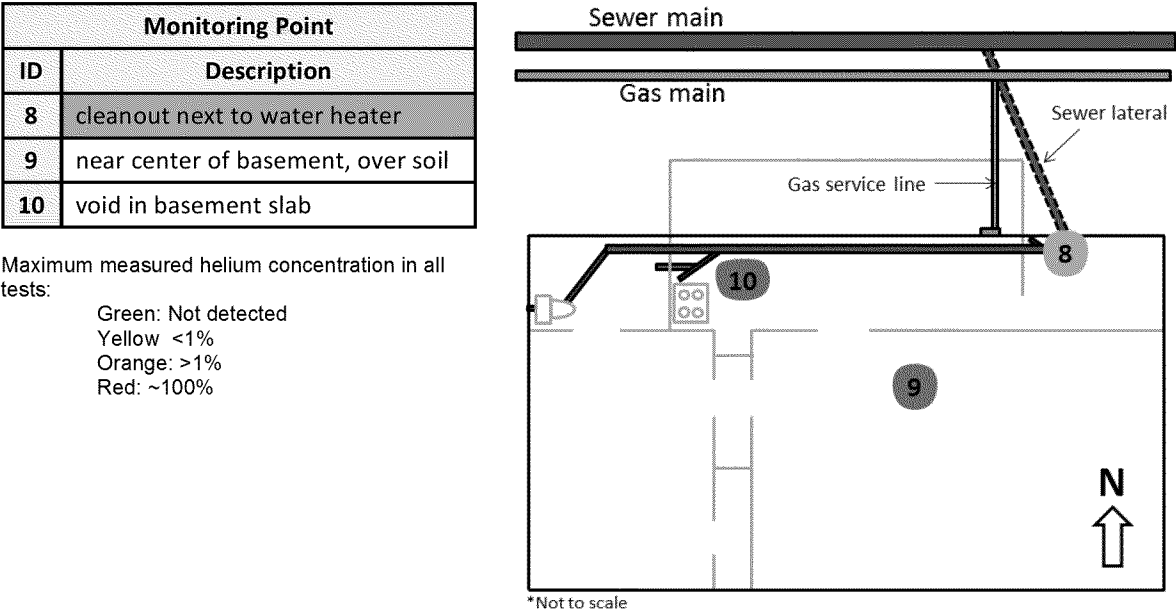
Figure 53. Helium test monitoring points and results at the residence’s basement.

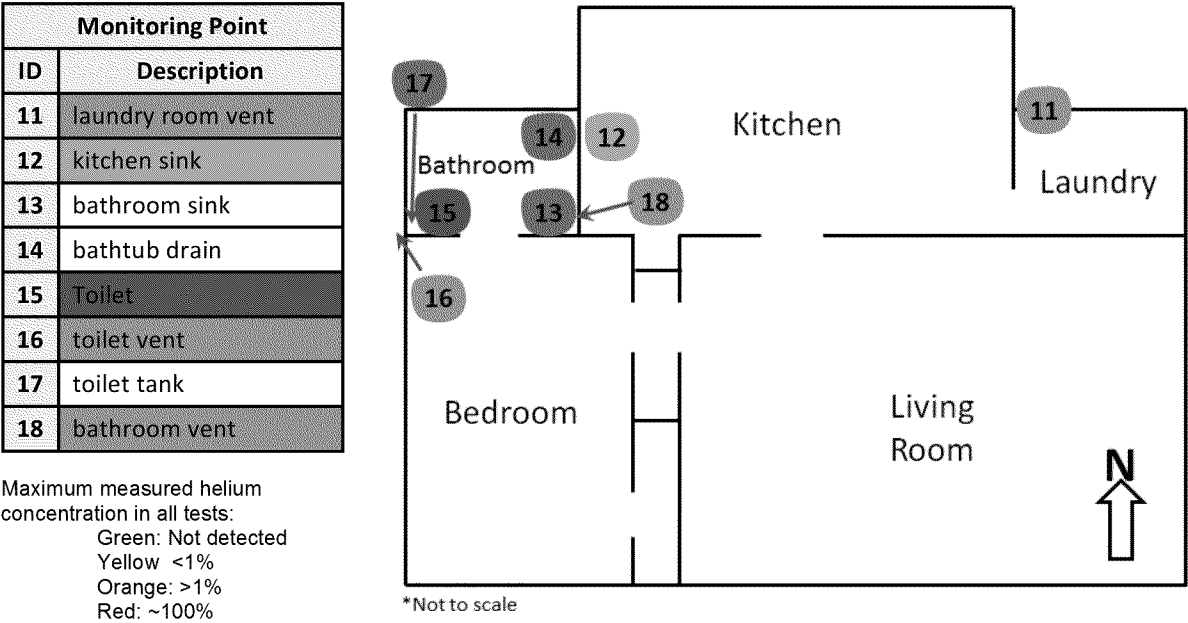
Figure 54. Helium test monitoring points and results at the residence’s first floor.

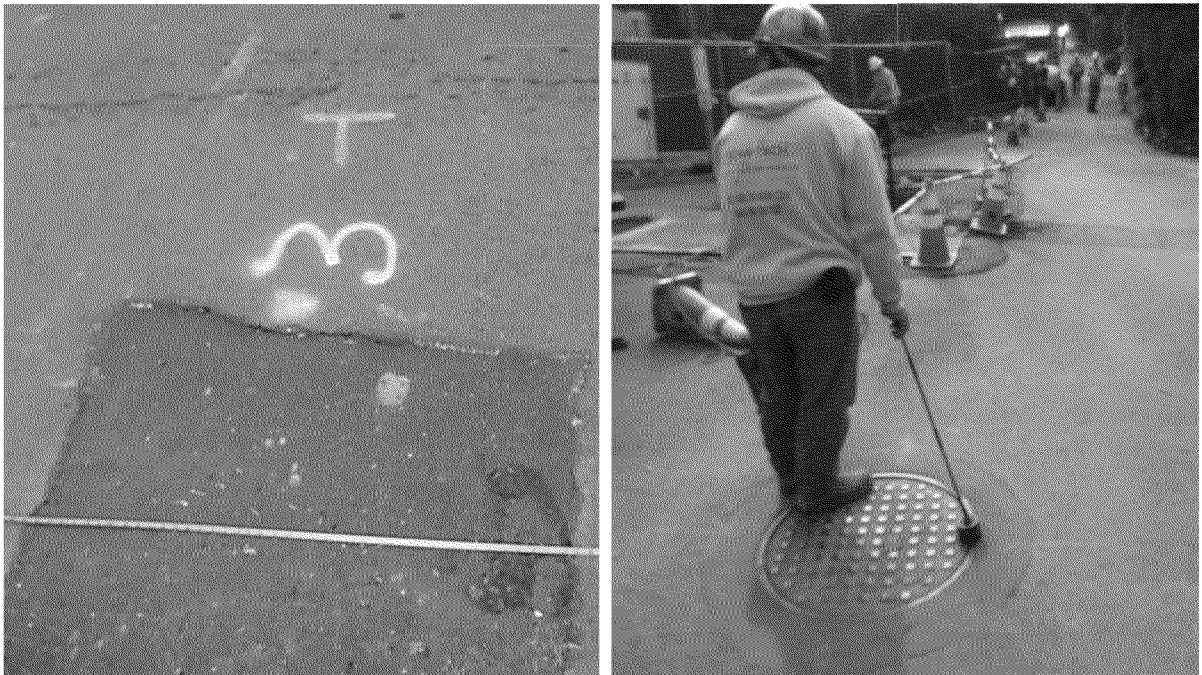
Figure 55. Example monitoring points outside of residence. Monitoring point #3 (left) near excavation performed by PG&E at gas service tee for residence. Monitoring point #19 (right) at sewer manhole near the intersection of Red
Redacted Photographs by Exponent on March 21, 2014.

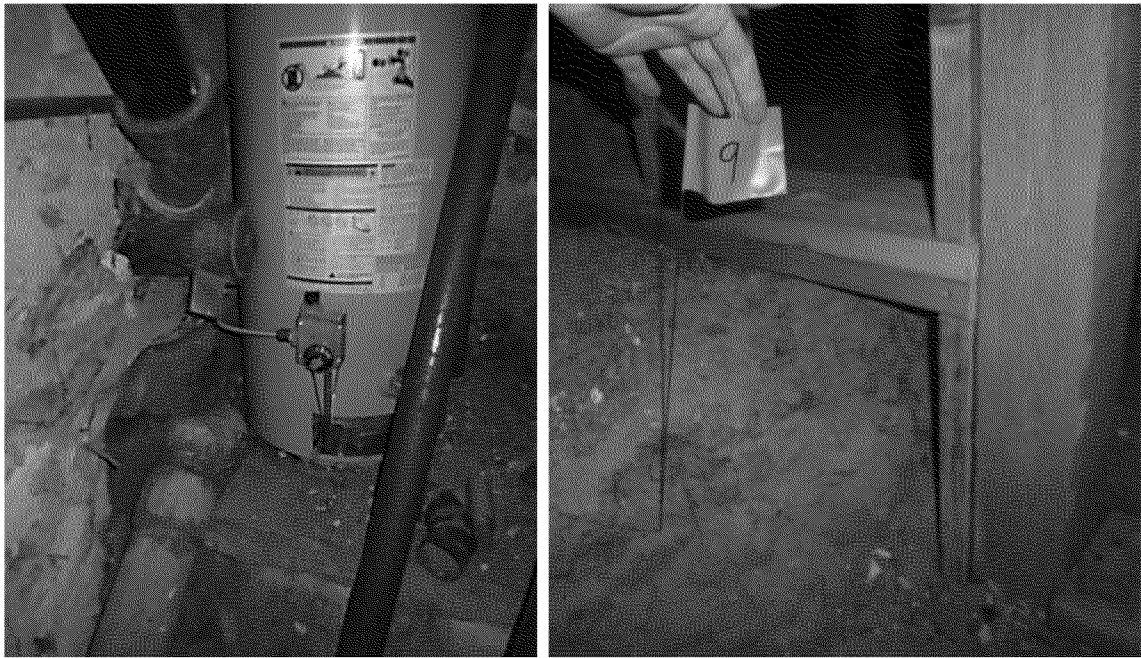
Figure 56. Example monitoring points at the residence's basement. Monitoring point #8 (left) by the cleanout next to water heater. Monitoring point #9 (right) near center of basement, over soil. Photographs by Exponent on March 21, 2014.

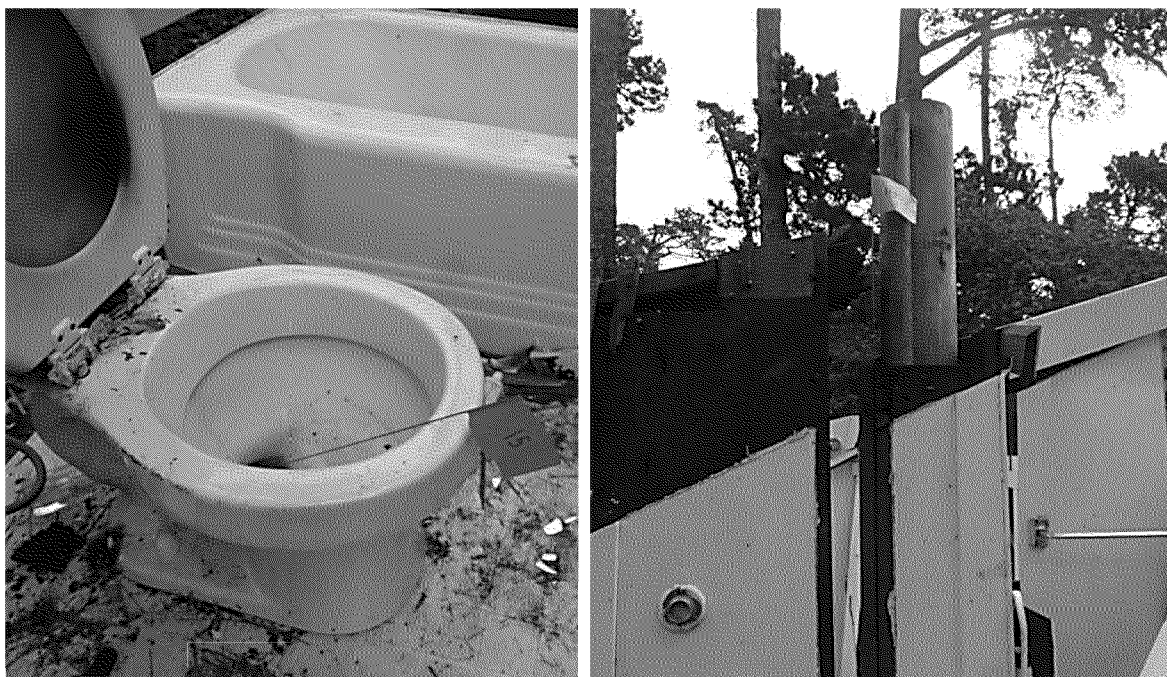
Figure 57. Example monitoring points at the residence's first floor. Monitoring point #15 (left) at the toilet. Monitoring point #18 (right) at bathroom vents. Photographs by Exponent on March 21, 2014.

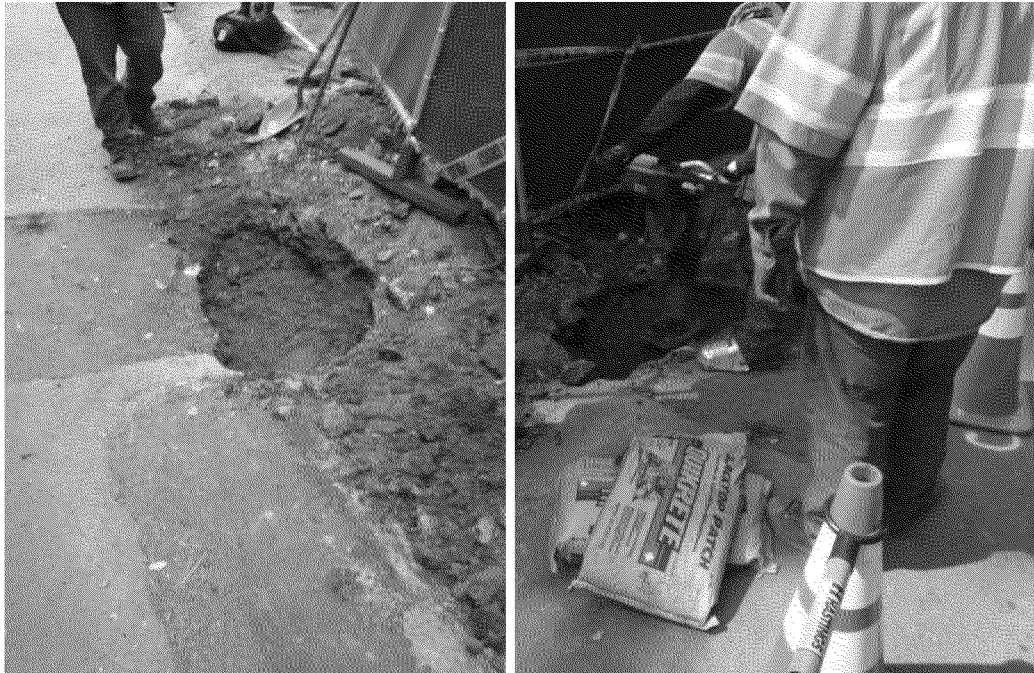
- Test 4: In an attempt to bring soil conditions closer to those present before the gas service tee excavation was performed by PG&E on the day of the explosion, the shallowest eight inches (approximately) of soil above the gas service tee were excavated, re-compacted in place and paved with an asphalt cold patch (Figure 58). Other field conditions were as described for Test 1.

Figure 58. Excavation (left) and re-compaction (right) near gas service tee. Photographs by Exponent on March 21, 2014.

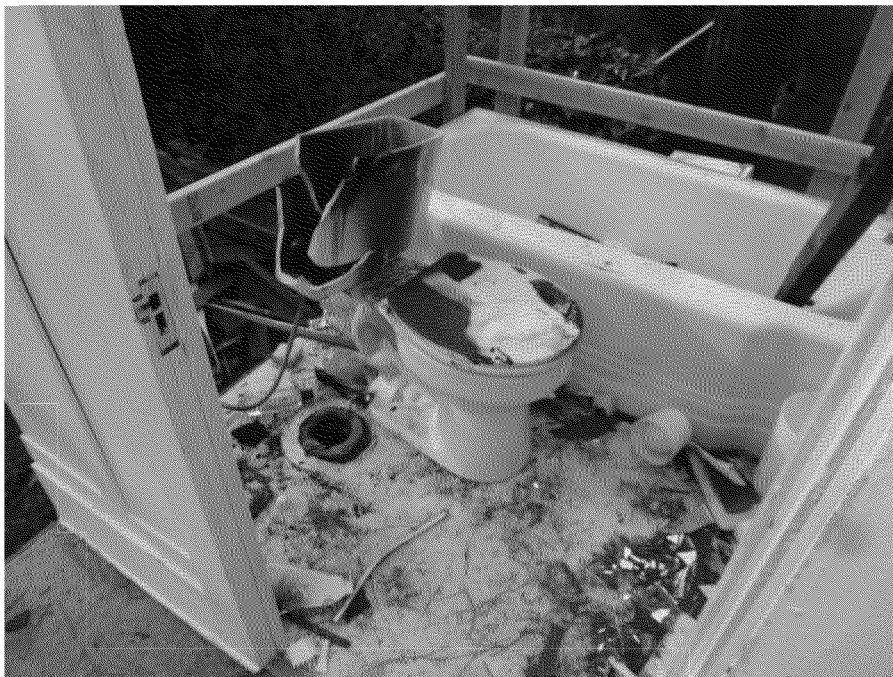
- Test 5: To test the condition of dry toilet bowl on the day of the explosion, the toilet was removed, and helium measurements were taken directly at the toilet sewer raiser (Figure 59). Other field conditions were as described for Test 4.

Figure 59. Monitoring point #15 after removal of the toilet. Photograph by Exponent on March 21, 2014.
