**Carmel Gas Incident**

Doc. no. 1401752.000 - 4253

Pacific Gas and Electric (PG&E) has retained Exponent Failure Analysis Associates (Exponent) to conduct a failure analysis investigation of a gas leak and subsequent explosion on March 3, 2014 in Carmel-by-the-Sea (Carmel), California.

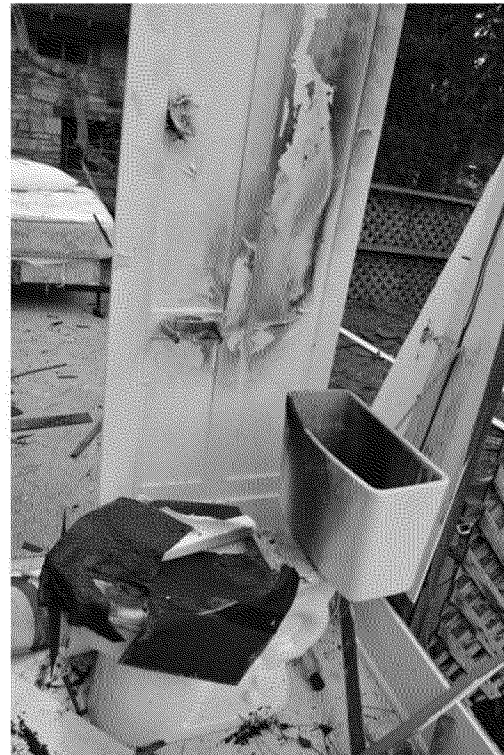
Figure 14. Bathroom toilet. Photograph by Exponent on March 6, 2014.

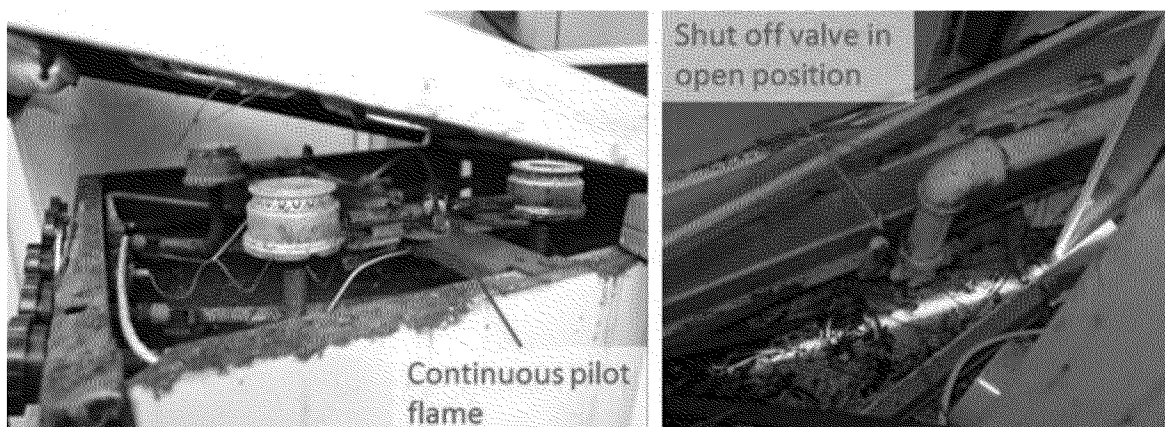
**Stove** – A kitchen stove was present in the subject house. The location of the stove is shown in Figure 20. The appliance shut-off valve for the stove was found in the open position and the stove was equipped with a continuous pilot flame (Figure 21). Based on these facts, the stove cannot be ruled out as a likely ignition source for the incident explosion.

Figure 21. Kitchen stove components. Photographs by Exponent on March 6, 2014.

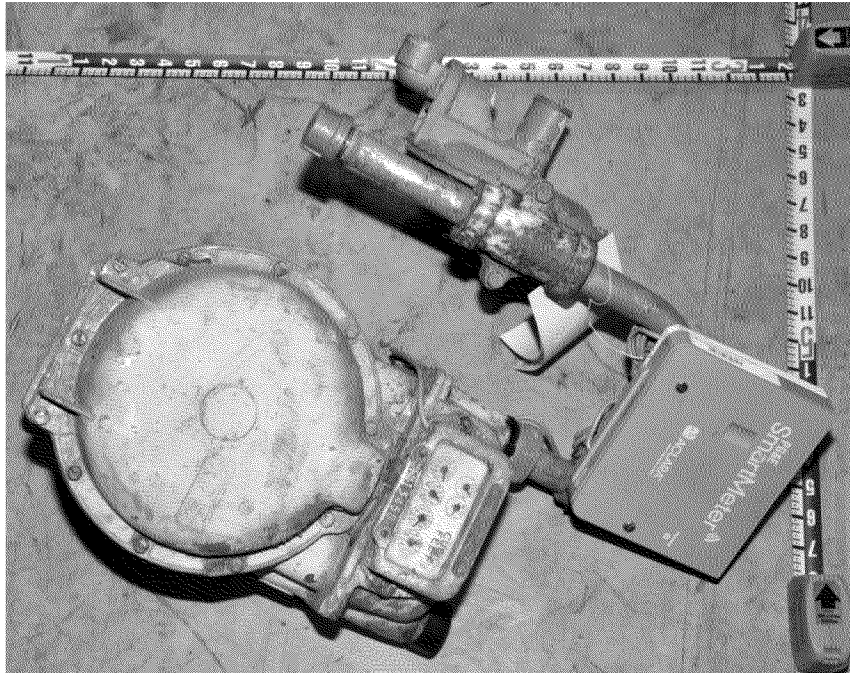
The regulator and meter set (Figure 22) had been removed just downstream of the service riser shut-off valve. The meter was equipped with a SmartMeter module. No functional tests were performed during the inspection.

Figure 22. Regulator meter set removed from incident house. Photograph by Exponent on March 10, 2014.

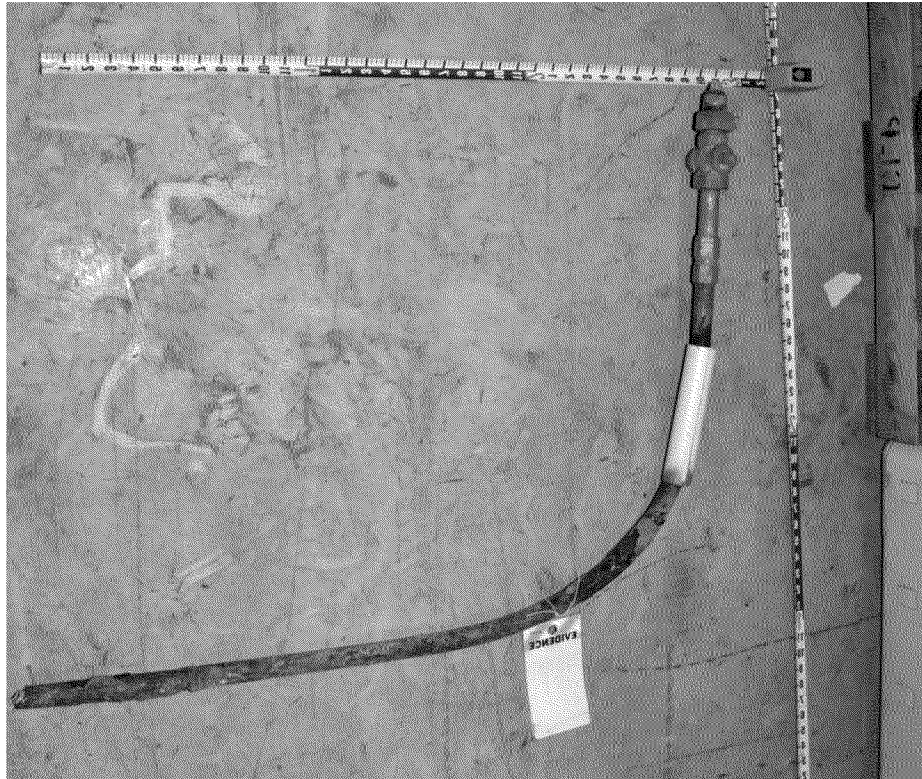
The steel  $\frac{3}{4}$ -inch gas service line and riser are shown in Figure 23. The steel line is approximately five feet in length and inserted with a  $\frac{1}{2}$ -inch plastic line (Figure 24). The line segment terminates in a service head adapter kit and service riser shut-off valve. According to the PG&E leak repair report, the service riser shut-off valve was turned to the closed position during the incident response operations.

Figure 23. Portion of the gas service line to incident house. Photograph by Exponent on March 10, 2014.

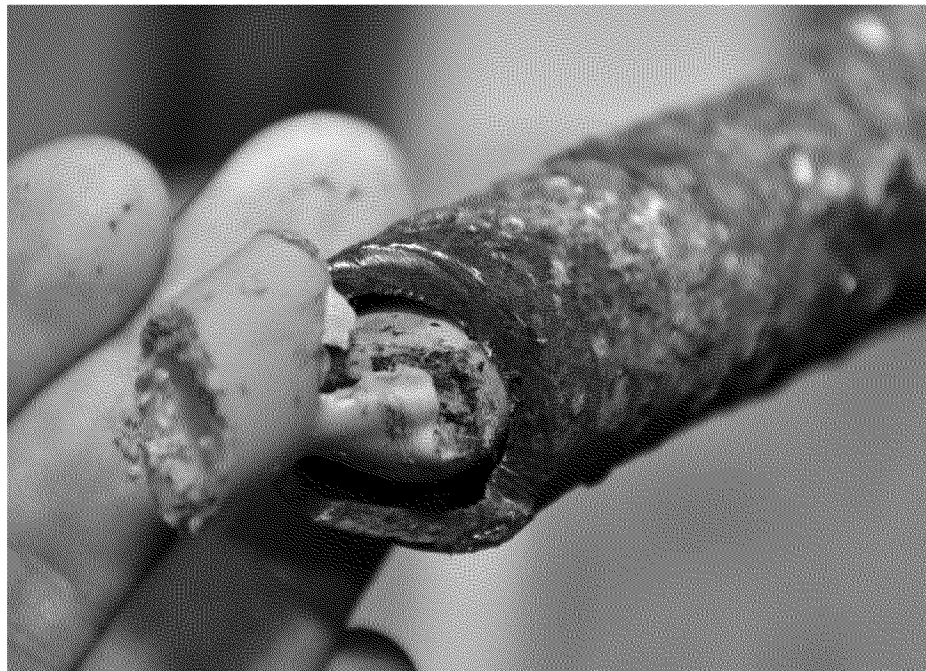
Figure 24. Close-up of the cut end of the gas service line. Photograph by Exponent on March 10, 2014.

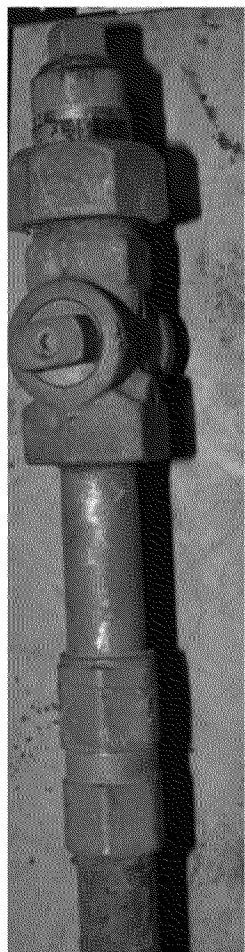
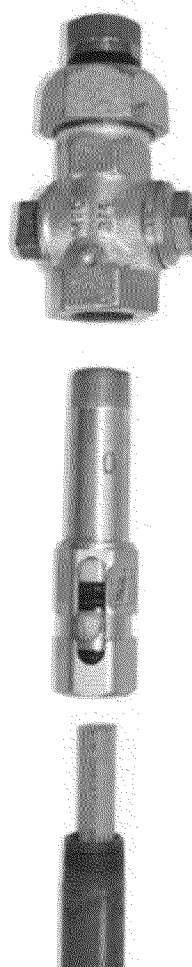
The service head adapter seals the annular space between the 3/4-inch steel pipe and the 1/2-inch plastic pipe. The service head adapter was lacking identifying markings, but appears to be similar to a Perfection 3/4" x (1/2" PE) x 3/4" Extended Service-Head Adapter. The two service head adapters are shown in Figure 25.

Figure 25. Service head adapter. Sources: Photograph by Exponent on March 10, 2014, service head adapter image from PG&E Gas Methods and Procedures document Service-Head Adapter Photo Identification.

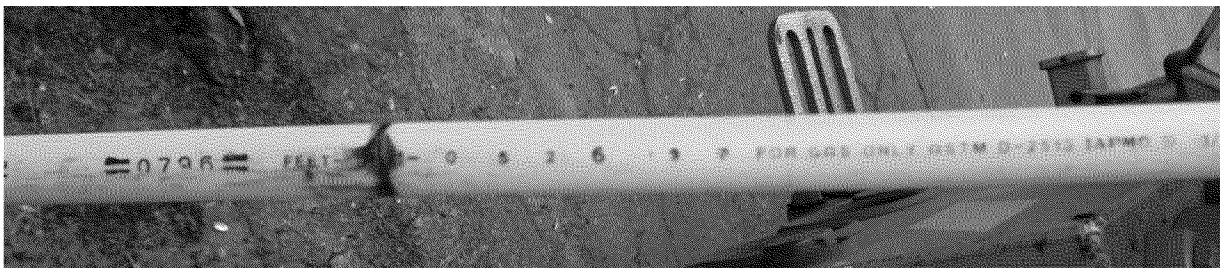
The inserted plastic pipe from the service line had a date code that read "052697", indicating a date of manufacture of May 26, 1997. The inserted plastic service line is shown in Figure 26.

Figure 26. Inserted plastic service line. Photograph source: PG&E.

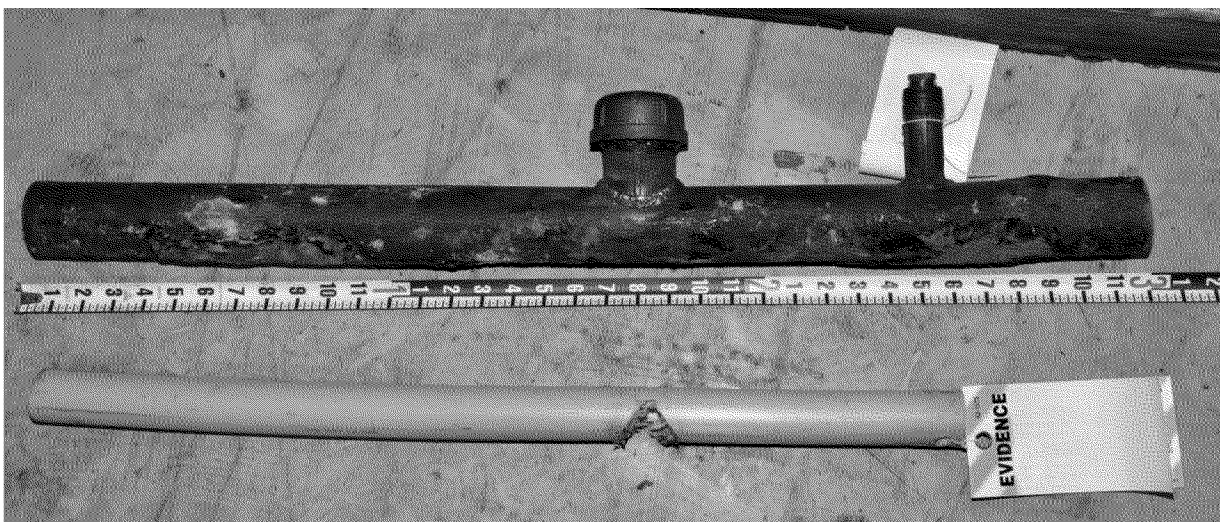
A three foot long section of the 2-inch steel main running along [Redacted] was removed from the bell hole at the intersection of [Redacted] (Figure 27). The steel pipe segment has two welded fittings that were installed on March 3, 2014; one is a one-inch Save-a-valve fitting and the other is a two-inch M/2 line stopper fitting. There were no obstructions either in the main pipe or the two ports.

Figure 27. Portion of the gas main along [Redacted] Steel pipe (top) with welded fittings and plastic pipe insert. Photograph by Exponent on March 10, 2014.

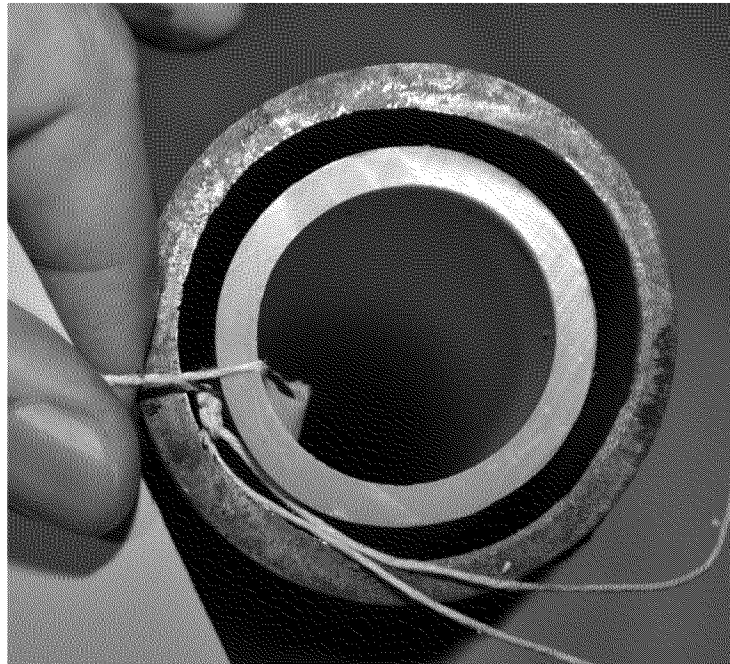
pipes (Figure 28). The plastic line segment has two perforations that correspond to the Save-a-Valve and M/2 fittings (Figure 29). There are some markings printed along the exterior of the pipe. A portion of the writing is associated with the fabrication date; in this particular piece only the year is visible, 1997 (Figure 30).

Figure 28. Plastic gas line inserted into steel line. Photograph by Exponent on March 10, 2014.

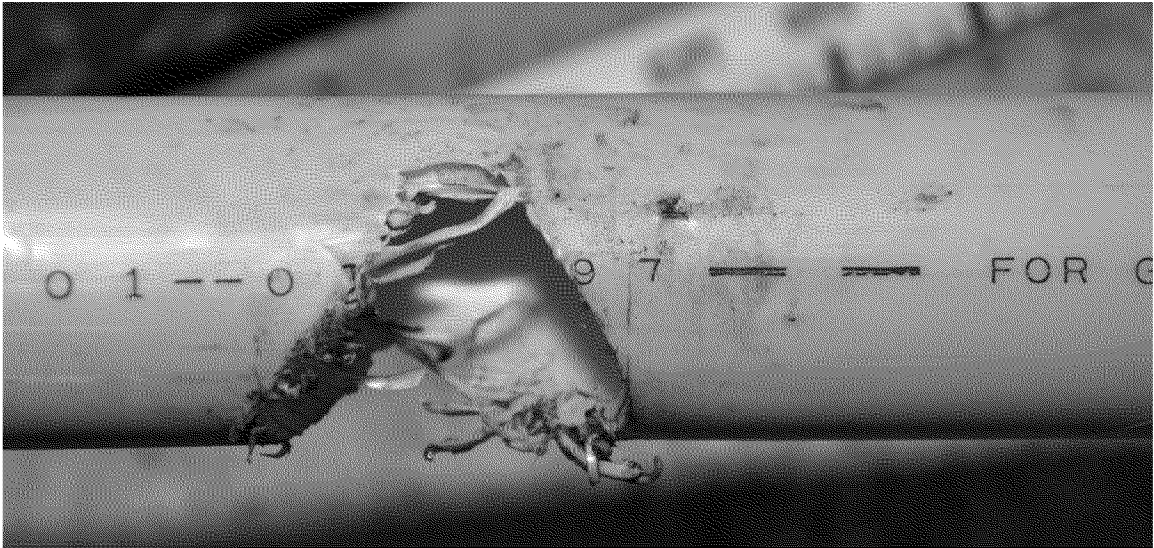
Figure 30. Close-up of the visible portion of the date code on the plastic pipe. Photograph by Exponent on March 10, 2014.

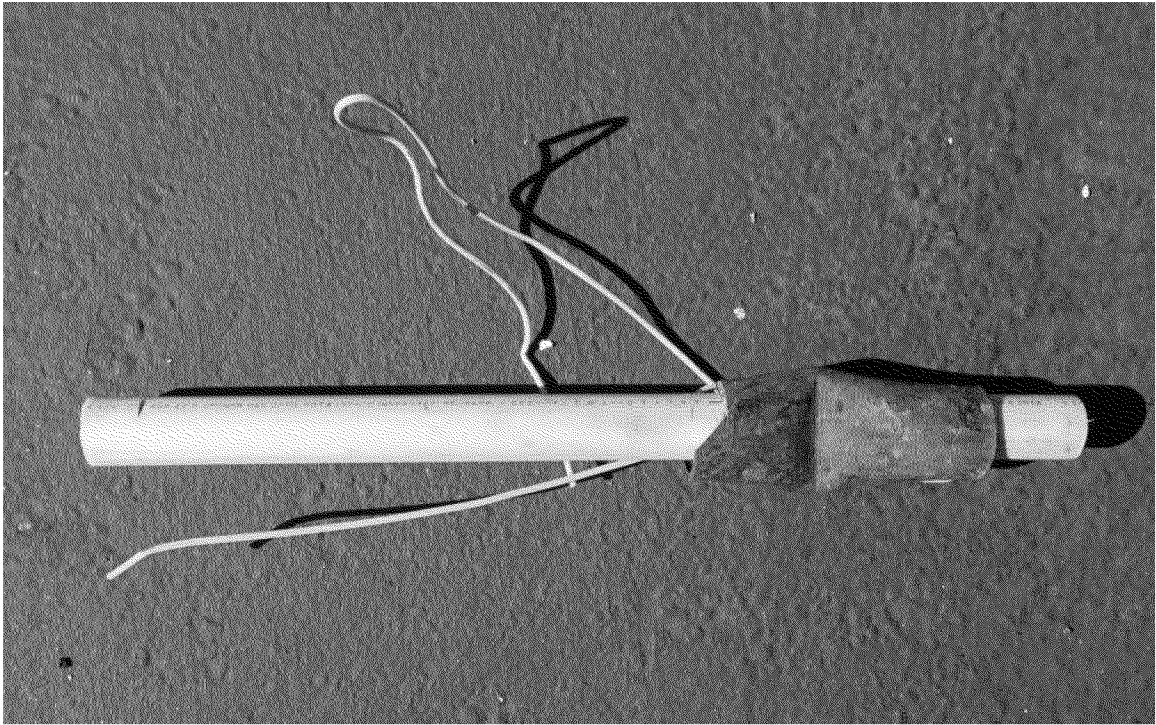
An additional portion of the gas main along Redacted was taken into evidence by PG&E. Exponent did not inspect this item but PG&E provided multiple pictures to Exponent. The additional item corresponds to the west side gas main portion where the line had been squeezed after the incident (Figure 31). The writing on the photographs shown to Exponent indicates that the plastic pipe had a complete manufacturing date code of July 17, 1997 (Figure 32).

Figure 31. West-side squeeze point of the gas main along [Redacted]. Photograph provided by PG&E.

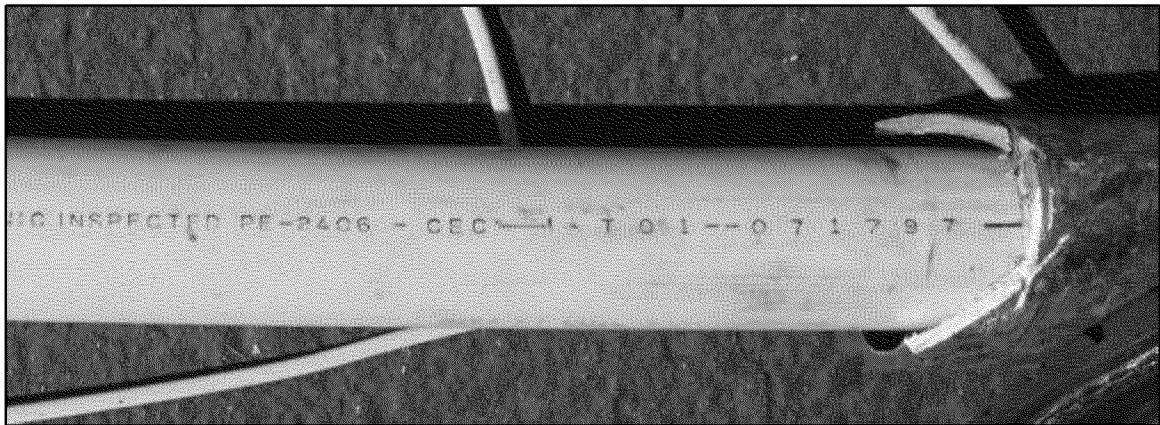
Figure 32. Close-up of the complete manufacturing date code of the plastic gas main. Photograph provided by PG&E.

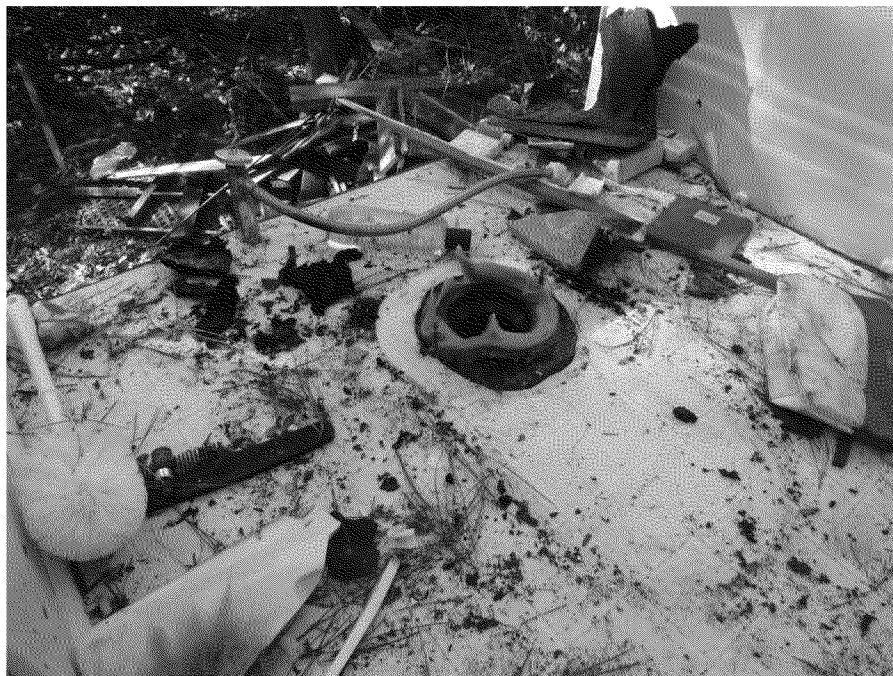
At the subject residence, because of the sewer lateral joint offset near the sewer main, video of the sewer lateral was attempted from the interior of the residence. The selected entry point for the video was a toilet, which was removed to allow for the push camera to enter the sewer pipe (Figure 39).

Figure 39. Toilet removed to allow for insertion of sewer push camera. Photograph by Exponent on March 11, 2014.

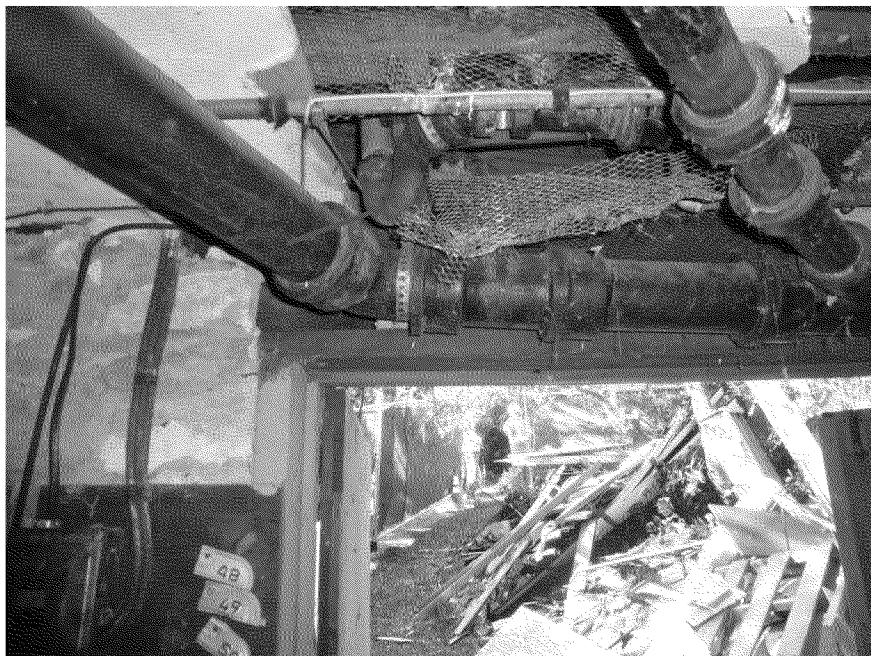
Figure 41. Multiple connections to building sewer system inside residence. Arrow indicates plumbing trap. Photograph from inside residence's basement. Photograph by Exponent on March 11, 2014.

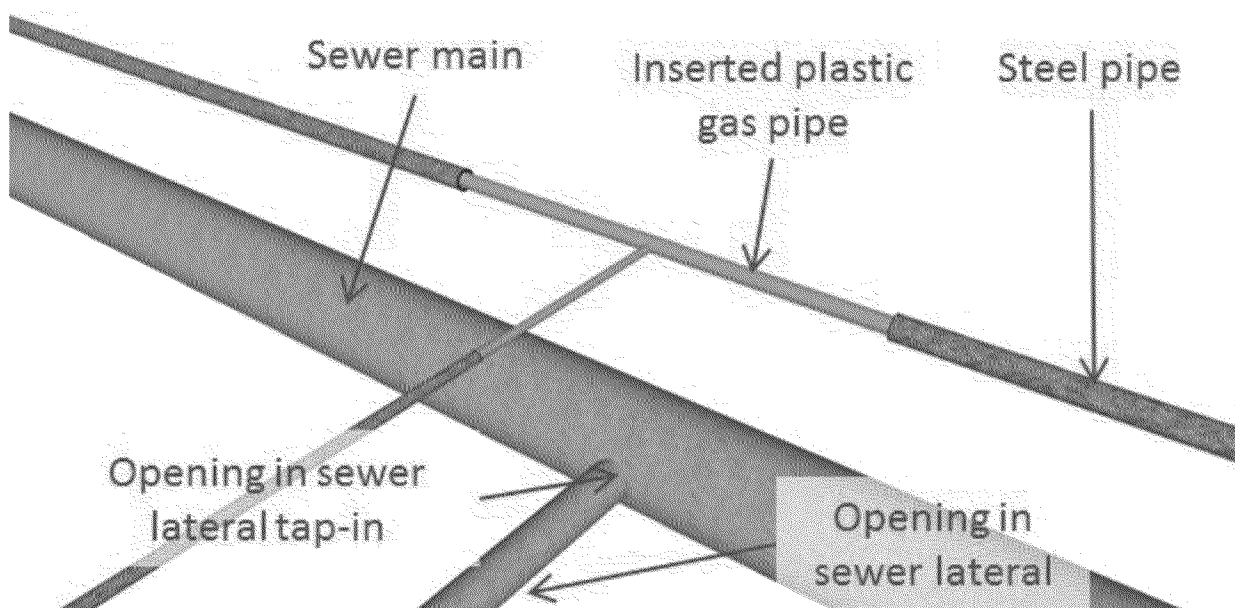
Figure 44. Schematic configuration of the sewer and gas systems in the vicinity of the excavation. Figure not to scale.

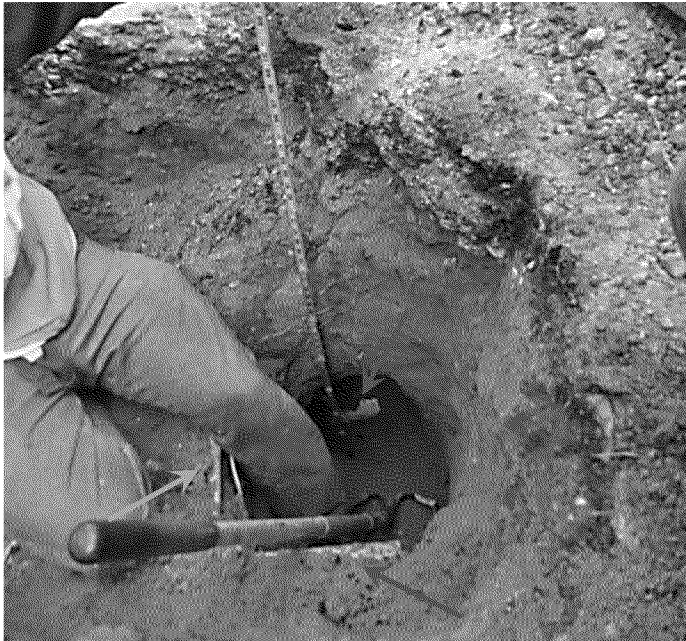
The approximate area previously excavated by PG&E on the day of the explosion (Figure 35) was re-excavated. The depth of excavation continued until a portion of the sewer lateral was exposed (Figure 45). As shown in Figure 46, the presence of a white plastic segment of sewer lateral, and an offset of the pipe, was confirmed by the excavation. The date of installation of the plastic segment in the sewer lateral is unknown. According to statements by John White of Fire Cause Analysis, the homeowners stated that they have not performed sewer replacement/repair work since they purchased the property in 1999.

Figure 45. Excavation to expose sewer lateral at subject residence in the vicinity of gas service tee. Yellow arrow indicates gas main along [Redacted] Red arrow indicates gas service line. Green arrow indicates sewer lateral. Photograph by Exponent on March 21, 2014.

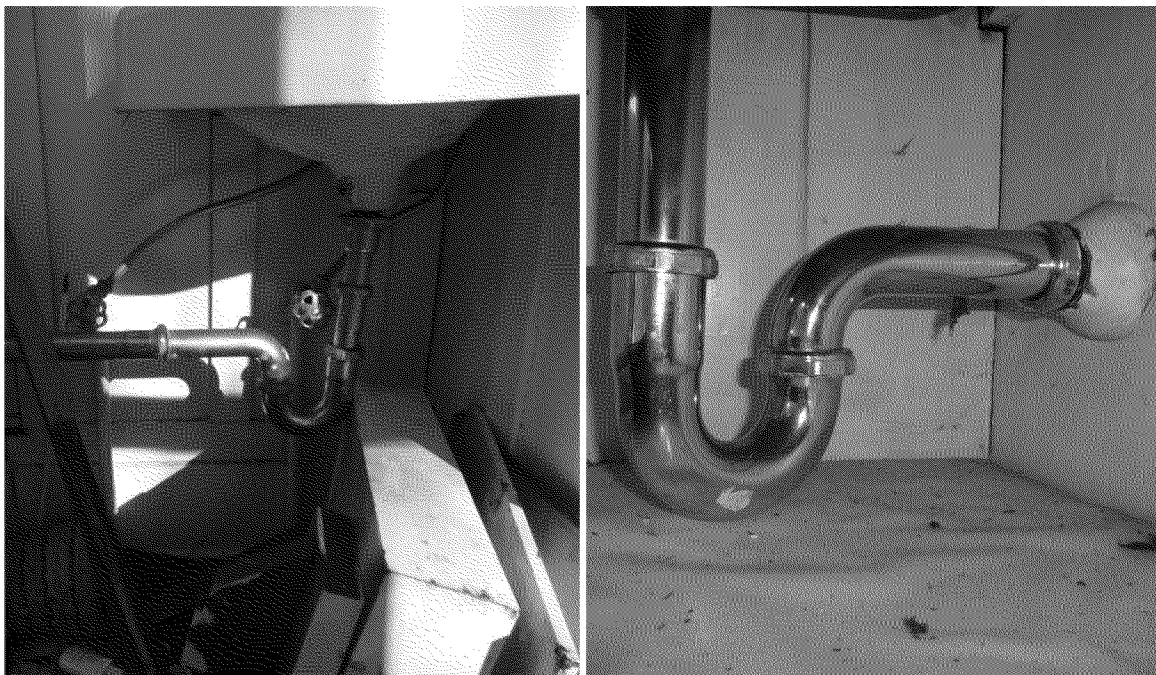
Plumbing traps are curved sections of pipe installed to contain water and provide a barrier to sewer gases entering living space. The water seal trap on any plumbing fixture or plumbing drain line must be filled with water to be effective. At the subject residence, traps were observed in all lines leading to, or in, all plumbing fixtures present.<sup>20</sup> Some of these plumbing fixture traps are shown in Figure 48 and some of the plumbing line traps are shown in Figure 41.

Figure 48. Plumbing traps at bathroom sink (left) and kitchen sink (right). Photographs by Exponent on March 11, 2014.

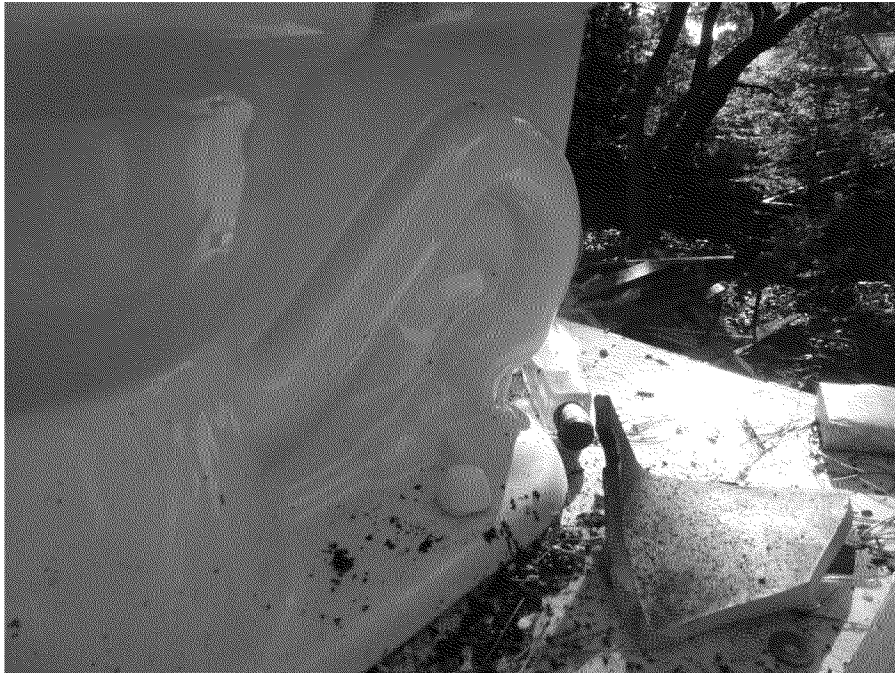
As previously noted, there was no plumbing trap in the sewer drain line section video recorded from the toilet towards the sewer main on [Redacted]. The only trap along this sewer line path was the integral trap in the toilet fixture. Figure 49 documents this trap.

Figure 49. Toilet drain trap. Photograph by Exponent on March 11, 2014.

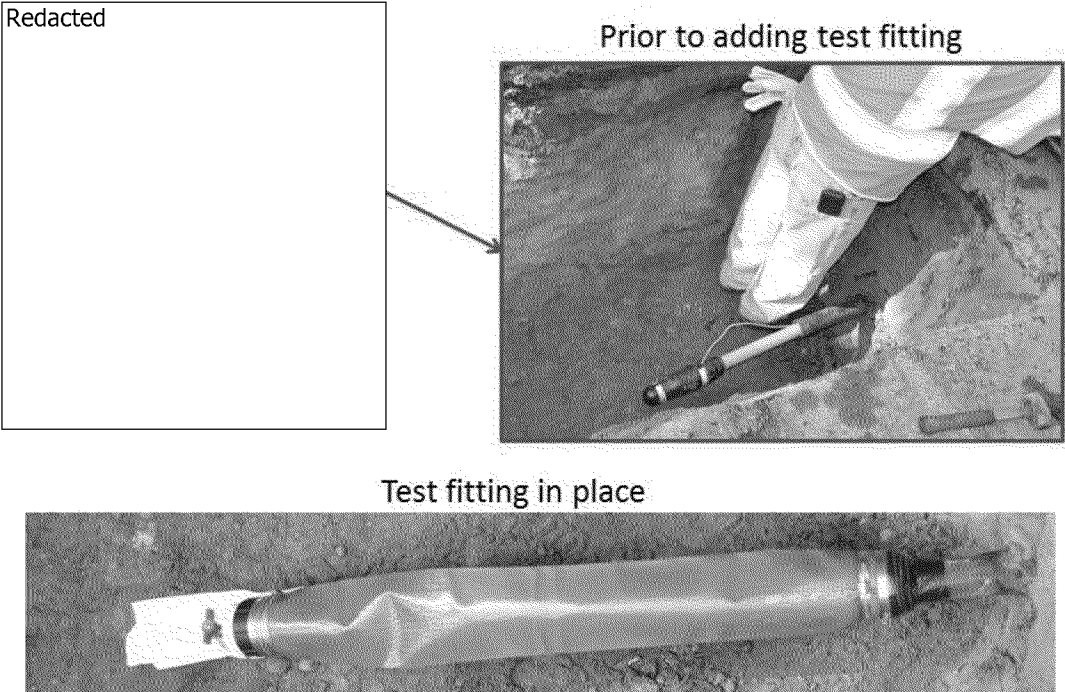
Figure 51. Annotated D-Plat 3956-C08 showing helium injection point and test fitting. Photographs by Exponent on March 21, 2014.

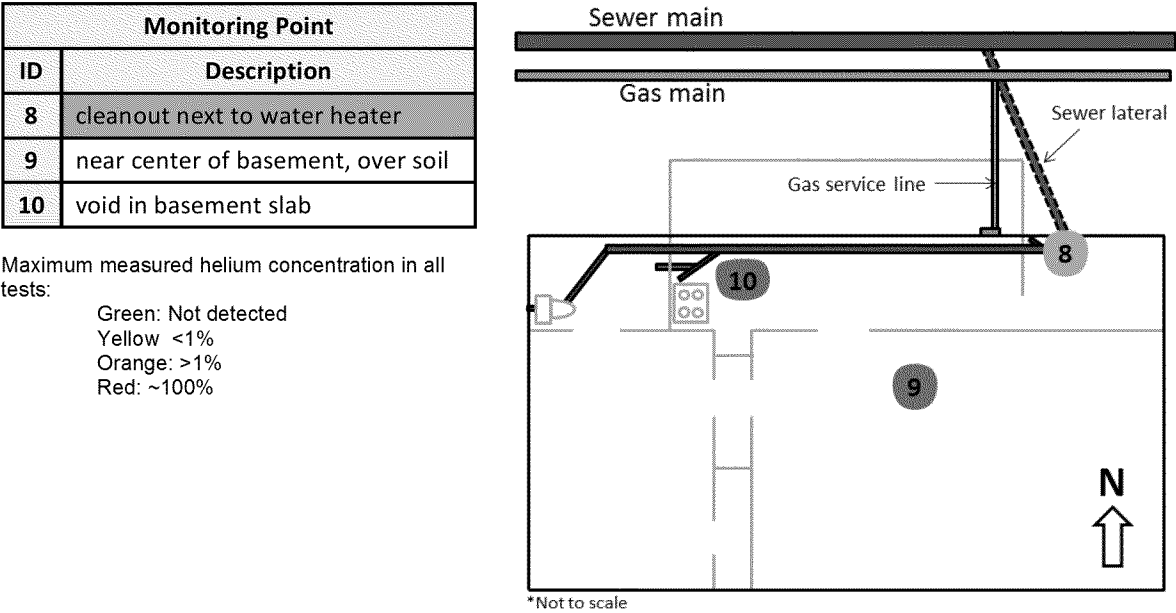
Figure 53. Helium test monitoring points and results at the residence’s basement.

As summarized in Table 1 and Figure 52 through Figure 54, the results of the helium gas migration test conclusively show that, when helium gas is released near the location where the puncturing of the plastic pipe occurred on March 3, 2014, the gas can enter the sewer system in the vicinity of the subject residence. Once inside the sewer system, helium gas can travel through the sewer system and be released into the living space of the subject residence.

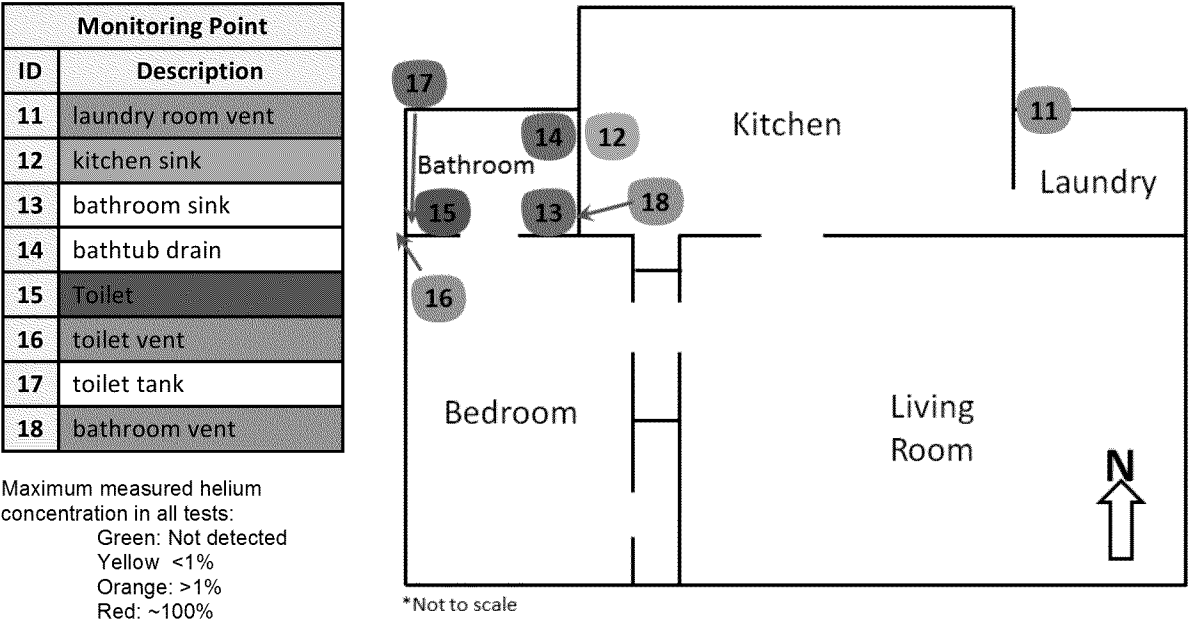
Figure 54. Helium test monitoring points and results at the residence’s first floor.

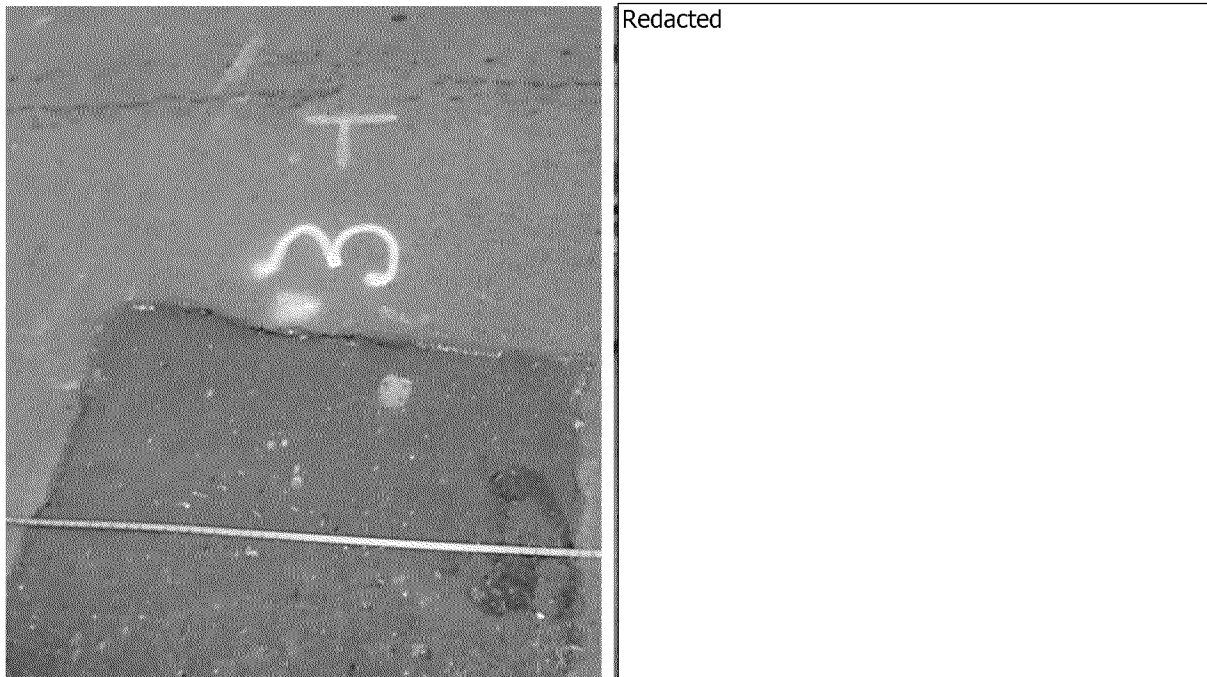
Figure 55. Example monitoring points outside of residence. Monitoring point #3 (left) near excavation performed by PG&E at gas service tee for residence. Monitoring point #19 (right) at sewer manhole near the intersection of Redacted  
Redacted Photographs by Exponent on March 21, 2014.

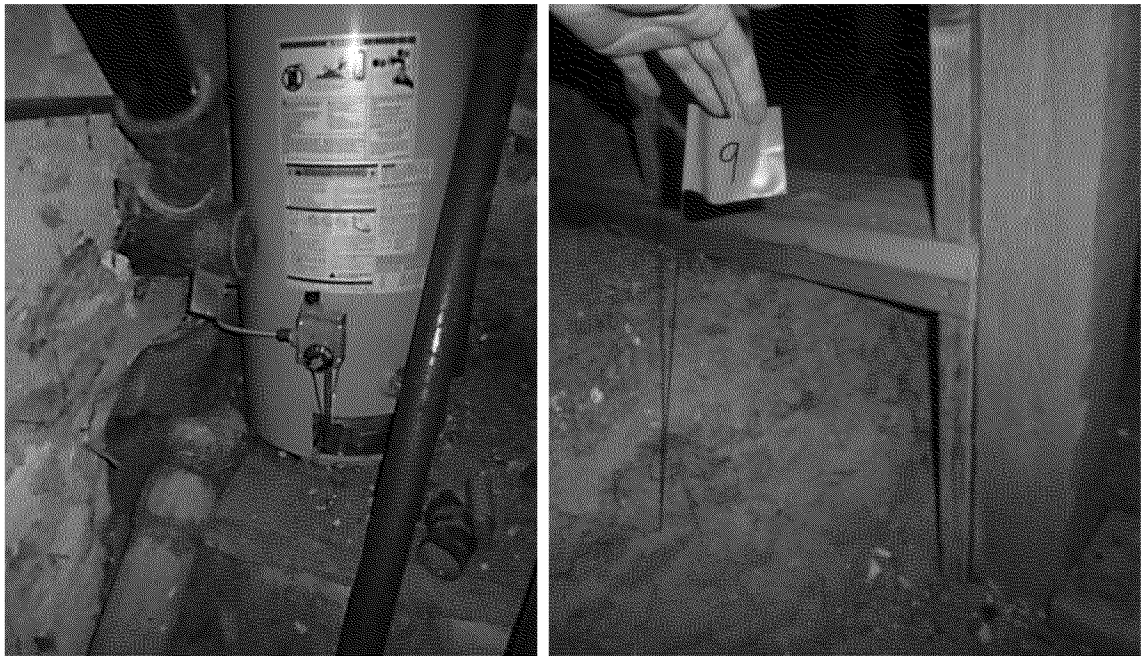
Figure 56. Example monitoring points at the residence's basement. Monitoring point #8 (left) by the cleanout next to water heater. Monitoring point #9 (right) near center of basement, over soil. Photographs by Exponent on March 21, 2014.

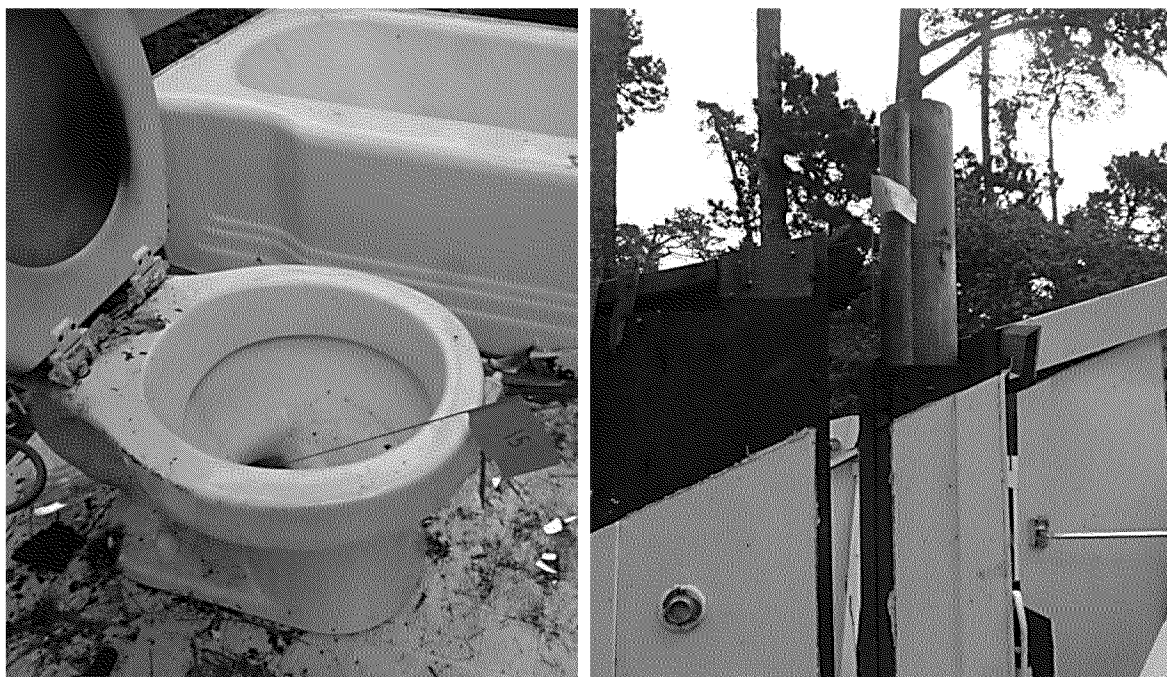
Figure 57. Example monitoring points at the residence's first floor. Monitoring point #15 (left) at the toilet. Monitoring point #18 (right) at bathroom vents. Photographs by Exponent on March 21, 2014.

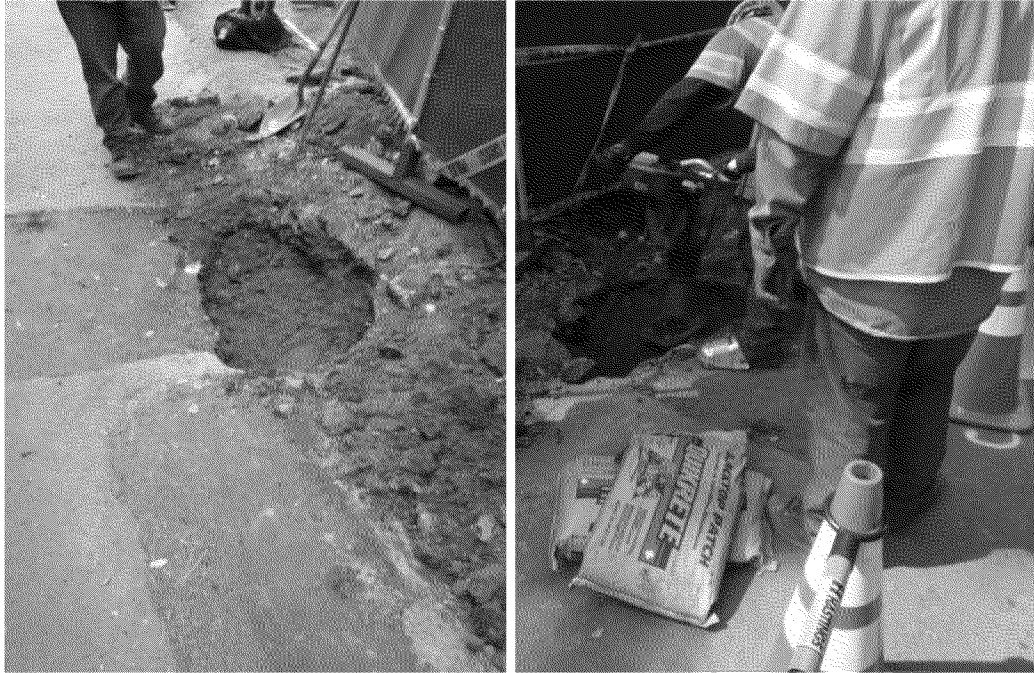
- Test 4: In an attempt to bring soil conditions closer to those present before the gas service tee excavation was performed by PG&E on the day of the explosion, the shallowest eight inches (approximately) of soil above the gas service tee were excavated, re-compacted in place and paved with an asphalt cold patch (Figure 58). Other field conditions were as described for Test 1.

Figure 58. Excavation (left) and re-compaction (right) near gas service tee. Photographs by Exponent on March 21, 2014.

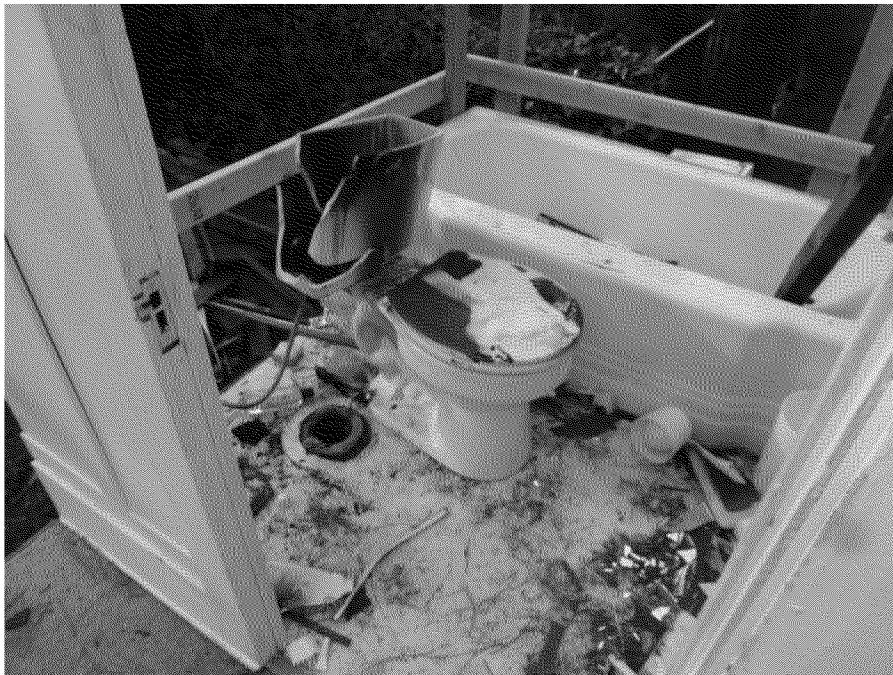
- Test 5: To test the condition of dry toilet bowl on the day of the explosion, the toilet was removed, and helium measurements were taken directly at the toilet sewer raiser (Figure 59). Other field conditions were as described for Test 4.

Figure 59. Monitoring point #15 after removal of the toilet. Photograph by Exponent on March 21, 2014.
