Exponent<sup>®</sup>

**Carmel Gas Incident**

April 2014

Doc. no. 1401752.000 - 4253

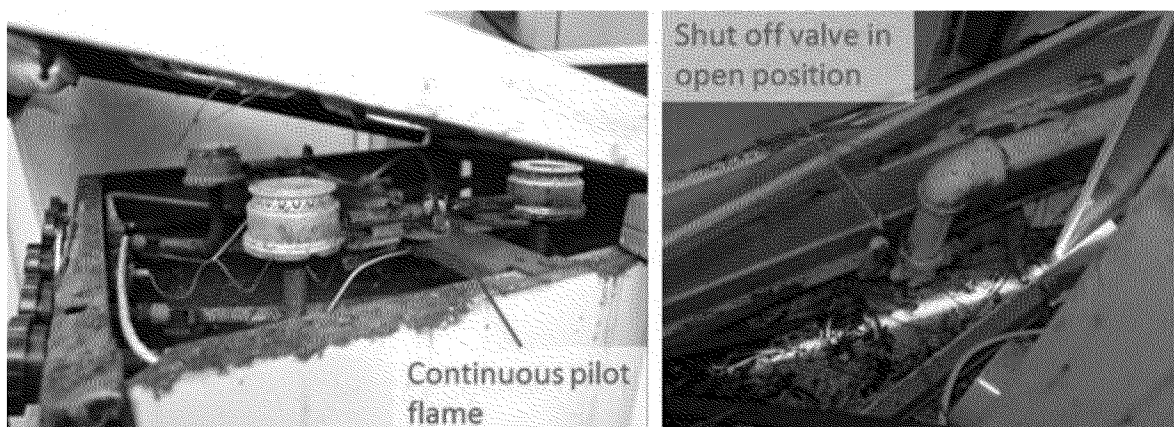
**Stove** – A kitchen stove was present in the subject house. The location of the stove is shown in Figure 20. The appliance shut-off valve for the stove was found in the open position and the stove was equipped with a continuous pilot flame (Figure 21). Based on these facts, the stove cannot be ruled out as a likely ignition source for the incident explosion.

Figure 21. Kitchen stove components. Photographs by Exponent on March 6, 2014.

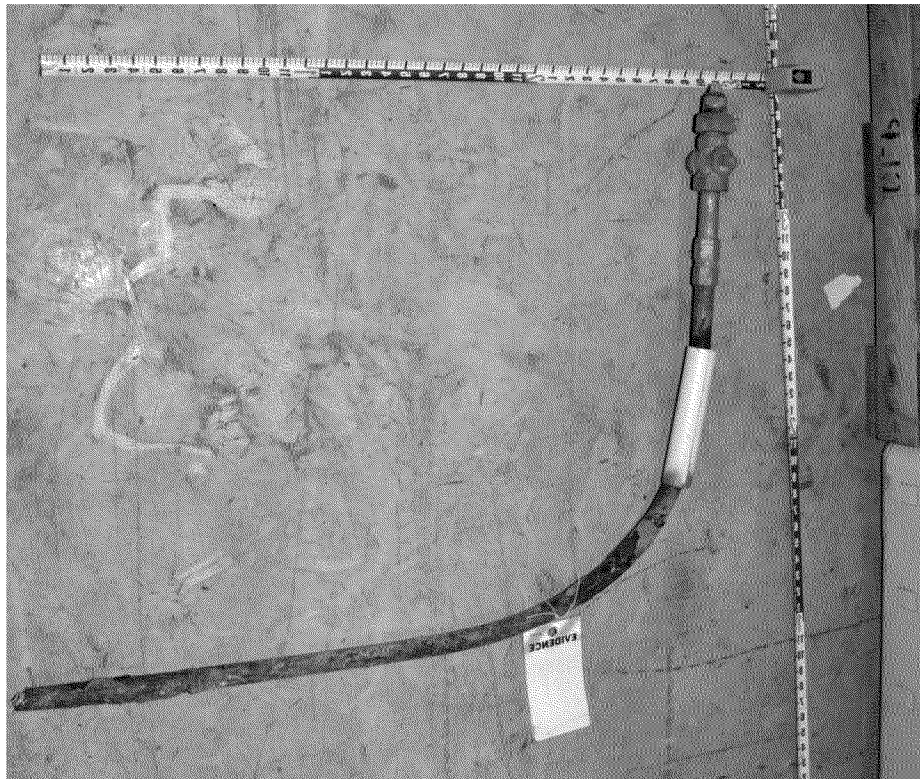
The steel  $\frac{3}{4}$ -inch gas service line and riser are shown in Figure 23. The steel line is approximately five feet in length and inserted with a  $\frac{1}{2}$ -inch plastic line (Figure 24). The line segment terminates in a service head adapter kit and service riser shut-off valve. According to the PG&E leak repair report, the service riser shut-off valve was turned to the closed position during the incident response operations.

Figure 23. Portion of the gas service line to incident house. Photograph by Exponent on March 10, 2014.

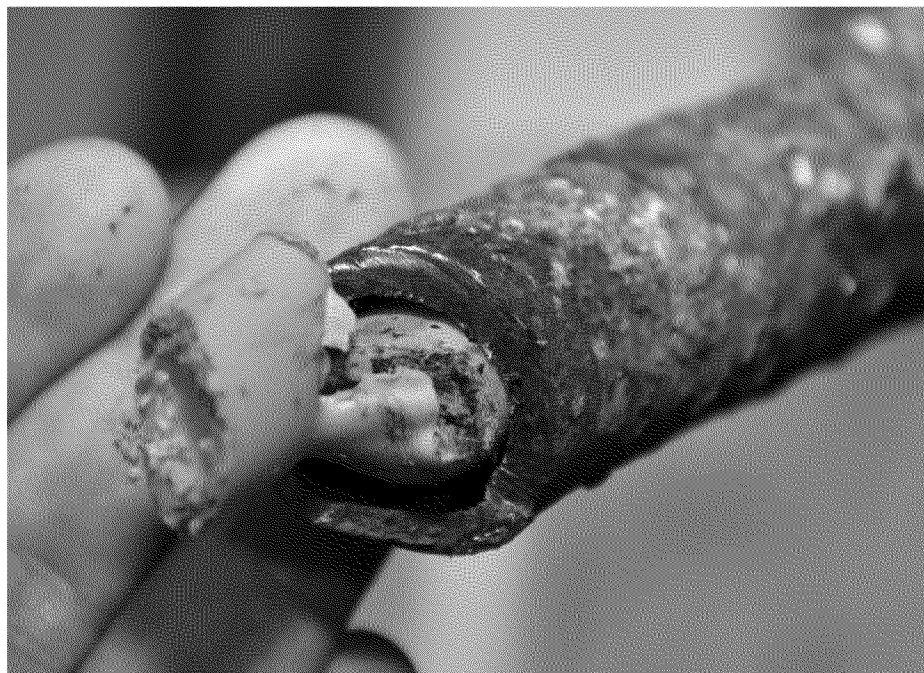
Figure 24. Close-up of the cut end of the gas service line. Photograph by Exponent on March 10, 2014.

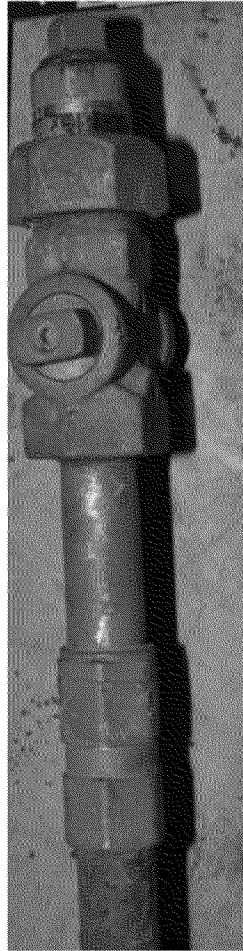
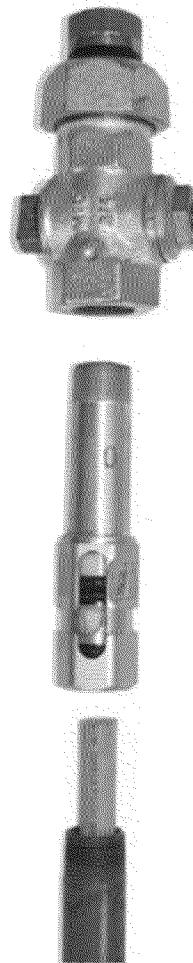
The service head adapter seals the annular space between the 3/4-inch steel pipe and the 1/2-inch plastic pipe. The service head adapter was lacking identifying markings, but appears to be similar to a Perfection 3/4" x (1/2" PE) x 3/4" Extended Service-Head Adapter. The two service head adapters are shown in Figure 25.

Figure 25. Service head adapter. Sources: Photograph by Exponent on March 10, 2014, service head adapter image from PG&E Gas Methods and Procedures document Service-Head Adapter Photo Identification.

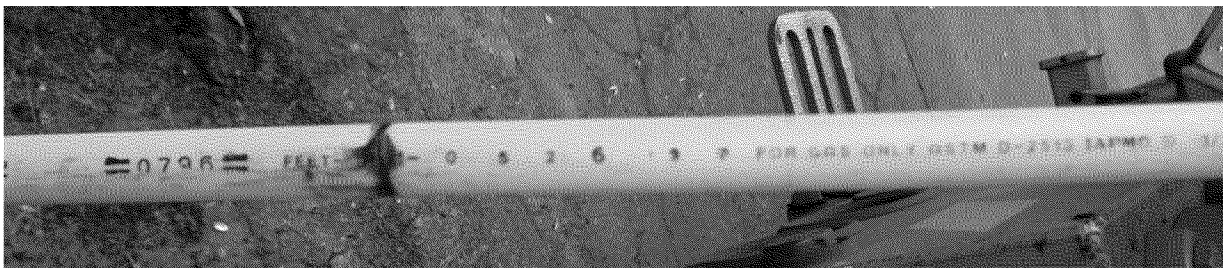
The inserted plastic pipe from the service line had a date code that read “052697”, indicating a date of manufacture of May 26, 1997. The inserted plastic service line is shown in Figure 26.

Figure 26. Inserted plastic service line. Photograph source: PG&E.

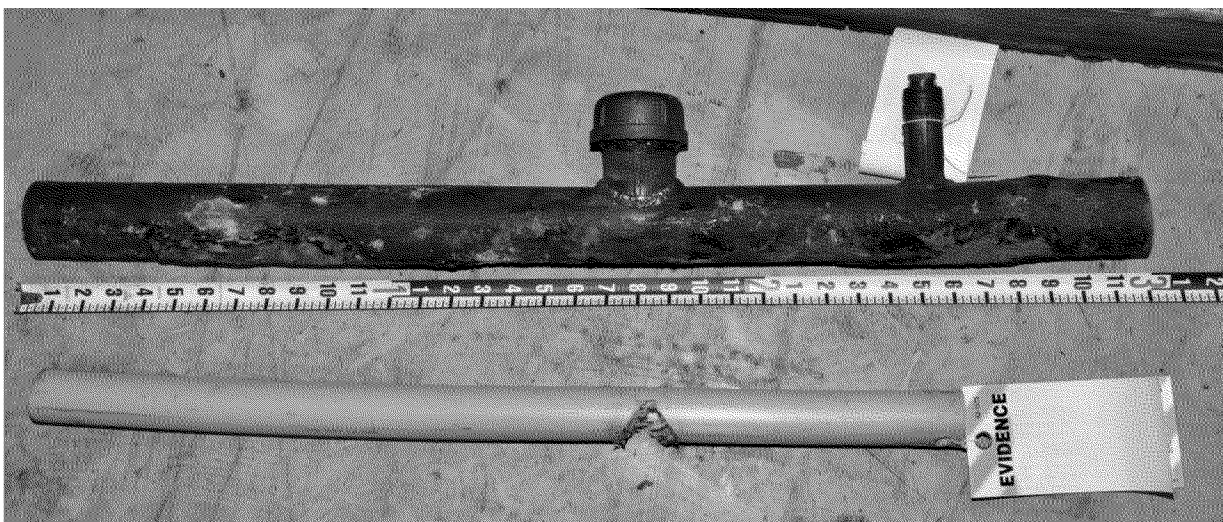
A three foot long section of the 2-inch steel main running along [Redacted] was removed from the bell hole at the intersection of [Redacted] (Figure 27). The steel pipe segment has two welded fittings that were installed on March 3, 2014; one is a one-inch Save-a-valve fitting and the other is a two-inch M/2 line stopper fitting. There were no obstructions either in the main pipe or the two ports.

Figure 27. Portion of the gas main along [Redacted]. Steel pipe (top) with welded fittings and plastic pipe insert. Photograph by Exponent on March 10, 2014.

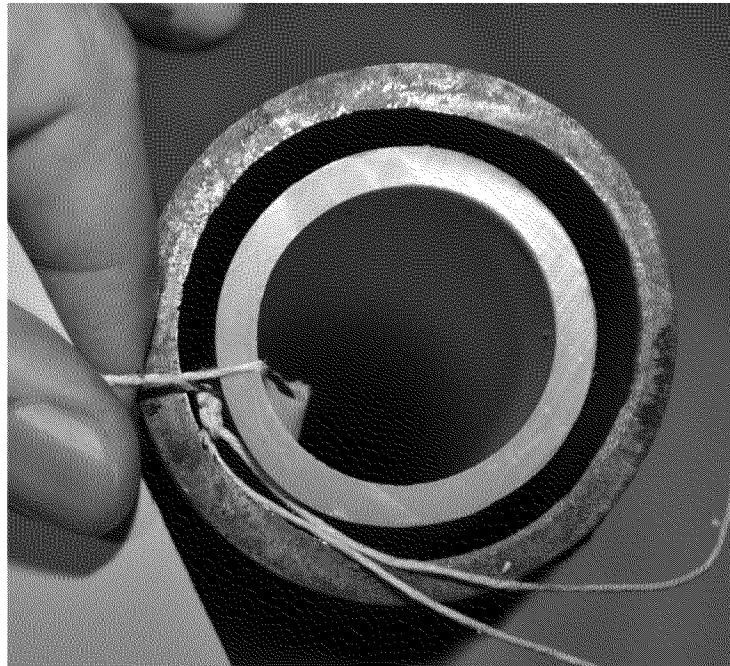
pipes (Figure 28). The plastic line segment has two perforations that correspond to the Save-a-Valve and M/2 fittings (Figure 29). There are some markings printed along the exterior of the pipe. A portion of the writing is associated with the fabrication date; in this particular piece only the year is visible, 1997 (Figure 30).

Figure 28. Plastic gas line inserted into steel line. Photograph by Exponent on March 10, 2014.

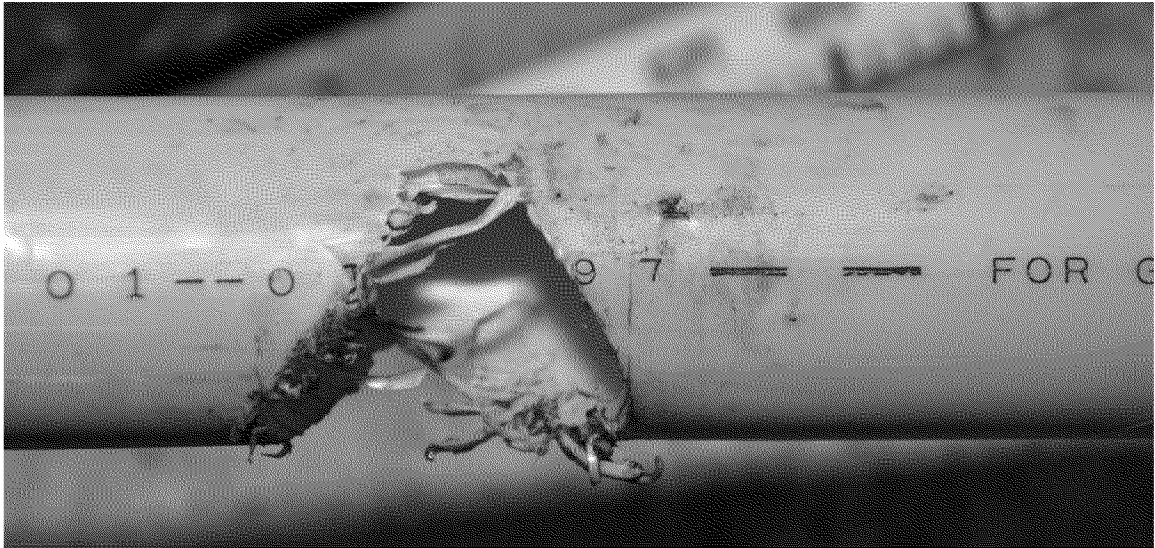
Figure 30. Close-up of the visible portion of the date code on the plastic pipe. Photograph by Exponent on March 10, 2014.

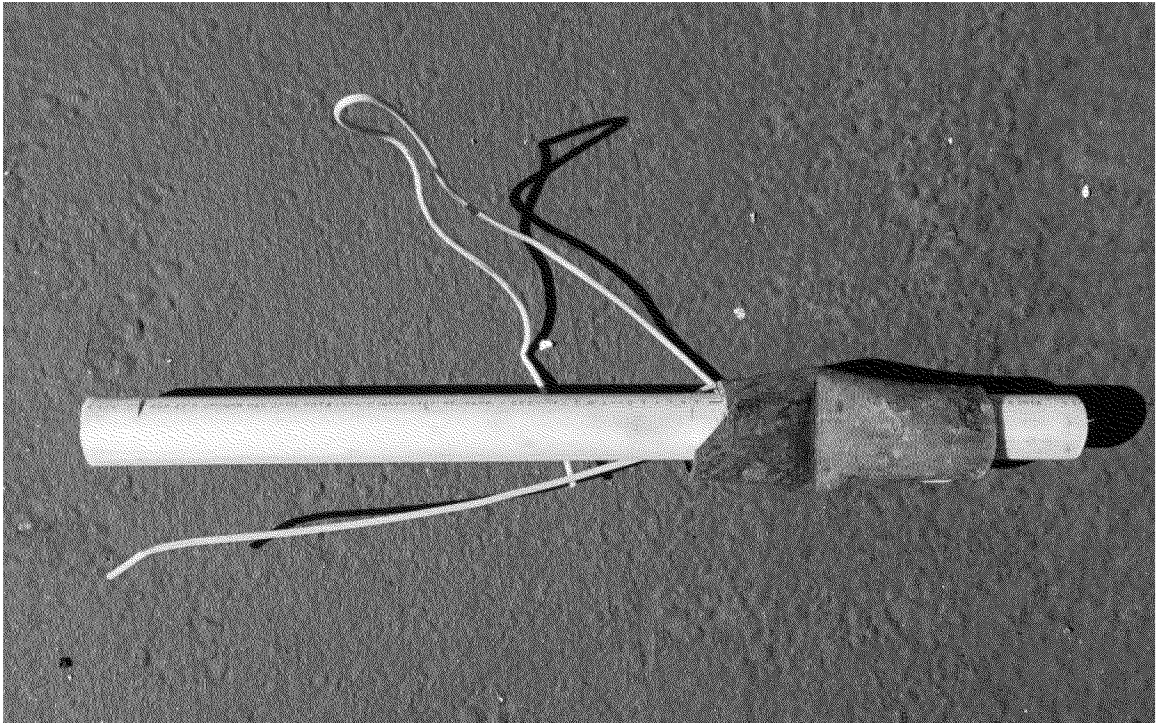
An additional portion of the gas main along Redacted was taken into evidence by PG&E. Exponent did not inspect this item but PG&E provided multiple pictures to Exponent. The additional item corresponds to the west side gas main portion where the line had been squeezed after the incident (Figure 31). The writing on the photographs shown to Exponent indicates that the plastic pipe had a complete manufacturing date code of July 17, 1997 (Figure 32).

Figure 31. West-side squeeze point of the gas main along Redacted Photograph provided by PG&E.

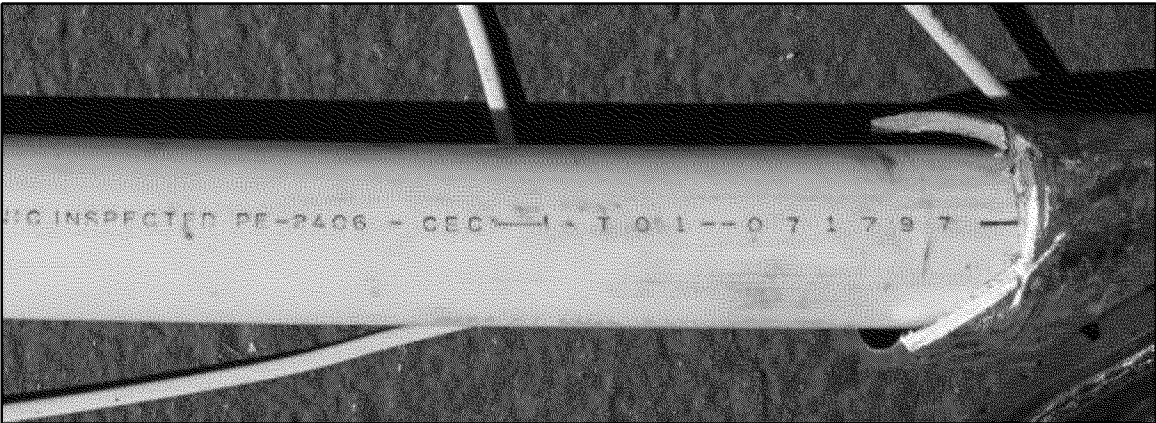
Figure 32. Close-up of the complete manufacturing date code of the plastic gas main. Photograph provided by PG&E.

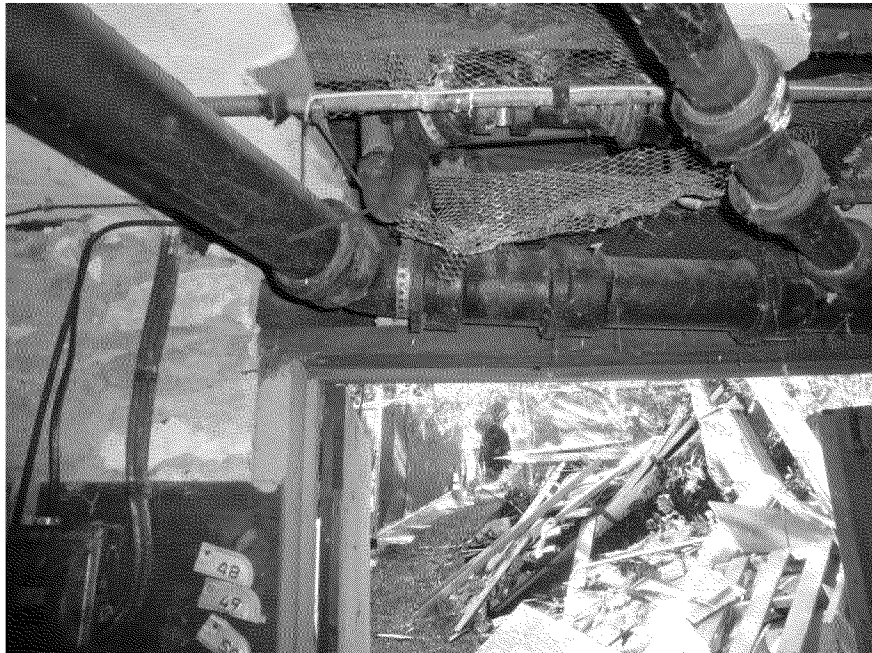
Figure 41. Multiple connections to building sewer system inside residence. Arrow indicates plumbing trap. Photograph from inside residence's basement. Photograph by Exponent on March 11, 2014.

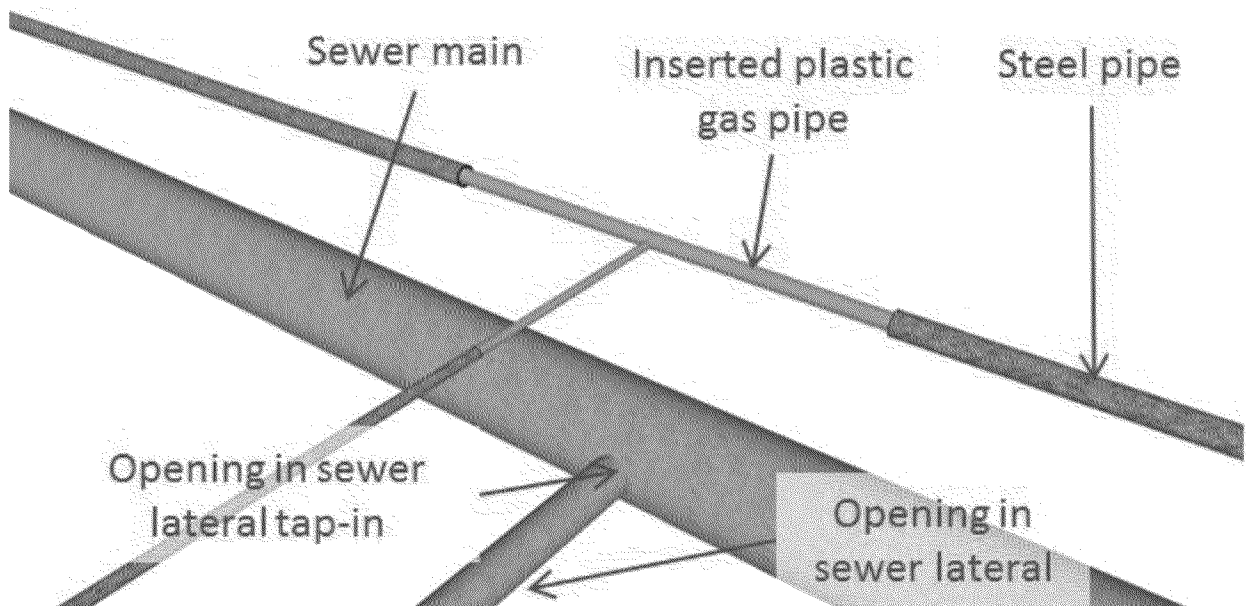
Figure 44. Schematic configuration of the sewer and gas systems in the vicinity of the excavation. Figure not to scale.

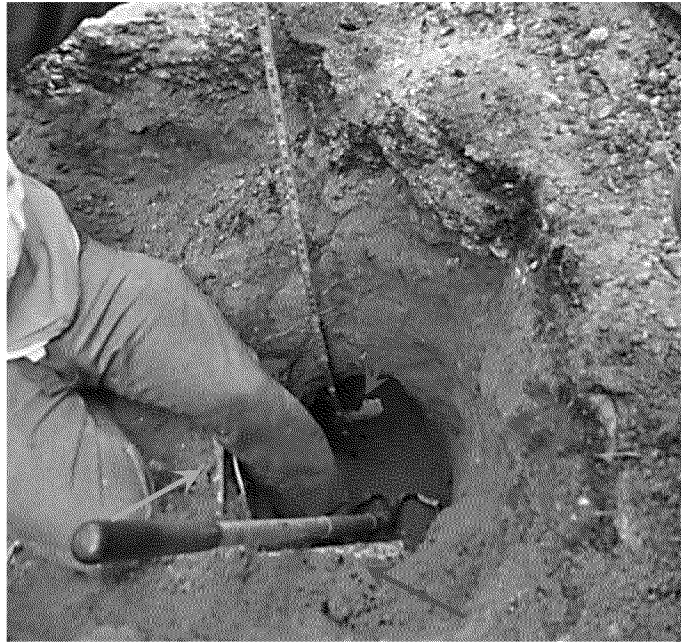
The approximate area previously excavated by PG&E on the day of the explosion (Figure 35) was re-excavated. The depth of excavation continued until a portion of the sewer lateral was exposed (Figure 45). As shown in Figure 46, the presence of a white plastic segment of sewer lateral, and an offset of the pipe, was confirmed by the excavation. The date of installation of the plastic segment in the sewer lateral is unknown. According to statements by John White of Fire Cause Analysis, the homeowners stated that they have not performed sewer replacement/repair work since they purchased the property in 1999.

Figure 45. Excavation to expose sewer lateral at subject residence in the vicinity of gas service tee. Yellow arrow indicates gas main along Re  
Redacted Red arrow indicates gas service line. Green arrow indicates sewer lateral. Photograph by Exponent on March 21, 2014.

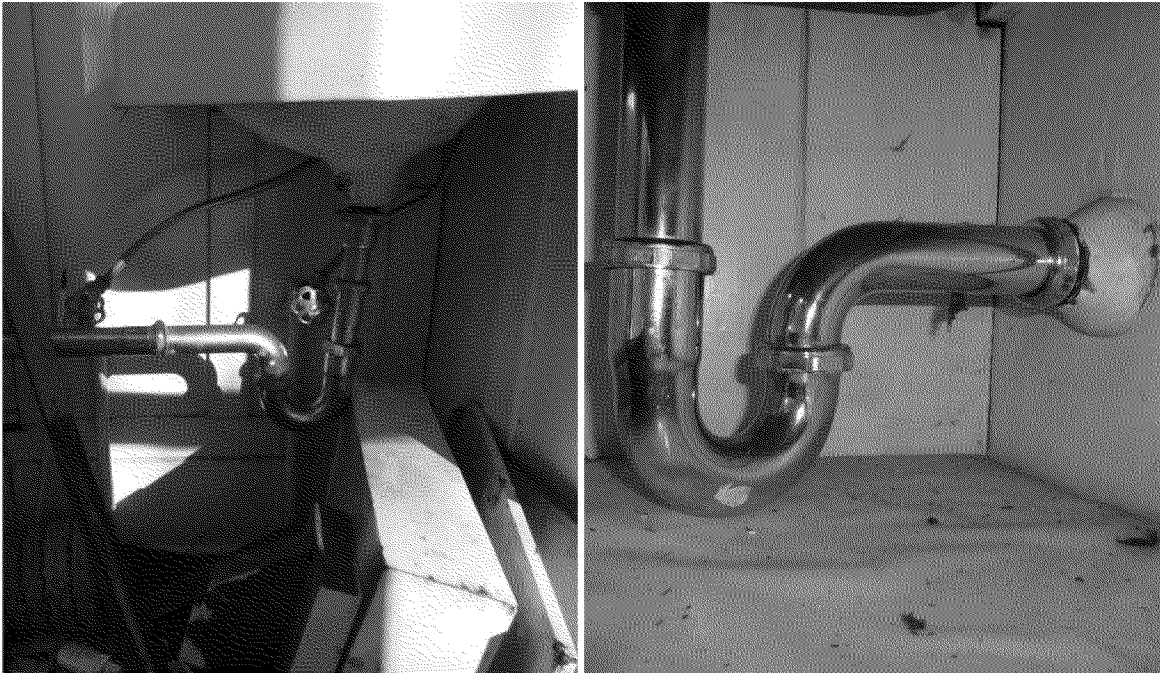
Plumbing traps are curved sections of pipe installed to contain water and provide a barrier to sewer gases entering living space. The water seal trap on any plumbing fixture or plumbing drain line must be filled with water to be effective. At the subject residence, traps were observed in all lines leading to, or in, all plumbing fixtures present.<sup>20</sup> Some of these plumbing fixture traps are shown in Figure 48 and some of the plumbing line traps are shown in Figure 41.

Figure 48. Plumbing traps at bathroom sink (left) and kitchen sink (right). Photographs by Exponent on March 11, 2014.

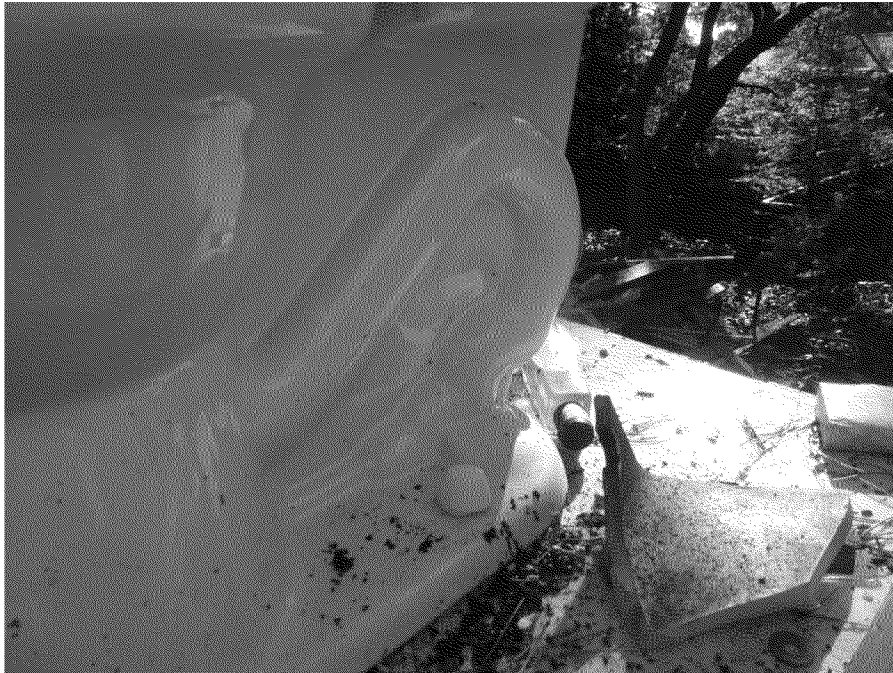
As previously noted, there was no plumbing trap in the sewer drain line section video recorded from the toilet towards the sewer main on Redacted. The only trap along this sewer line path was the integral trap in the toilet fixture. Figure 49 documents this trap.

Figure 49. Toilet drain trap. Photograph by Exponent on March 11, 2014.

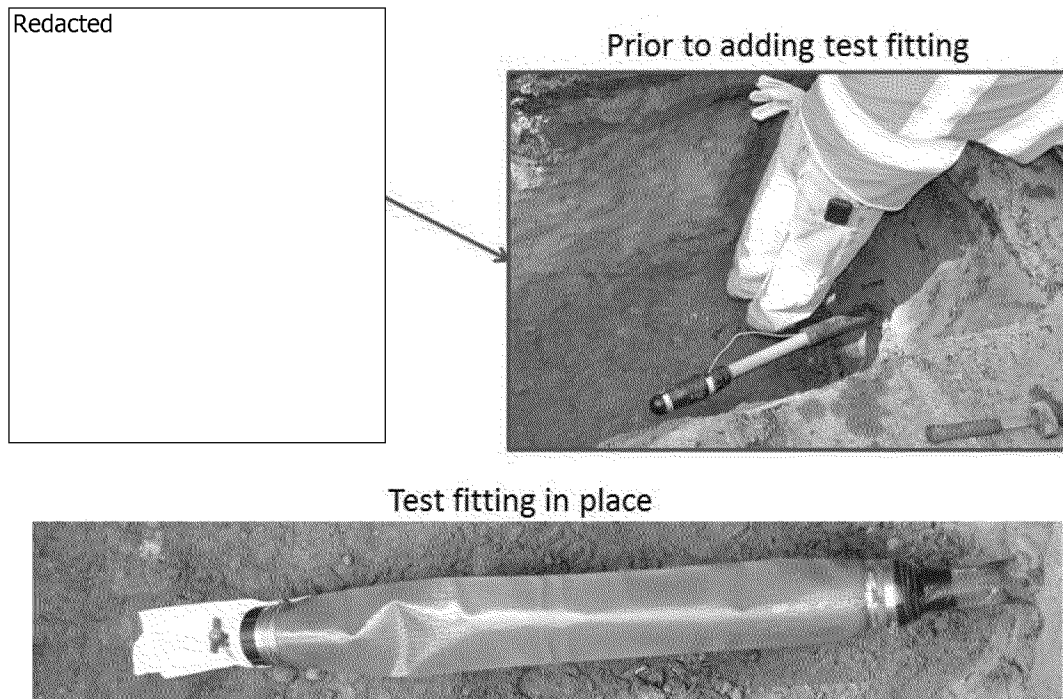
Figure 51. Annotated D-Plat 3956-C08 showing helium injection point and test fitting. Photographs by Exponent on March 21, 2014.

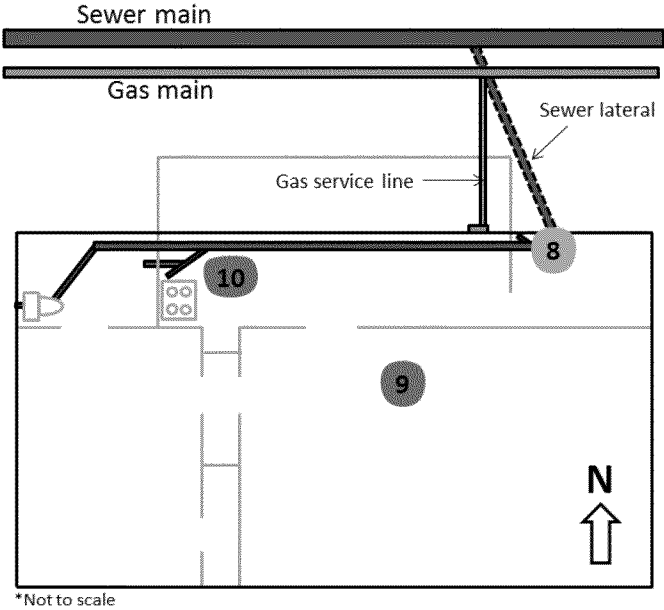
Monitoring Point	
ID	Description
8	cleanout next to water heater
9	near center of basement, over soil
10	void in basement slab

Figure 53. Helium test monitoring points and results at the residence’s basement.

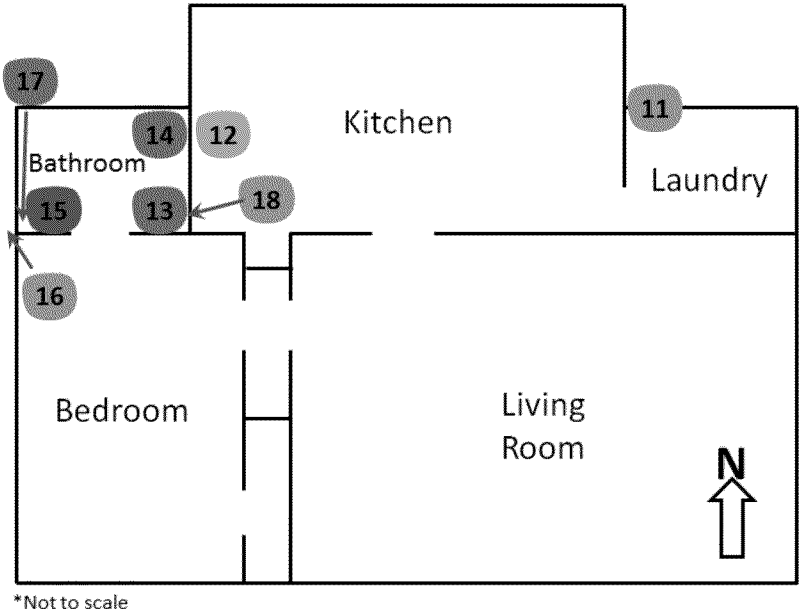
Monitoring Point	
ID	Description
11	laundry room vent
12	kitchen sink
13	bathroom sink
14	bathtub drain
15	Toilet
16	toilet vent
17	toilet tank
18	bathroom vent

Figure 54. Helium test monitoring points and results at the residence’s first floor.

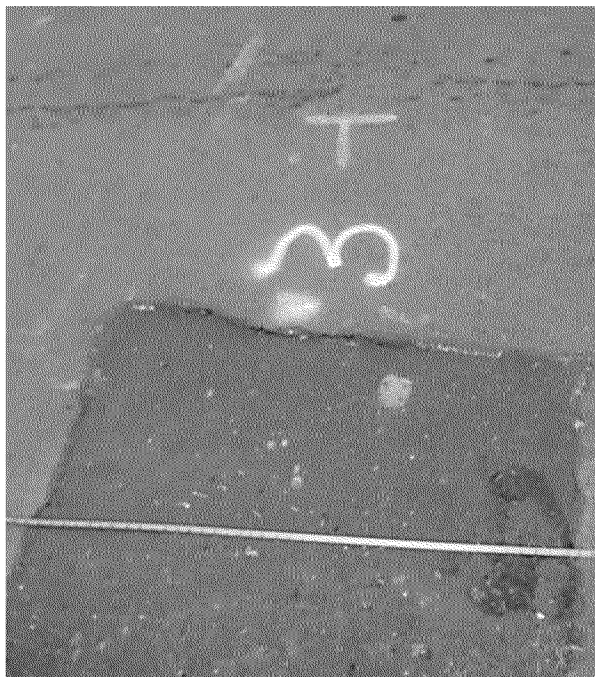
Figure 55. Example monitoring points outside of residence. Monitoring point #3 (left) near excavation performed by PG&E at gas service tee for residence. Monitoring point #19 (right) at sewer manhole near the intersection of Red  
Redacted Photographs by Exponent on March 21, 2014.

Tests 3: a hole created by escaping helium was found close to point 3b.

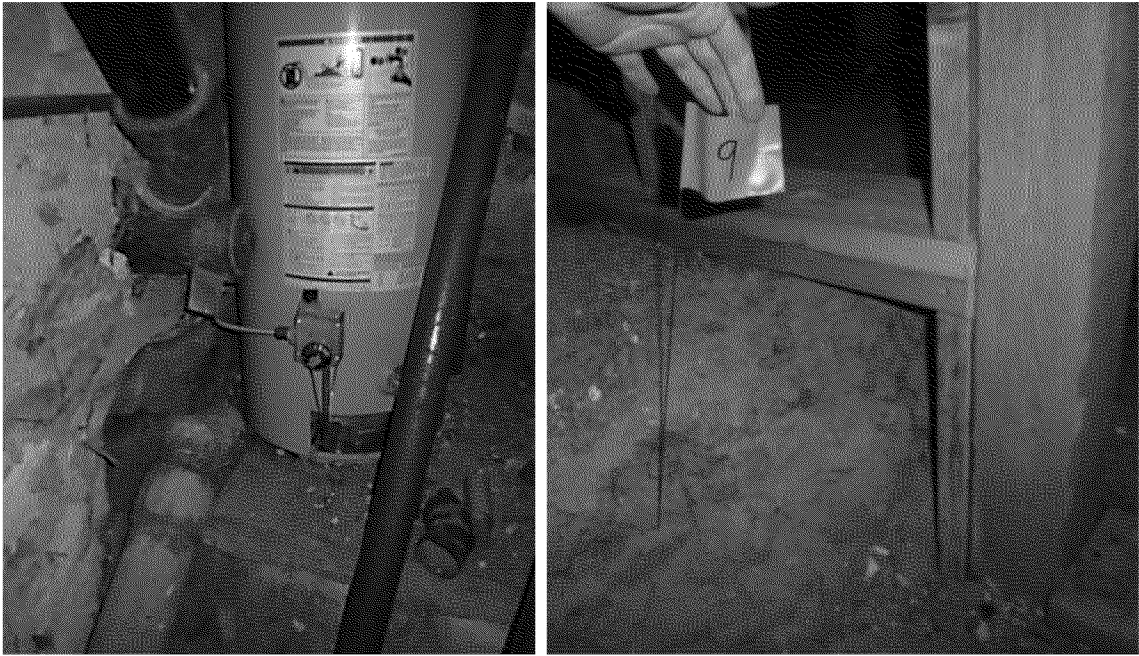
Figure 56. Example monitoring points at the residence's basement. Monitoring point #8 (left) by the cleanout next to water heater. Monitoring point #9 (right) near center of basement, over soil. Photographs by Exponent on March 21, 2014.

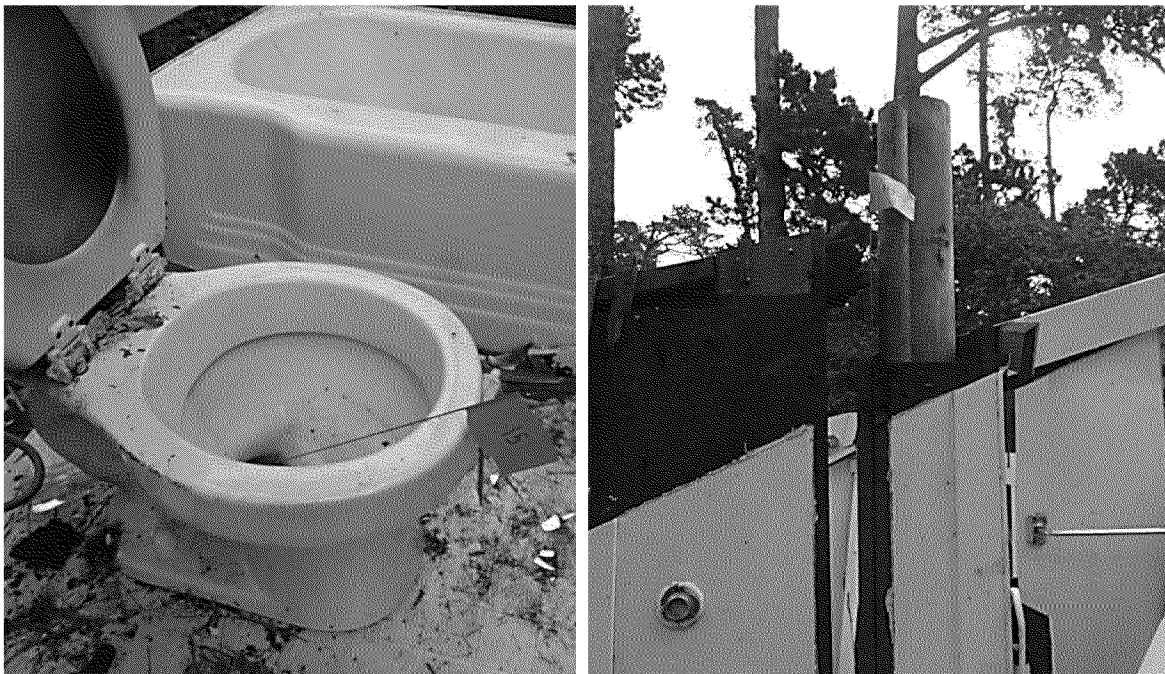
Figure 57. Example monitoring points at the residence's first floor. Monitoring point #15 (left) at the toilet. Monitoring point #18 (right) at bathroom vents. Photographs by Exponent on March 21, 2014.

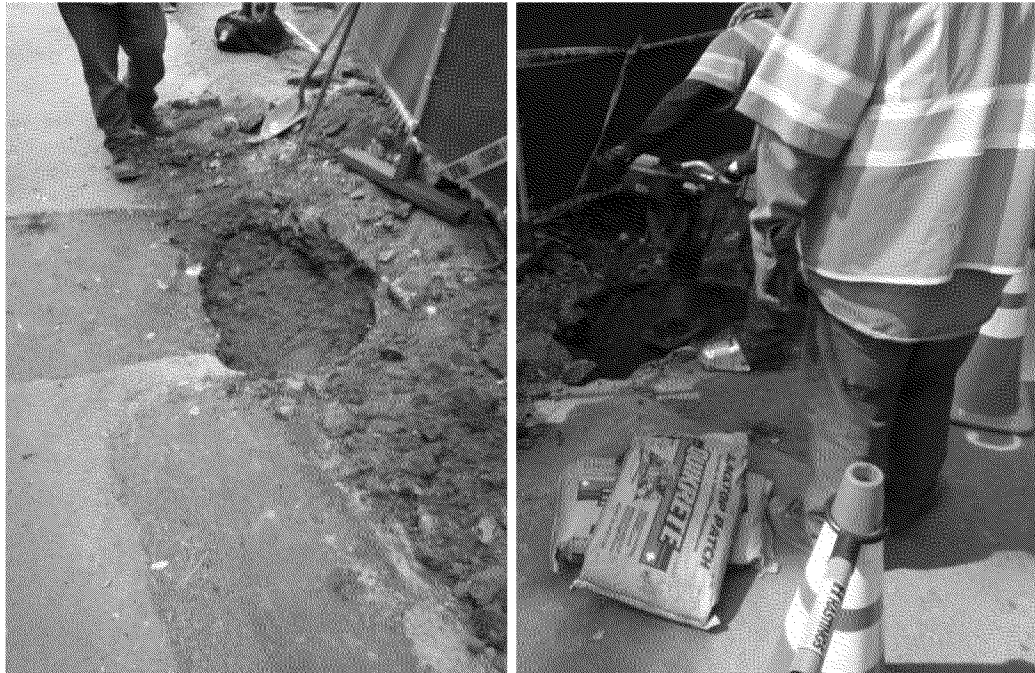
- Test 4: In an attempt to bring soil conditions closer to those present before the gas service tee excavation was performed by PG&E on the day of the explosion, the shallowest eight inches (approximately) of soil above the gas service tee were excavated, re-compacted in place and paved with an asphalt cold patch (Figure 58). Other field conditions were as described for Test 1.

Figure 58. Excavation (left) and re-compaction (right) near gas service tee. Photographs by Exponent on March 21, 2014.

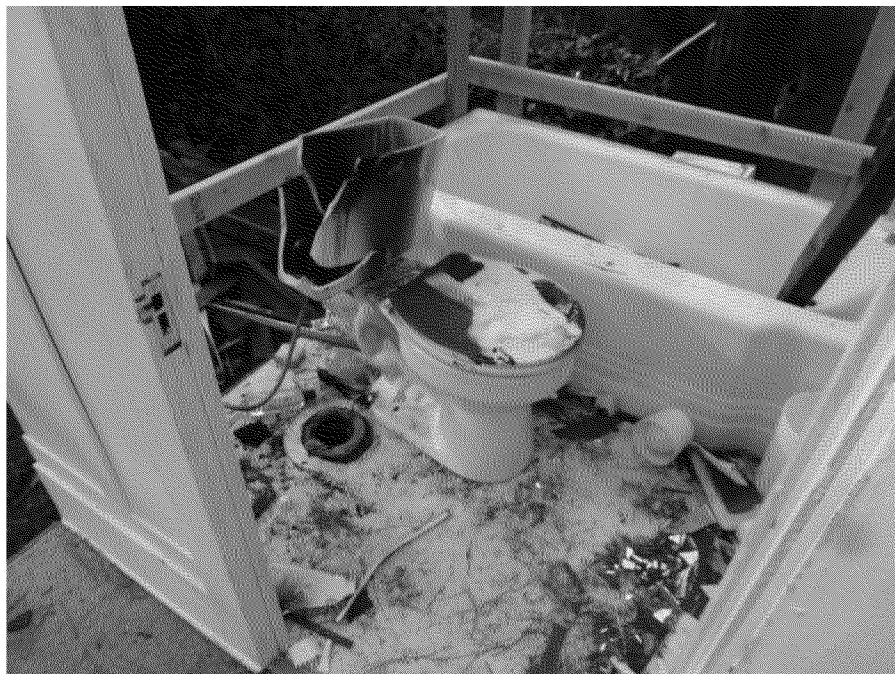
- Test 5: To test the condition of dry toilet bowl on the day of the explosion, the toilet was removed, and helium measurements were taken directly at the toilet sewer raiser (Figure 59). Other field conditions were as described for Test 4.

Figure 59. Monitoring point #15 after removal of the toilet. Photograph by Exponent on March 21, 2014.
