RE: PG&E DRAFT Supplemental Information Report & Materials

At the request of PG&E, Exponent conducted an investigation of the gas leak and subsequent explosion on March 3, 2014 in Carmel-by-the-Sea (Carmel), California. Exponent investigated specific issues relevant to this incident, as requested by the client. Exponent submitted its report to PG&E on April 25, 2014. The scope of services performed during the investigation was focused on the cause of the incident and did not address actions taken by PG&E and other parties with respect to the incident.

Pacific Gas and Electric (PG&E) retained Exponent Failure Analysis Associates (Exponent) to conduct a failure analysis investigation of a gas leak and subsequent explosion on March 3, 2014 in Carmel-by-the-Sea (Carmel), California. Exponent's report was submitted to PG&E on April 25, 2014, and discussed at a City Council Meeting at Carmel city offices on May 6, 2014. Subsequent to that meeting, PG&E requested that Exponent supplement its report to address specific questions raised at the meeting. This supplemental report includes the following:

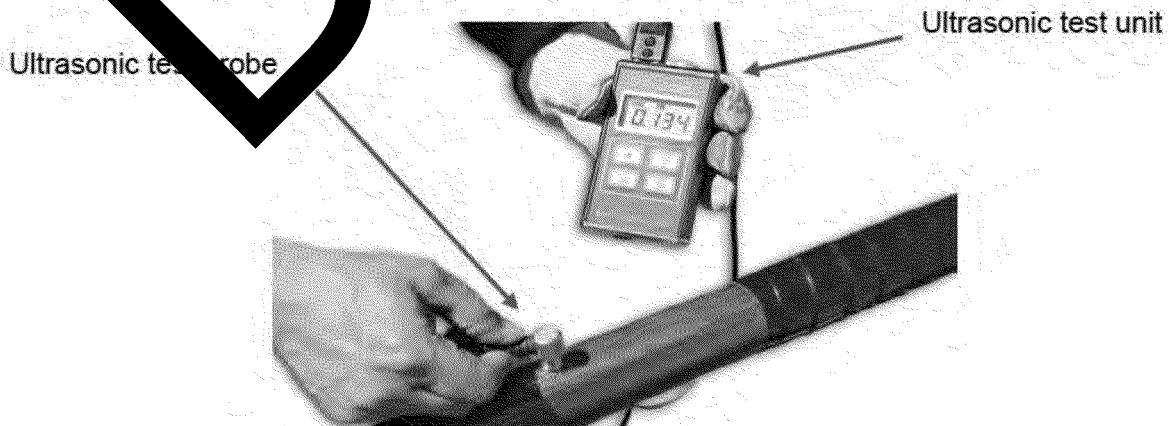
Figure 1. Check Pipeline Wall Thickness

- 1.4 Check steel pipeline wall thickness with an ultrasonic tester. Ensure the wall thickness **does not exceed 0.280**. Refer to Figure 1; "Check Pipeline Wall Thickness" below.

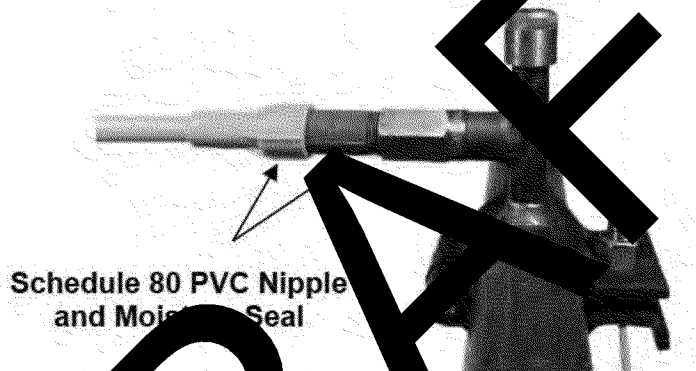
Figure 4. Installation of Schedule 80 PVC Nipple

2.15 Install PVC schedule 80 nipple with moisture seal into the outlet of the moisture shield nut AND hand tighten (Figure 4).
