July 8, 2014

**RE: PG&E DRAFT Supplemental Information Report & Materials**

At the request of PG&E, Exponent conducted an investigation of the gas leak and subsequent explosion on March 3, 2014 in Carmel-by-the-Sea (Carmel), California. Exponent investigated specific issues relevant to this incident, as requested by the client. Exponent submitted its report to PG&E on April 25, 2014. The scope of services performed during the investigation was focused on the cause of the incident and did not address actions taken by PG&E and other parties with respect to the incident.

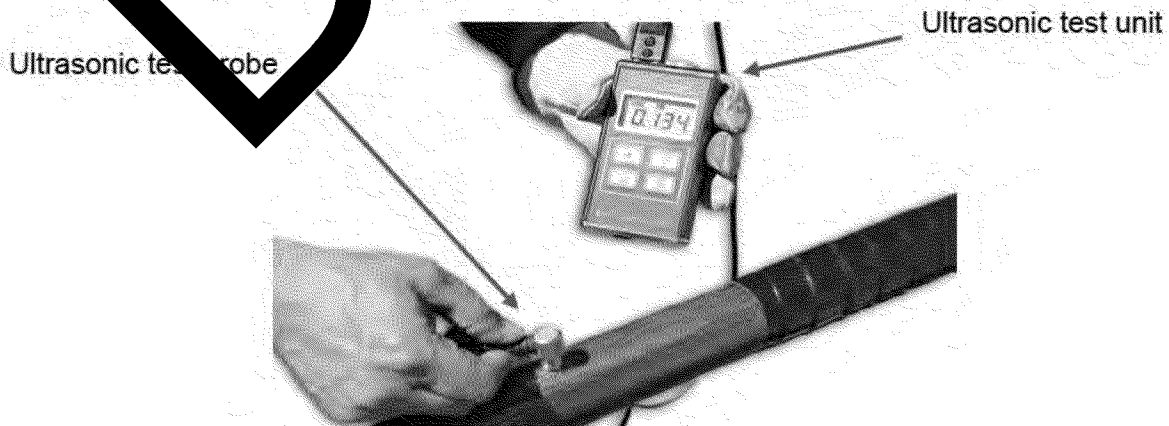
**Figure 1. Check Pipeline Wall Thickness**

- 1.4 Check steel pipeline wall thickness with an ultrasonic tester. Ensure the wall thickness **does not exceed 0.280**. Refer to Figure 1; "Check Pipeline Wall Thickness" below.

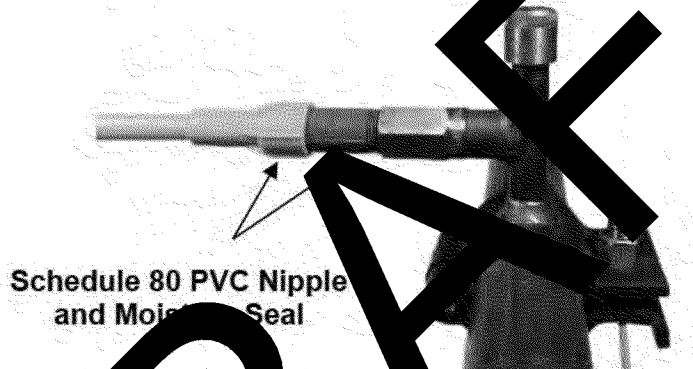
Figure 4. Installation of Schedule 80 PVC Nipple

2.15 Install PVC schedule 80 nipple with moisture seal into the outlet of the moisture shield nut AND hand tighten (Figure 4).
