July 30, 2014

RE: PG&E Supplemental Information Report & Materials

Carmel Gas Incident – Summary Timeline

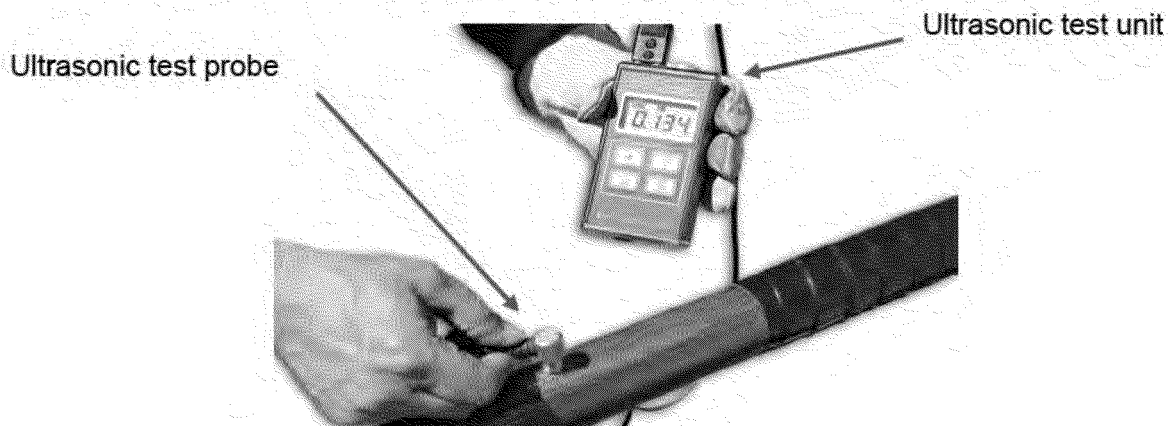
Figure 1. Check Pipeline Wall Thickness

- 1.4 Check steel pipeline wall thickness with an ultrasonic tester. Ensure the wall thickness **does not** exceed 0.280. Refer to Figure 1; "Check Pipeline Wall Thickness" below.

It is recommended to clean steel pipeline in the area to be ultrasonic tested to bare metal AND perform multiple ultrasonic tests in various locations to insure accurate wall thickness measurements.
