July 30, 2014

RE: PG&E Supplemental Information Report & Materials

Pacific Gas and Electric (PG&E) retained Exponent Failure Analysis Associates (Exponent) to conduct a failure analysis investigation of a gas leak and subsequent explosion on March 3, 2014 in Carmel-by-the-Sea (Carmel), California. Exponent's report was submitted to PG&E on April 25, 2014, and discussed at a City Council Meeting at Carmel city offices on May 6, 2014. Subsequent to that meeting, PG&E requested that Exponent supplement its report to address specific questions raised at the meeting. This supplemental report includes the following:

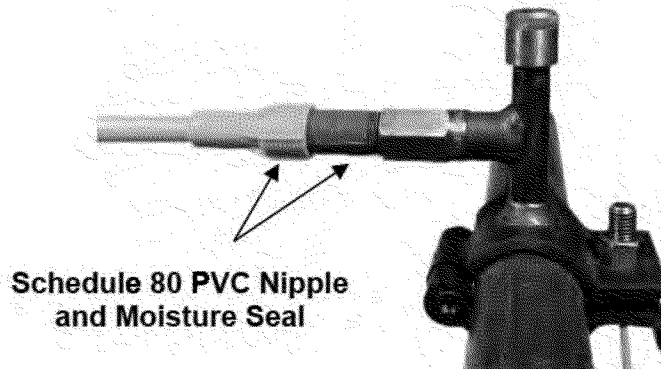
Figure 4. Installation of Schedule 80 PVC Nipple

2.15 Install PVC schedule 80 nipple with moisture seal into the outlet of the line shield nut AND hand tighten (Figure 4).
