RE: PG&E Supplemental Information Report & Materials

Pacific Gas and Electric (PG&E) retained Exponent Failure Analysis Associates (Exponent) to conduct a failure analysis investigation of a gas leak and subsequent explosion on March 3, 2014 in Carmel-by-the-Sea (Carmel), California. Exponent's report was submitted to PG&E on April 25, 2014, and discussed at a City Council Meeting at Carmel city offices on May 6, 2014. Subsequent to that meeting, PG&E requested that Exponent supplement its report to address specific questions raised at the meeting. This supplemental report includes the following:

Carmel Gas Incident – Summary Timeline

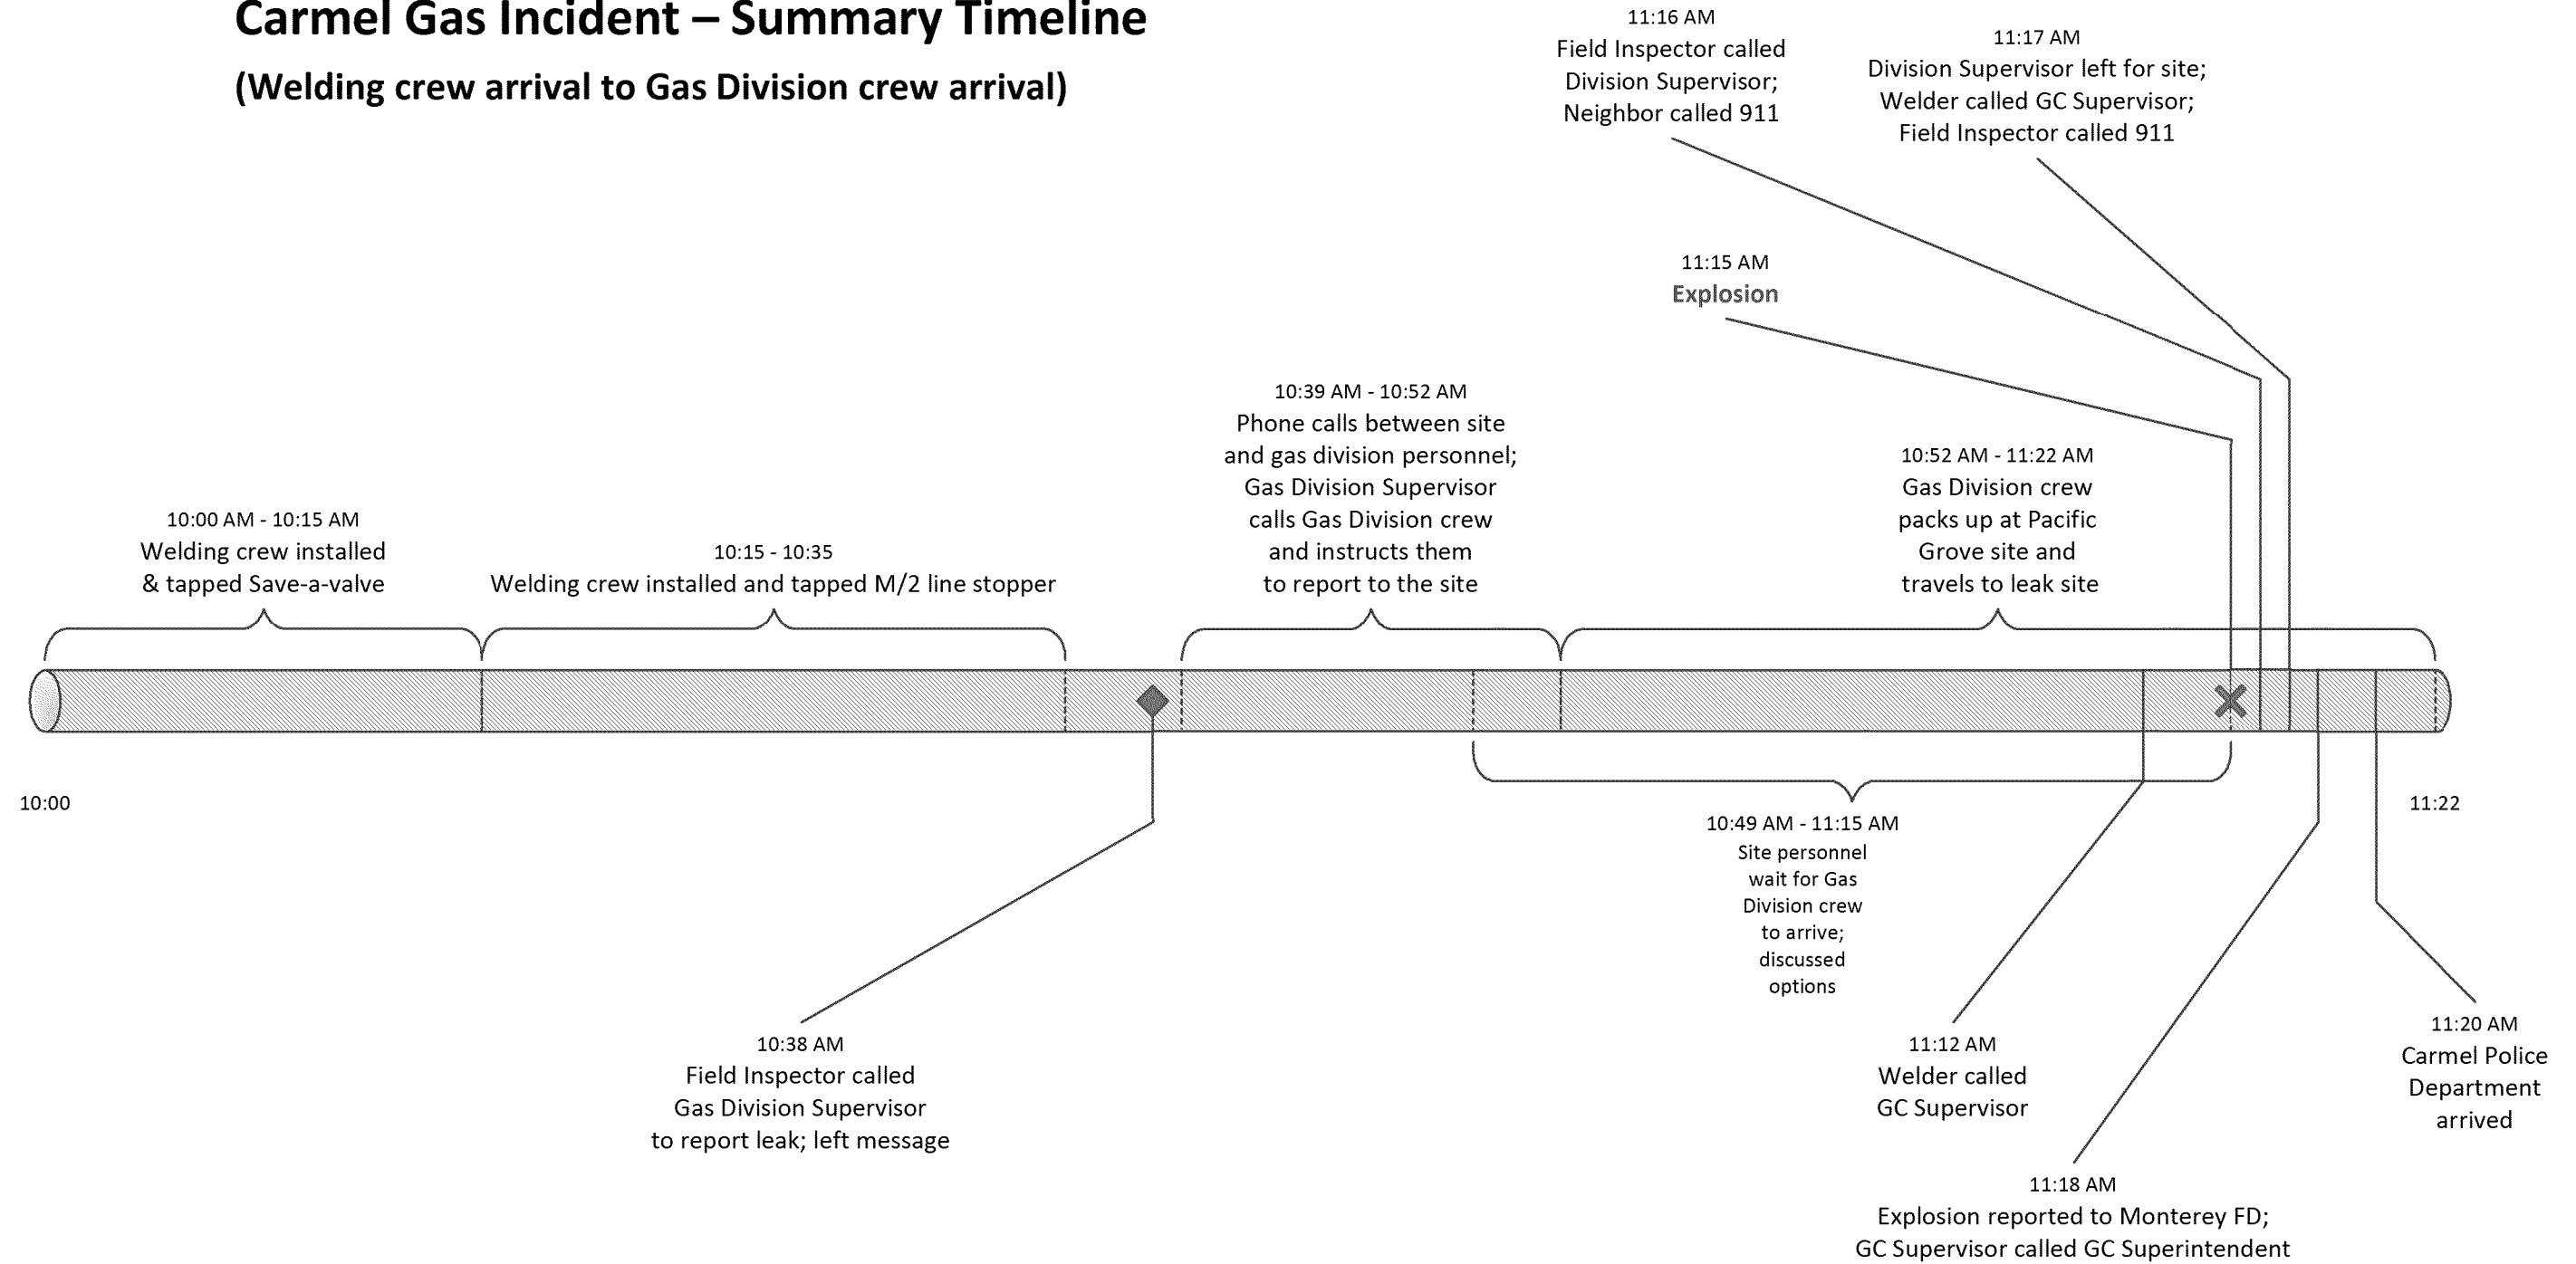
(Welding crew arrival to Gas Division crew arrival)

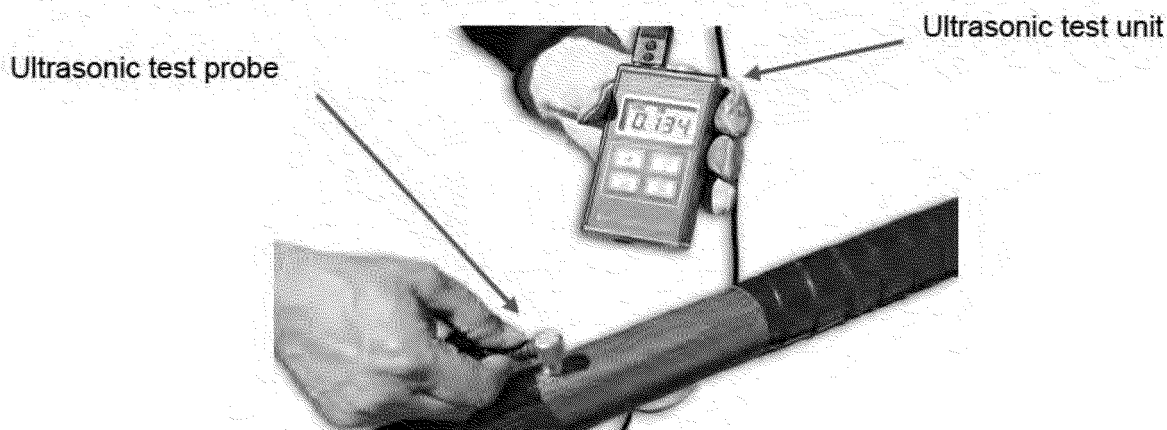
Figure 1. Check Pipeline Wall Thickness

- 1.4 Check steel pipeline wall thickness with an ultrasonic tester. Ensure the wall thickness **does not** exceed 0.280. Refer to Figure 1; "Check Pipeline Wall Thickness" below.
